国際協力機構（JICA）

スリランカ国  
災害脆弱地域における道路防災事業情報収集調査

ファイナルレポート（2/2）  
巻末資料

2012年12月

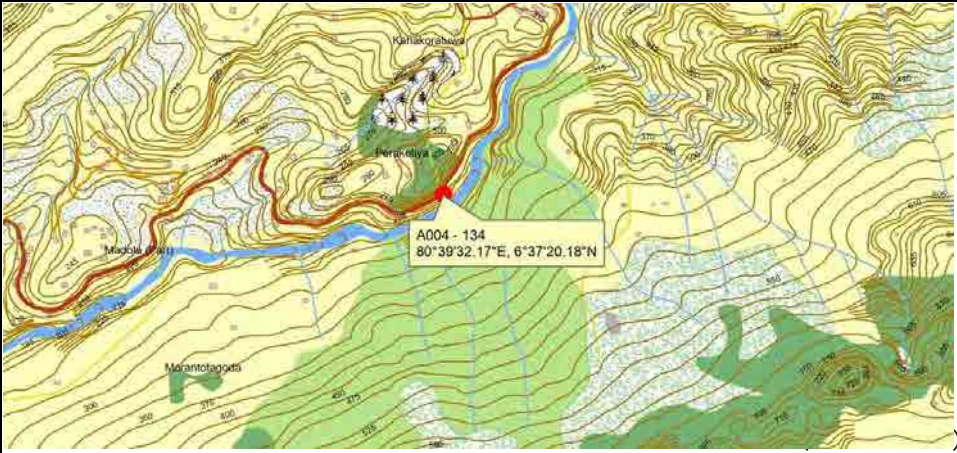
Environmental issue
Comment concerning slope situation	Recorded Disaster : Rock Fall (Boulder Size).  Failure Type: Rock Fall or Rock Slide (Wedge type slide). Geological Condition: Weathered Gneiss with dyke rich in feldspar, Trigger of Failure: (Supposed) Tremendous rainfall + open cracks,  Featured Points: At the beginning part, the slope is rich in cracks and thus rock fall may occur. In contrast, at the ending part, outcrop is rather massive and thus wedge type rock slide can be supposed.  Supposed countermeasures: For rock fall, ring net can be applied. For rock slide, removal of unstable part after detailed investigation can be applied.			50

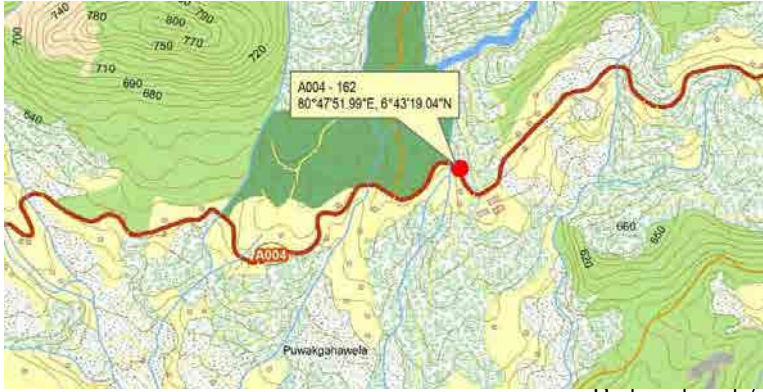
Reduced scale( 1 : )
Comment concerning slope situation	<p>Recorded Disaster : Debris flow in 2003. The source of the debris flow lay at 8km upstream of the river.</p> <p>Failure Type: Debris flow involving big boulder, the diameter of which exceeds 5m,            Geological Condition: Colluvium or debris flow deposit,            Trigger of Failure: (Supposed) Tremendous amount of rainfall triggered collapse in the middle of the mountain,</p> <p>Supposed countermeasures: Special investigation against debris flow is recommended before setting up appropriate countermeasures.</p>

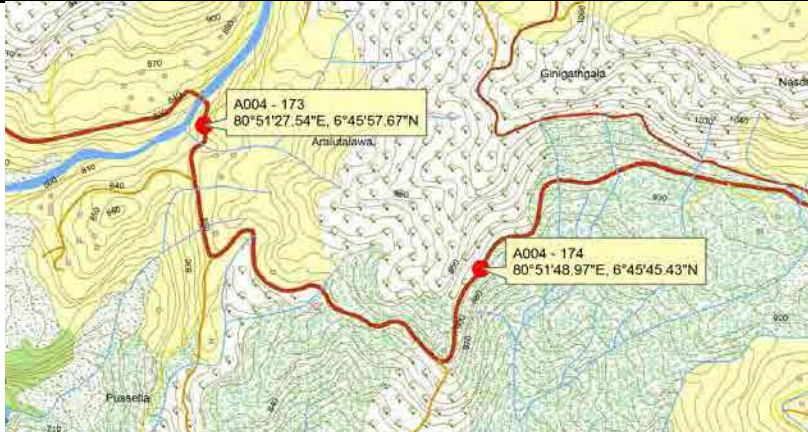
Environm ental issue
Comment concerning slope situation	<p>Recorded Disaster : Not clear but traces of collapse can be seen.</p> <p>Failure Type: Slope failure involving residual soil and weathered rock.,  Geological Condition: Residual soil, highly weathered feldspar quartzite,  Trigger of Failure: (Supposed) Rainfall,</p> <p>Featured Points: Pylons of high-tension cables are located adjacent to the shoulder of the slope. Thus retrogressive failure from the shoulder may damage the pylons.</p> <p>Supposed countermeasures: Gentler gradient of slope, or grating crib works and ground anchors.</p>			110

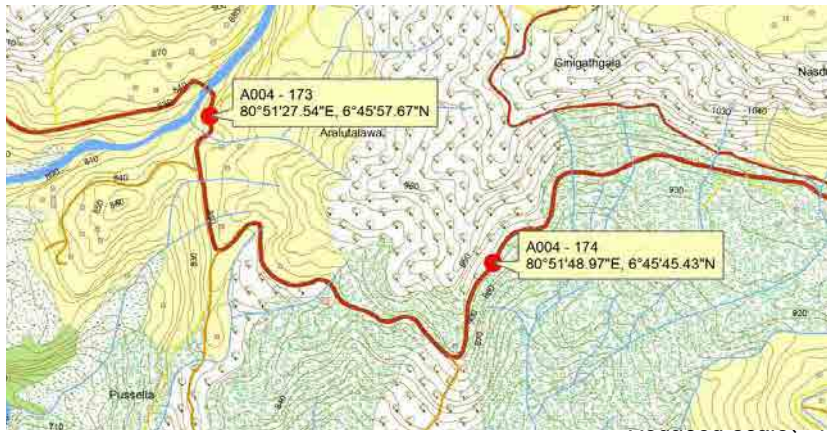
Comment concerning slope situation	<p>There are 2 slope failure sites in this section, at 175/1 and 175/3; 175/1 is larger.</p> <p>Recorded Disaster : Not clear but traces of collapse can be seen.</p> <p>Failure Type: Slope failure involving residual soil and weathered rock.,</p> <p>Geological Condition: Residual soil, highly weathered rock,</p> <p>Trigger of Failure: (Supposed) Rainfall,</p> <p>Featured Points: Slope failure in weathered rock, remarkable gully erosion.</p> <p>Supposed countermeasures: Gentler gradient of slope, or grating crib works and ground anchors.</p>

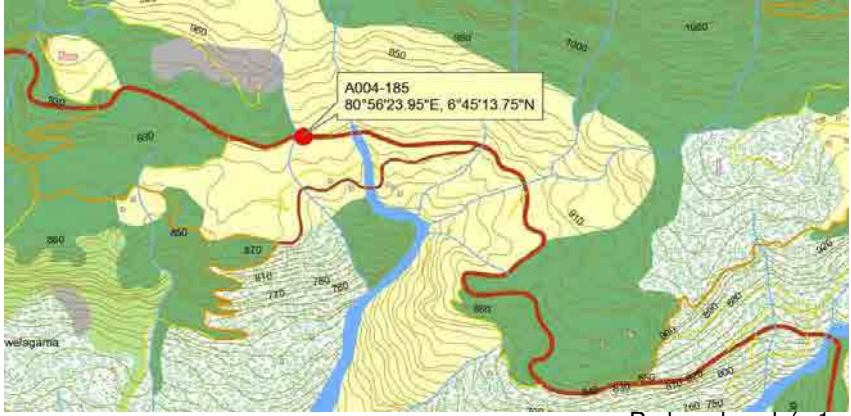
Reduced scale( 1: )
Comment concerning slope situation	<p>Recorded Disaster : Minor settlement of the road surface.</p> <p>Failure Type: Landslide.</p> <p>Geological Condition: Colluvium,</p> <p>Trigger of Failure: (Supposed) Rise in groundwater,</p> <p>Featured Points: Retaining wall by gabion was installed on some parts of the toe.</p> <p>Supposed countermeasures: Surface drainage system and underground drainage system.</p>

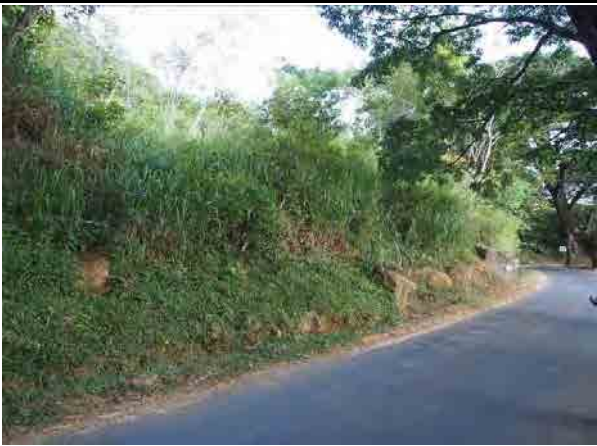
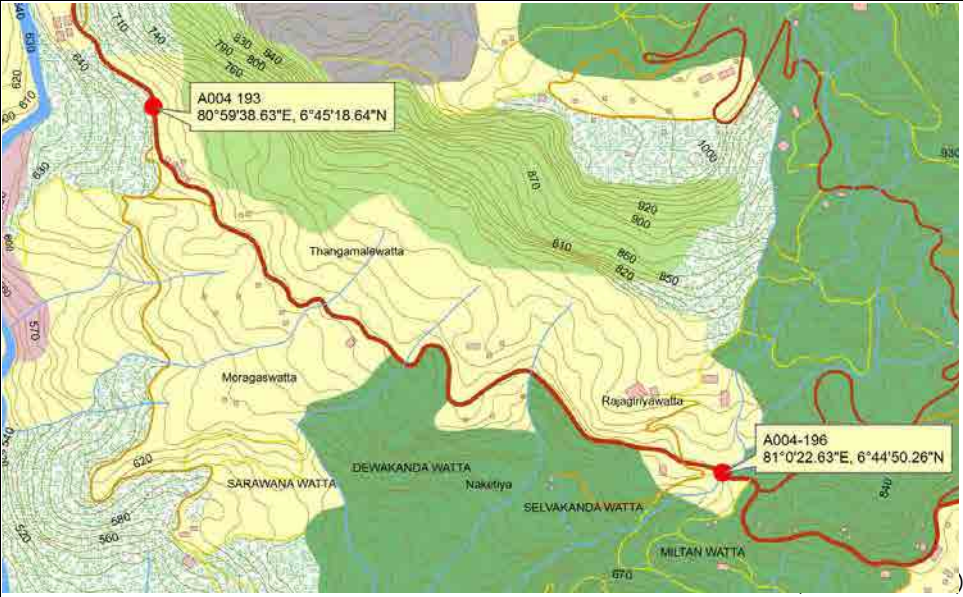
Environmental issue
Comment concerning slope situation	<p>Recorded Disaster : Since 2007 (or 2008), during every rainy season, debris from the toe of the landslide has covered the road. Thus RDA needs to keep readiness to immediately respond to the road closing debris.</p> <p>Failure Type: Landslide.            Geological Condition: Colluvium,            Trigger of Failure: (Supposed) Rise in groundwater,</p> <p>Featured Points: 13houses are located downstream of the toe of the landslide.</p> <p>Supposed countermeasures: Surface drainage system and underground drainage system.</p>			10

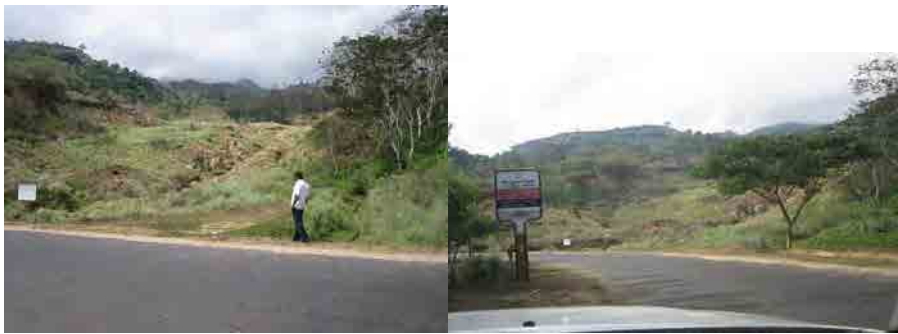
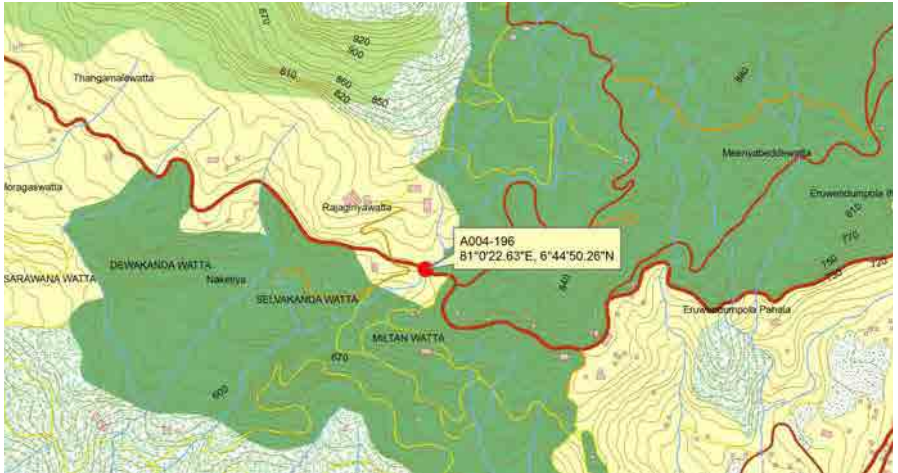
Reduced scale( 1 : )
Comment concerning slope situation	<p>Recorded Disaster : First landslie occured in 19 Nov 1997(according to residents). In that slide 06 houses were destroyed, The previous bridge (Iron bridge) was thrown away &amp; cultivations in downstam areas were destroyed. After major slide, in some rainy seasons, small sliding/collapsing/flowing debris takesplace. Insted of previous bridge on this A004 road, culvert has been constructed on filled ground.</p> <p>Failure Type: Landslide.            Geological Condition: Mainly weathered rock (Fractured Zone) along with colluvium, Natural Stream present. Flows along this fractured zone.            Trigger of Failure: (Supposed) Rise in groundwater,            Topographic Condition: Water collecting valley (formed probably because of fractured zone) , The stream is running accross the road.</p> <p>Featured Points: The affecting landslide seems to be one of devided landslide from much wider series of landslides. Which is mainly composed of weathered rock which seems to be low resistant because of weathering and prone to alter into clay. At the head scarps at the shoulder and upper-middle of the affecting landslide, outcrops of weathered rocks At the toe of the landslide, some springs were observed.</p>

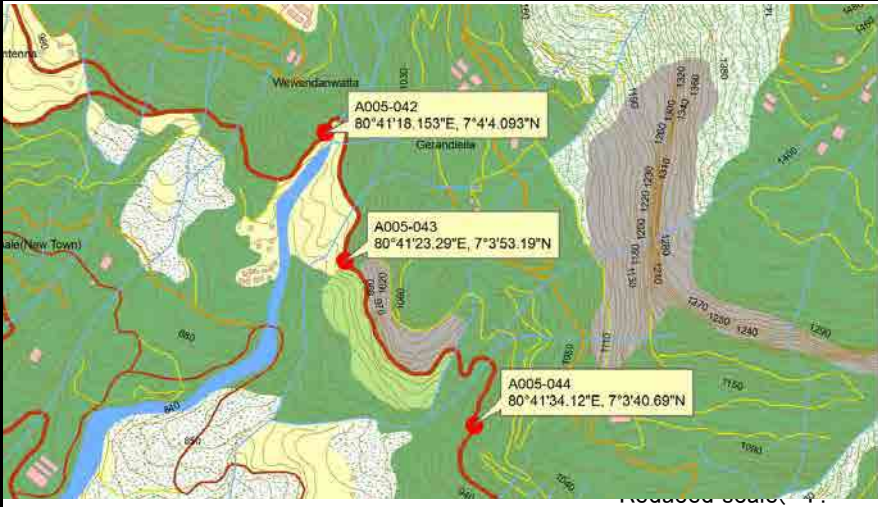
Comment concerning slope situation	<p>Recorded Disaster : Periodical records of landslide activity. No damage on A005 but local residences and public building locating around the head scarp were damaged by the landslide. Another national road running around the head scarp was also damaged.</p> <p>Failure Type: Landslide.          Geological Condition: Colluvium,          Trigger of Failure: (Supposed) Rise of groundwater,</p> <p>Featured Points: The landslides at this location is composed of 3 blocks of landslides; 1 upper landslide and 2 lower landslides. The 2 lower landslides face the road of A005 and divided by a ridge of base rock.          The landslides are under investigation by NBRO. The total length of the landslides is estimated to be 900 ~ 1,000m.          No damage has been reported so far, but blockade by debris from the toe of the lower landslide can be considered as possible damage.</p> <p>Supposed countermeasures: Surface drainage system and underground drainage system</p>

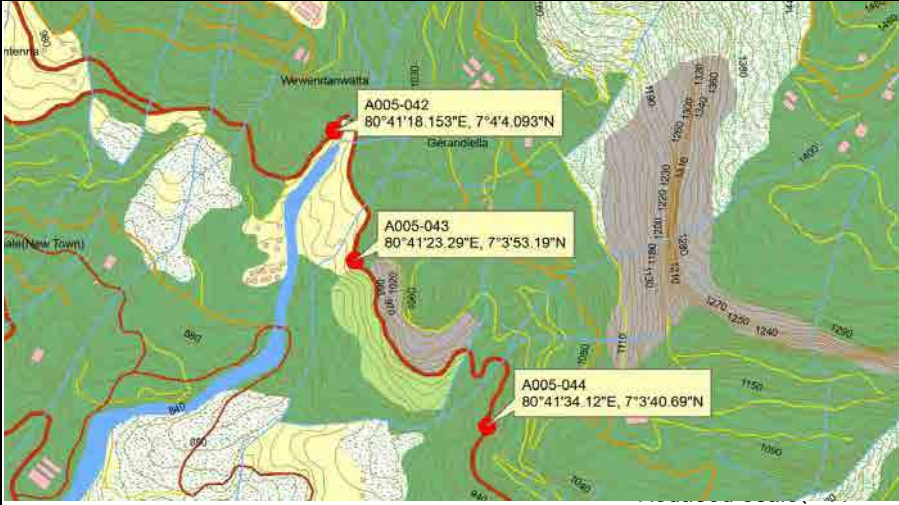
Comment concerning slope situation	<p>Recorded Disaster : unclear, but small rock falls are confirmed during the site visit.            Failure Type: Rock slide in weathered rock (feldspar quartzite), toppling may occur under this situation.            Geological Condition: Weathered rock rich in vertical open cracks,            Trigger of Failure: (Supposed) Rainfall,</p> <p>Featured Points: There are two factors for possible hazards; fragile rock property and vertical open cracks.            Feldspar quartzite has relatively poor resistance property against weathering. At the site, outcrops may be seen as sound and strong. However with a hit of a rock hammer, surface of outcrop can be broken easily with muffled sound.            Vertical cracks filled with clayey soil can be easily detected on site. Open vertical cracks as well.</p> <p>Supposed countermeasures: Drainage ditches along the shoulder of the slope along with vertical drainage. Fixed with rock bolts or removal of unstable parts.</p>

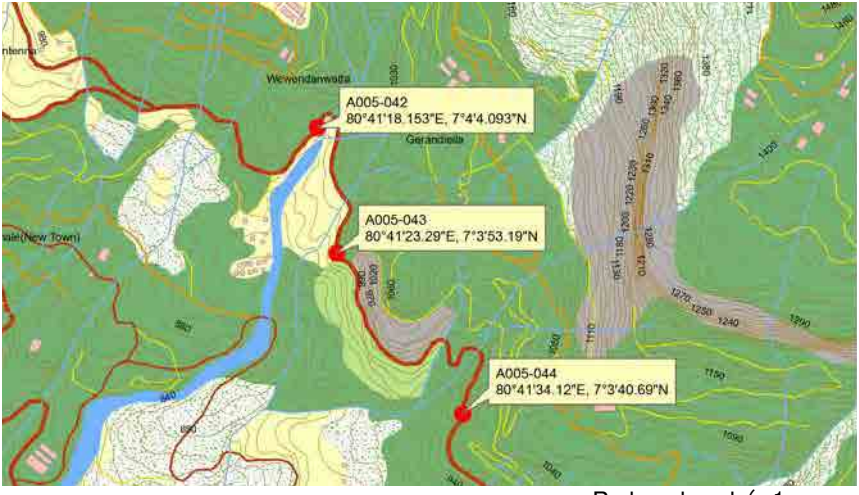
Reduced scale( 1: )
Comment concerning slope situation	<p>Same situation can be seen at Km 46/5.</p> <p>Recorded Disaster : unclear, but small rock falls are confirmed during the site visit.  Failure Type: Rock slide in weathered rock (feldspar quartzite), toppling may occur under this situation.  Geological Condition: Weathered rock rich in vertical open cracks,  Trigger of Failure: (Supposed) Rainfall,</p> <p>Featured Points: There are two factors for possible hazards; fragile rock property and vertical open cracks.  Feldspar quartzite has relatively poor resistance property against weathering. At the site, outcrops may be seen as sound and strong. However with a hit of a rock hammer, surface of outcrop can be broken easily with muffled sound.  Vertical cracks filled with clayey soil can be easily detected on site. Open vertical cracks as well.</p> <p>Supposed countermeasures: Drainage ditches along the shoulder of the slope along with vertical drainage. Fixed with rock bolts or removal of unstable parts.</p>

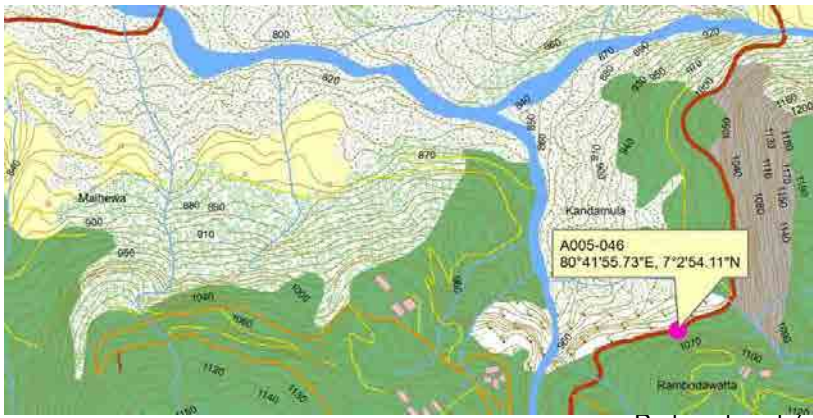
Reduced scale( 1: )
Comment concerning slope situation	<p>Recorded Disaster : unclear, but traces of rock failure were confirmed during the site visit. Rock fall and small rock slide often occur during heavy rains.                      Failure Type: Rock slide in weathered rock, rock fall.                      Geological Condition: Weathered rock rich in vertical open cracks along with foliation,                      Trigger of Failure: (Supposed) Rainfall,</p> <p>Featured Points: Rock wall with almost perpendicular slope.                      Well developed foliation and vertical cracks are primary causes of possible failures..</p> <p>Supposed countermeasures: Drainage ditches along the shoulder of the slope along with vertical drainage. Removal of unstable parts and installation of ring net.</p>

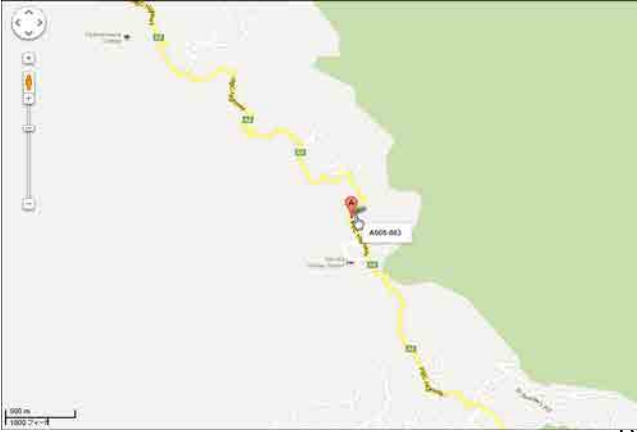
Environmental issue
Comment concerning slope situation	<p>Recorded Disaster : Damage at shoulder, subsidence and cracks on the pavement.</p> <p>Failure Type: Slope Slope failure.            Geological Condition: Colluvium,            Trigger of Failure: (Supposed) Relaxed shoulder caused by a too steep gradient of slope as 54 degrees,</p> <p>Featured Points: Steep slope composed of colluvium declines from the shoulder of the road. It is likely that the damage was caused by loose shoulder relaxed by the too steep gradient of slope.</p> <p>Supposed countermeasures: Drainage system along the shoulder, retaining wall or grating cribs with ground anchor if necessary.</p>			55

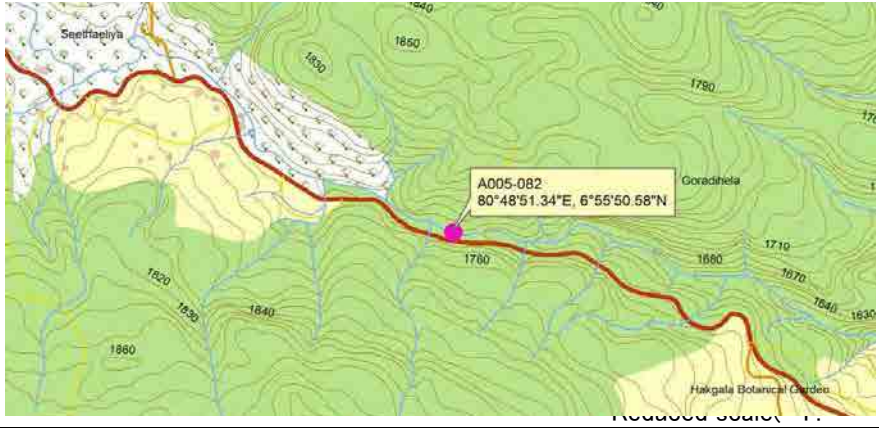
Comment concerning slope situation	<p>Recorded Disaster : Slope failures were seen at the site.            Failure Type: Slope failure in weathered rock.            Geological Condition: Weathered rock and residual soil.            Trigger of Failure: (Supposed) Rainfall,</p> <p>Featured Points: Gradient of slope is apparently too steep for the heavily weathered gneiss confirmed at the site. The heavily weathered gneiss showed fragile strength property. Gully erosion was also confirmed. Successive slope failures which can entail retrogressive development of failures behind the shoulder of the slope are anticipated.</p> <p>Supposed countermeasures: Drainage ditches along the shoulder of the slope along with vertical drainage. Reshaping the slope with stable angle or grating cribs with ground anchors.</p>

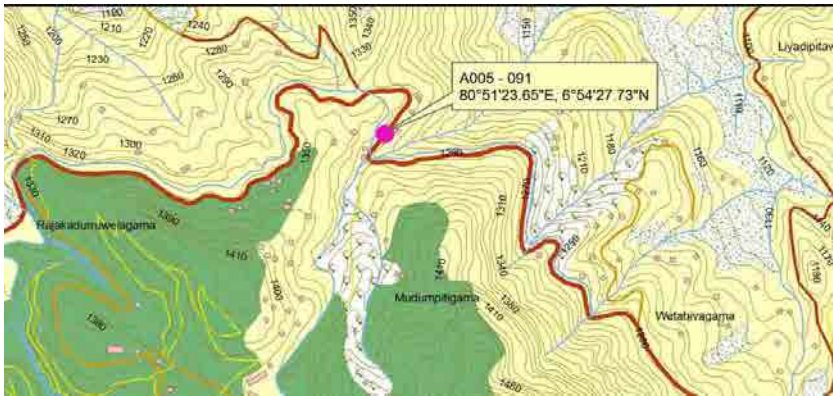
Reduced scale( 1: )
Comment concerning slope situation	<p>Recorded Disaster : Every rainy season, slope failures have occurred. In January 2007, the road was closed for 2 days due to the debris from the failure.                  Failure Type: Slope failure in residual soil and weathered rock.                  Geological Condition: Residual soil and weathered rock.                  Trigger of Failure: Rainfall, rise in ground water level,                  Topographic Condition: Water collectiong vally,</p> <p>Featured Points: Gradient of slope is apparently too steep for the heavily weathered rock and residual soil confirmed at the site. The actual gradient of slope at the section is 80 ~ 90 degrees.                  Gully erosion was also confirmed.                  In addition, many open cracks were confirmed behind the head scarp.                  Successive slope failures which can entail retrogressive development of failures behind the shoulder of the slope are anticipated.</p> <p>Supposed countermeasures: Reshaping the slope with stable angle or grating cribs with ground anchors. Removal of unstahe parts behind the shoulder. Drainage ditches along the shoulder of the slope along with vertical drainage.</p>

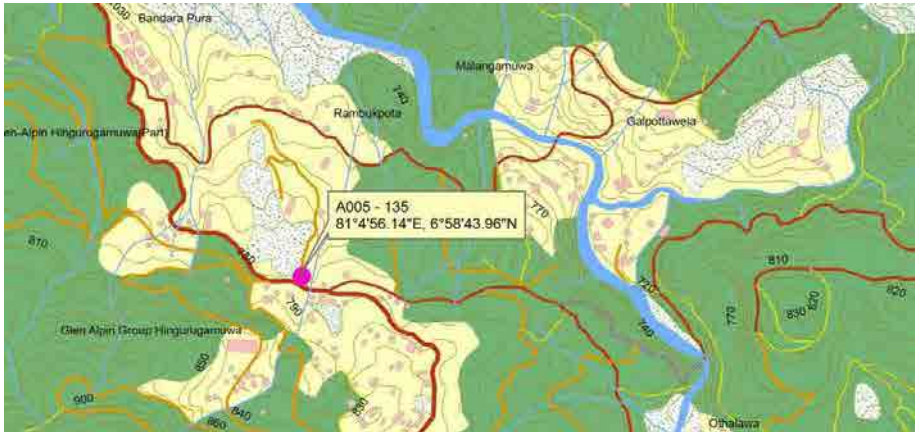
Comment concerning slope situation	<p>Recorded Disaster : From December 2010 when an accumulated precipitation recorded 400 mm, cracks related to one of head scarps appeared at the house of the regional director for the plantation. (This plantation is rehabilitated by PRPII project supported by JICA). In every rainy season, movements of the landslides are observed.</p> <p>As for the damage, severe damage has affected many buildings including a hospital for the plantation and a government office. A005 itself is not included in the landslide mass; the road is just beside the toe of the landslides. Thus when the landslides moved, debris from the toe of the landslides cover the road and RDA shall remove the debris.</p> <p>Failure Type: Landslide.            Geological Condition: Colluvium,            Trigger of Failure: (Supposed) Rise in groundwater,</p> <p>Featured Points: The type of landslide can be categorized as multiple landslide. The landslide mass was divided into more than 2 subdivided landslides. Head scarps were confirmed not only at the upper part but at middle of the landslide mass.            The landslides are under investigation by NBRO. Based on its initial investigation, NBRO estimated</p> <p>Supposed countermeasures: Surface drainage system and underground drainage system.</p>

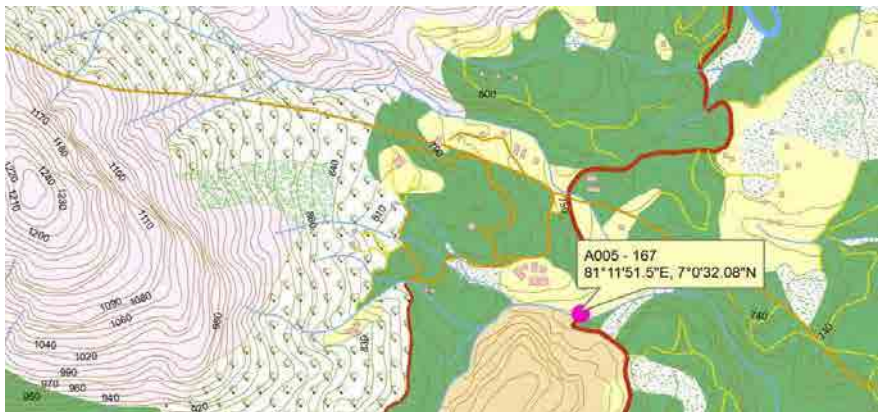
Reduced scale( 1 : )
Comment concerning slope situation	<p>Recorded Disaster : For more than 10 years, in every rainy season, the landslides moved toward A005 and the debris from the toe covered the road. Against each blockade by the debris, RDA needs to remove it from the road surface.</p> <p>Failure Type: Landslide.            Geological Condition: Mainly weathered rock along with colluvium,            Trigger of Failure: (Supposed) Rise in groundwater,            Topographic Condition: Water collecting valley, a stream is running along the road.</p> <p>Featured Points: The affecting landslide seems to be one of devided landslide from much wider landslide which was moved far past. The affecting landslide is mainly composed of weathered rock which seems to be low resistant against weathering and prone to alter into clay. At the head scarps at the shoulder and upper-middle of the affecting landslide, outcrops of weathered rocks can be observed.            At the toe of the landslide, a spring was observed.</p> <p>Supposed countermeasures: Surface drainage system and underground drainage system. Ground anchor at the toe.            Relocation of the bridge passing the stream can be an option.</p>

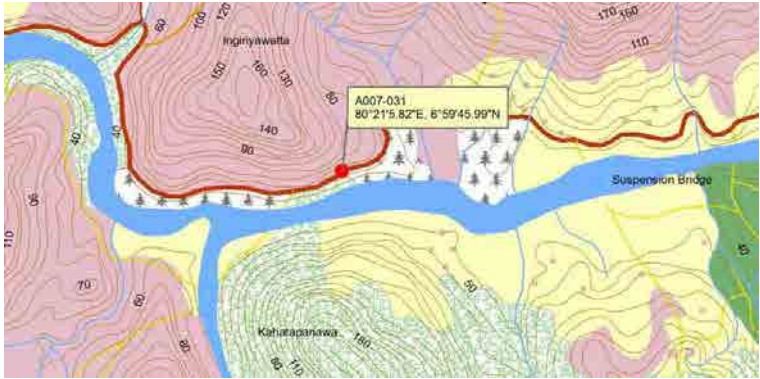
<p style="text-align: right;">Reduced scale( 1: )</p>			
Comment concerning slope situation	<p>Recorded Disaster : Slope failure in lower slope moved away the shoulder. Cracks appeared on the pavement.</p> <p>Failure Type: Slope failure in residual soil and weathered rock.          Geological Condition: Residual soil and weathered rock.          Trigger of Failure: (Supposed) Erosion of toe of the slope by Kelani River, and steeper gradient of slope.</p> <p>Featured Points: Slope failure by river erosion.</p> <p>Supposed countermeasures: Retaining wall against the erision as well as to reinforce the slope.</p>

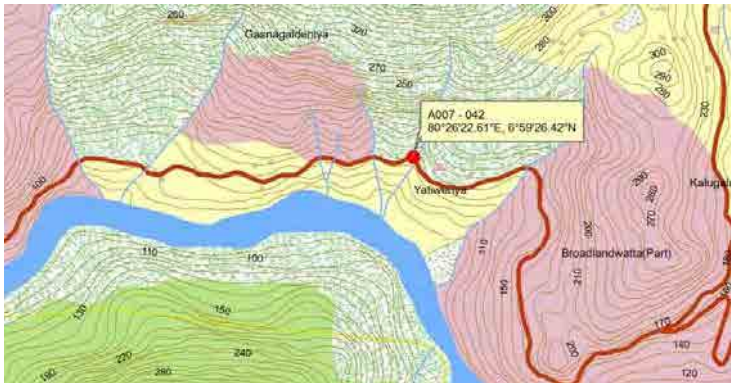
Reduced scale( 1 : )
Comment concerning slope situation	<p>Recorded Disaster : In 1989 and between 2005 and 2007, the landslide moved and the road was closed for several days. Landslide activities were seen during the rainy season. Damage on the pavement, possibly caused by infiltration of water to the pavement structure. Traces of slope failures on the slopes.</p> <p>Failure Type: Landslide or slope failure. Further investigation is required.          Geological Condition: Residual soil and colluvium or valley deposit.          Trigger of Failure: (Supposed) Raise in ground water.</p> <p>Featured Points: It is said to be landslide activities in 1989 and between 2005 and 2007. Thus another landslide activity is anticipated by local people. It is not clear, however, that the damage was caused by landslide or slope failure, because there was not clear evidence of landslide activities. There were, however, a lot of cracks on the pavement which imply infiltration of water to the pavement structure. This damage suggests high ground water level at this location.          Based on the site situation, debris flow can be a possible disaster.          Topographic Feature: Valley type landform with a stream.</p> <p>Supposed countermeasures: Further investigation is required to set up appropriate countermeasures. Based on the site situation, however, surface drainage system and underground drainage can be amongst appropriate countermeasures.</p>

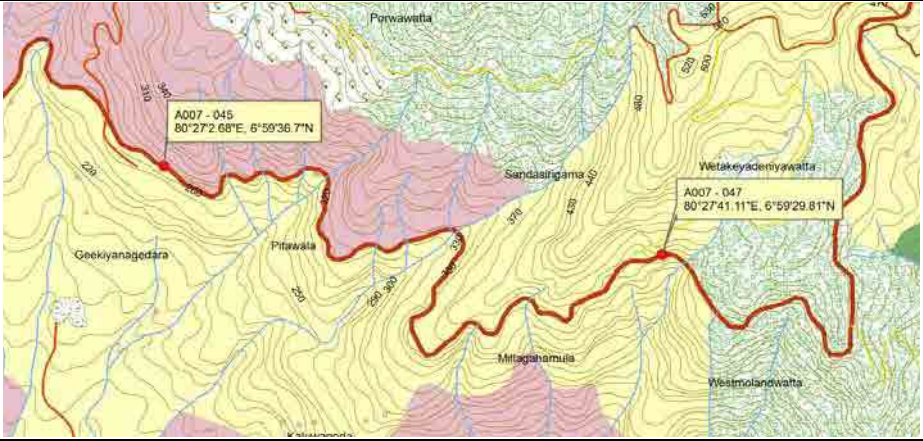
Comment concerning slope situation	<p>Recorded Disaster : Unclear. Fallen boulders, however, were seen on site.</p> <p>Failure Type: Rock fall, slope failure in colluvium.</p> <p>Geological Condition: At the ending part, massive rock with cracks, at the beginning part, colluvium..</p> <p>Trigger of Failure: (Supposed) Rainfall, erosion, and development of open cracks..</p> <p>Featured Points: Boulders were seen at the shoulder of cutting slope composed of colluvium. Boulders were also seen in the upper slopes. In addition, unstable parts of outcrop with cracks were seen at the shoulder of rocky slope.</p> <p>Supposed countermeasures: Further investigation is required to set up appropriate countermeasures. Based on the site situation, however, removal of boulders and unstable parts of rock can be amongst countermeasures along with fixing unstable parts with rock bolts or other fixing methods.</p>

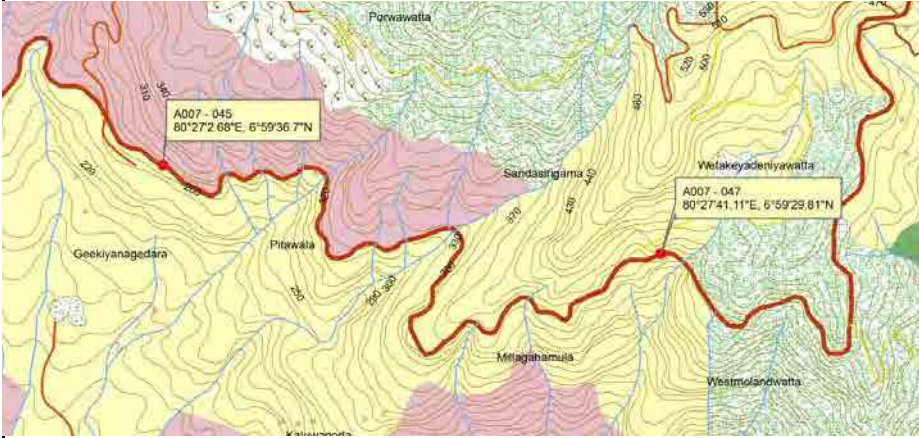
Comment concerning slope situation	<p>Recorded Disaster : Not every year, during rainy season. A part of gabion wall seemd to have been damaged and reconstructed.</p> <p>Failure Type: Multiple landslide. Geological Condition: (Probably) Colluvium. Trigger of Failure: (Supposed) Raise in ground water.</p> <p>Featured Points: Multiple landslide. According to the vegetation on the slope, groundwater level is supposed to be hgh. In addition, a spring were seen on the toe of the slope. Topographic Feature: Valley type landform with a stream.</p> <p>Supposed countermeasures: Further investigation is required to set up appropriate countermeasures. Based on the site situation, however, surface water drainge system and underground drainage can be amongst the supposed countermeasures.</p>

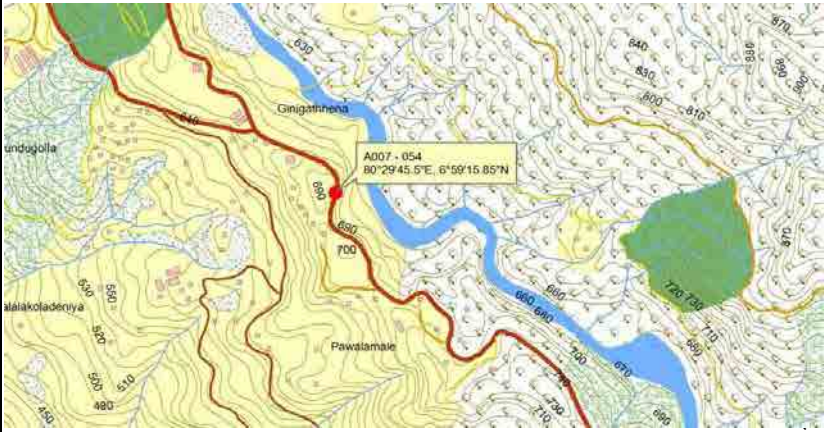
Comment concerning slope situation	<p>Recorded Disaster : Shoulder of the road collapsed. Cracks developed on the nearby pavement.</p> <p>Failure Type: Slope failure in residual soil.          Geological Condition: Residual soil.          Trigger of Failure: (Supposed) Rainfall, erosion, and steeper gradient of slope.</p> <p>Featured Points: There were 2 slope failures; one was under the shoulder and another was in the upper slope.</p> <p>Supposed countermeasures: Further investigation is required to set up appropriate countermeasures. Based on the site situation, however, grating cribs with ground anchors can be amongst the supposed.</p>

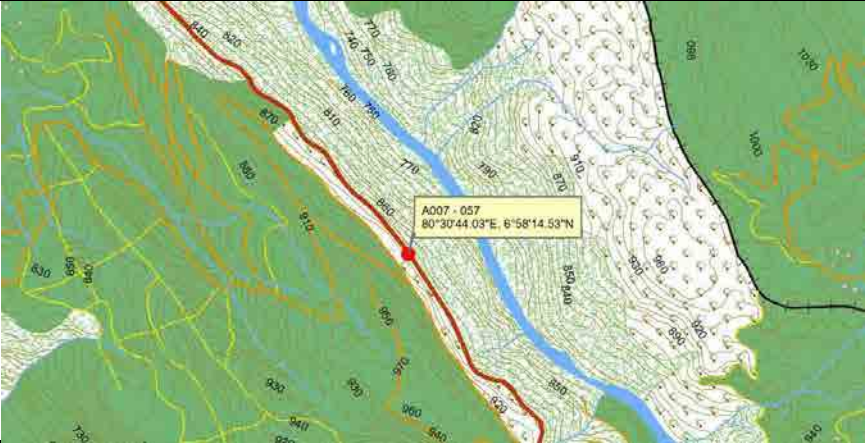
Comment concerning slope situation	<p>Recorded Disaster : Debris provided from the slope failure closed the road.</p> <p>Failure Type: Slope failure in residual soil and weathered rock.          Geological Condition: Residual soil and weathered gneiss rich in cracks. Vertical cracks attract the attention.          Trigger of Failure: (Supposed) Rainfall, erosion, and steeper gradient of slope.</p> <p>Featured Points: Springs were confirmed in the middle of the slope at the beginning side.</p> <p>Supposed countermeasures: Further investigation is required to set up appropriate countermeasures. Based on the site situation, however, drainage system and grating cribs with ground anchors can be amongst the supposed.</p>

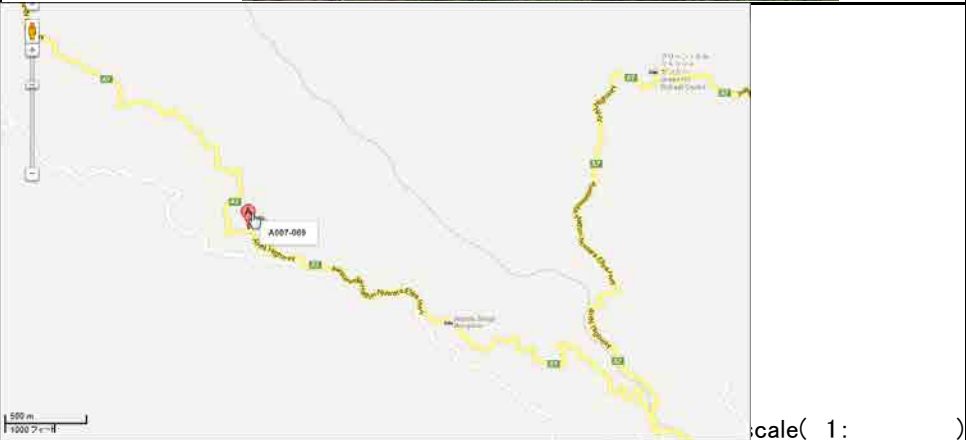
Comment concerning slope situation	<p>Recorded Disaster : Landslide in the lower slope moved and the foundation of the old road was moved away.</p> <p>Failure Type: Landslide.          Geological Condition: (Probably) Colluvium.          Trigger of Failure: (Supposed) Erosion at the toe of the landslide. Raise in ground water.</p> <p>Featured Points: The stream eroded the toe of landslide and activated the landslid. The moved landslide mass closed the stream and then created a pond. The watercourse of the stream was bended and circumnavigated the toe of the landslide. At the same time, the head scarp appeared crossing the old road and the foundation of the old roas was moved away along with the subsidence of the head.          Topographic Feature: Located at the slope surrounding the ridge.</p> <p>Supposed countermeasures: It is obious that the further erosion of the toe will reactivate the landslide movement. Thus counter-erosion shall be installed. Reinforcement to shoulder behind the head scarp may be considered.</p>

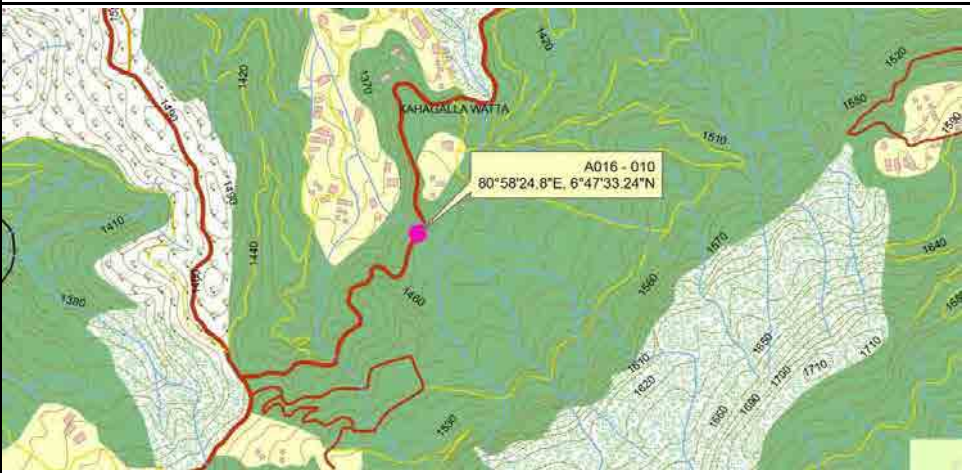
70
	Reduced scale( 1 : )			Environmental issue
Comment concerning slope situation	<p>Recorded Disaster : From 1996, landslide activities have been observed every 2 years. This landslide affects the road running at its middle and houses located downstream of its toe.</p> <p>Failure Type: Landslide. Geological Condition: Colluvium, Trigger of Failure: (Supposed) Rise in groundwater,</p> <p>Featured Points: When the toe of the landslide moves triggered by a rainfall , the body of landslide at the toe turns into fluid and strikes the houses with a high speed movement. A head scarp of a devided landslide locates just beside the road shoulder and poses a threat of subsidence or collapse of the foundation of the road. The initial investigation by NBRO was done in 2001 or 2002. The 2nd investigation was in 2011. The thickness of the landslide is said to be 20 meters or more. An improvement of the road was completed in 2009 ~2010.</p> <p>Supposed countermeasures: Surface drainage system and underground drainage system. Ground anchor or pile works to support the sholder affected by the devided landslide..</p>			70

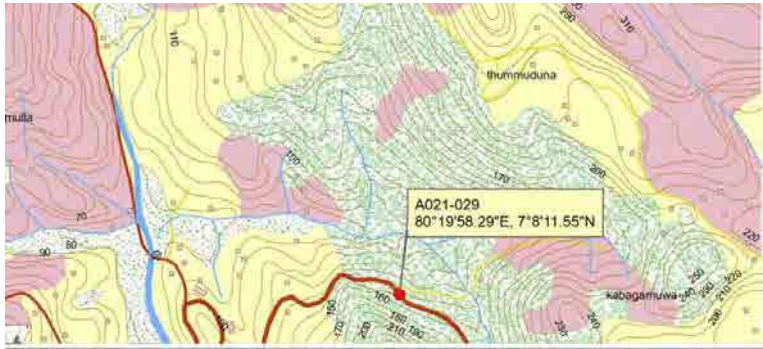
Reduced scale( 1: )
Comment concerning slope situation	<p>Recorded Disaster : From 2006, when plenty rainfall provided, the landslide moved. Debris provided from the toe of the landslide blocked the road.</p> <p>Failure Type: Landslide            Geological Condition: (Probably) Colluvium.            Trigger of Failure: (Supposed) Raise in groundwater.</p> <p>Featured Points:Land owner has not allowed RDA to access the slope. No investigation results are available.</p> <p>Supposed countermeasures: Further investigation is required to set up appropriate countermeasures. Based on the site situation, however, surface draiange system and underground drainage can be amongst the supposed.</p>

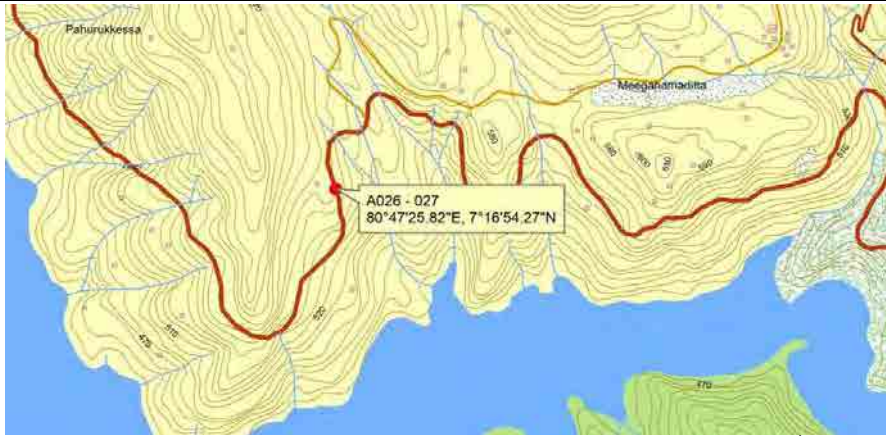
0
Comment concerning slope situation	Recorded Disaster : Jan 2007, during rainy season Failure Type: Slope Failure involving Rock Sliding, Geological Condition: Residual soil, Highly weathered ~ weathered rock with cracks, Supposed countermeasures: Fixed with rock bolts or removal of unstable parts.

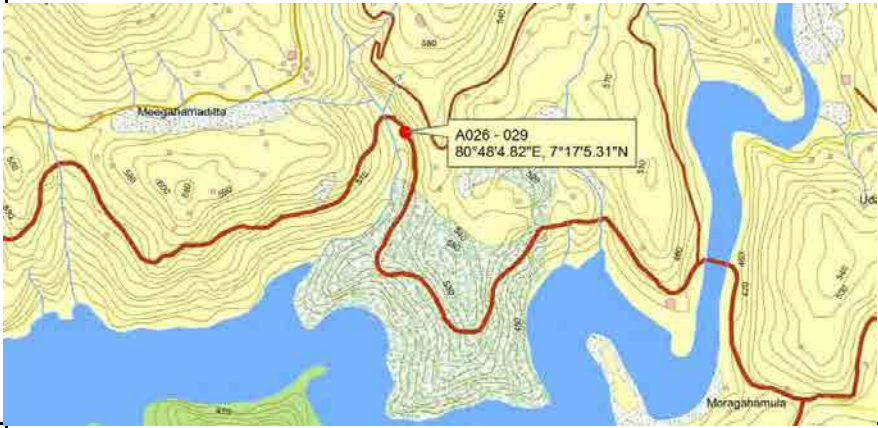
Environm ental issue
Comment concerning slope situation	<p>Recorded Disaster : Jan 2007, during rainy season            Failure Type: Rock Sliding,            Geological Condition: Highly foliated Gneiss, Dip slope condition,            Topographic Condition: Water collectiong vally,</p> <p>Supposed countermeasures: Fixed with rock bolts or removal of unstable parts.</p> <p>Note: From Km 29~ Km 31, overhanging rocks rocks were seen remaining unstable at shoulder of slopes.</p>			0

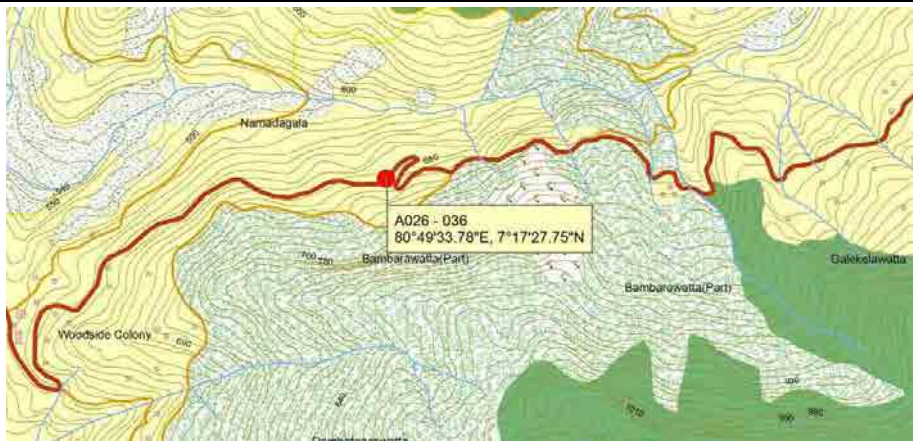
Comment concerning slope situation	<p>Recorded Disaster : 2011, during construction by Keangnam, slope of overburden collapsed after cutting with almost vertical angle. After removing deposits of the collapsed overburden, retaining well was constructed.</p> <p>Failure Type: Slope failure in residual soil,          Geological Condition: Residual soil, weathered rock          Trigger of Failure: Construction,          Topographic Condition: Water collectiong vally,</p> <p>Featured Points: After the construction of the retaining wall, the failure was settled.          Gradient of Slope is too steep for residual soil.</p> <p>Supposed countermeasures: (If additional countermeasures are required) Drainage ditches along the shoulder of the slope along with vertical drainage. Removal of deposits and reshaping of the slope with stable angle.</p>

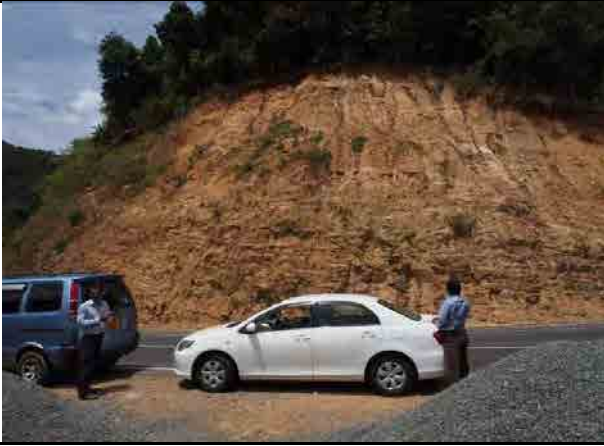
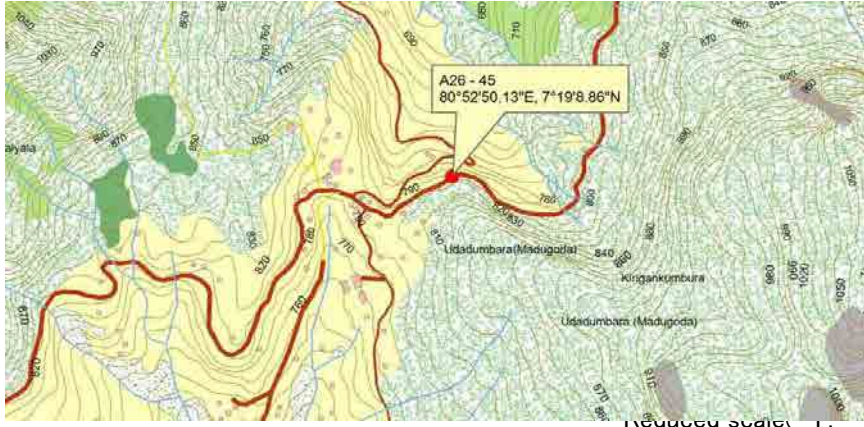
Comment concerning slope situation	<p>Recorded Disaster : 2010, during construction by Keangnam.            Failure Type: Slope failure in residual soil and weathered rock,            Geological Condition: Residual soil, weathered rock (Garnet biotite Gneiss) with dip slope condition,            Trigger of Failure: Construction,            Topographic Condition: Ridge,            Featured Points: Gully erosion is seen on the slope surface of residual soil.            Dip slope condition in weathered rock part.            Gradient of Slope is too steep for residual soil.</p> <p>Supposed countermeasures: Drainage ditches along the shoulder of the slope along with vertical drainage. Reshaping the slope with stable angle or retaining methods such as anchoring or R/B with grating cribs.</p>

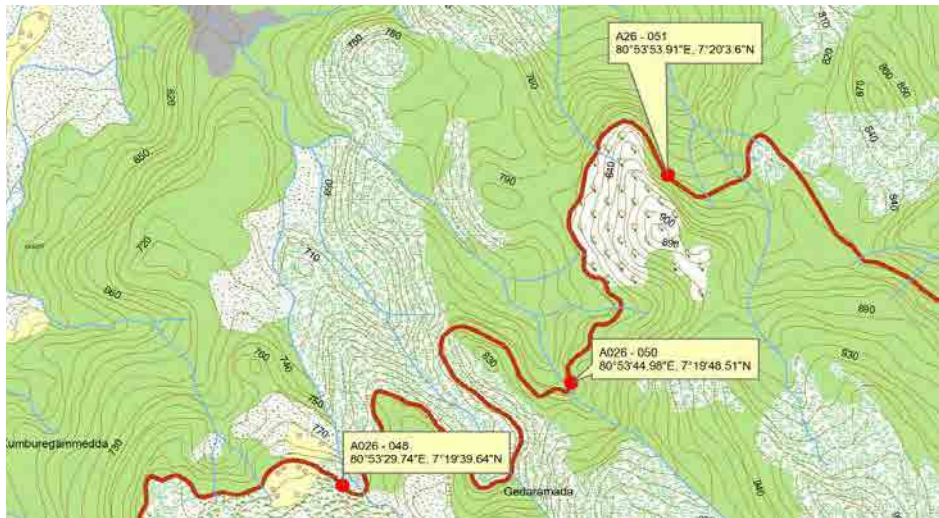
Environmental issue
	Reduced scale( 1: )			0
Comment concerning slope situation	<p>Recorded Disaster : 2011, rainy season,            Failure Type: Slope failure in residual soil and weathered rock,            Geological Condition: Residual soil, weathered rock (very weak and fragile),            Topographic Condition: Valley,</p> <p>Featured Points: A fresh failure was seen at the site.            Gradient of Slope is too steep for residual soil and weathered rock.</p> <p>Supposed countermeasures: Drainage ditches along the shoulder of the slope along with vertical drainage. Reshaping the slope with stable angle or retaining methods such as anchoring or R/B with grating cribs.</p>

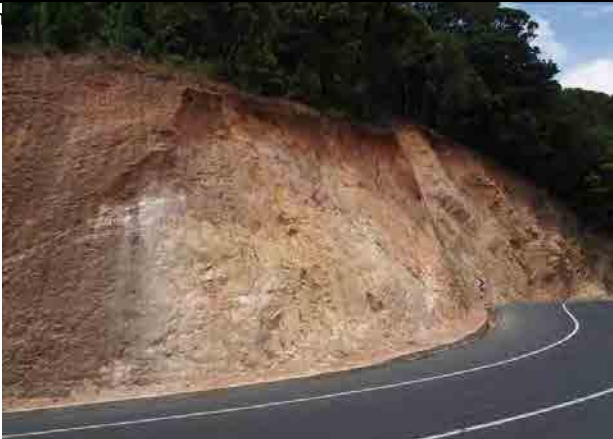
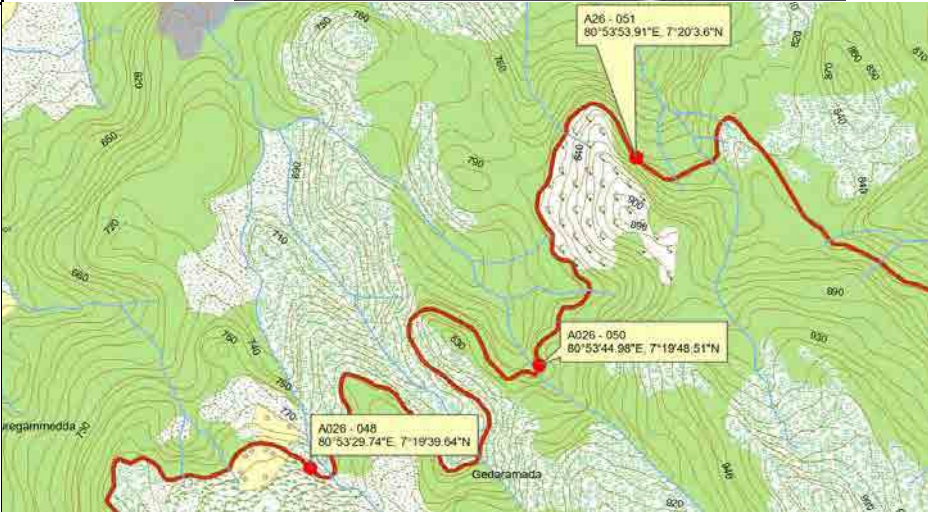
Reduced scale( 1: )			
Comment concerning slope situation	<p>Recorded Disaster : 2011, rainy season,            Failure Type: Slope failure mainly in weathered rock, involving very thin residual soil.            Geological Condition: Weathered rock (very weak and fragile),            Topographic Condition: Valley,</p> <p>Featured Points:            Gradient of Slope is too steep for fragile weathered rock at the site.</p> <p>Supposed countermeasures: Drainage ditches along the shoulder of the slope along with vertical drainage. Reshaping the slope with stable angle or retaining methods such as anchoring or R/B with grating cribs.</p>

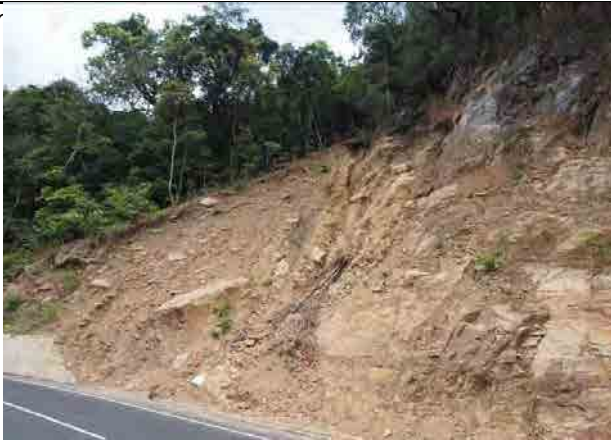
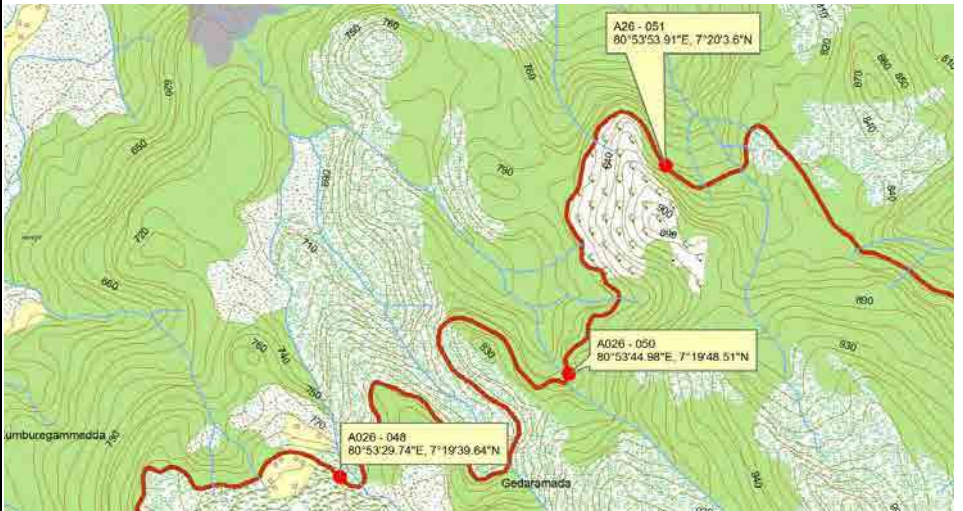
<p style="text-align: right;">Reduced scale( 1 :</p>			
Comment concerning slope situation	<p>Recorded Disaster : 2011, during construction by Keangnam,                  Failure Type: Slope failure in colluvium.                  Geological Condition: Colluvium,                  Trigger of Failure: Rainfall, construction,                  Topographic Condition: Valley,</p> <p>Featured Points: Gully erosion was observed on site. Retaining wall at the toe of the slope seems to be demolished.                  Gradient of Slope is too steep for colluvium.</p> <p>Supposed countermeasures: Drainage ditches along the shoulder of the slope along with vertical drainage. Reshaping the slope with stable angle or retaining methods such as anchoring with grating cribs.</p>

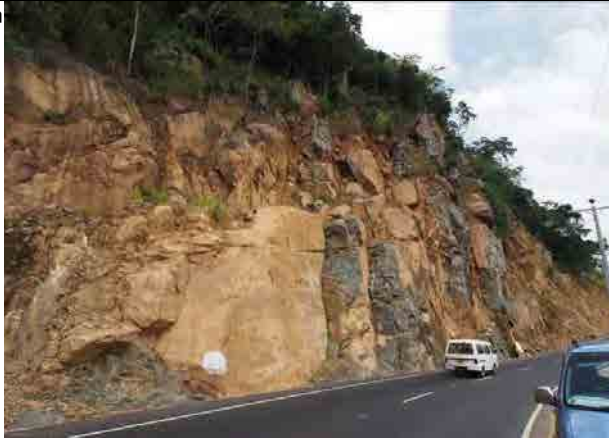
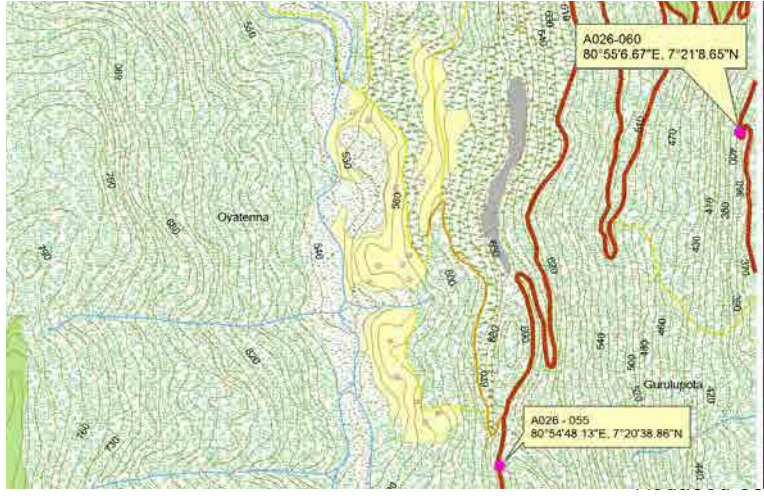
scale( 1: )
Comment concerning slope situation	<p>Recorded Disaster : 2010 ~ 2011, during construction, after rain,            Failure Type: Slope failure (Rock Sliding) in weathered rock, rock fall.            Geological Condition: Rock (charnokite) with cracks including vertical open crack,            Trigger of Failure: Rainfall, construction,</p> <p>Featured Points: Weathering developed along the cracks and altered rock rody along the cracks. Amongst the cracks developed vertically, some cracks show wide opening or are filled with clay rich soil. Thus rock sliding is anticipated in this section along with rock fall from the shoulder of the slope.</p> <p>Supposed countermeasures: Fixed with rock bolts or removal of unstable parts.</p>
