国際協力機構（JICA）

スリランカ国  
災害脆弱地域における道路防災事業情報収集調査

ファイナルレポート（2/2）  
巻末資料

2012年12月

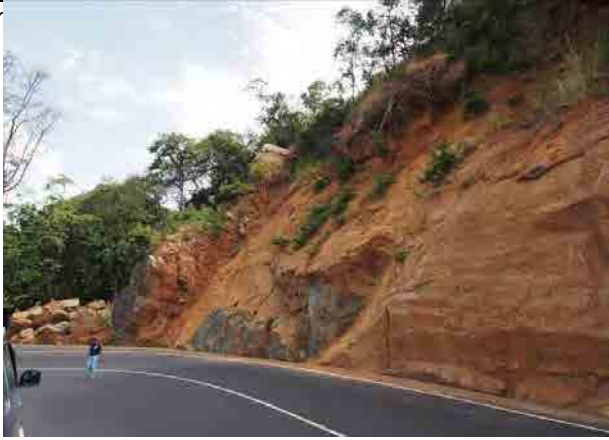
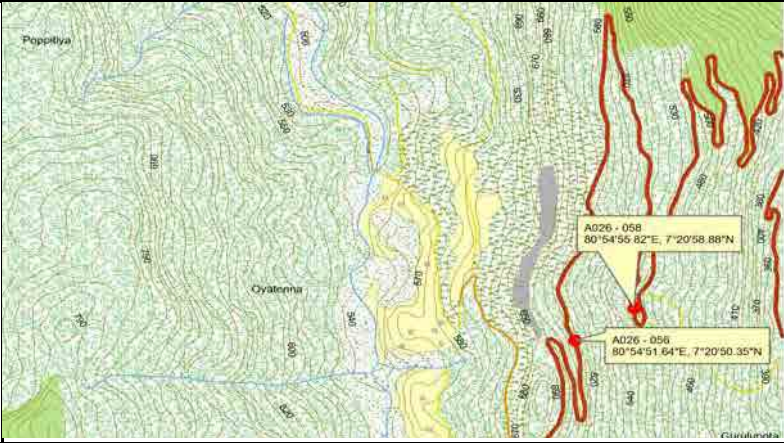
Comment concerning slope situation	<p>Located at the No.2 curve of 19 bends (hair pin curves).</p> <p>Recorded Disaster : unclear                      Failure Type: Slope failure in colluvium.                      Geological Condition: Thin colluvium, weathered rock (charnokite),                      Trigger of Failure: (Supposed) Rainfall, construction,</p> <p>Featured Points: It is highly probable that thin colluvium remained on the slope collapsed due to construction and rainfall. Still remaining thin colluvium can be observed at the shoulder of the slope along with at the left side boundary of the existing failure.                      Gradient of Slope is too steep for colluvium.</p> <p>Supposed countermeasures: Removal of the remaining colluvium on the slope.                      Drainage ditches along the shoulder of the slope along with vertical drainage.</p>

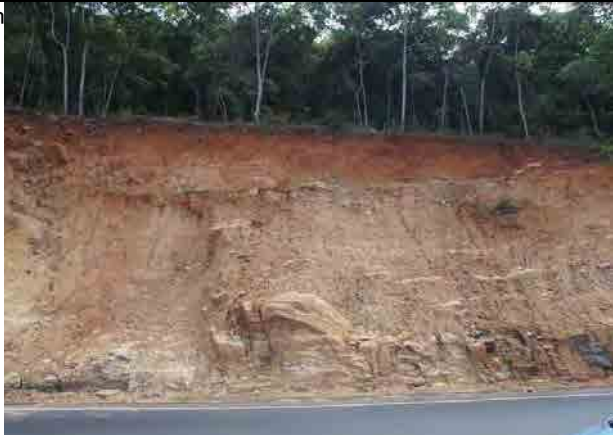
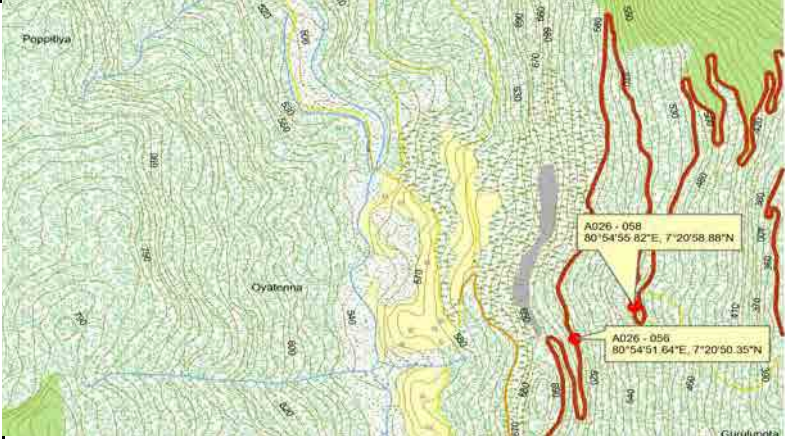
e( 1: )
Comment concerning slope situation	<p>Located at the No.4 curve of 19 bends (hair pin curves).</p> <p>Recorded Disaster : unclear            Failure Type: Slope failure in weathered rock and residual soil.            Geological Condition: Weathered rock, residual soil,            Trigger of Failure: (Supposed) Rainfall, construction,</p> <p>Featured Points: It is highly probable that highly weathered rock part along with residual soil caused failure due to construction and rainfall. Gully erosion is observed on the slope surface.            Gradient of Slope is too steep for weathered rock at the site.</p> <p>Supposed countermeasures: Drainage ditches along the shoulder of the slope along with vertical drainage. Reshaping the slope with stable angle or retaining methods such as anchoring with grating cribs.</p>

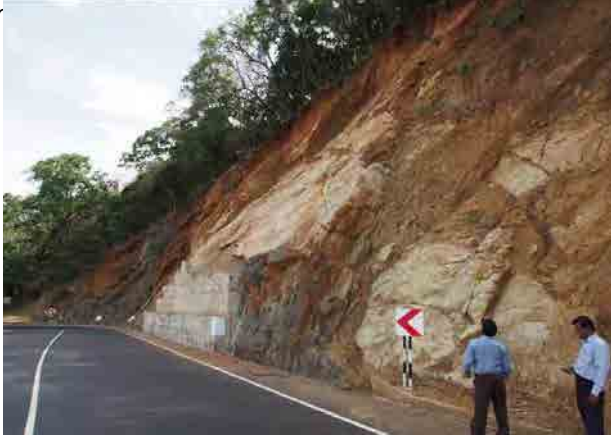
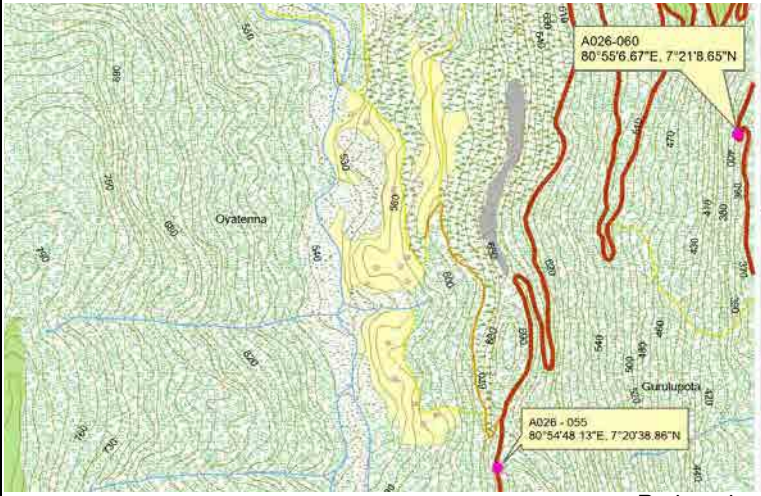
Reduced scale( 1: )
Comment concerning slope situation	<p>Located at the No.14 curve of 19 bends (hair pin curves).</p> <p>Recorded Disaster : unclear            Failure Type: Dip slope failure (rock slide) in weathered rock.            Geological Condition: Weathered rock, residual soil,            Trigger of Failure: (Supposed) Rainfall, construction,</p> <p>Featured Points: Dip slope structure is posing threats of rock slide to the road. Although retaining wall is constructed and covers some parts of the toe, remaining bodies at the shoulder can be possible hazards. In addition, a wide band of argillization is observed filing a vertical crack behind a big rock body located in the middle of the slope.</p> <p>Supposed countermeasures: Drainage ditches along the shoulder of the slope along with vertical drainage. Fixed with rock bolts or removal of unstable parts.</p>

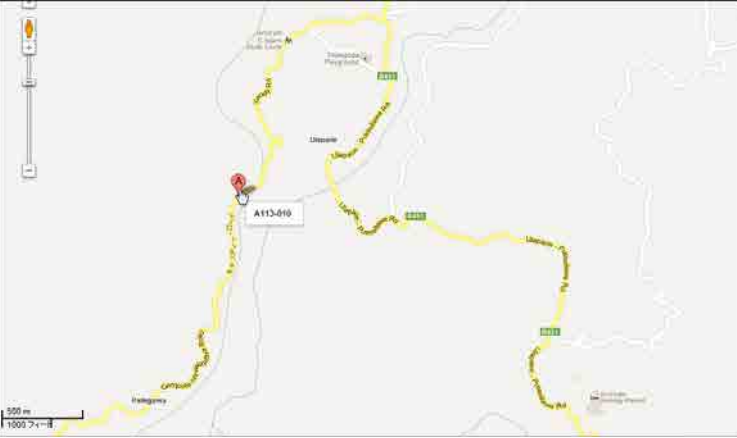
scale( 1: )
Comment concerning slope situation	<p>Recorded Disaster : Periodical records of landslide activity. In every rainy season, gaps have developed on the pavement The gaps correspond to the head scarp of lower landslide.</p> <p>Failure Type: Landslide.          Geological Condition: Embankment, original ground is supposed to be colluvium,          Trigger of Failure: (Supposed) Rise of groundwater, Construction,</p> <p>Featured Points: Single isolated landslide causes damage on the road surface. The landslide is said to be caused by embankment construction. A railway track runs parallel to the road but no damage is reported at the track.          The size of the landslide is supposed to be relatively small.</p> <p>Supposed countermeasures: Surface drainage system and underground drainage system. Counter embankment if necessary.</p>

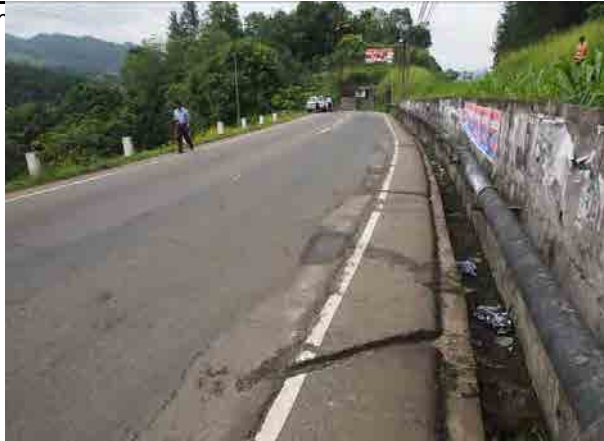
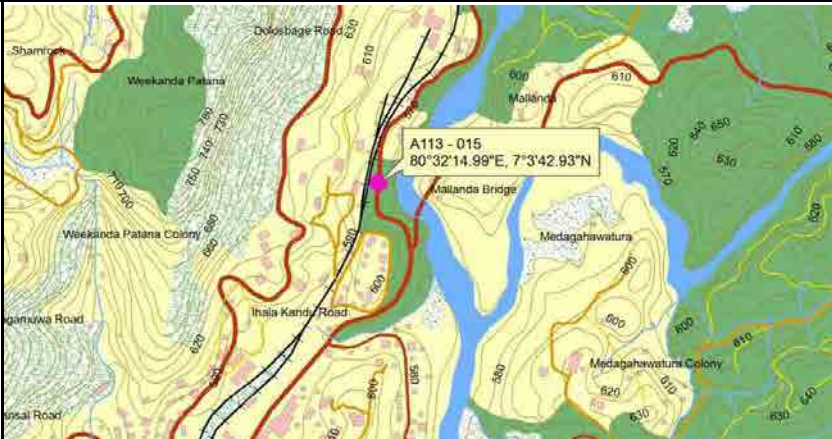
Comment concerning slope situation	<p>Recorded Disaster : Periodical records of landslide activity. In every rainy season, especially in December, gaps have developed on the pavement with an aperture of 4 ~ 6 inches (10 ~ 15cm). The gaps correspond to the head scarp of lower landslide.</p> <p>Failure Type: Landslide.          Geological Condition: Colluvium,          Trigger of Failure: (Supposed) Rise of groundwater,</p> <p>Featured Points: The landslides at this location involve not only road, but houses and railway. Two landslides are confirmed so far. The upper landslide is said to have been stabilized by the retaining wall constructed along the railway. The head scarp of the upper landslide may be located under the passage paved with concrete slab. The lower landslide still shows periodical movement during rainy seasons and damages the A-113 road with subsidence and open gaps which reaches 15cm. 3 piezometers were placed and observed by RDA.</p> <p>Supposed countermeasures: Surface drainage system and underground drainage system. Pile works or ground anchors to retain the road. Retaining wall against erosion by the Mahaweli river.</p>
