Appendix 3-2 Slope inspection sheets for Rank C and B

General Information Sheet

Management office	Ratnapura										
Management number	A004-134	Route No	A004	Location(m)	134/15	to	134	Distance	200	m	
Disaster	Rock fall	Name of Road		Landmark		latitude	N 06°37'20.18"	longitude	E 080°39'32.17"		
Schematic sketch				Reporter's name :	M. Enokida

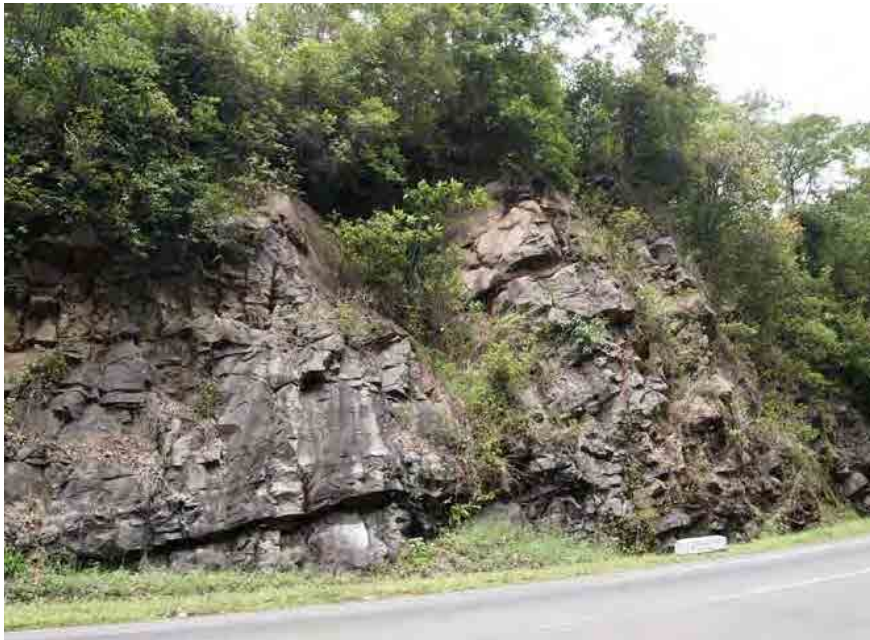
Condition of slope, there are a lot of cracks and floatstones.

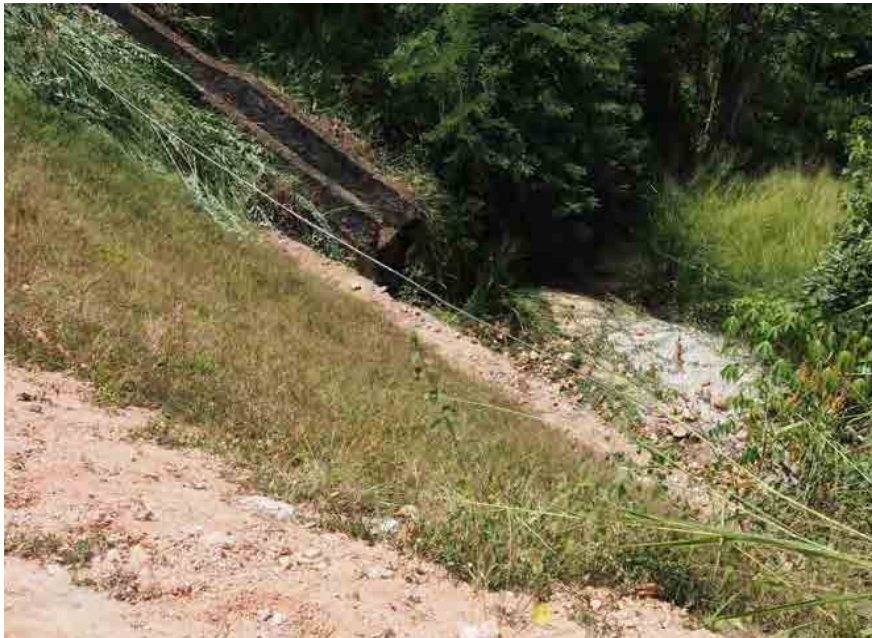
Condition of slope

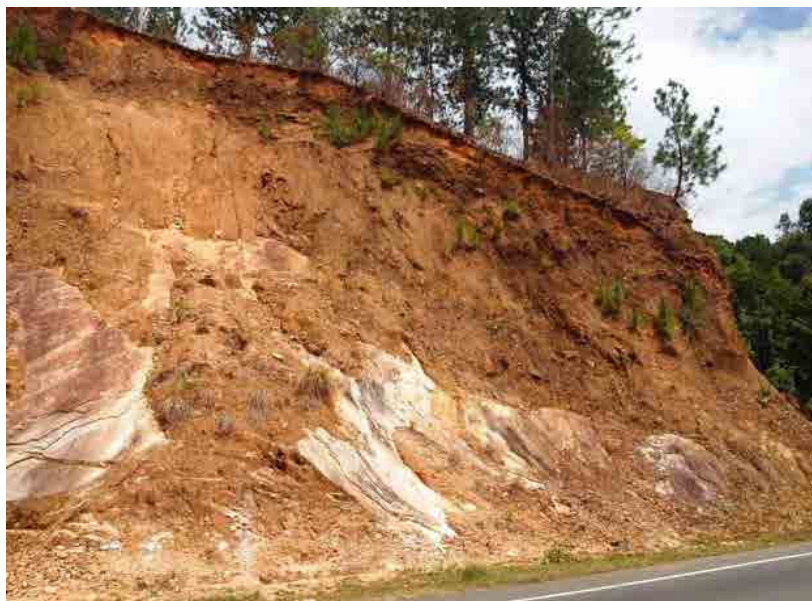
Condition of slope, a loose sedimentary soil is recorded on the base rock.

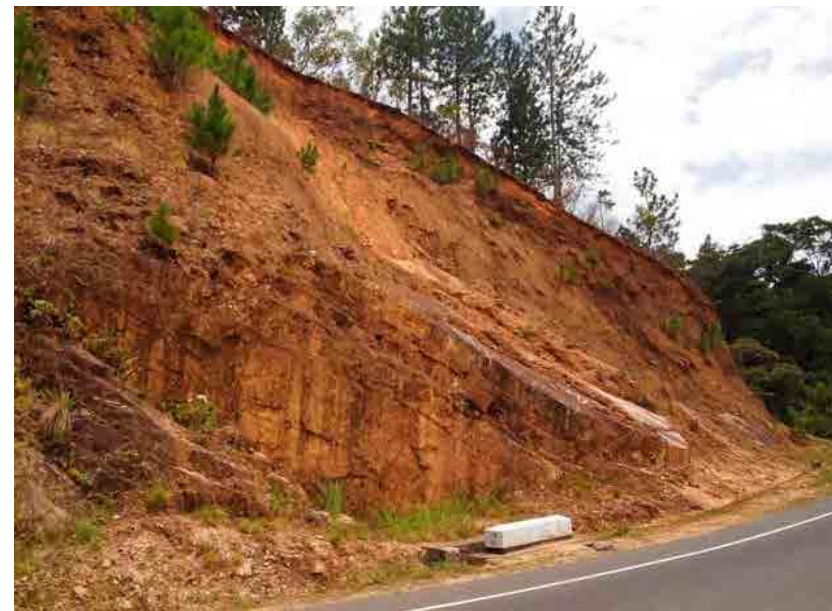
Condition of slope, basement rock of dip slope structure

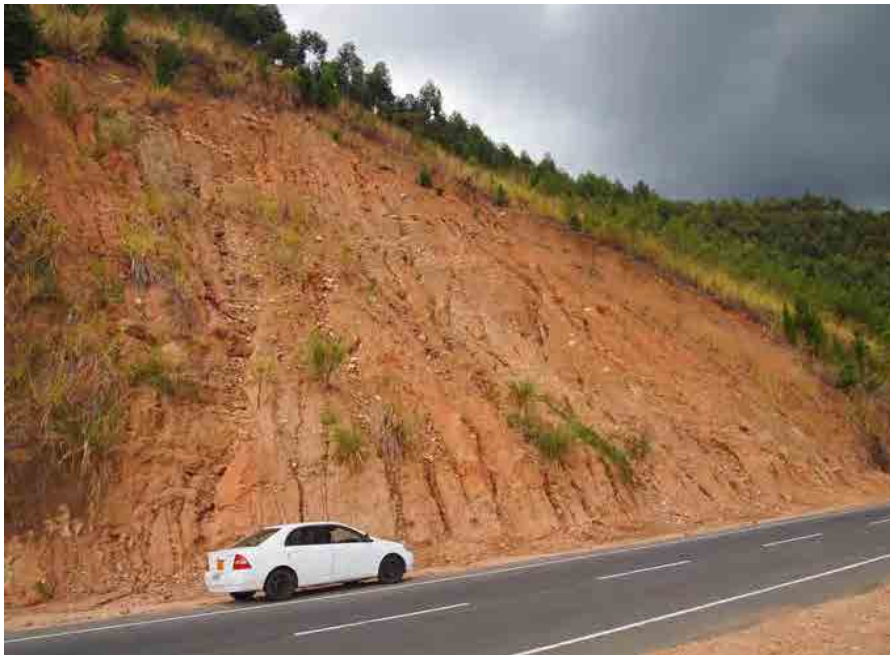
Condition of slope, many can confirm the mark of erosion

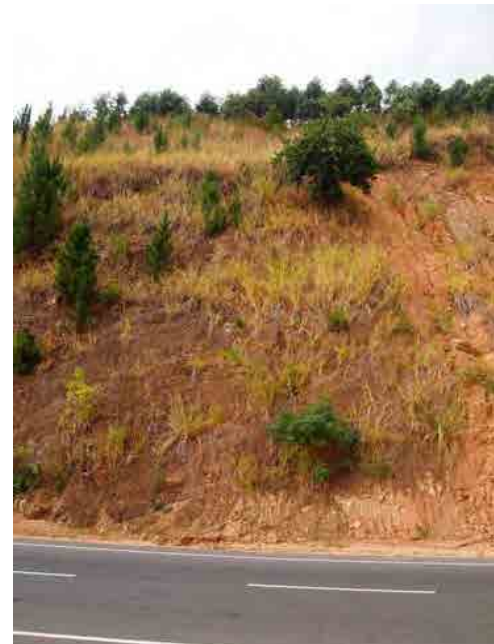
Condition of slope, the slope on the start side is a slope of a steady sedimentary rock

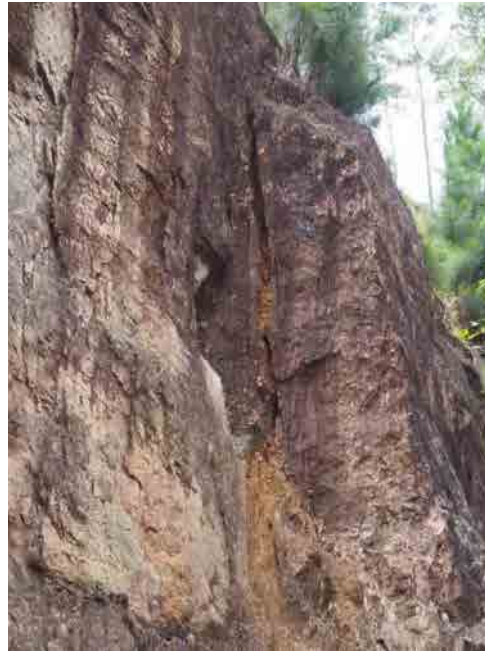
Condition of the slope, open cracks developed behind the rock mass almost perpendicularly.

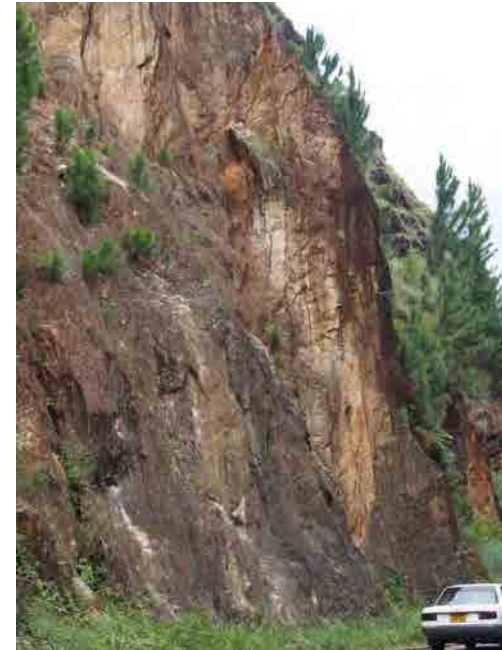
Condition of the slope, Rock slide and rock fall are anticipated. Toppling may occur under certain condition.

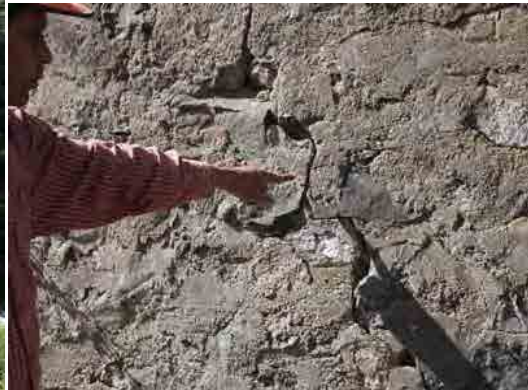
Crack of retaining wall on part slope on road

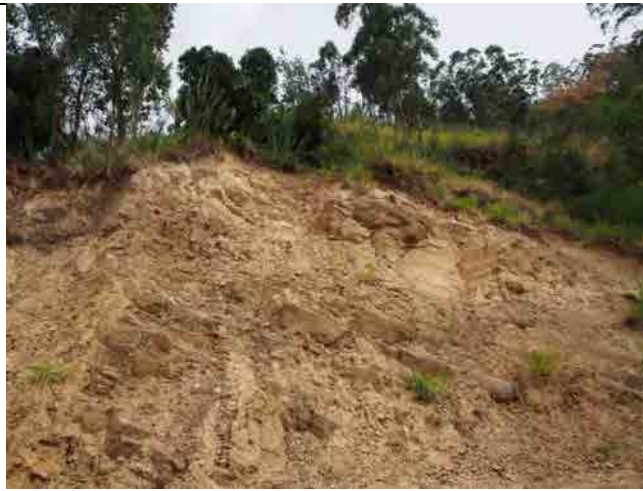
Condition of the slope. Heavily weathered condition are understood. Foliation and cracks developed densely and helped weathering proceed.

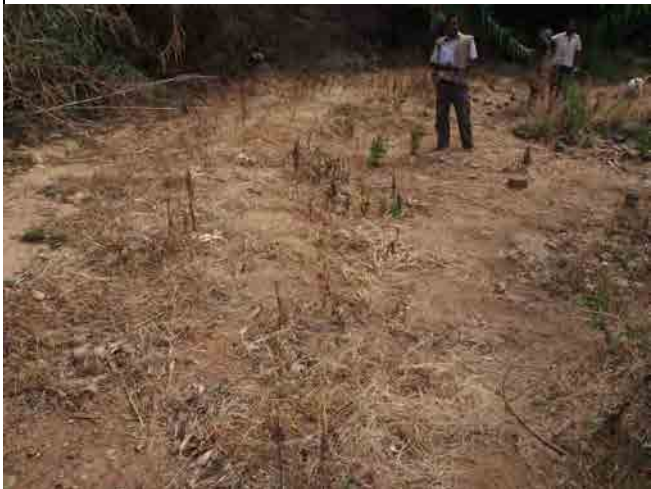
Open cracks along with subsidence seen at the terraces .

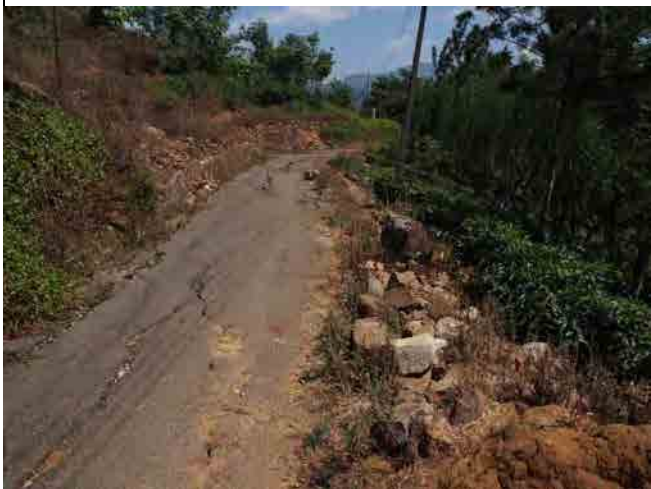
Cracks at the middle of landslide.

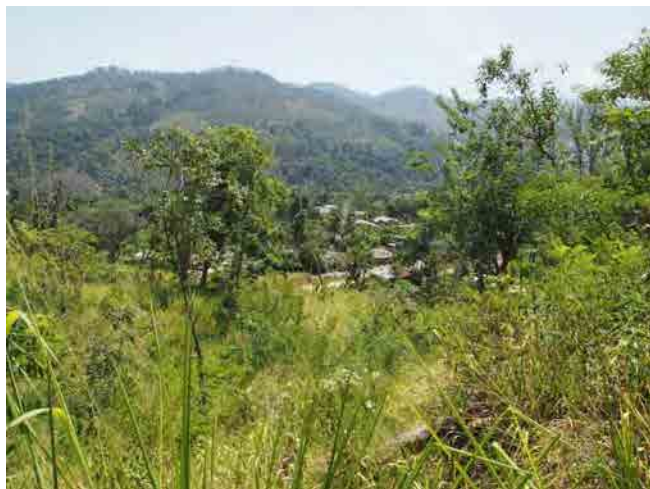
Seeing downward from the middle of the landslide.
Houses may be affected by the landslide movements.

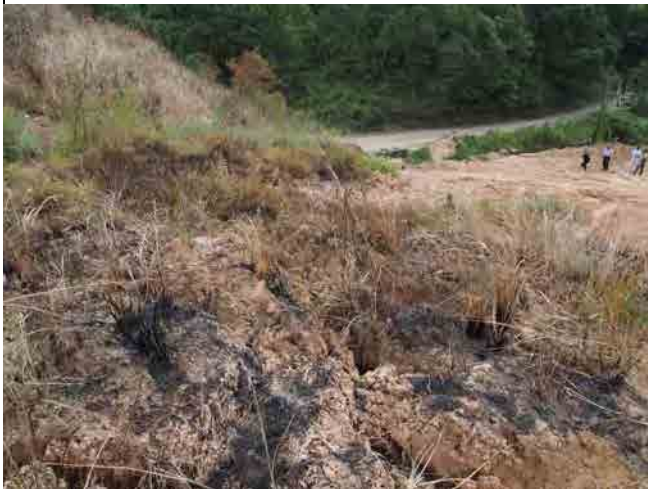
Open cracks were seen at the middle of the landslide.

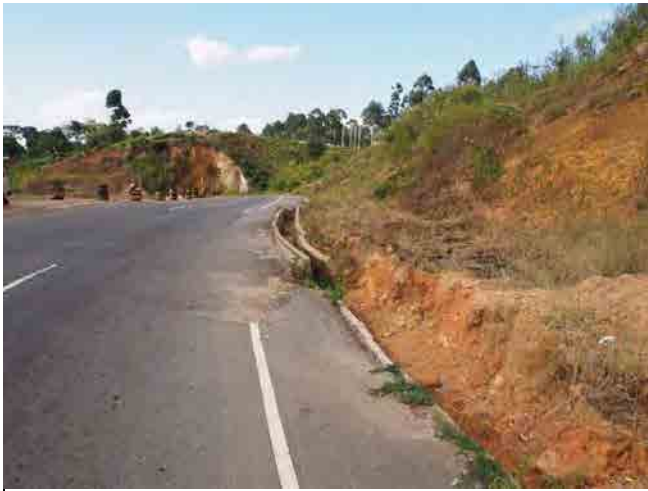
Damage on the road at the middle of the landslide

Proposed countermeasures	Type:	
	Specifi-cation:	Horizontal Draiange Drilling: 70m * 8 pipes * 3 sites = 1680m Surface Draiange Ditch: 1500m Reshaping by soil removal: 100m3 Reshaping by embankment: 100m3
	Quantity	Steel Pile (D1200*t60@2600,L=50m), Lenth of Pile Array :200m * 2 lines (Zig zag alignment)
	Cost (million Birr):

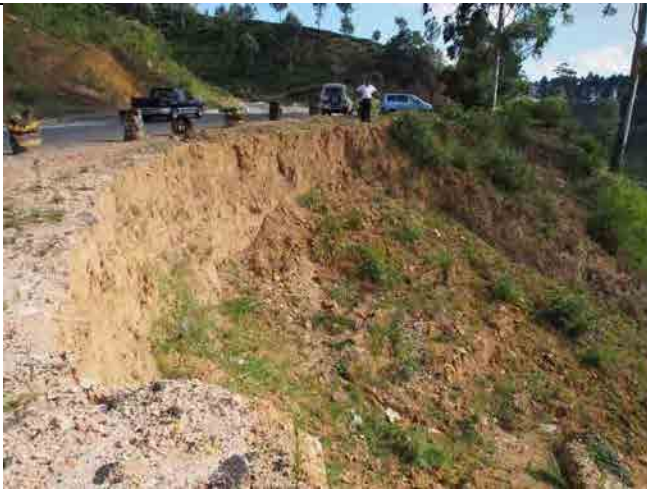
Headscarp along the road shoulder at the ending side

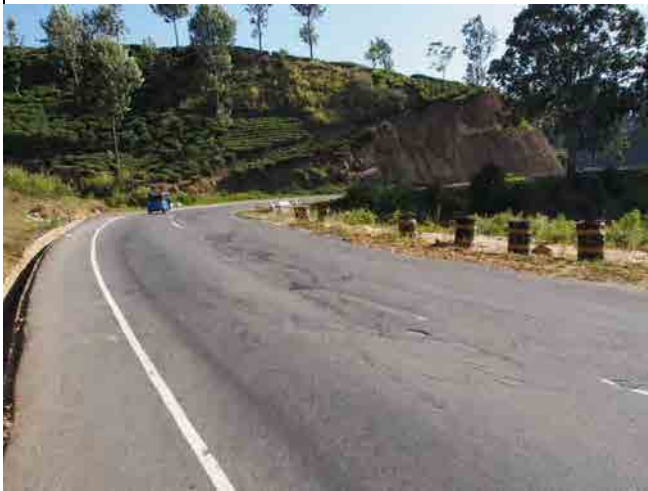
Subsidence on the road at the beginning side.

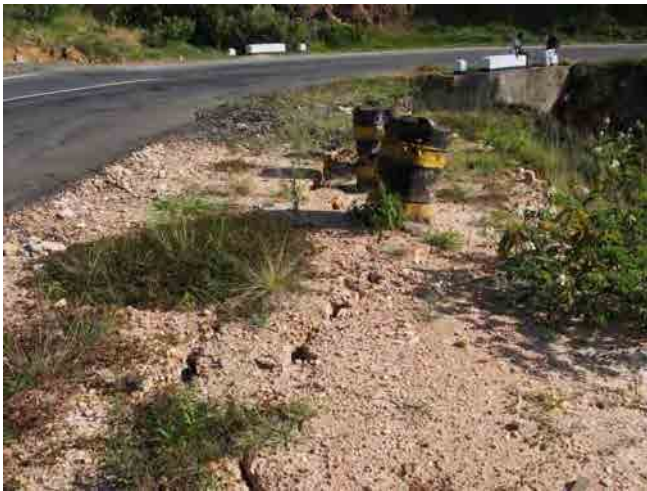
Tension cracks along the shoulder of the road at the beginning side.

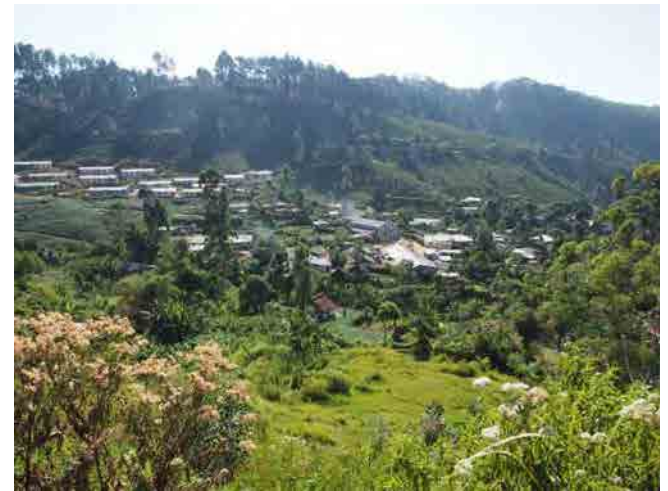
Village developed downward of the toe of the landslide
The debris is said to turn into mud flow when the landslide is activated, so the supposed affected area of the landslide can reach to the middle of the village, around the church.

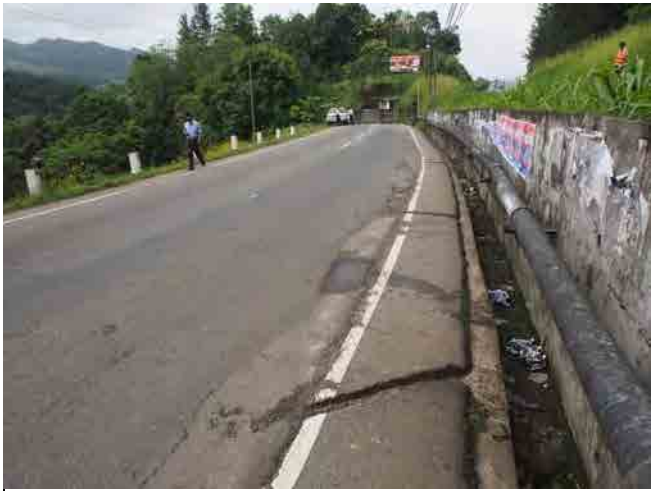
Damage on the road at the middle of the landslide

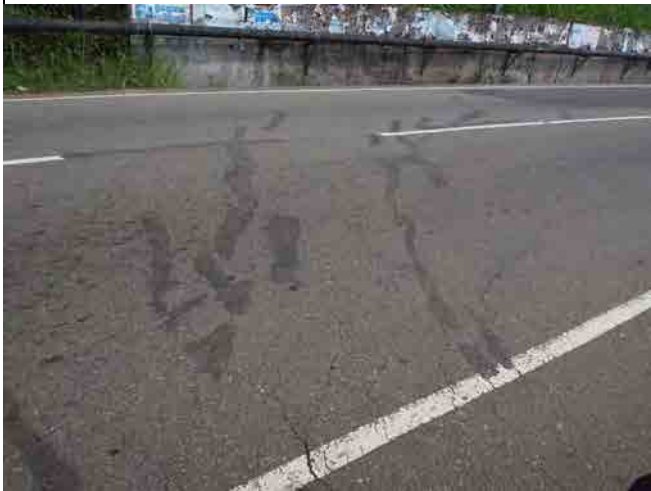
Cracks appeared on the road surface. Cracks seem to follow the shape of a head scarp under the pavement.
