**The Data Collection Survey on Road
Protection against Natural Disaster
(Landslide-Disaster)**

**FINAL REPORT (2/2)
Appendix**

December, 2012

**KOKUSAI KOGYO CO., LTD.
ORIENTAL CONSULTANTS CO., LTD.
JAPAN CONSERVATION ENGINEERS CO., LTD.**

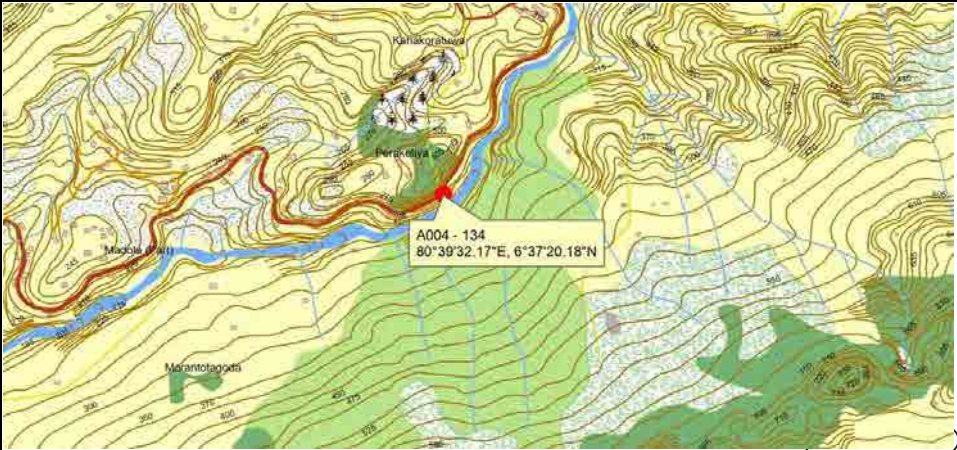
Environmental issue
Comment concerning slope situation	Recorded Disaster : Rock Fall (Boulder Size). Failure Type: Rock Fall or Rock Slide (Wedge type slide). Geological Condition: Weathered Gneiss with dyke rich in feldspar, Trigger of Failure: (Supposed) Tremendous rainfall + open cracks, Featured Points: At the beginning part, the slope is rich in cracks and thus rock fall may occur. In contrast, at the ending part, outcrop is rather massive and thus wedge type rock slide can be supposed. Supposed countermeasures: For rock fall, ring net can be applied. For rock slide, removal of unstable part after detailed investigation can be applied.			50

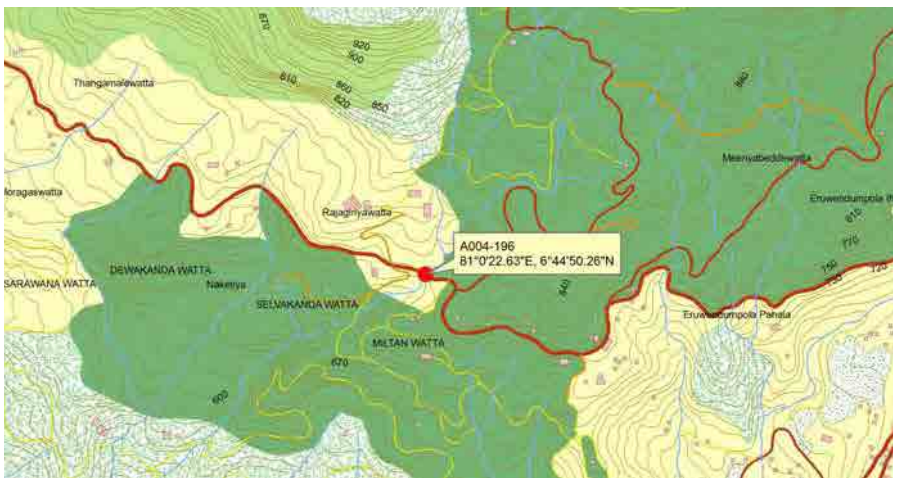
Environm ental issue
Comment concerning slope situation	<p>Recorded Disaster : First landslie occured in 19 Nov 1997(according to residents). In that slide 06 houses were destroyed, The previous bridge (Iron bridge) was thrown away & cultivations in downstam areas were destroyed. After major slide, in some rainy seasons, small sliding/collapsing/flowing debris takesplace. Insted of previous bridge on this A004 road, culvert has been constructed on filled ground.</p> <p>Failure Type: Landslide. Geological Condition: Mainly weathered rock (Fractured Zone) along with colluvium, Natural Stream present. Flows along this fractured zone. Trigger of Failure: (Supposed) Rise in groundwater, Topographic Condition: Water collecting valley (formed probably because of fractured zone) , The stream is running accross the road.</p> <p>Featured Points: The affecting landslide seems to be one of devided landslide from much wider series of landslides. Which is mainly composed of weathered rock which seems to be low resistant because of weathering and prone to alter into clay. At the head scarps at the shoulder and upper-middle of the affecting landslide, outcrops of weathered rocks At the toe of the landslide, some springs were observed.</p>			30

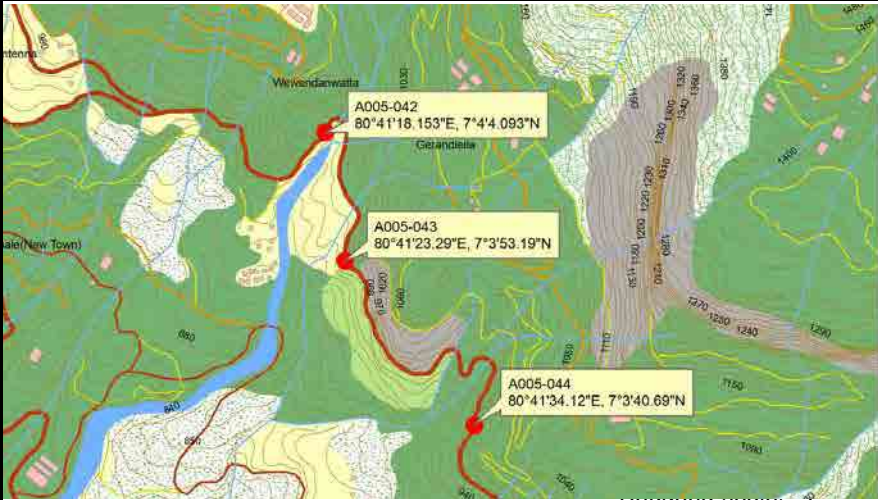
Comment concerning slope situation	<p>Recorded Disaster : Periodical records of landslide activity. No damage on A005 but local residences and public building locating around the head scarp were damaged by the landslide. Another national road running around the head scarp was also damaged.</p> <p>Failure Type: Landslide. Geological Condition: Colluvium, Trigger of Failure: (Supposed) Rise of groundwater,</p> <p>Featured Points: The landslides at this location is composed of 3 blocks of landslides; 1 upper landslide and 2 lower landslides. The 2 lower landslides face the road of A005 and divided by a ridge of base rock. The landslides are under investigation by NBRO. The total length of the landslides is estimated to be 900 ~ 1,000m. No damage has been reported so far, but blockade by debris from the toe of the lower landslide can be considered as possible damage.</p> <p>Supposed countermeasures: Surface drainage system and underground drainage system</p>

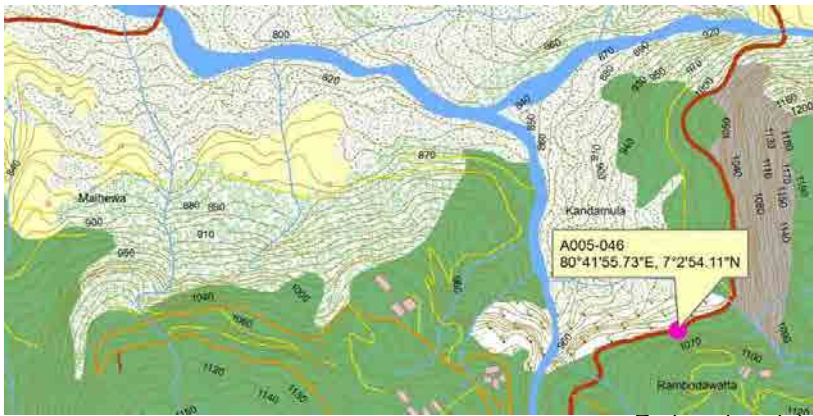
Reduced scale(1:)
Comment concerning slope situation	<p>Recorded Disaster : unclear, but traces of rock failure were confirmed during the site visit. Rock fall and small rock slide often occur during heavy rains. Failure Type: Rock slide in weathered rock, rock fall. Geological Condition: Weathered rock rich in vertical open cracks along with foliation, Trigger of Failure: (Supposed) Rainfall,</p> <p>Featured Points: Rock wall with almost perpendicular slope. Well developed foliation and vertical cracks are primary causes of possible failures..</p> <p>Supposed countermeasures: Drainage ditches along the shoulder of the slope along with vertical drainage. Removal of unstable parts and installation of ring net.</p>

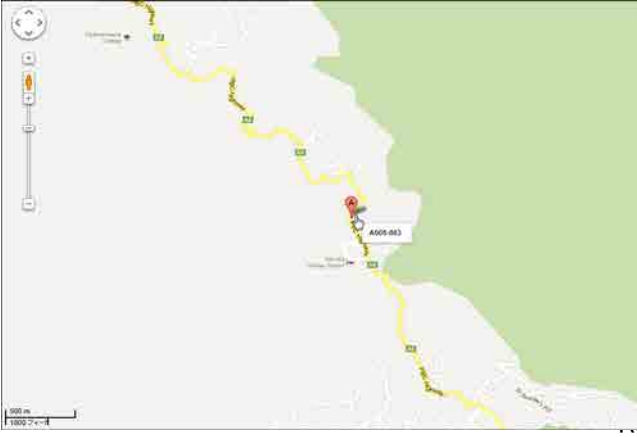
Environmental issue
Comment concerning slope situation	<p>Recorded Disaster : Damage at shoulder, subsidence and cracks on the pavement.</p> <p>Failure Type: Slope Slope failure. Geological Condition: Colluvium, Trigger of Failure: (Supposed) Relaxed shoulder caused by a too steep gradient of slope as 54 degrees,</p> <p>Featured Points: Steep slope composed of colluvium declines from the shoulder of the road. It is likely that the damage was caused by loose shoulder relaxed by the too steep gradient of slope.</p> <p>Supposed countermeasures: Drainage system along the shoulder, retaining wall or grating cribs with ground anchor if necessary.</p>			55

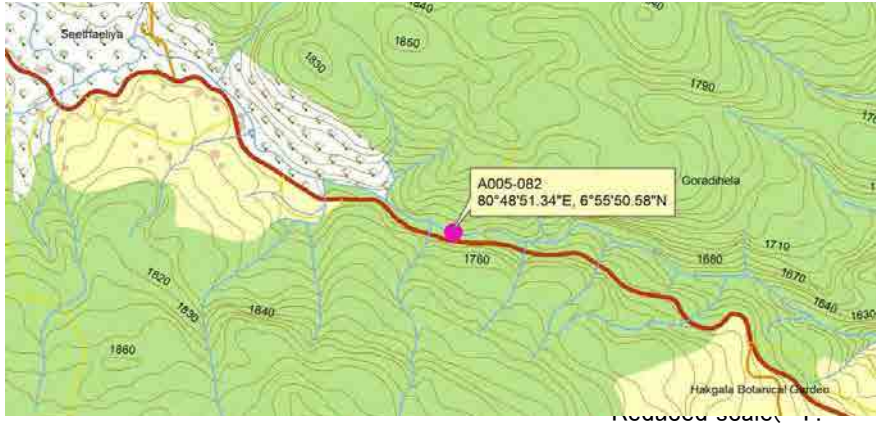
Comment concerning slope situation	<p>Recorded Disaster : Slope failures were seen at the site. Failure Type: Slope failure in weathered rock. Geological Condition: Weathered rock and residual soil. Trigger of Failure: (Supposed) Rainfall,</p> <p>Featured Points: Gradient of slope is apparently too steep for the heavily weathered gneiss confirmed at the site. The heavily weathered gneiss showed fragile strength property. Gully erosion was also confirmed. Successive slope failures which can entail retrogressive development of failures behind the shoulder of the slope are anticipated.</p> <p>Supposed countermeasures: Drainage ditches along the shoulder of the slope along with vertical drainage. Reshaping the slope with stable angle or grating cribs with ground anchors.</p>

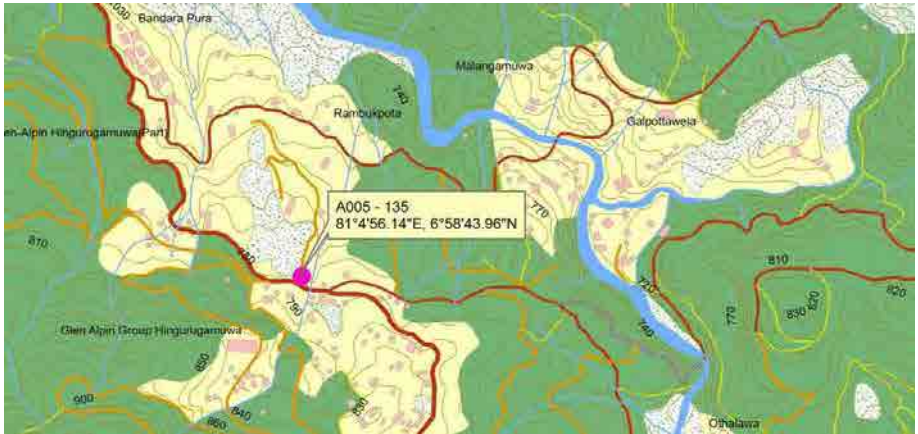
Comment concerning slope situation	<p>Recorded Disaster : From December 2010 when an accumulated precipitation recorded 400 mm, cracks related to one of head scarps appeared at the house of the regional director for the plantation. (This plantation is rehabilitated by PRPII project supported by JICA). In every rainy season, movements of the landslides are observed.</p> <p>As for the damage, severe damage has affected many buildings including a hospital for the plantation and a government office. A005 itself is not included in the landslide mass; the road is just beside the toe of the landslides. Thus when the landslides moved, debris from the toe of the landslides cover the road and RDA shall remove the debris.</p> <p>Failure Type: Landslide. Geological Condition: Colluvium, Trigger of Failure: (Supposed) Rise in groundwater,</p> <p>Featured Points: The type of landslide can be categorized as multiple landslide. The landslide mass was divided into more than 2 subdivided landslides. Head scarps were confirmed not only at the upper part but at middle of the landslide mass. The landslides are under investigation by NBRO. Based on its initial investigation, NBRO estimated</p> <p>Supposed countermeasures: Surface drainage system and underground drainage system.</p>

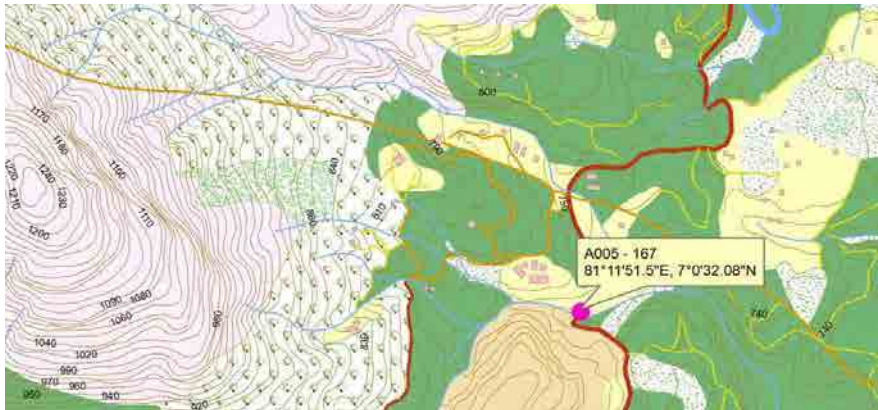
Reduced scale(1 :)
Comment concerning slope situation	<p>Recorded Disaster : For more than 10 years, in every rainy season, the landslides moved toward A005 and the debris from the toe covered the road. Against each blockade by the debris, RDA needs to remove it from the road surface.</p> <p>Failure Type: Landslide. Geological Condition: Mainly weathered rock along with colluvium, Trigger of Failure: (Supposed) Rise in groundwater, Topographic Condition: Water collecting valley, a stream is running along the road.</p> <p>Featured Points: The affecting landslide seems to be one of devided landslide from much wider landslide which was moved far past. The affecting landslide is mainly composed of weathered rock which seems to be low resistant against weathering and prone to alter into clay. At the head scarps at the shoulder and upper-middle of the affecting landslide, outcrops of weathered rocks can be observed. At the toe of the landslide, a spring was observed.</p> <p>Supposed countermeasures: Surface drainage system and underground drainage system. Ground anchor at the toe. Relocation of the bridge passing the stream can be an option.</p>

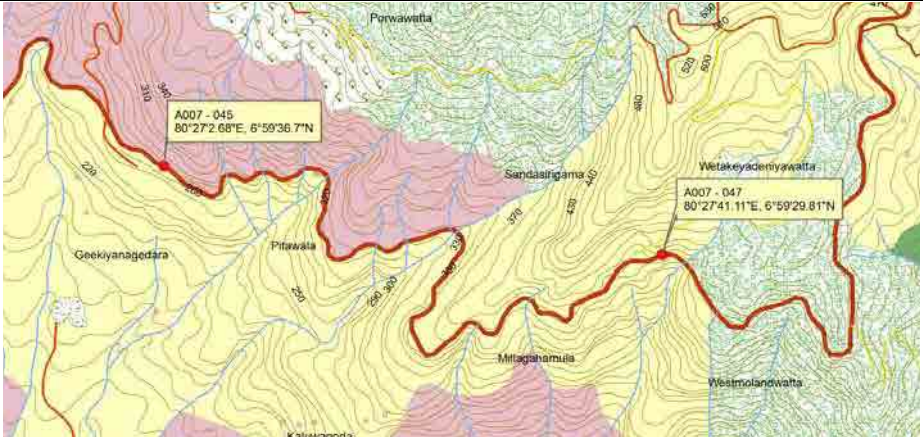
Comment concerning slope situation	<p>Recorded Disaster : Unclear. Fallen boulders, however, were seen on site.</p> <p>Failure Type: Rock fall, slope failure in colluvium.</p> <p>Geological Condition: At the ending part, massive rock with cracks, at the beginning part, colluvium..</p> <p>Trigger of Failure: (Supposed) Rainfall, erosion, and development of open cracks..</p> <p>Featured Points: Boulders were seen at the shoulder of cutting slope composed of colluvium. Boulders were also seen in the upper slopes. In addition, unstable parts of outcrop with cracks were seen at the shoulder of rocky slope.</p> <p>Supposed countermeasures: Further investigation is required to set up appropriate countermeasures. Based on the site situation, however, removal of boulders and unstable parts of rock can be amongst countermeasures along with fixing unstable parts with rock bolts or other fixing methods.</p>

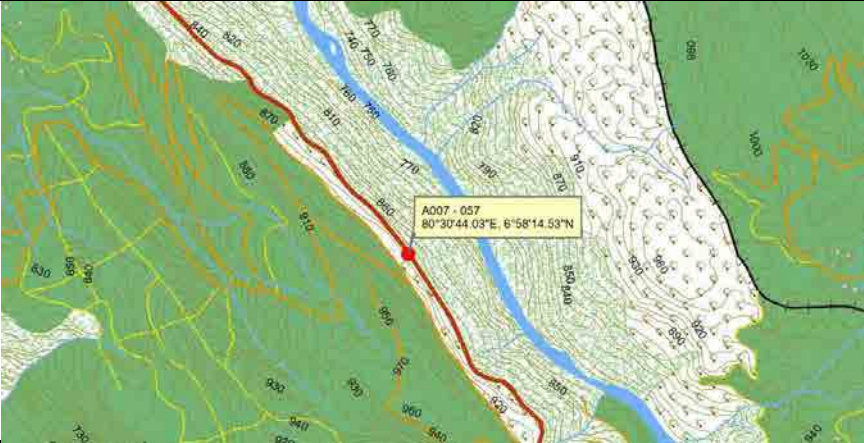
105
Comment concerning slope situation	<p>Recorded Disaster : Debris provided from the slope failure closed the road.</p> <p>Failure Type: Slope failure in residual soil and weathered rock. Geological Condition: Residual soil and weathered gneiss rich in cracks. Vertical cracks attract the attention. Trigger of Failure: (Supposed) Rainfall, erosion, and steeper gradient of slope.</p> <p>Featured Points: Springs were confirmed in the middle of the slope at the beginning side.</p> <p>Supposed countermeasures: Further investigation is required to set up appropriate countermeasures. Based on the site situation, however, drainage system and grating cribs with ground anchors can be amongst the supposed.</p>

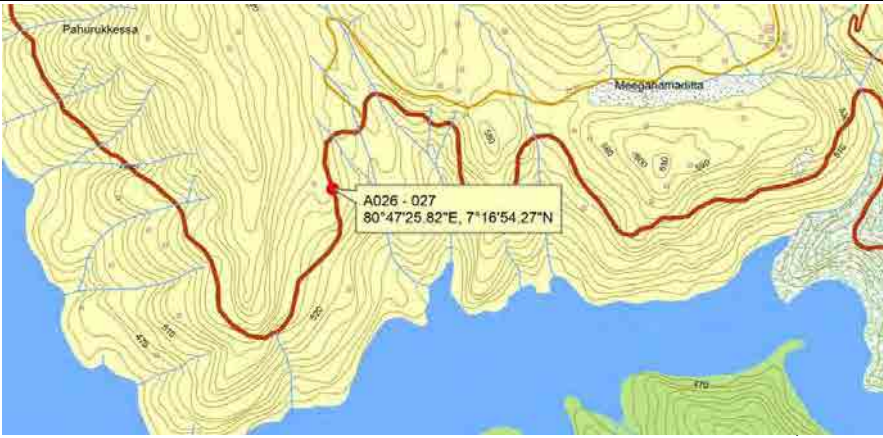
0
Comment concerning slope situation	<p>Recorded Disaster : Jan 2007, during rainy season Failure Type: Slope Failure involving Rock Sliding, Geological Condition: Residual soil, Highly weathered ~ weathered rock with cracks, Supposed countermeasures: Fixed with rock bolts or removal of unstable parts.</p>

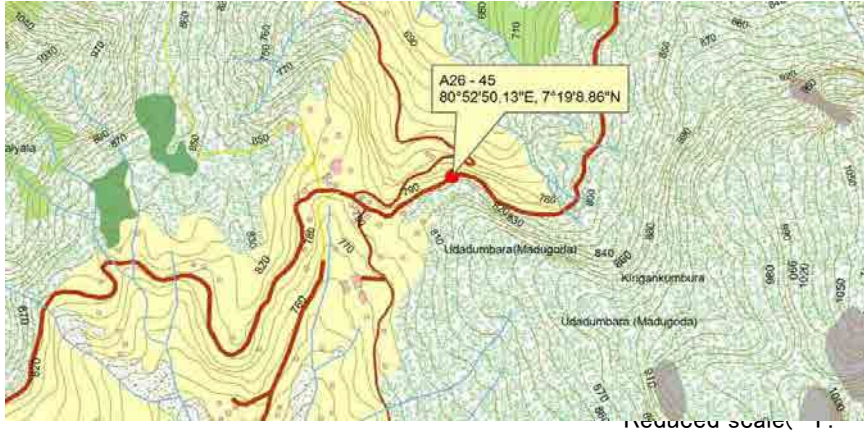
0
Comment concerning slope situation	<p>Recorded Disaster : 2010, during construction by Keangnam. Failure Type: Slope failure in residual soil and weathered rock, Geological Condition: Residual soil, weathered rock (Garnet biotite Gneiss) with dip slope condition, Trigger of Failure: Construction, Topographic Condition: Ridge,</p> <p>Featured Points: Gully erosion is seen on the slope surface of residual soil. Dip slope condition in weathered rock part. Gradient of Slope is too steep for residual soil.</p> <p>Supposed countermeasures: Drainage ditches along the shoulder of the slope along with vertical drainage. Reshaping the slope with stable angle or retaining methods such as anchoring or R/B with grating cribs.</p>
