Appendix 3-2 Slope inspection sheets for Rank C and B

General Information Sheet

Management office	Ratnapura												
Management number	A004-134	Route No	A004	Location(m)	134/15	to	134	Distance	200	m			
Disaster	Rock fall	Name of Road		Landmark		latitude	N 06°37'20.18"	longitude	E 080°39'32.17"				
Schematic sketch				Reporter's name :	M. Enokida

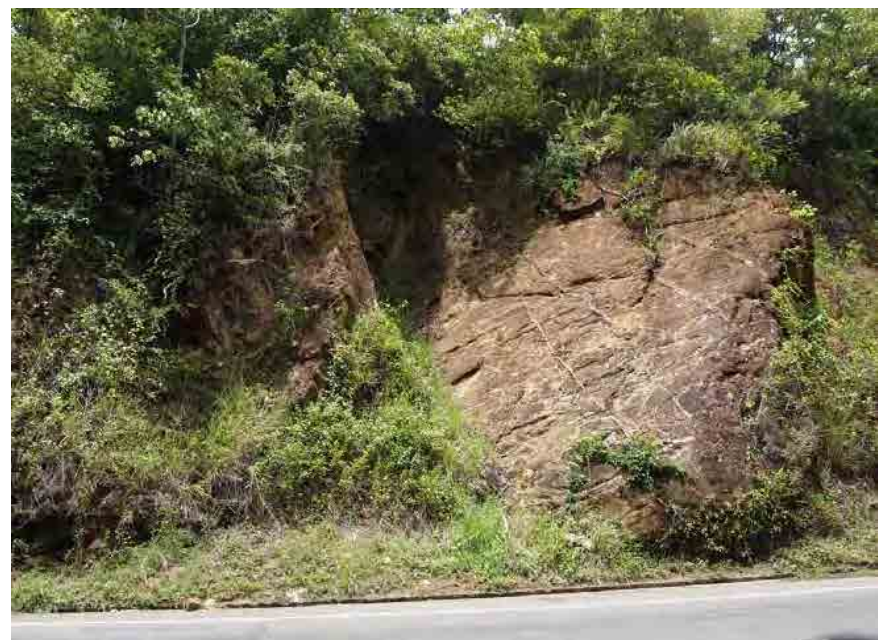
Mark that comes off rock and fell

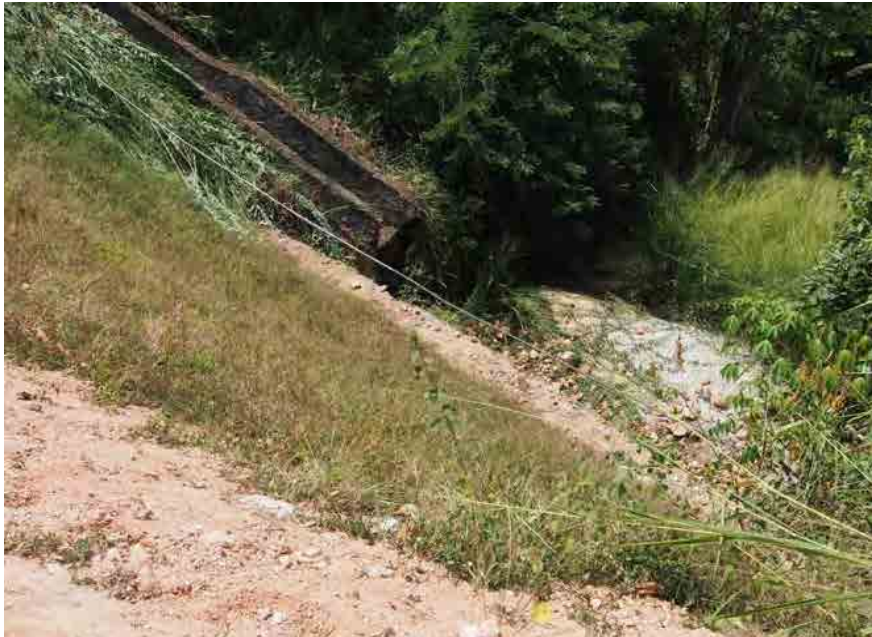
Condition of slope

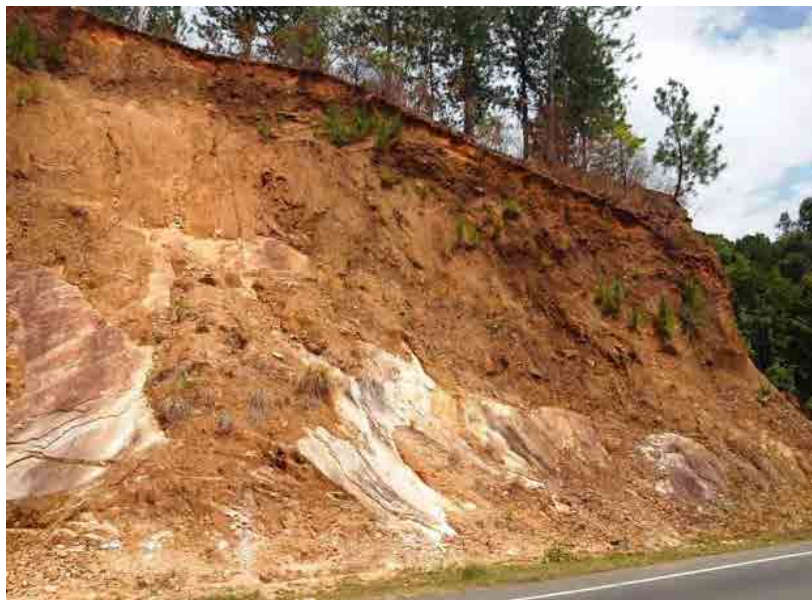
Condition of slope, a loose sedimentary soil is recorded on the base rock.

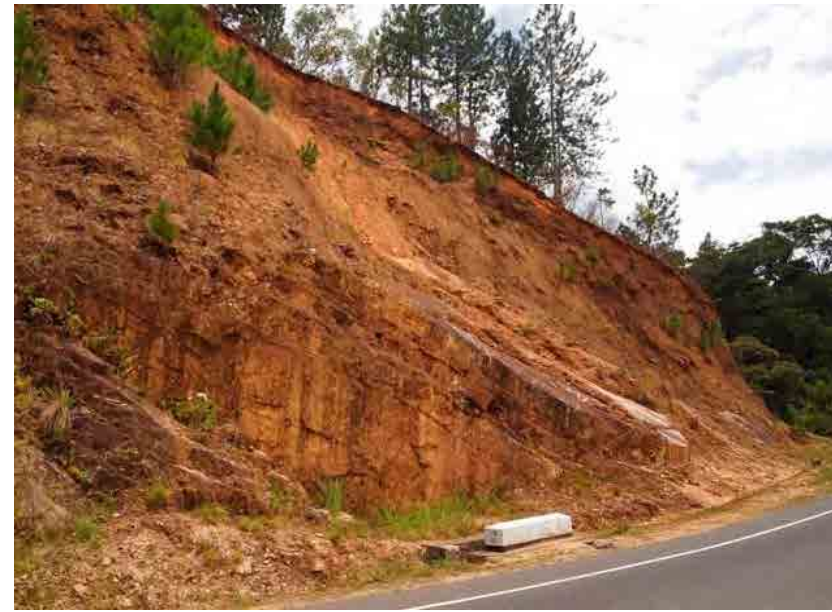
Condition of slope, basement rock of dip slope structure

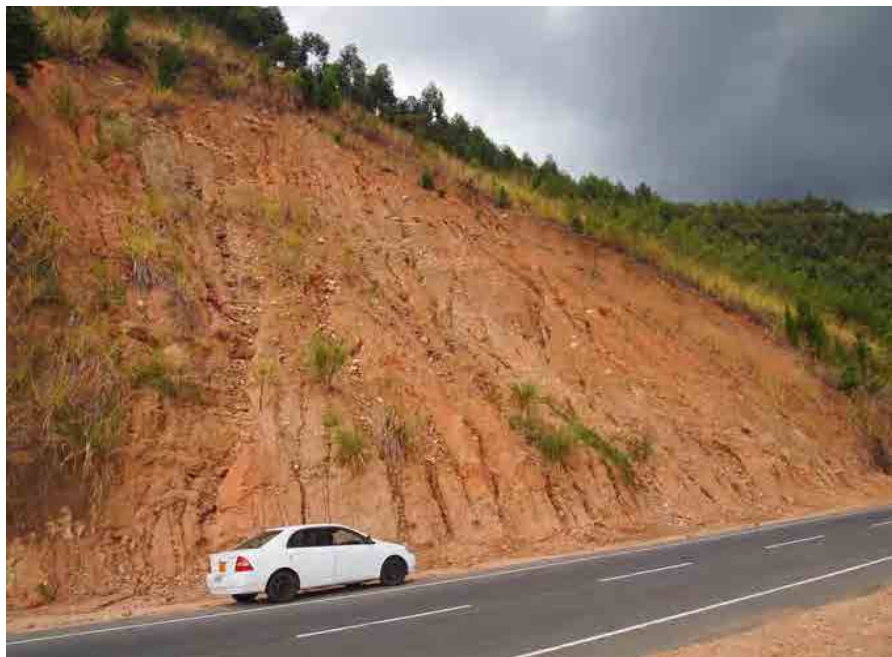
Condition of slope, many can confirm the mark of erosion

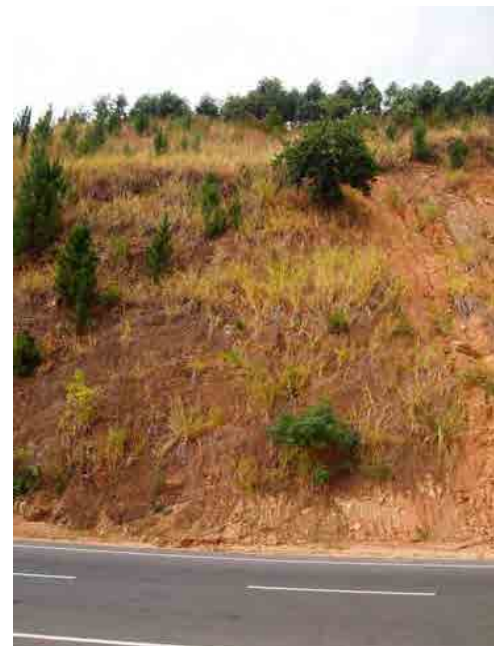
Condition of slope, the slope on the start side is a slope of a steady sedimentary rock

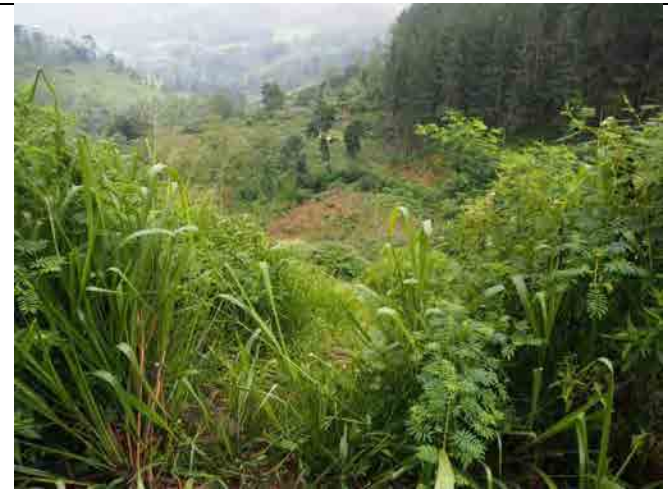
Condition of the lower slope. From the shoulder of the road, very steep lower slope descends downward.

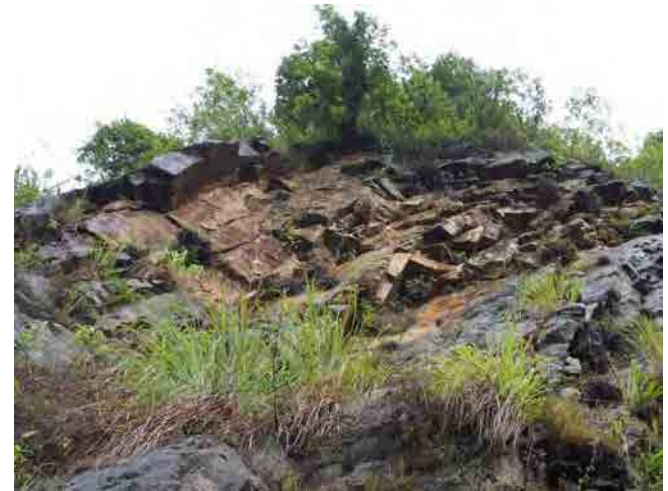
Close up view of the left. With foliation plunging to the slope, vertical cracks can form slip surfaces for rock slides.

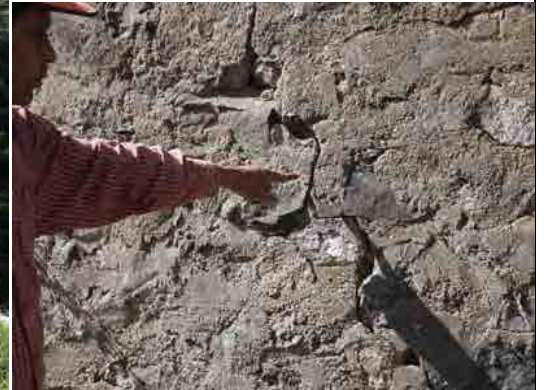
Crack of retaining wall on part slope on road

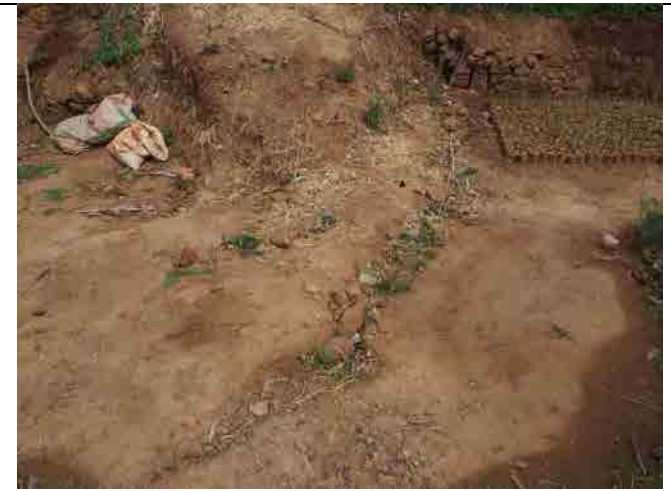
Open cracks seen at the terraces on the upper slope.

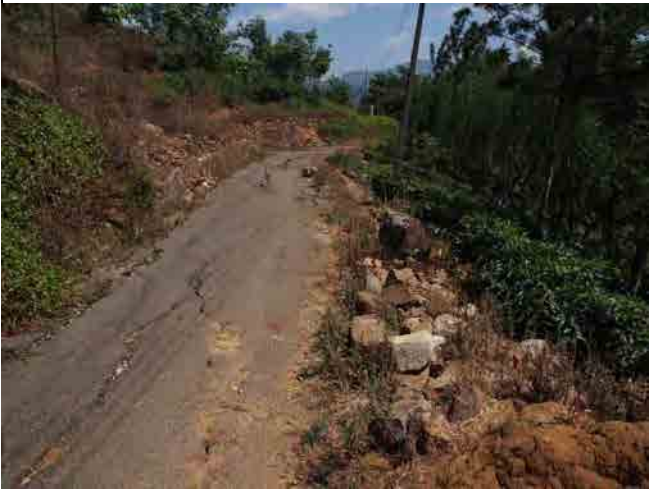
Cracks at the middle of landslide.

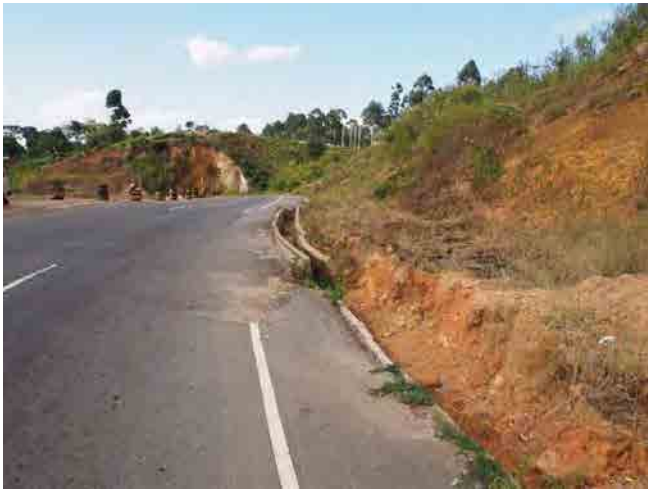
Damage on the road at the middle of the landslide

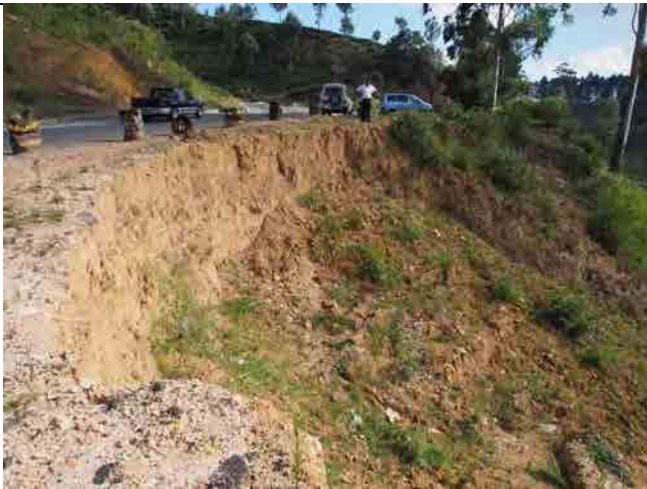
Headscarp along the road shoulder at the ending side

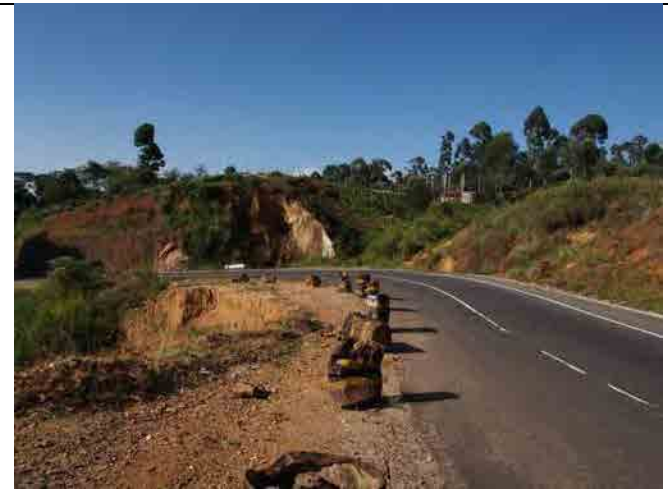
Condition of the road around the head scarp at the ending side.

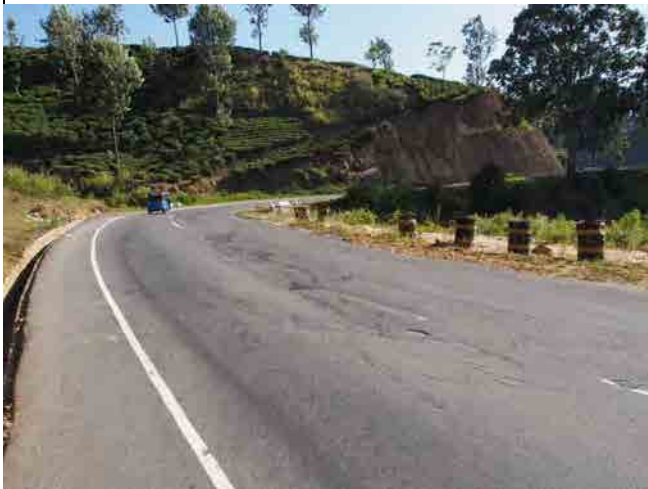
Subsidence on the road at the beginning side.

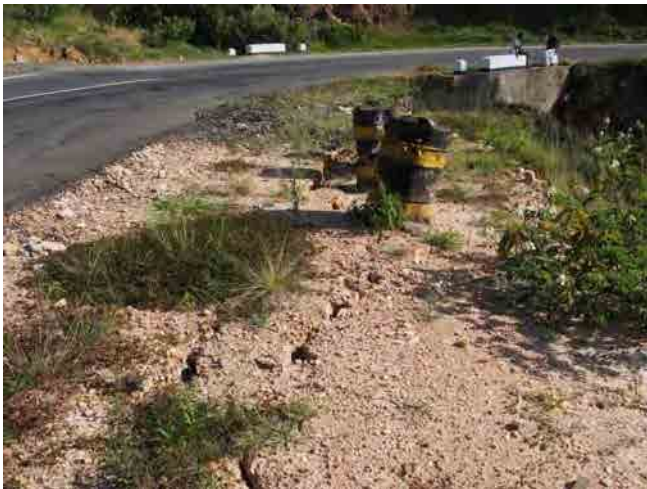
Tension cracks along the shoulder of the road at the beginning side.

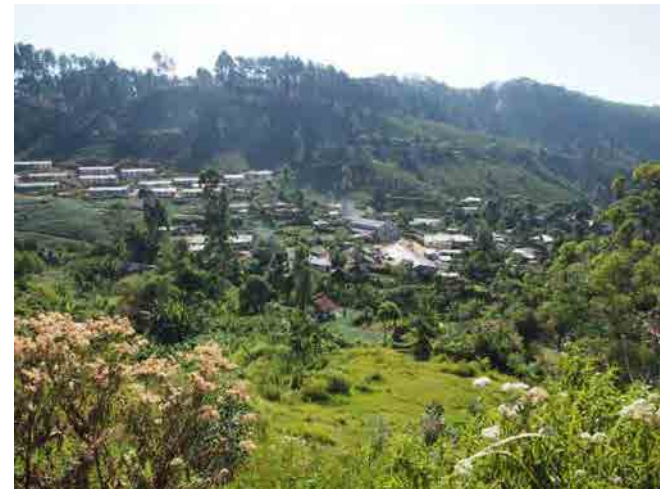
Village developed downward of the toe of the landslide
The debris is said to turn into mud flow when the landslide is activated, so the supposed affected area of the landslide can reach to the middle of the village, around the church.

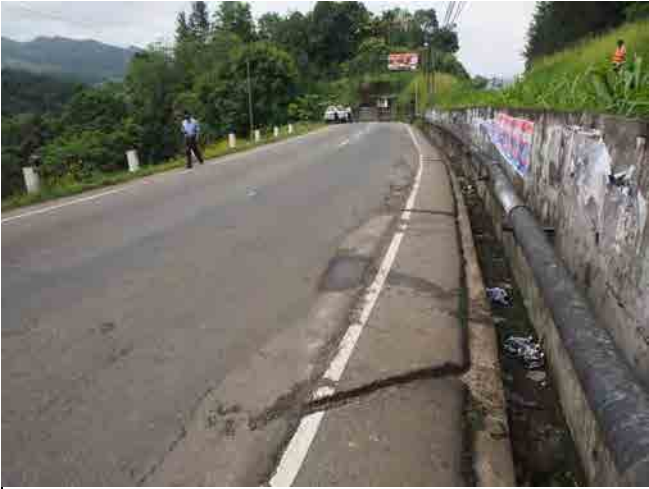
Damage on the road at the middle of the landslide

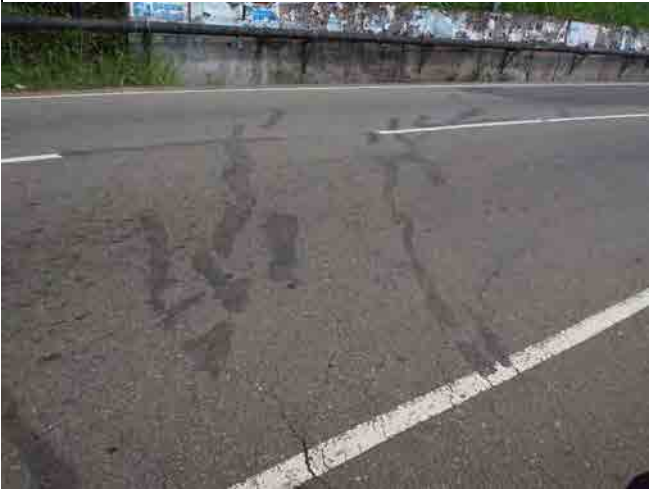
Cracks appeared on the road surface. Cracks seem to follow the shape of a head scarp under the pavement.
