**FOLLOW-UP COOPERATION STUDY  
ON  
THE PROJECT FOR CONSTRUCTION  
OF  
THE SUEZ CANAL BRIDGE  
(PAVEMENT on STEEL DECK)**

**FINAL REPORT**

**MARCH 2013**

**JAPAN INTERNATIONAL COOPERATION AGENCY**

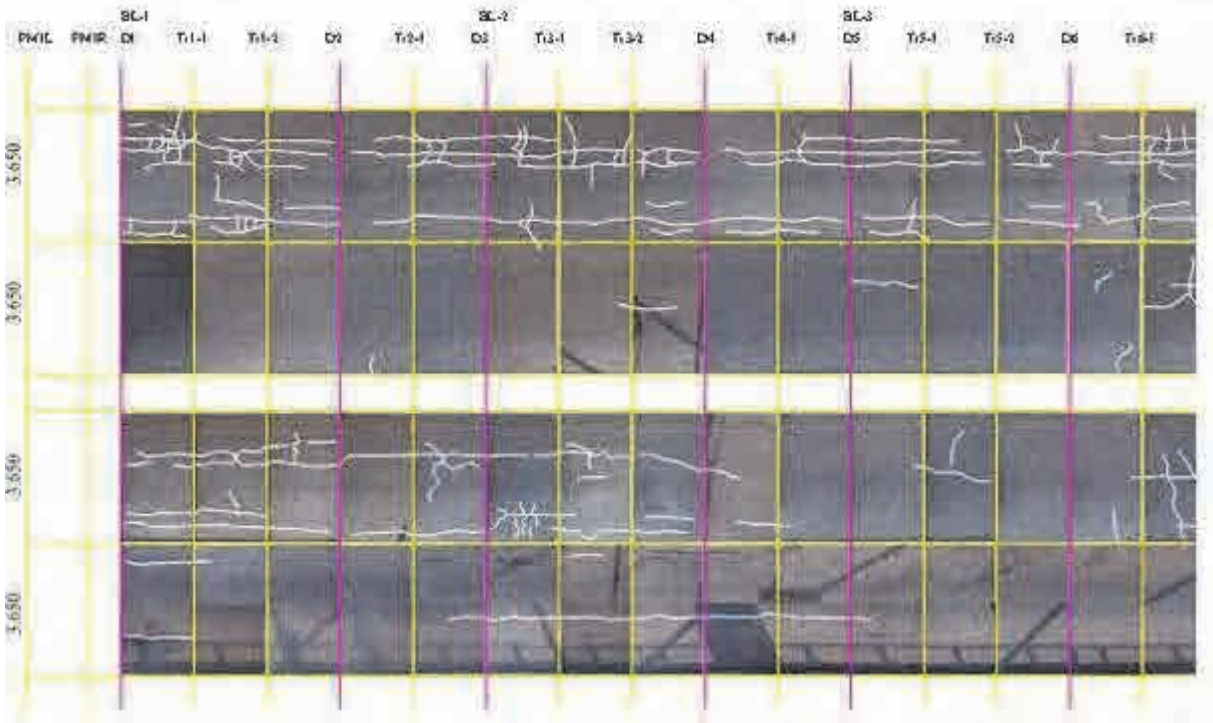
Figure 2.2.1 Crack Map (BL1 – BL 4)

- The photographs were arranged in a plane view to confirm the conditions easily.
- The crack map was made based on the photographs.

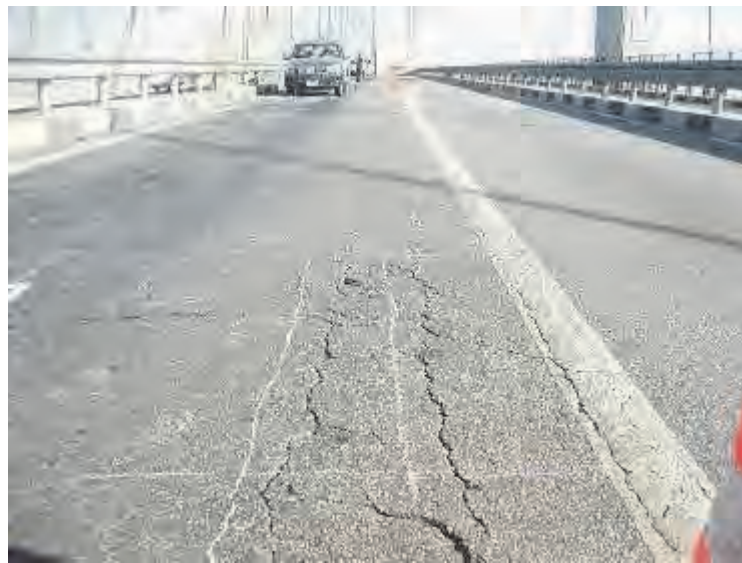
- The largest crack was 40 mm in width and 80 mm in depth; thus, major cracks reached the steel deck plate.
- A pothole of 70 mm x 50 mm was found.
- Flatness of the pavement surface was good with a difference of less than 5 mm against the critical maintenance value of 20 mm.
- Some points were confirmed as isolated areas because of deterioration of bonding strength.
- Major cracks were intensively located under the wheel-loaded line.

**Photo 2.2.5 Major Cracks on Wheel-Loaded Line**

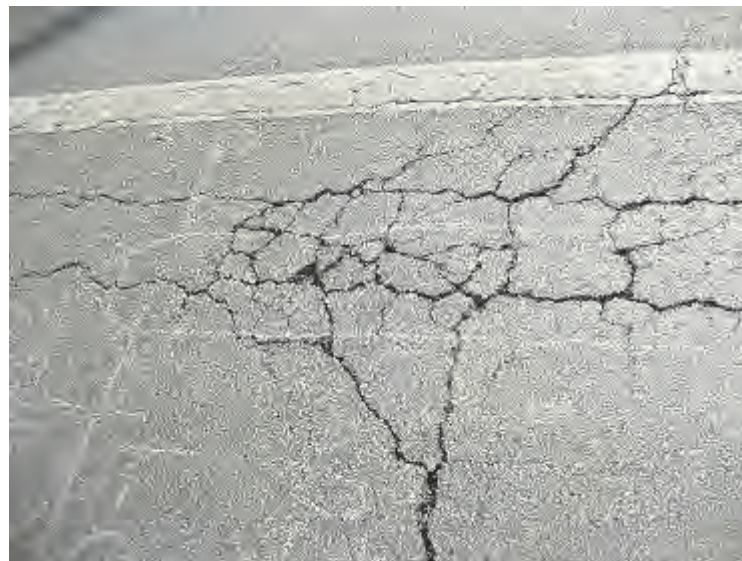
- In detail, major cracks occurred along the line between the rib plates.

**Photo 2.2.6 Major Cracks between the Rib Plates of the Steel Deck Plate**

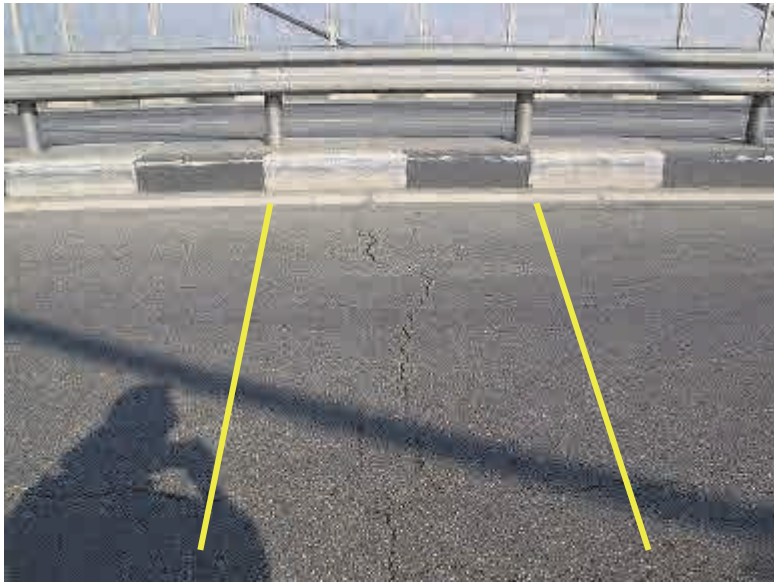
- Also, some major cracks in the transverse direction were located between the diaphragms.

**Photo 2.2.7 Major Cracks between Transverse Diaphragms**

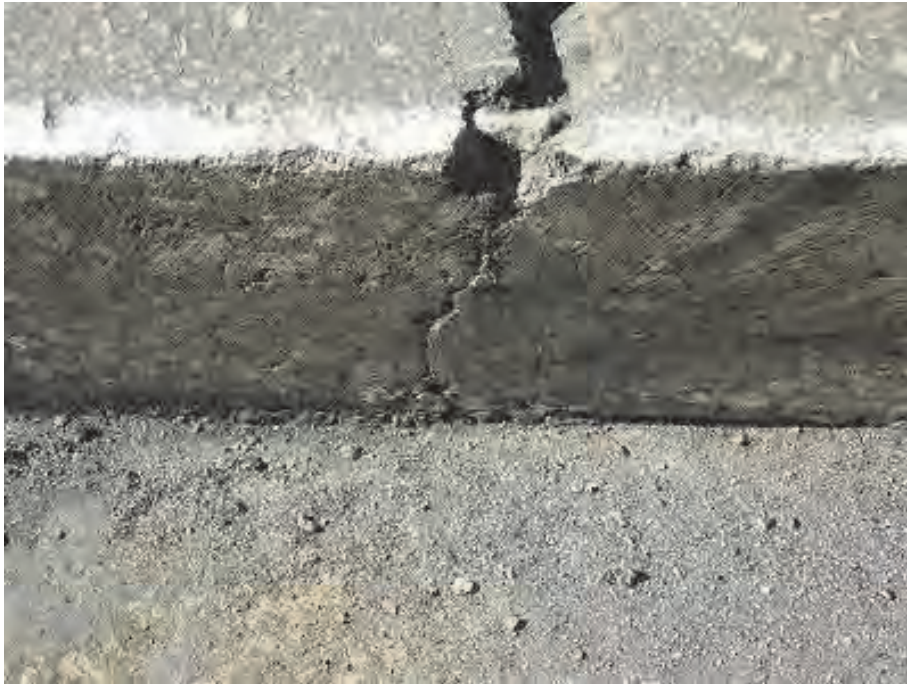
- Some cracks with widths of 10 mm reached the steel deck plate.

**Photo 2.2.12 Cross Section of Cut Pavement (L2)**

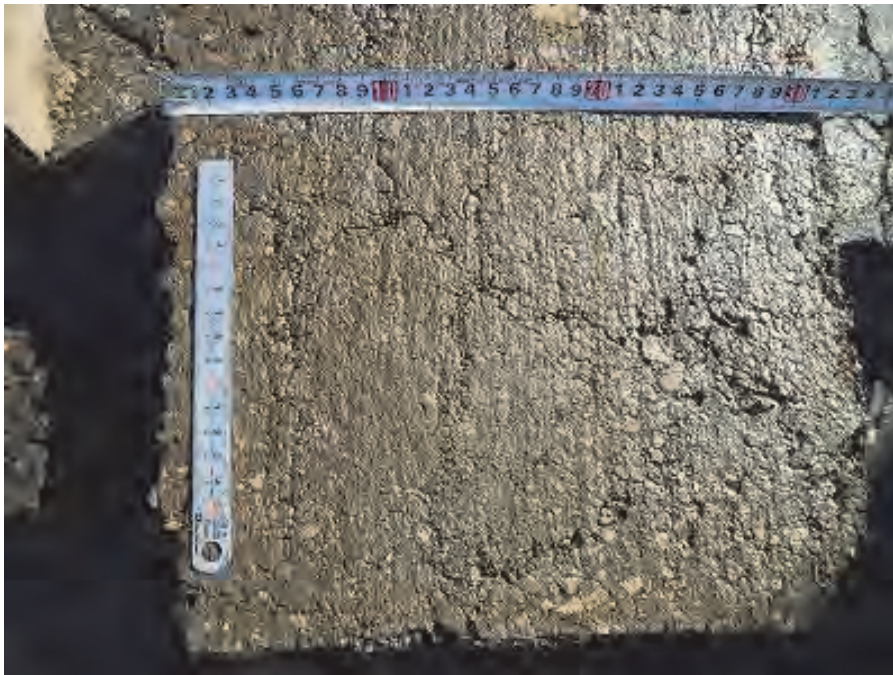
- In all inspected spots, bonding strengths between the base course and steel deck plate were deteriorated.

**Photo 2.2.13 Bottom Face of Excavated Block (Bonding Face) L2**

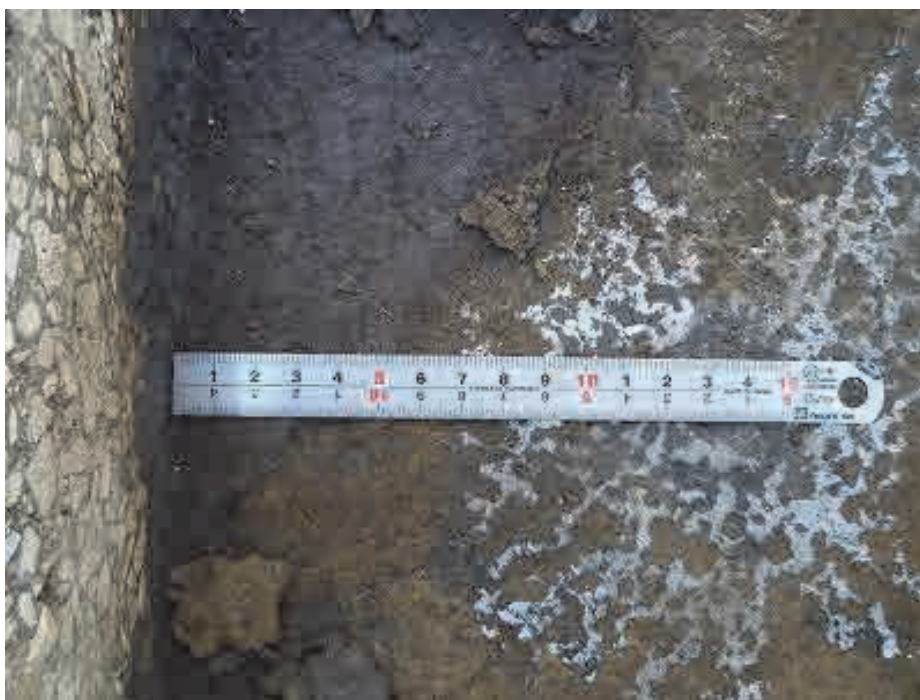
**Photo 2.2.14 Peeling of Bonding Layer with Corrosion (L2)**

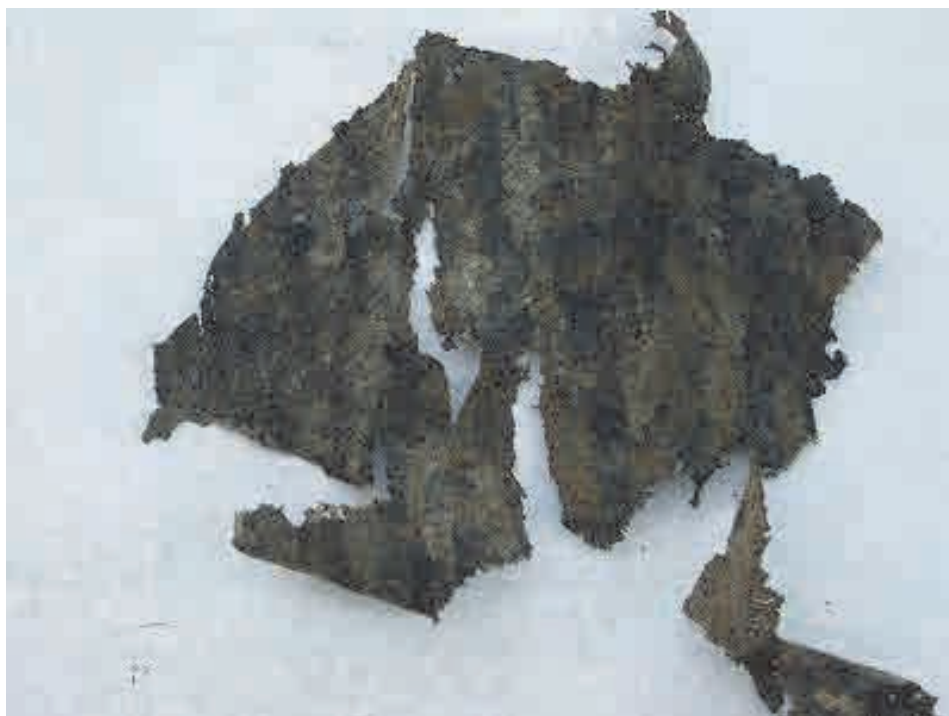
**Photo 2.2.15 Peeling of Bonding Layer with Corrosion (L1)**

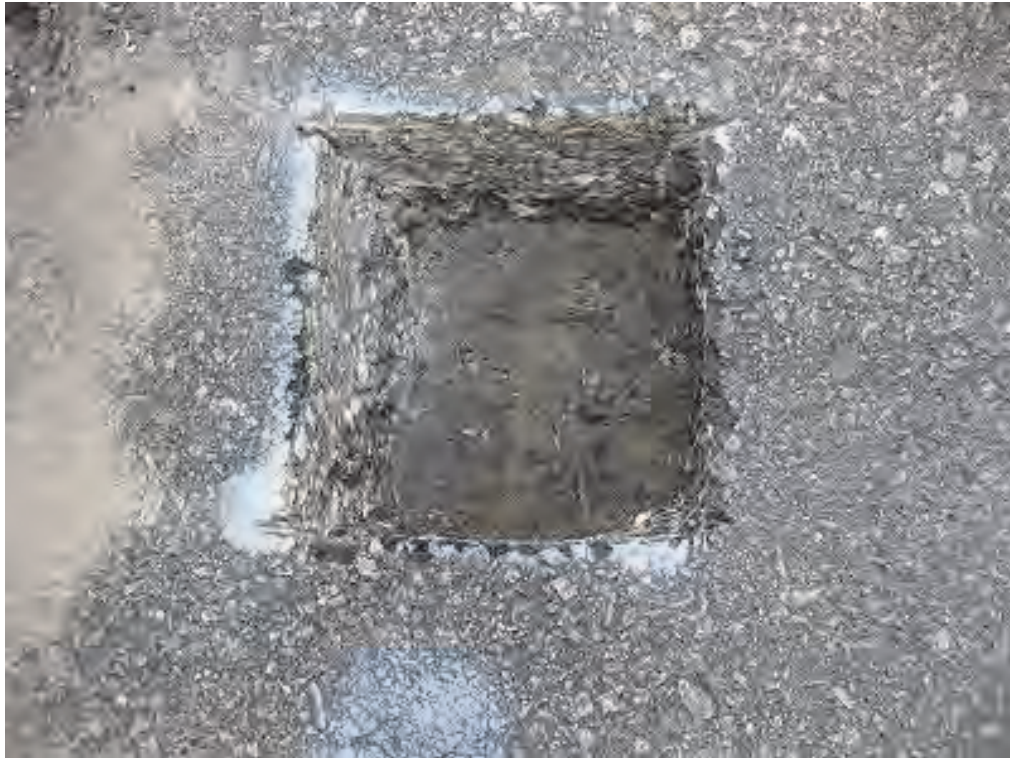
- The condition of the adhesive layer of the two additional spots (sound area) seemed good.

**Photo 2.2.16 Condition of Additional Spot (Sound Area) SA2**

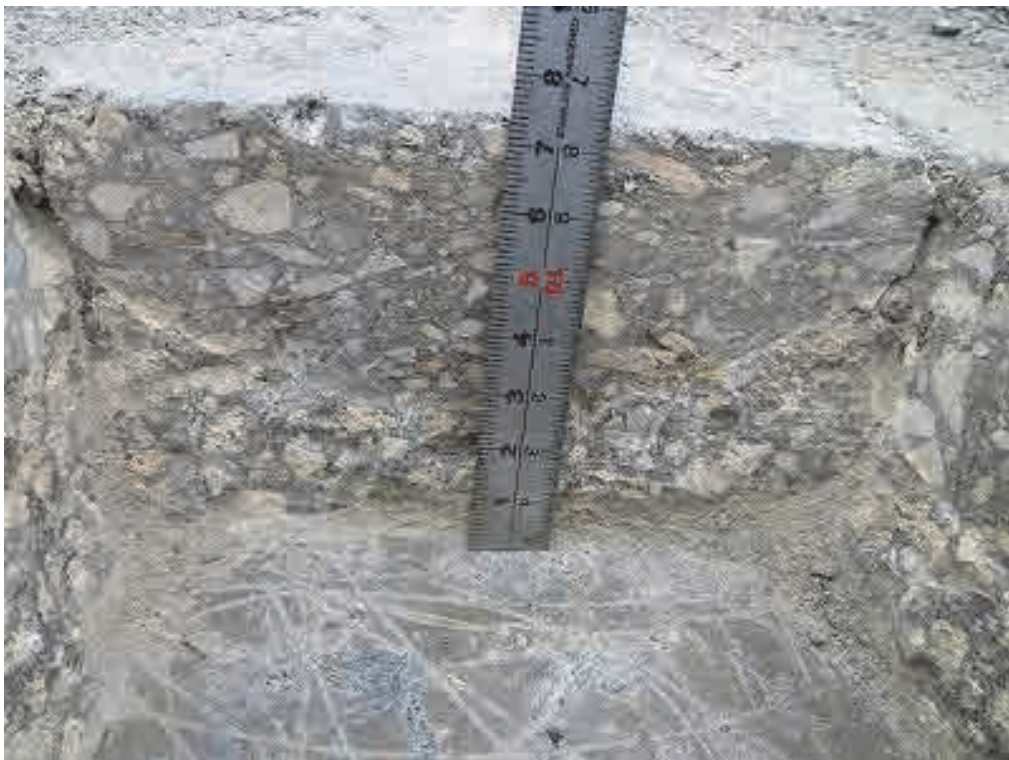
**Photo 2.2.17 Condition of Additional Spot (Sound Area) SA2---Magnified**

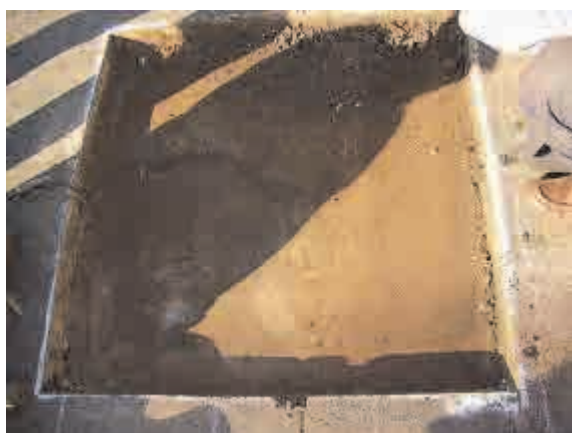
1) L1

After the Removal of Asphalt Layer,  
Red Material Adheared to the Stick Layer

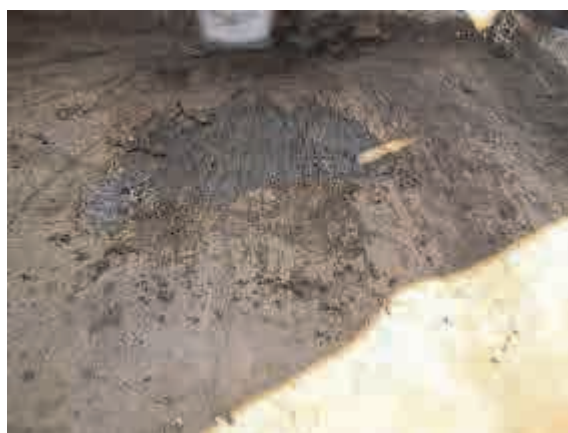
Stick Layer (Bonding and Corrosion)

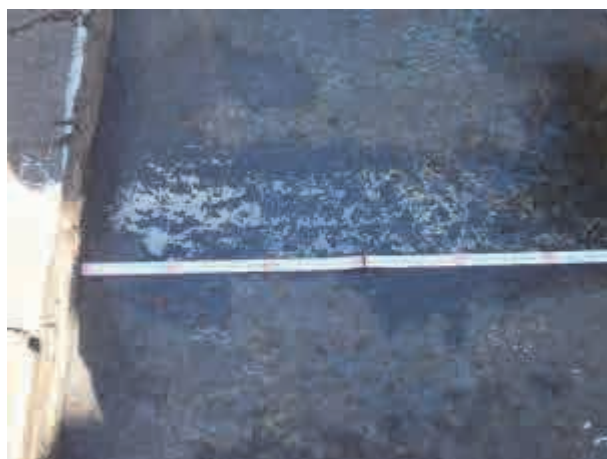
Surface Condition after Removal of Corrosion

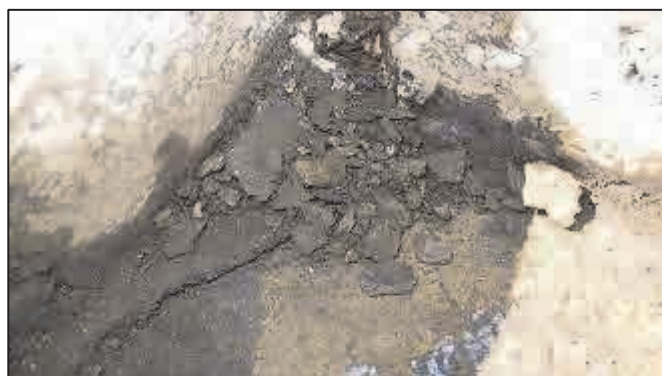
- The rust layer was removed easily and broke into pieces.

**Photo 2.3.4 Top Surface of Steel Deck (S2)**

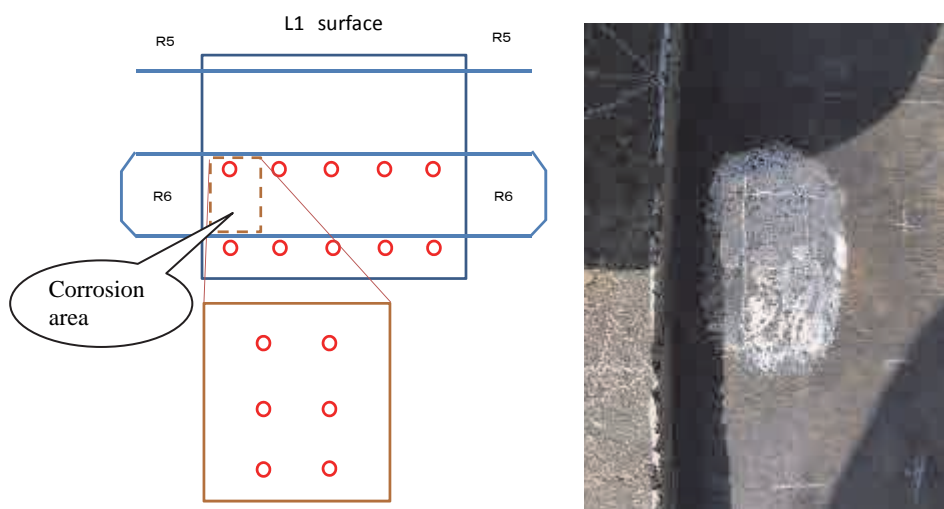
- Thicknesses of plates were measured in 5 cutouts. L1, S1 (north side), L2, S2, L3 (south side).
- Corrosion on L2 seems to be the most severe in the inspection.
- Average thickness of L2 is 11.5 mm after the smoothing of the surface.
- L1: A little corrosion was observed on the center part. The corroded region in the west part was ground smooth and thicknesses were measured.

**Figure 2.3.2 Thickness Measured on L1 Surface**

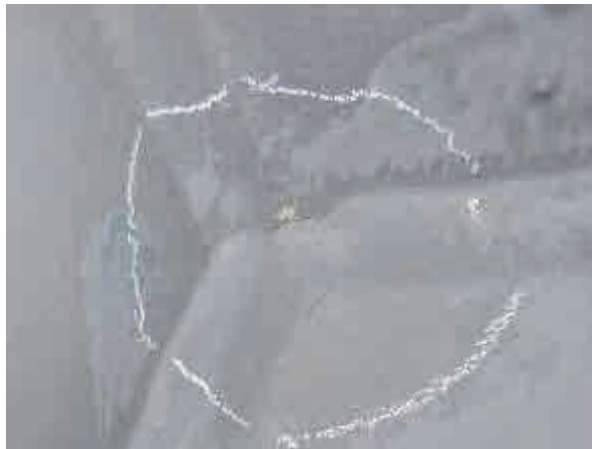
- Some poor welds were found and are listed in the appendix.
- A few paint cracks were found as shown in Photo 2.3.8. Patterns of these paint cracks are different from those of fatigue cracks.

Paint Crack L1 WTr20-1W-R6(5)

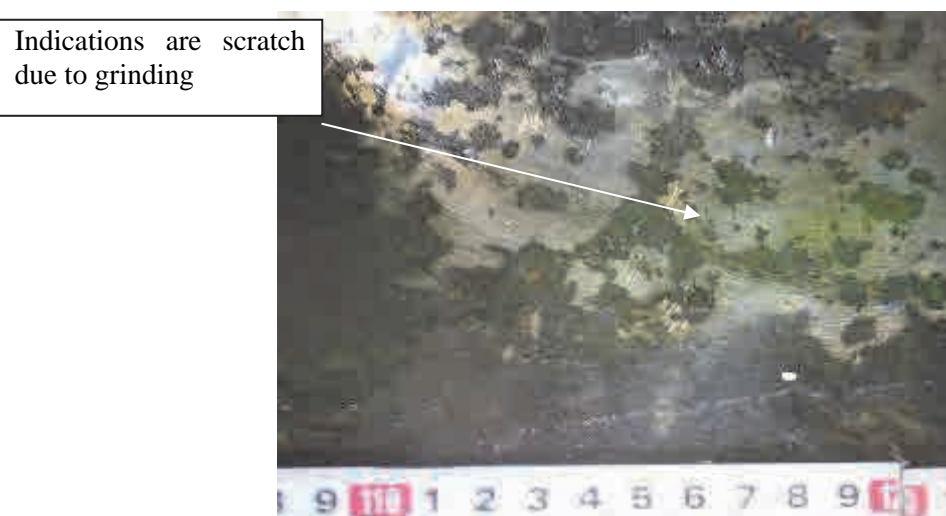
- MT was applied on the surface of the steel deck in the asphalt cutout areas (L1, L2, L3, S1, S2 surfaces).
- No fatigue cracks were detected.

**Photo 2.3.13 MT Inspection on Deck Surface S2**

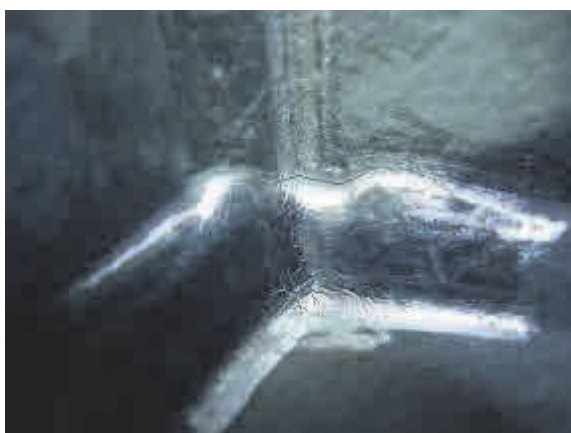
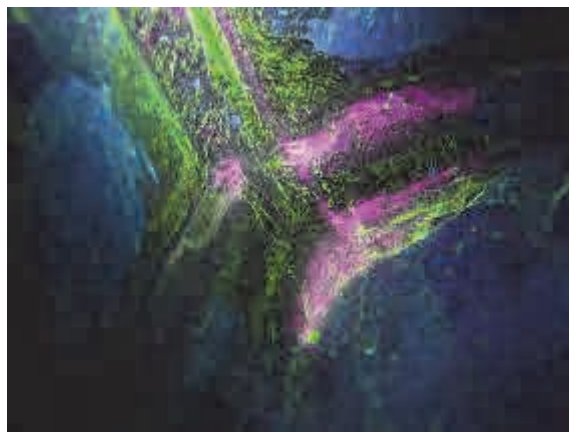
Before Grinding

- No fatigue cracks were detected.
- A small crack on the weld bead was observed in L1 (Photo 2.3.15). It is a weld crack generated in the welding process and can be removed by surface grinding.
- MT results are summarized in the D/B form in the appendix.

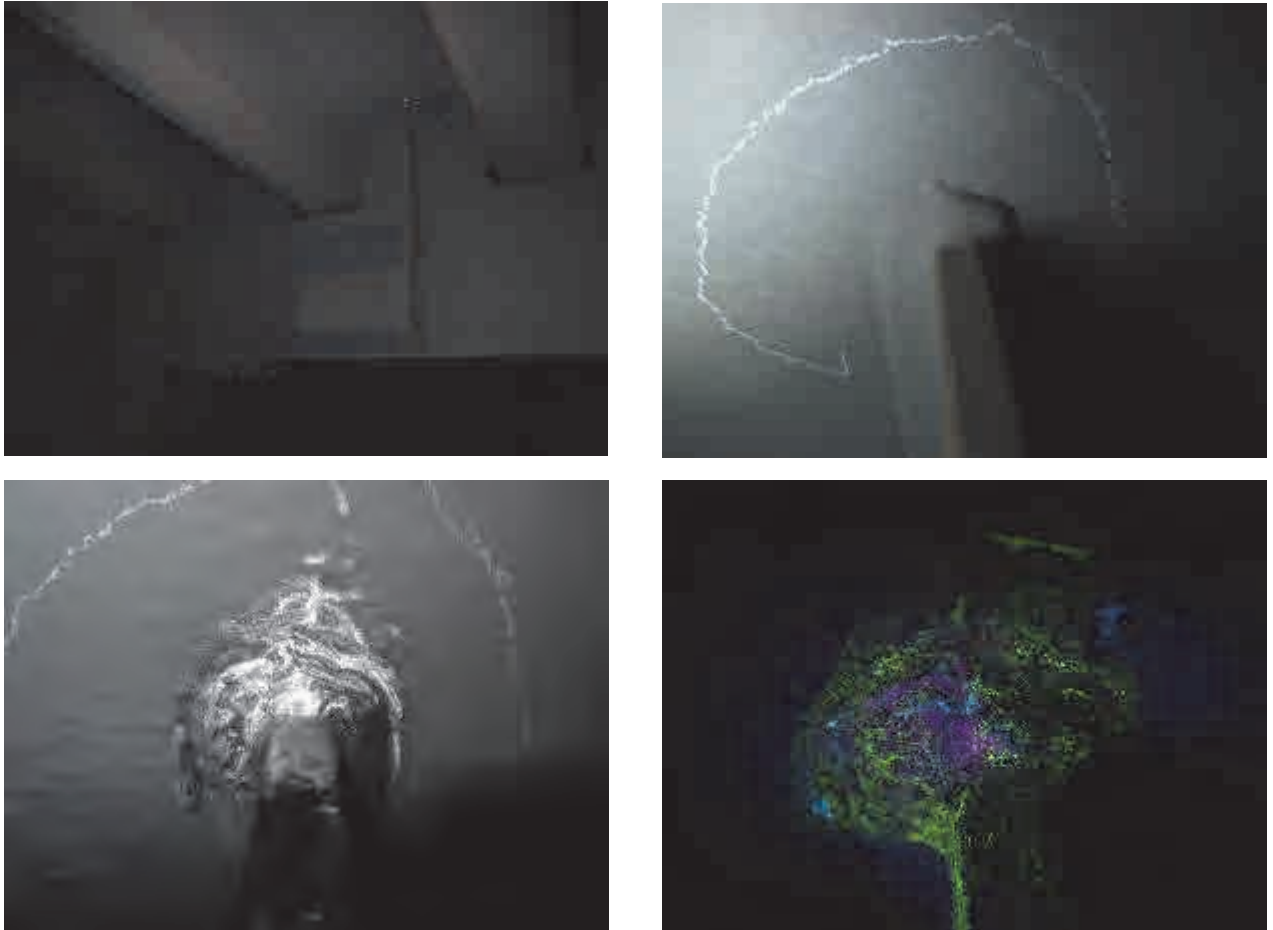
- No fatigue cracks were detected.
- A few paint cracks were detected and MT was applied after removal of the paint coat as shown in Photo 2.3.16.

**Photo 2.3.16 Example of MT Inspection under #7, 8 U-Rib: W T58-1E R9S(8)**

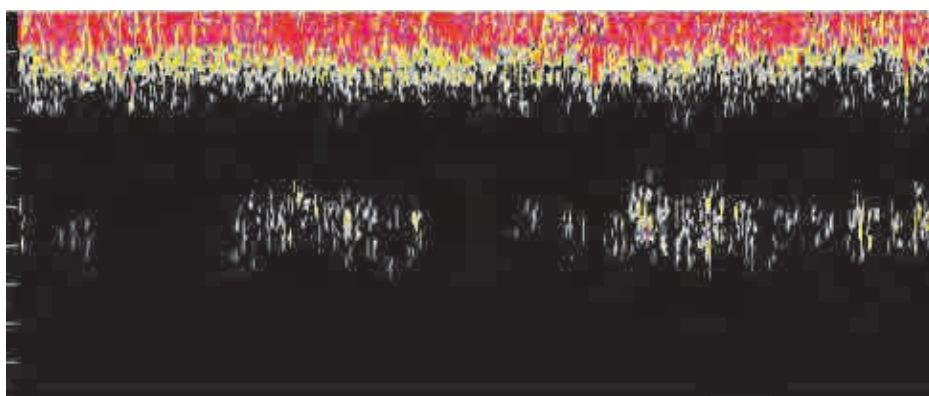
**Figure 2.3.11 Result of Inspection (Corrosion on the Surface of Deck Plate)**

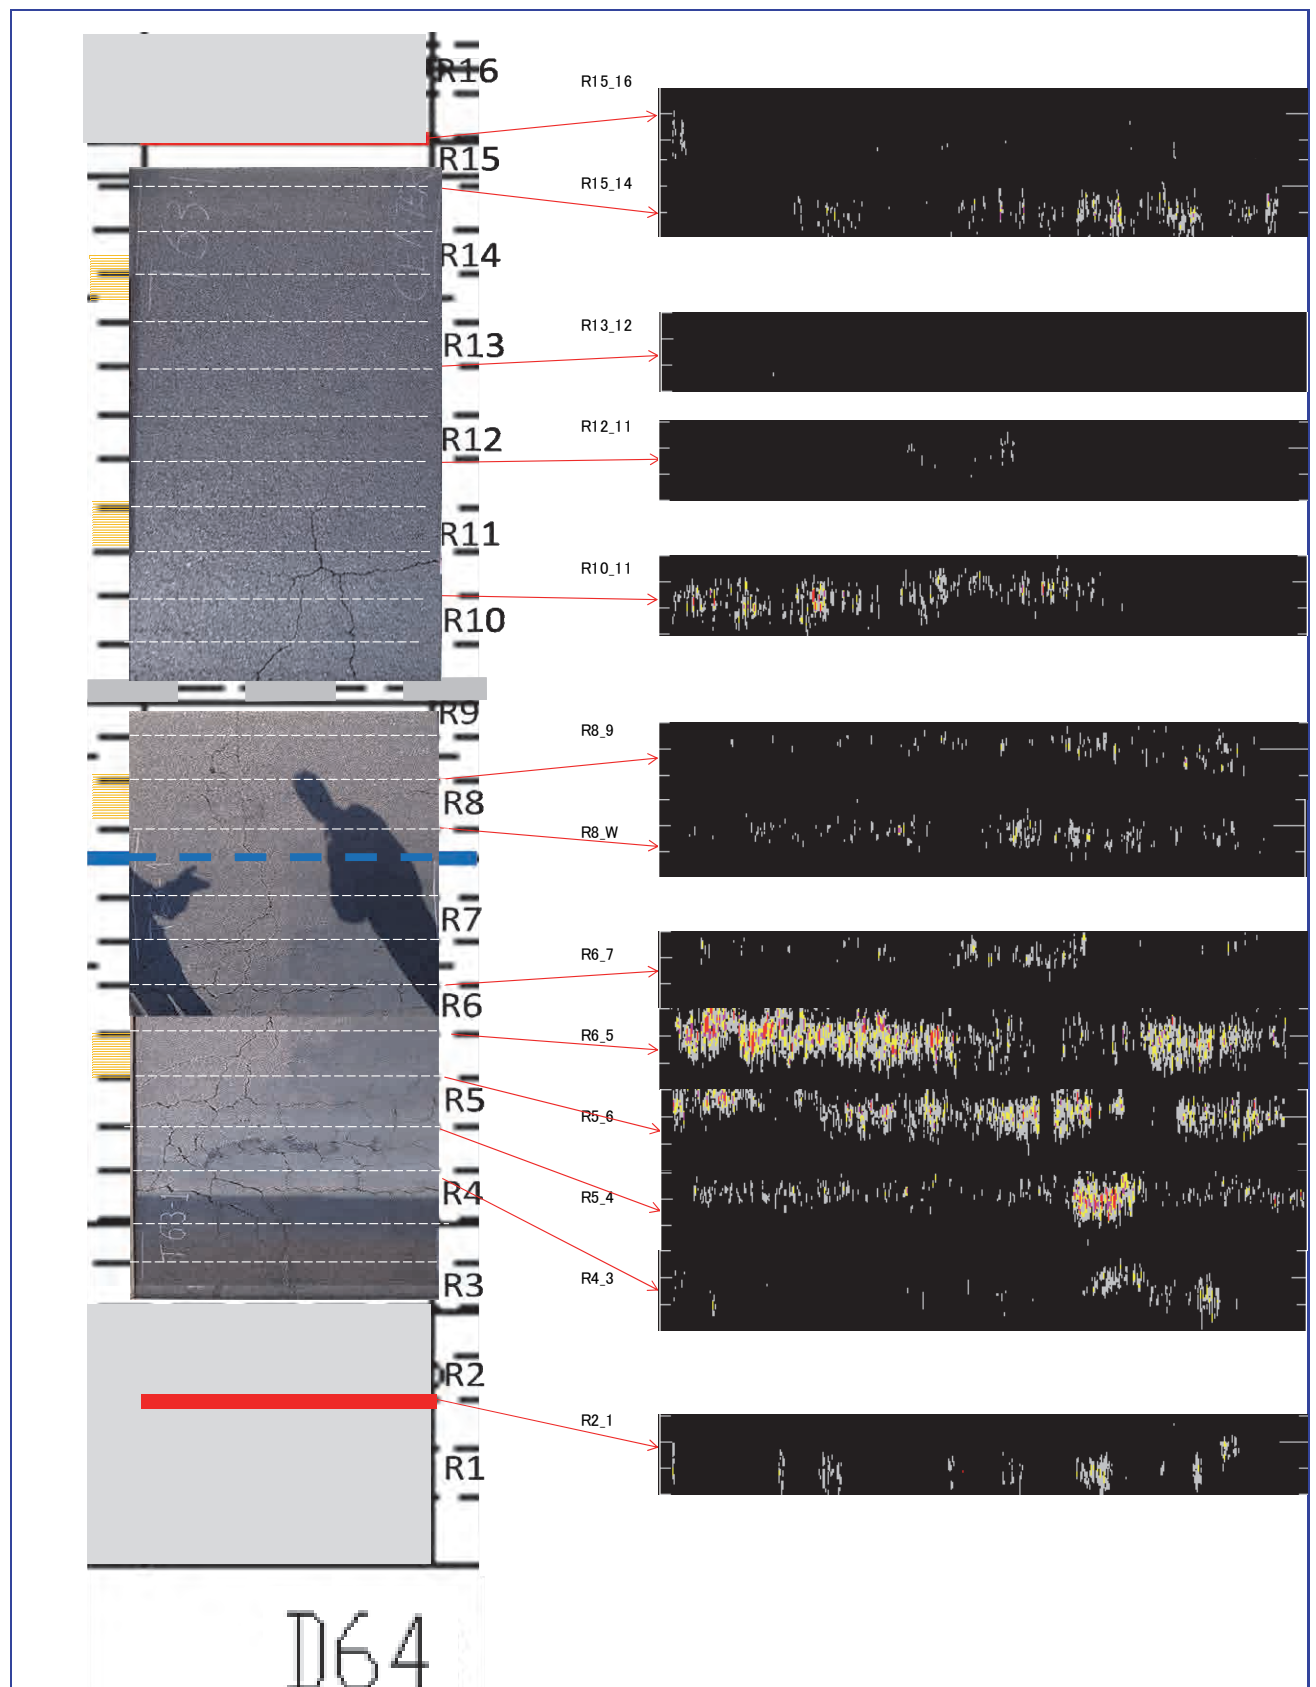
Figure 2.3.14 Pavement Crack Location and UT Signal of Corrosion (WTR63-1 to WD64)

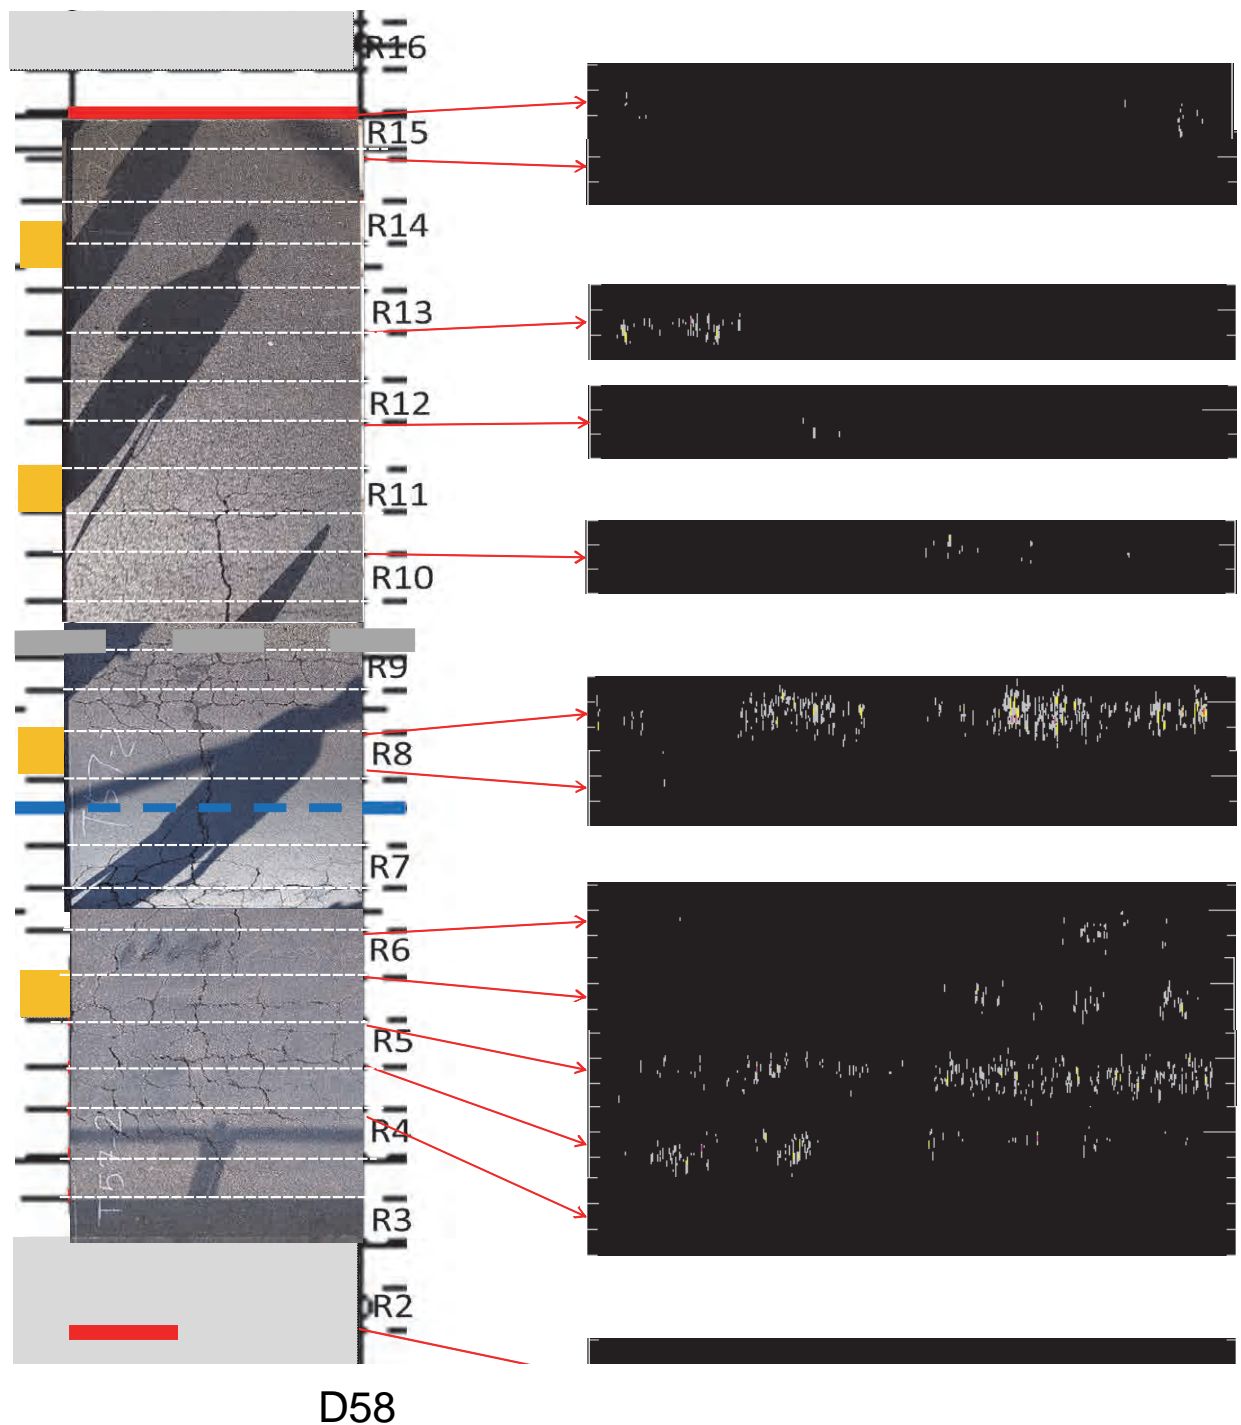
**Figure 2.3.15 Pavement Crack Location and UT Signal of Corrosion (WTR57-2 to WD58)**
