CHAPTER 6 MAINTAINANCE MANAGEMENT PLAN

7.1 The Damaged Condition of Pavement and Soundness of Steel Deck Plate

Inspection Photo D/B in the Suezu Cannal Bridge

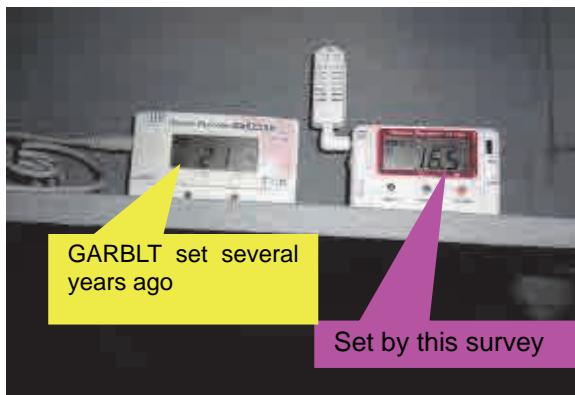
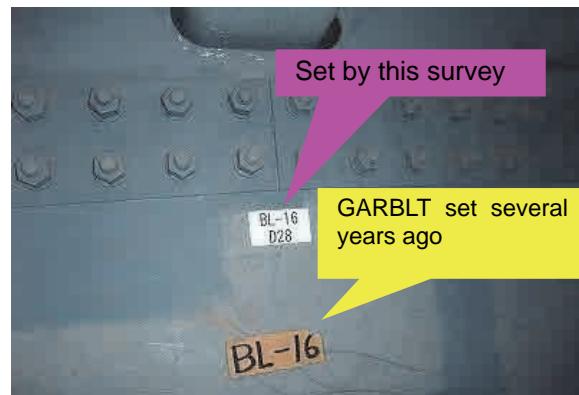
Photo6.1.2 Items of Maintenance Work in Steel Deck by GARBLT

Temperature and Humidity Sensors

Numbering of Diaphragm

GARBLT installed five sensors to monitor temperature and humidity in the steel deck. They monitor these throughout the year.

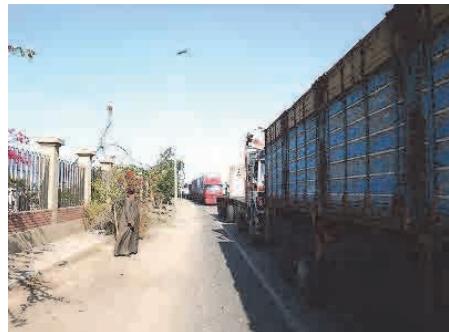
Photo 6.1.6 Traffic Jam due to Road Closure

GARBLT has to close the Suez Canal Bridge if the army uses the Suez Canal to move. At this time, traffic congestion occurs (Photo 2.7.6). The JICA Survey Team faced this “road closed” condition three times in the site survey period in November and December 2011.

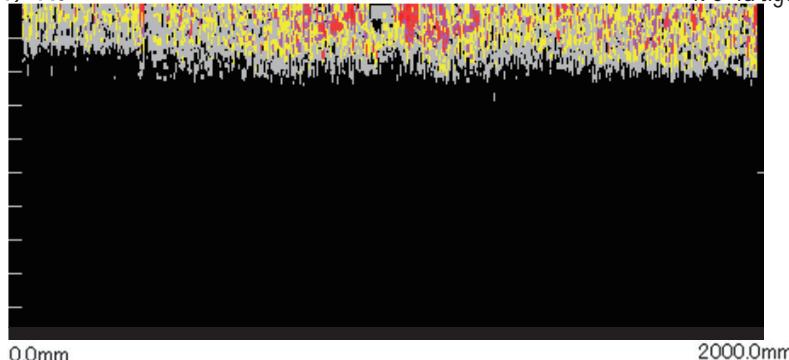
①N-W20(1)-R5_4

No fatigue crack

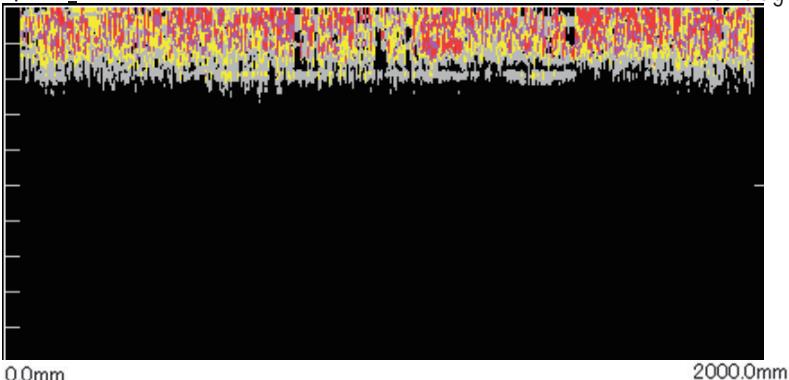
②N-W20(1)-R5_6

No fatigue crack

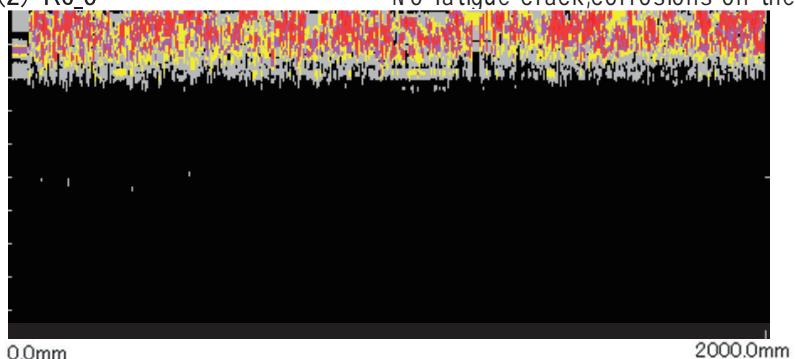
③N-W29(2)-R6_5 No fatigue crack,corrosions on the surface

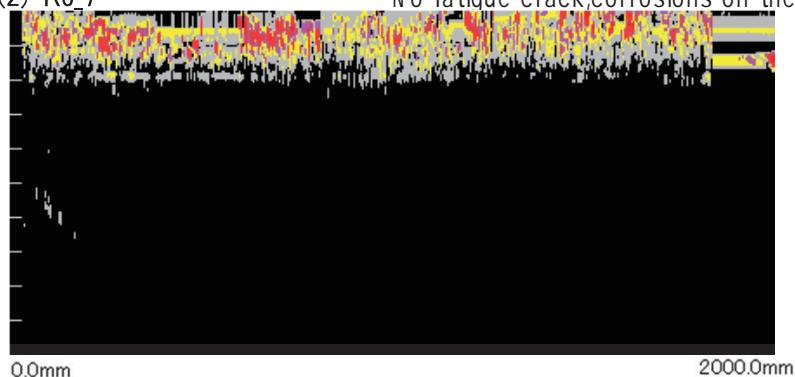
④N-W29(2)-R6_7 No fatigue crack,corrosions on the surface

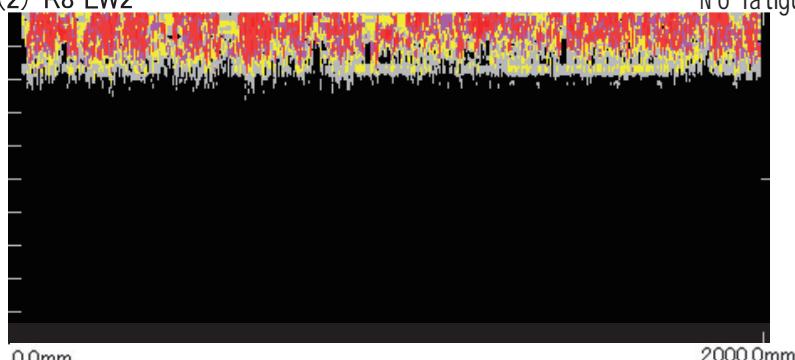
⑤N-W29(2)-R8 LW2 No fatigue crack

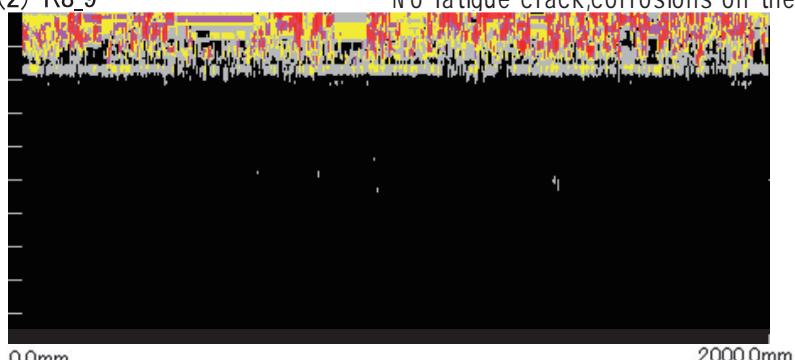
⑥N-W29(2)-R8_9 No fatigue crack,corrosions on the surface

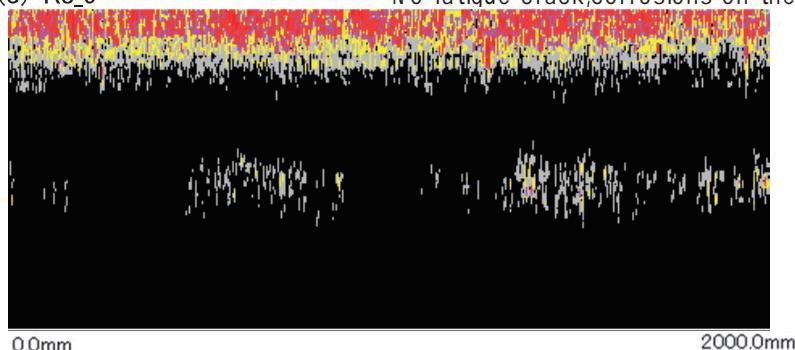
①N-W57(3)-R8.9

No fatigue crack,corrosions on the surface

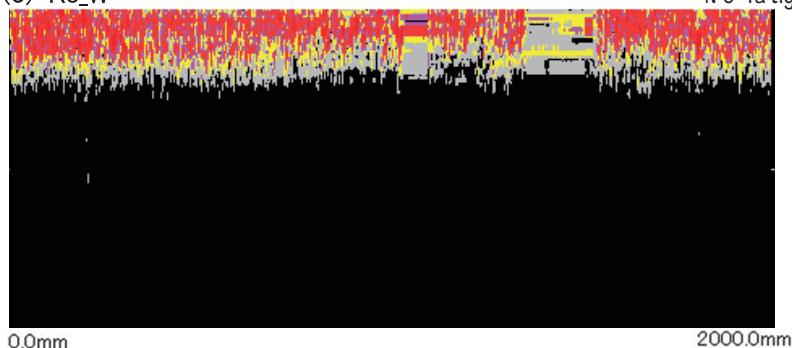
②N-W57(3)-R8_W

No fatigue crack

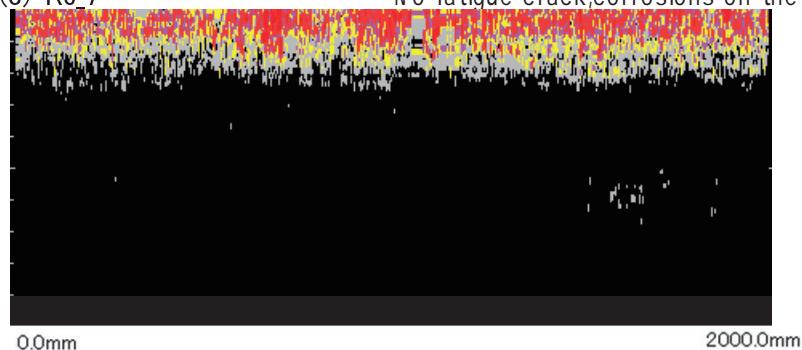
③N-W57(3)-R6_7

No fatigue crack,corrosions on the surface

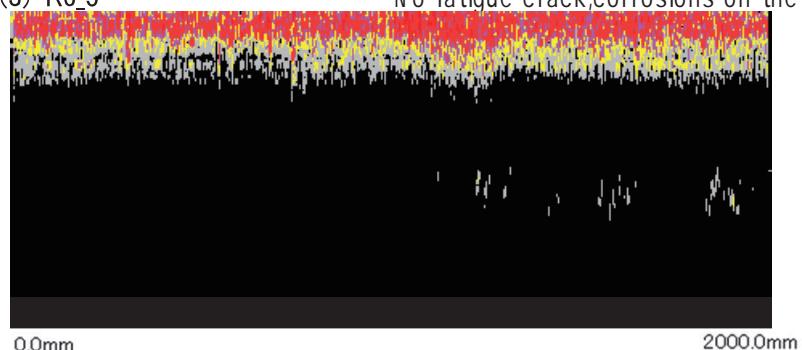
④N-W57(3)-R6_5

No fatigue crack,corrosions on the surface

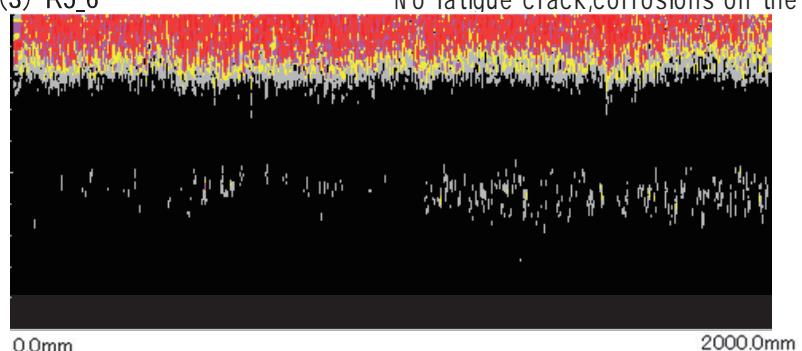
⑤N-W57(3)-R5_6

No fatigue crack,corrosions on the surface

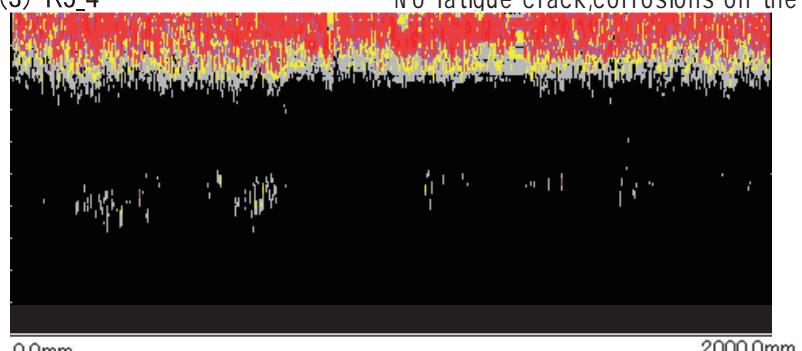
⑥N-W57(3)-R5_4

No fatigue crack,corrosions on the surface

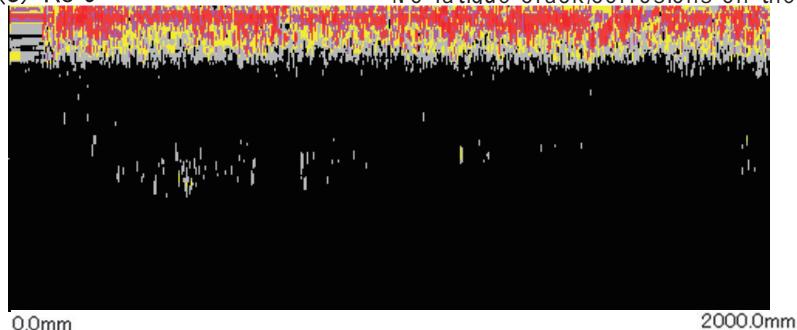
①N-W61(3)-R8_9

No fatigue crack,corrosions on the surface

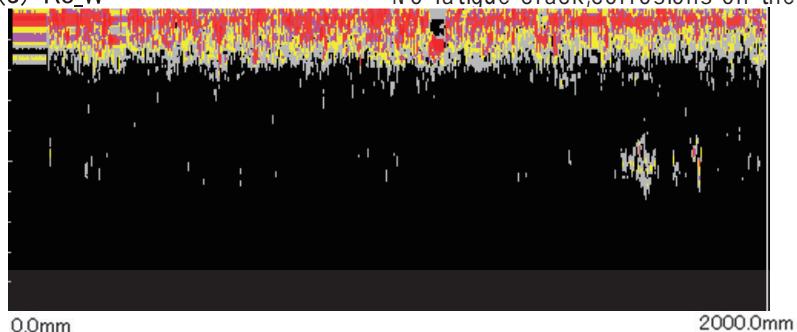
②N-W61(3)-R8_W

No fatigue crack,corrosions on the surface

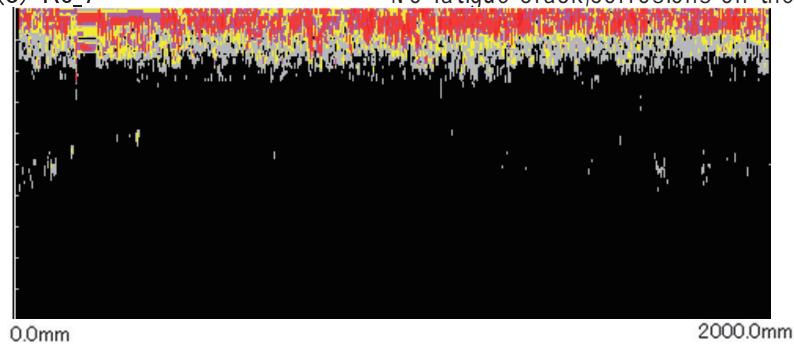
③N-W61(3)-R6_7

No fatigue crack,corrosions on the surface

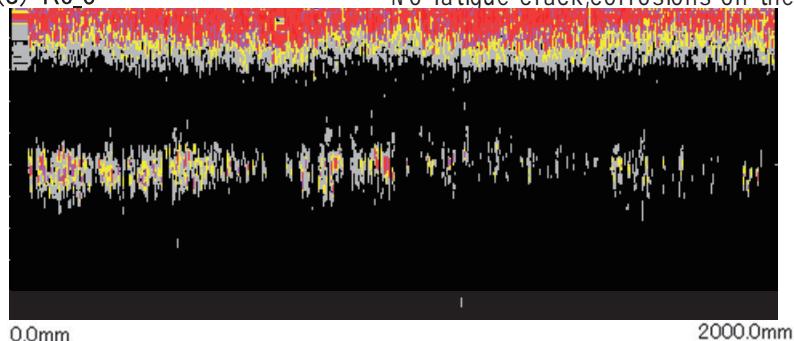
④N-W61(3)-R6_5

No fatigue crack,corrosions on the surface

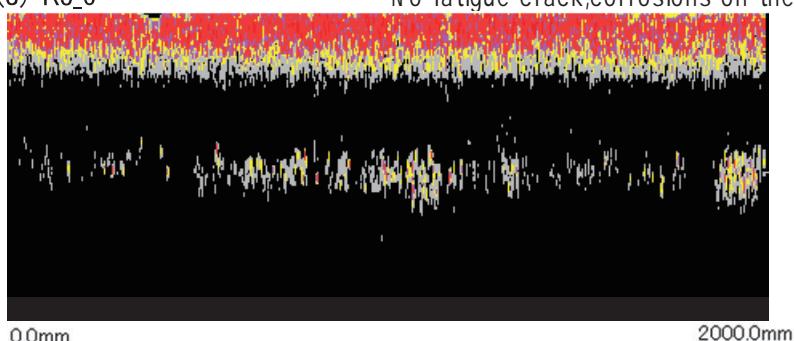
⑤N-W61(3)-R5_6

No fatigue crack,corrosions on the surface

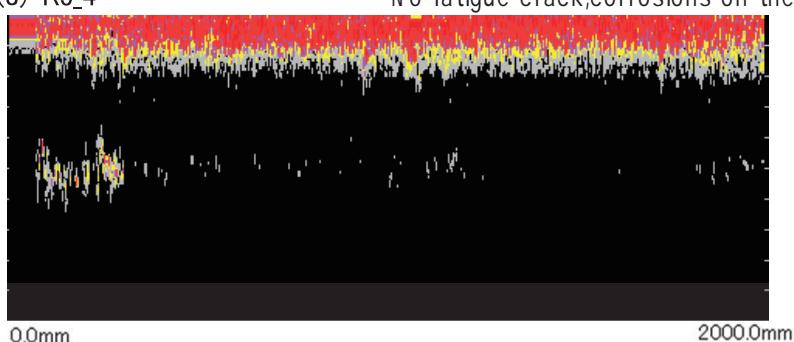
⑥N-W61(3)-R5_4

No fatigue crack,corrosions on the surface

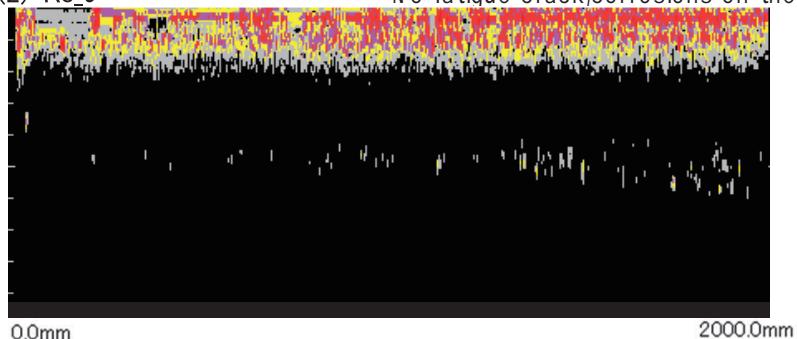
①N-W63(2)-R8_9

No fatigue crack,corrosions on the surface

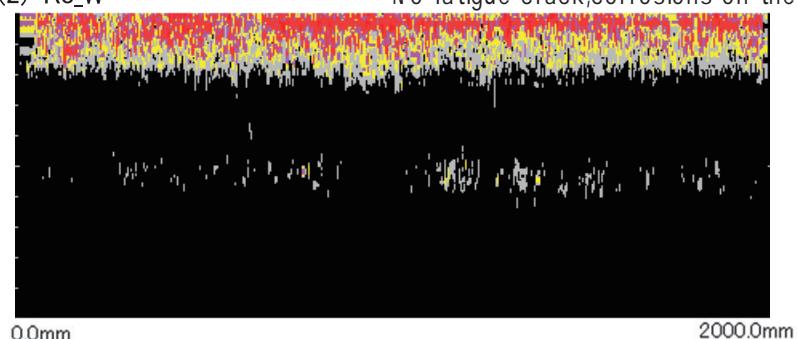
②N-W63(2)-R8_W

No fatigue crack,corrosions on the surface

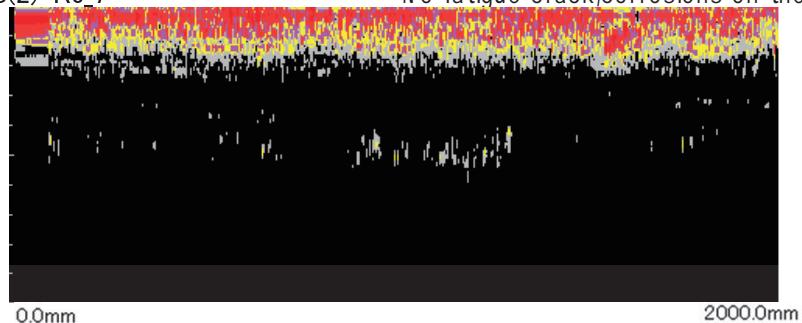
③N-W63(2)-R6_7

No fatigue crack,corrosions on the surface

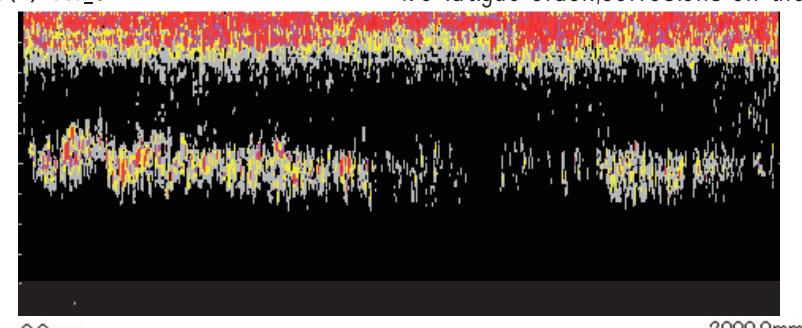
④N-W63(2)-R6_5

No fatigue crack,corrosions on the surface

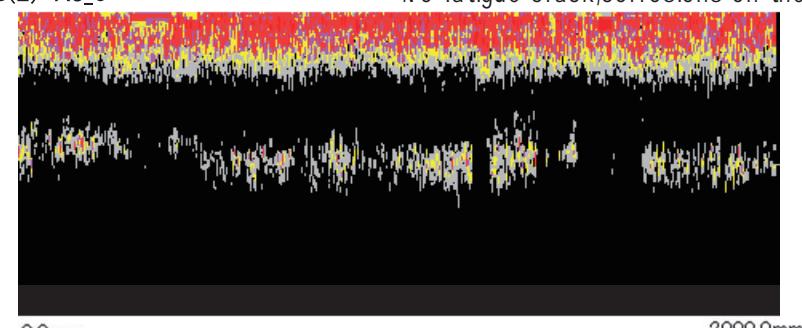
⑤N-W63(2)-R5_6

No fatigue crack,corrosions on the surface

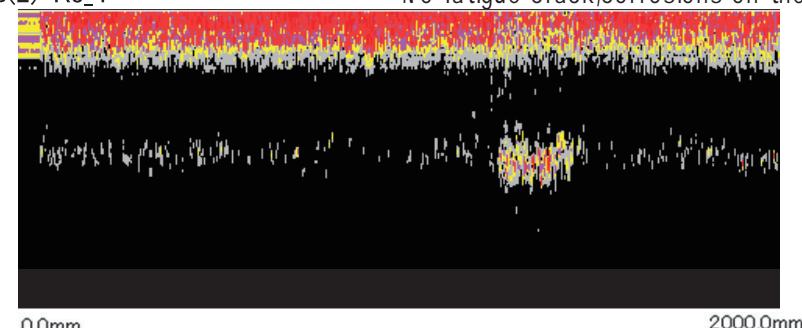
⑥N-W63(2)-R5_4

No fatigue crack,corrosions on the surface
