**FOLLOW-UP COOPERATION  
STUDY REPORT  
ON  
THE PROJECT FOR IMPROVEMENT  
OF  
FISHERY INFRASTRUCTURE  
IN  
ANSE LA RAYE, SAINT LUCIA**

**MARCH 2013**

**JAPAN INTERNATIONAL COOPERATION AGENCY**

**ECOH CORPORATION**

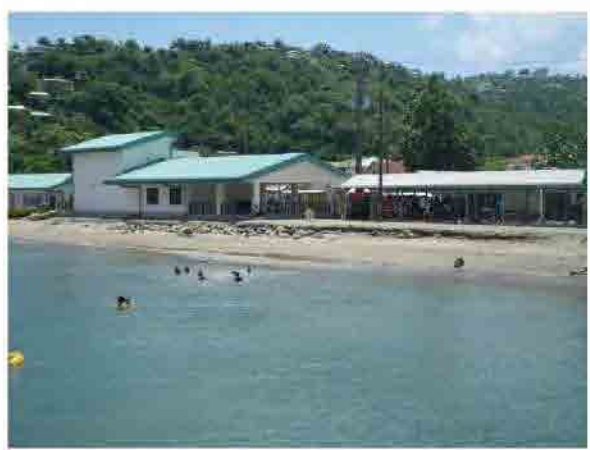
Photo-6 Foreshore condition at 23<sup>rd</sup> July, 2010 ( Erosion advancing)

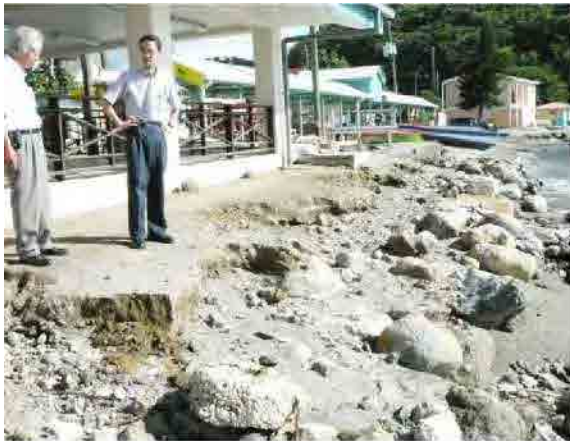
Photo-7 Foreshore condition of Fisheries Complex after passing the low pressure (2010/09/28)

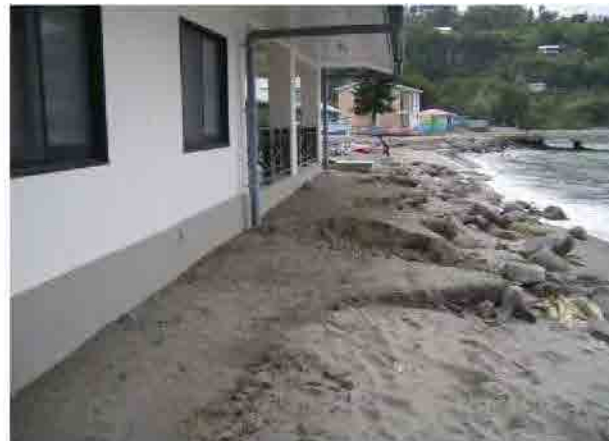
Photo-8 Foreshore condition of Fisheries Complex after passing Hurricane Tomas (2010/11/02)

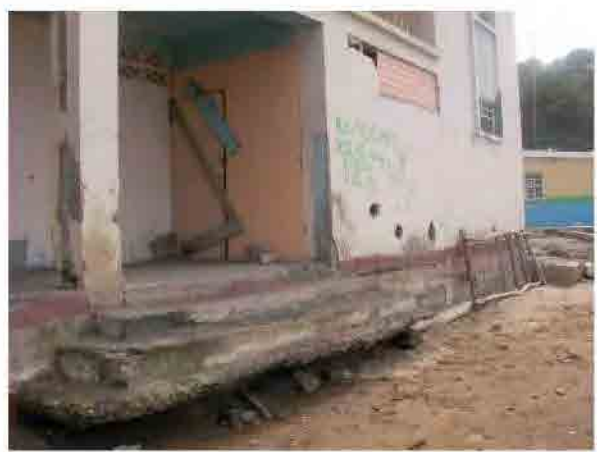
Photo-10 Erosion condition of Community Center at one year inspection (2011/02/28)

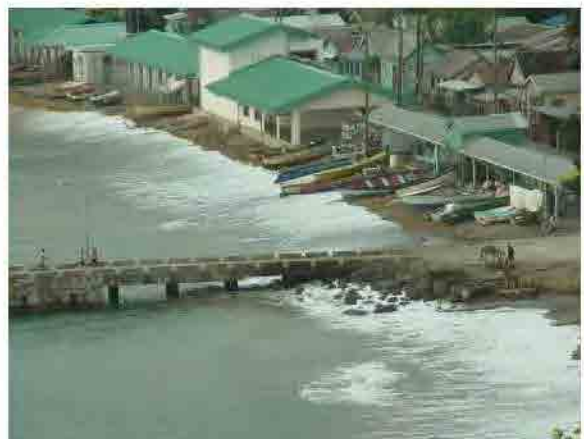
Photo-12 Wave run-up condition at Follow-up study (2011/09/19)

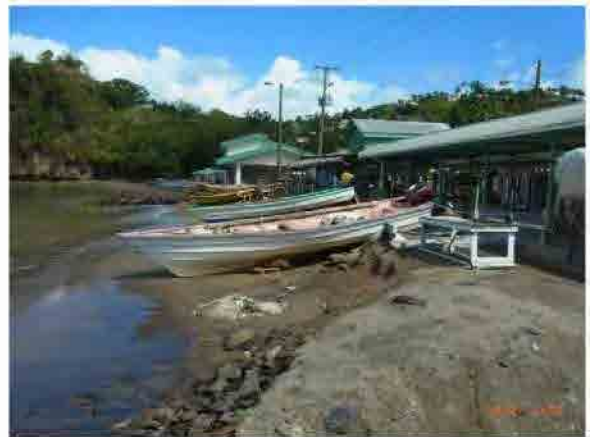
Photo-16 Foreshore condition of Vendors Arcade (Delay of recovery compare with neighbors)

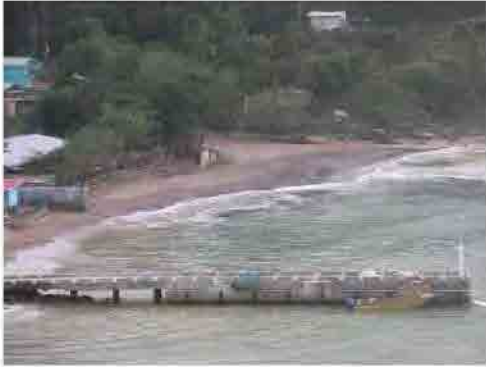
Subsidence and recession of shoreline in North side beach from the Jetty

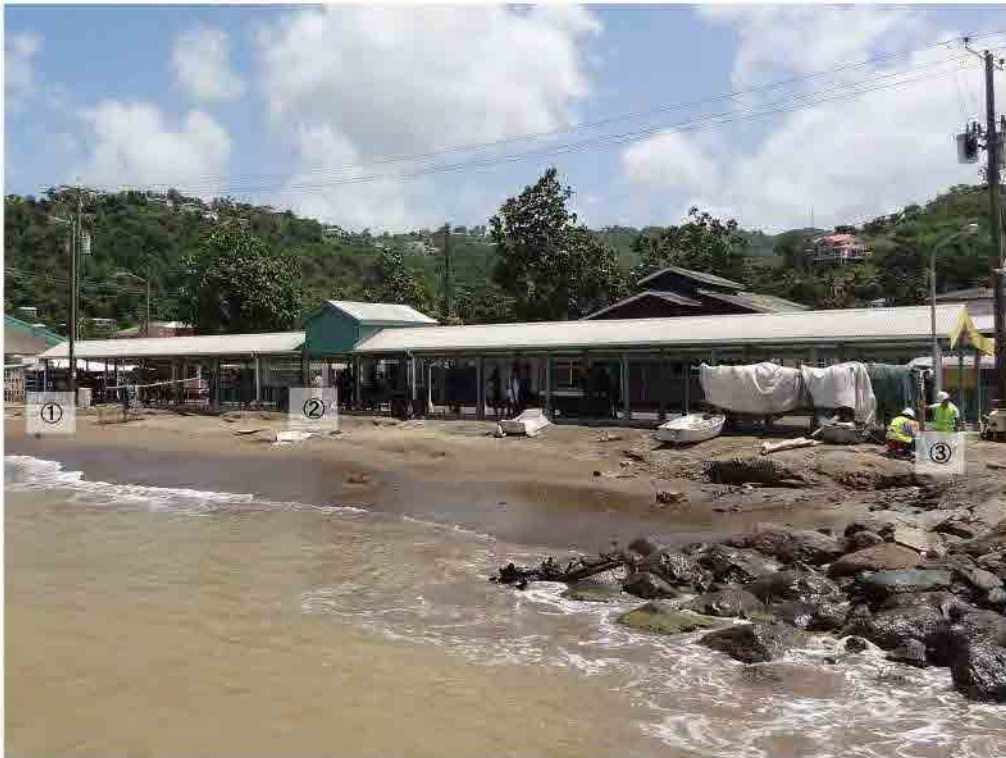
Photo 2-1-2-6 Grand subsidence situation of Fisheries Complex (2)

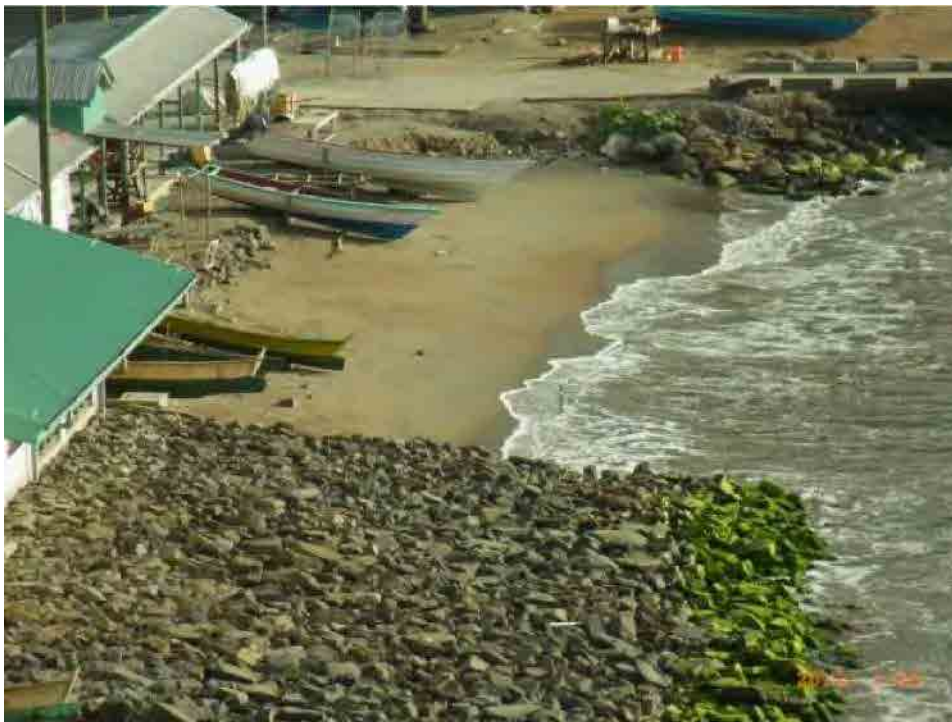
Photo 2-2-3-9 shows the foreshore status in front of Vendors Arcade. This part forms pocket beach with the rubble stones at front face of Fisheries Center and the rubble stones at the base part of the jetty. It can be understood that the foreshore slope is going to be the same as slopes in surrounding area. There arises uneven part between head part of protective rubble stones and foreshore in front of Arcade. Photo 2-2-3-10 shows the wave run-up situation at the foreshore. With this, it can be understood that wave run-up is higher in comparison with the rubble stone part in front of Fisheries Complex but the foreshore slope becomes stable just like surrounding beach. Photo 2-2-3-11 shows the diffraction status of protective rubble stones of the jetty base part and the foreshore slope in this part becomes steeper comparing with the one surrounding this part but it is predicted that this part produces a large effect on the recovery of foreshore when littoral drift is in the situation to reach to foreshore in front of Arcade over the jetty.

**Photo 2-2-3-9 Foreshore situation in front of Vendors Arcade**

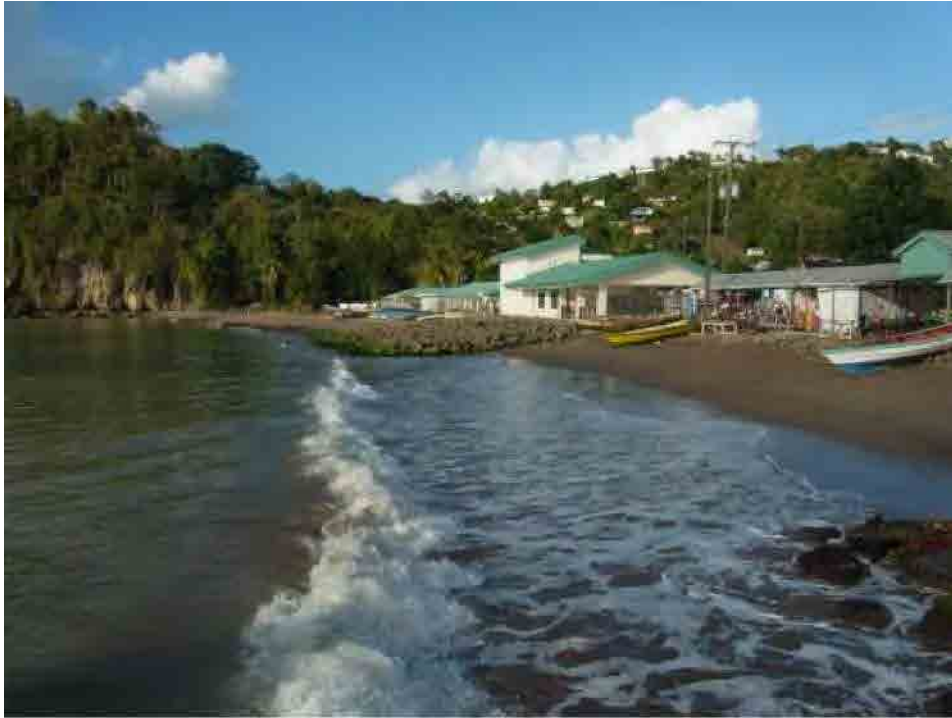
**Photo 2-2-3-10 Wave run-up situation at foreshore**

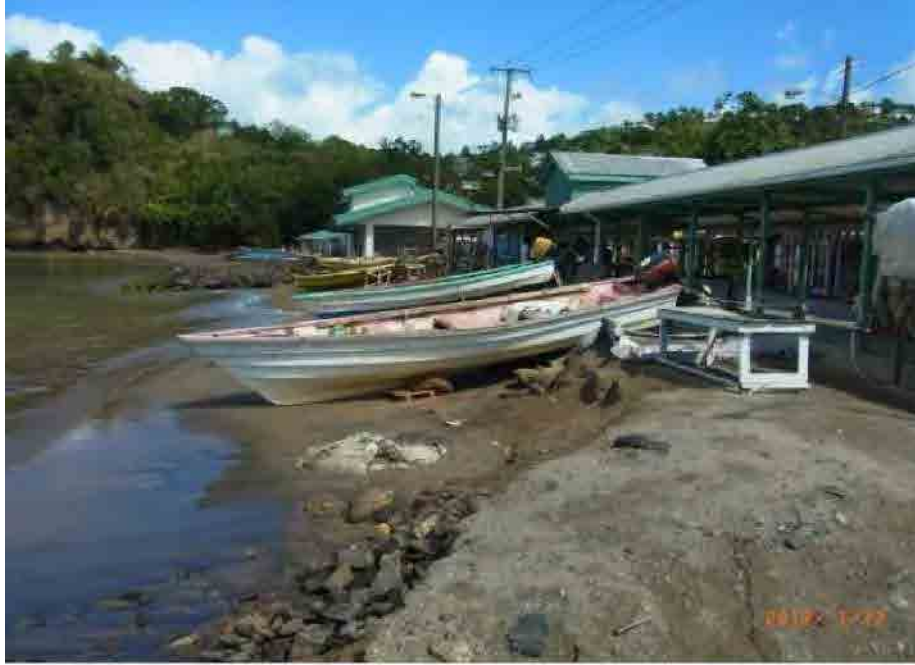
**Photo 2-2-3-12 Armor stones situation in front of Arcade**

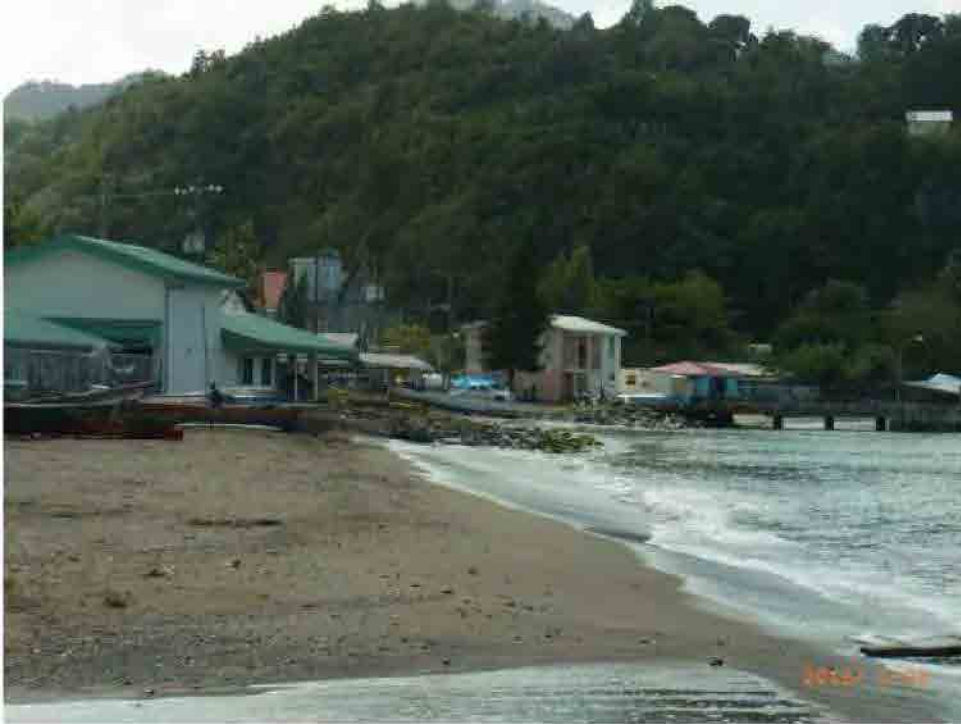
Photo 2-2-3-14 shows armor stone part and foreshore slope in front of Fisheries Complex. With this, it is understood that this armor stone part becomes fit in the foreshore slope. Photo 2-2-3-15 shows wave absorbing situation at the head of armor stones. It can be understood that wave absorption effect is worked at assumed head part of armor stones. Photo 2-2-3-16 shows the head part of armor stones and it can be understood that they becomes stable not largely pulling out to offshore side although there seen subsidence a little bit.

**Photo 2-2-3-14 Armor stone part and foreshore slope in front of Fisheries Complex (1)**

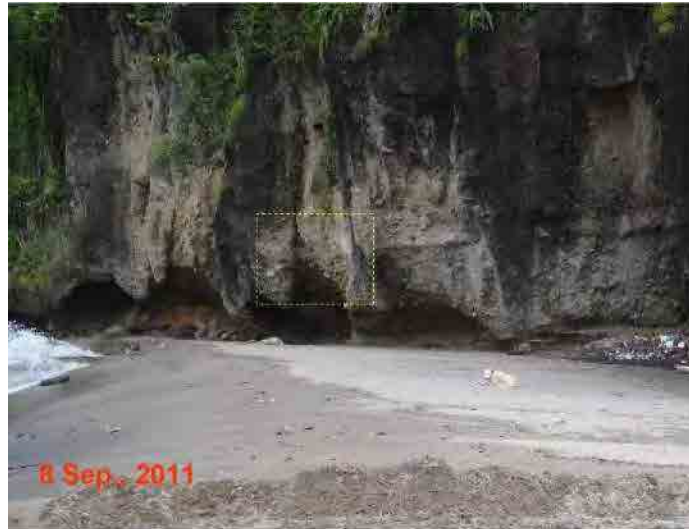
Figure 3-1-2-2 shows a condition of coastal cliff which is located at the right-side of the trees. The cliff over-hangs slightly over the sea, and a notch is formed due to erosion by waves at the base. The coastal cliff is sedimentary soft rock containing gravels, which seems to be not so strong. Taking these conditions into account, it is inferred that the trees on the cliff dropped to the base with the landslide before 2006, and they took root there.

**Figure 3-1-2-2 Coastal cliff (8 September, 2011)**

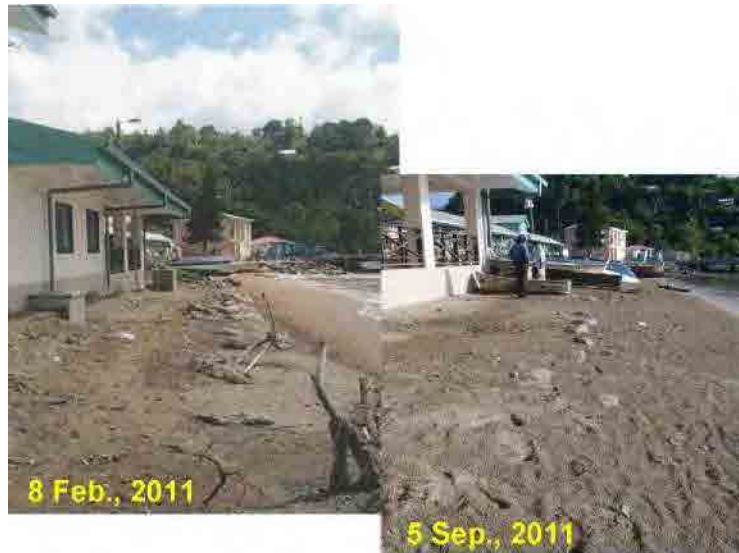
Figure 3-2-1-5 shows photos of beach in front of Fisheries Complex, taken on 8 Feb. and 5 Sep., 2011 respectively. Paying attention to rubble stones which are in existence at the place about 5 meters from the base, it is understood that the sand has accumulated there because the exposed part of stones became smaller on 5 Sep., 2011. Concerning to the area close to the base, the recovery of beach is not recognized because the distance from a handrail to the floor is nearly the same as that from the floor to the beach in both photos, which are enlarged in Figure 3-2-1-6.

**Figure 3-2-1-5 Conditions of beach in front of Fisheries Complex  
(taken on 8 Feb. and 5 Sep., 2011)**

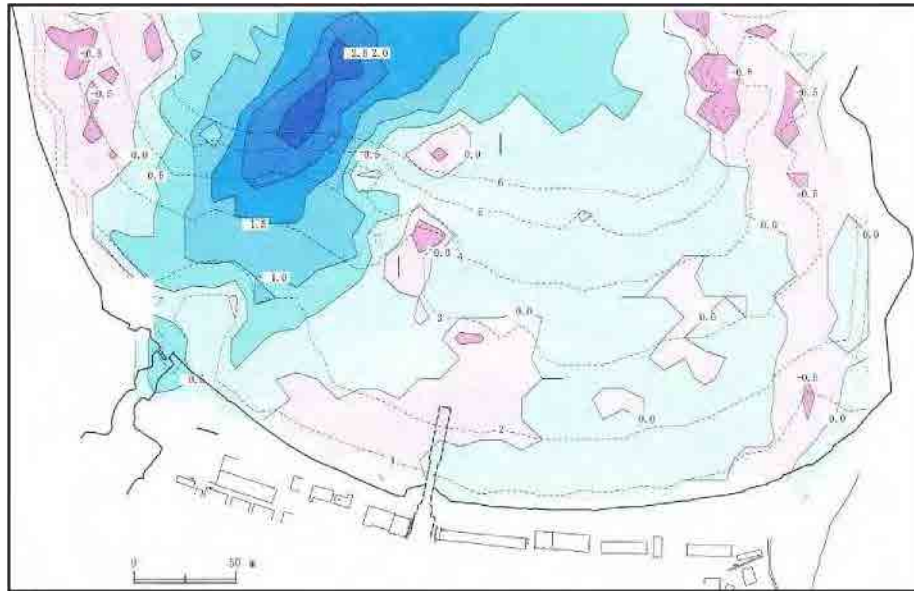
Figure 3-2-2-4 shows the change of topography from 2006 to 2011. The area of deposition is long and narrow in the cross-shore direction in front of river mouth, being the maximum thickness of deposition is more than 2.5 meters. This deposition is inferred to occur during a period from February 2009 to September 2011, because the rock reefs is still seen on the bottom and the shoal was not formed yet in front of river mouth in the aerial photograph, Figure 3-2-2-2, taken in February 2009.

**Figure 3-2-2-4 Change of topography from 20 Oct. 2006 to 8 Sep. 2011**

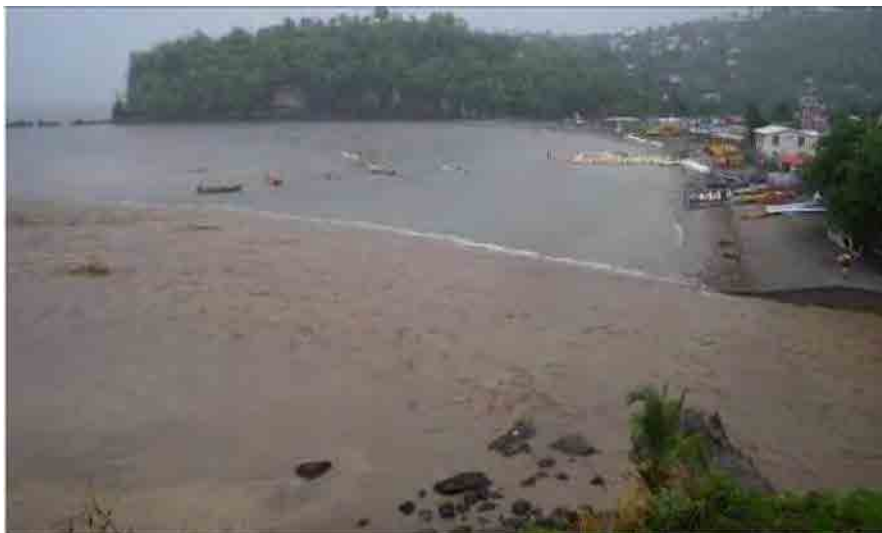
Concerning to the flood 1), there are two pictures, Figure 3-2-3-1 and 3-2-3-2, which were taken by Mr. Adachi, a resident engineer. Figure 3-2-3-1 shows a condition of flood with muddy water and Figure 3-2-3-2 shows a inundated village of Anse La Raye. Except these two pictures, there is no more quantitative information such as precipitation, duration time of rain or river discharge. But, it is no doubt that the large flood occurred.

**Figure 3-2-3-1 Large flood on 5 May, 2009**

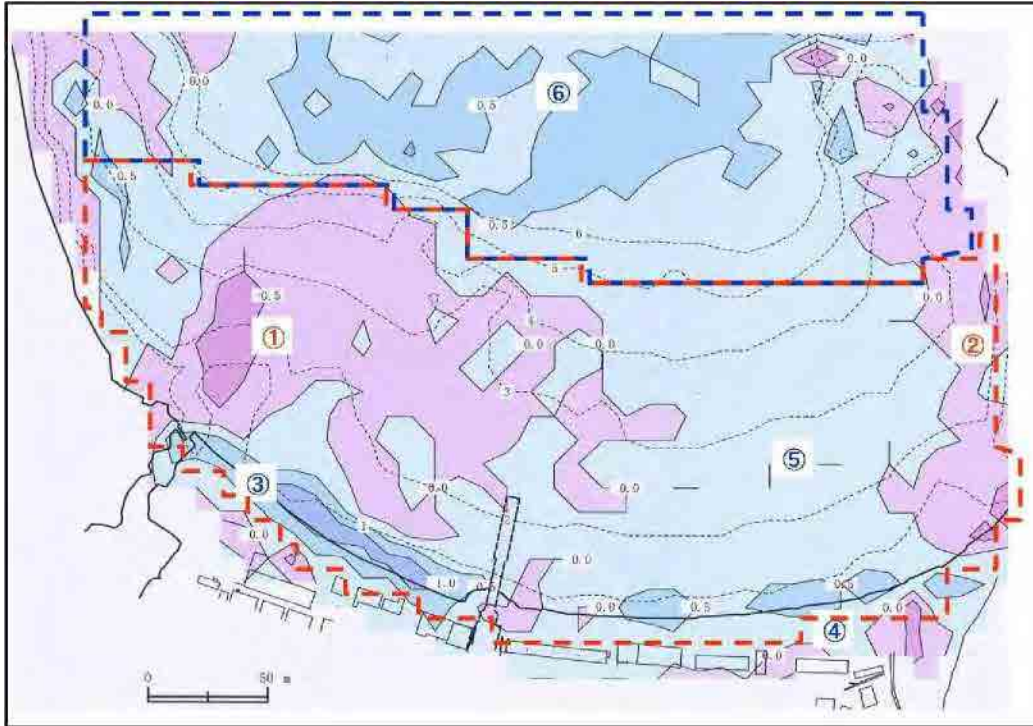
Next paying attention to the accumulated area in blue, the major accumulation is seen around the shoreline on the south-side beach of the jetty, which area is denoted by ③. It is inferred that the sand was transported to there from the area ① in front. The sand accumulation around the shoreline occurred also on the north-side beach of the jetty, denoted by ④, but the volume was less than in the area ③. It is very hard to guess where the sand was transported from. There are three possibilities, that is, the sand supplied from the smaller river located at the north-end of beach, from the eroded area ② or/and from the area ⑤ where the sand has deposited thinly but widely.

**Figure 3-3-1-22 Topographic change from 8 September, 2011 to 18 January, 2012**
