APPENDIX 6

Result of Accessibility Survey in Rio de Janeiro

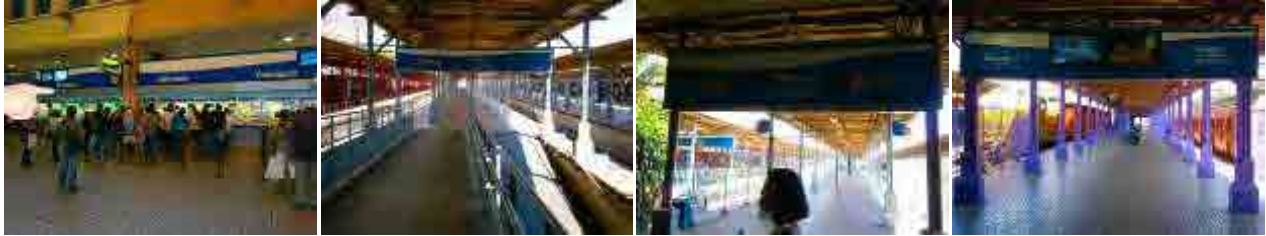
1. Condition		2. Issues	
Entrance/ Exit	No directions for entrance, no exit sign outside station.	<ul style="list-style-type: none"> > Safety hazard: level and the gap between the platform and the train; > Direction signs for entrance; > Lack of map or landmark information for exit; > No totem for self-service ticketing; > Add general route mapping and info at platform; > Accessibility for disabled people. 	
Ticketing	Crowded box office.		
Platform	No direction signs on the floor, no board, no map.		
Other	Almost no foreign language, Small character size. No travel time info.

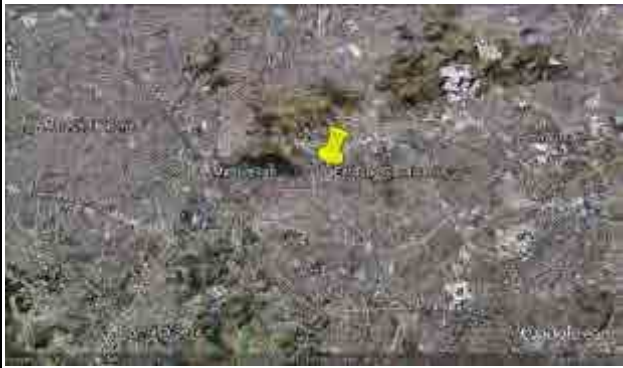
No.	03	Mode	Rail
Survey Date	11/10/12	Name of St.	Cavalcanti
Area	Cavalcanti	Line Name	Belford Roxo
Current Condition			
Entrance/ Approach		Location

Description			
5. Condition		6. Issues	
Entrance/ Exit	No directions for entrance, no exit sign outside station.	<ul style="list-style-type: none"> > Direction signs for entrance; > Lack of map or landmark information for exit; > Add general route mapping and info at platform; > Accessibility for disabled people. 	
Ticketing	Only one box office, Fare info with small letters.		
Platform	No direction signs on the floor, no board, no map.		
Other	No foreign language.

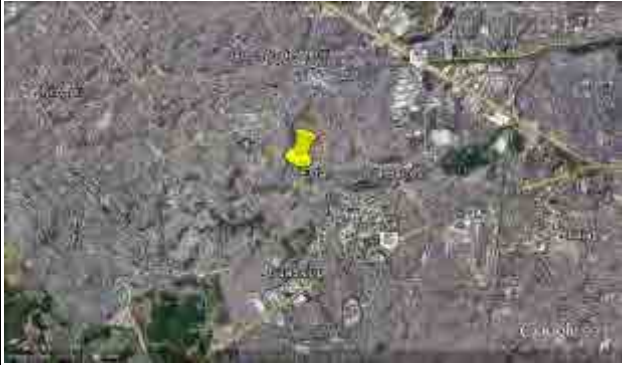
No.	04	Mode	Rail
Survey Date	15/10/12	Name of St.	Costa Barros
Area	Costa Barros	Line Name	Belford Roxo
Current Condition			
Entrance/ Approach		Location

Description			
7. Condition		8. Issues	
Entrance/ Exit	No directions for entrance, no exit sign outside station.	<ul style="list-style-type: none"> > Direction signs for entrance; > Lack of map or landmark information for exit; > Add general route mapping and info at platform; > Accessibility for disabled people. 	
Ticketing	<No photo>		
Platform	No direction signs on the floor, no board, no map.		
Other	No foreign language.

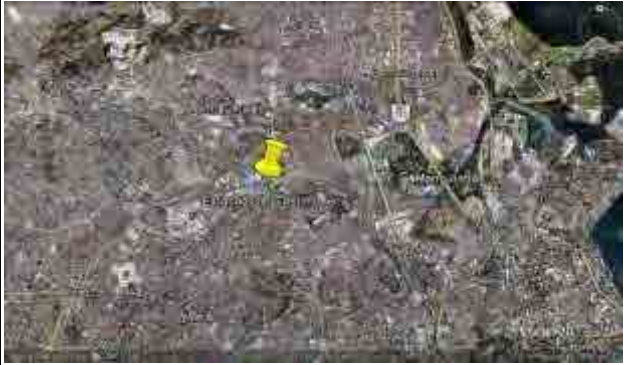
No.	05	Mode	Rail
Survey Date	11/10/12	Name of St.	Del Castilho
Area	Del Castilho	Line Name	Belford Roxo
Current Condition			
Entrance/ Approach		Location

Description			
9. Condition		10. Issues	
Entrance/ Exit	No directions for entrance, no exit sign outside station.	<ul style="list-style-type: none"> > Direction signs for entrance; > Lack of map or landmark information for exit; > Put more information at platform; > Accessibility for disabled people. 	
Ticketing	Only one box office, Fare info with small letters.		
Platform	No direction signs on the floor, no board, no map.		
Other	No foreign language. No accessibility ramps.

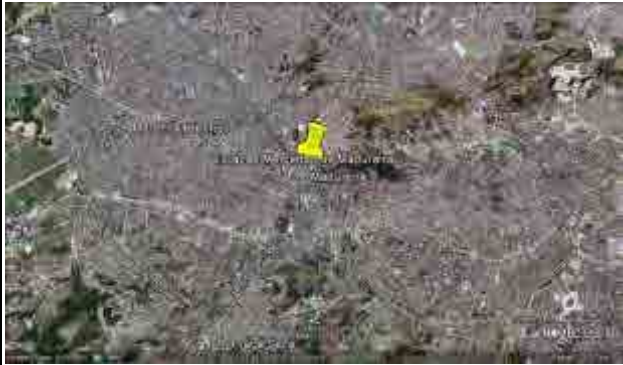
No.	07	Mode	Rail
Survey Date	11/10/12	Name of St.	Mercadao de Madureira
Area	Madureira	Line Name	Belford Roxo
Current Condition			
Entrance/ Approach		Location

Description			
13. Condition		14. Issues	
Entrance/ Exit	No directions for entrance, no exit sign outside station.	<ul style="list-style-type: none"> > Direction signs for entrance; > Lack of map or landmark information for exit; > Add general route mapping and info at platform; > Accessibility for disabled people. 	
Ticketing	Fare info with small letters.		
Platform	No direction signs on the floor, no board, no map.		
Other	No foreign language, small character size. No travel time info.

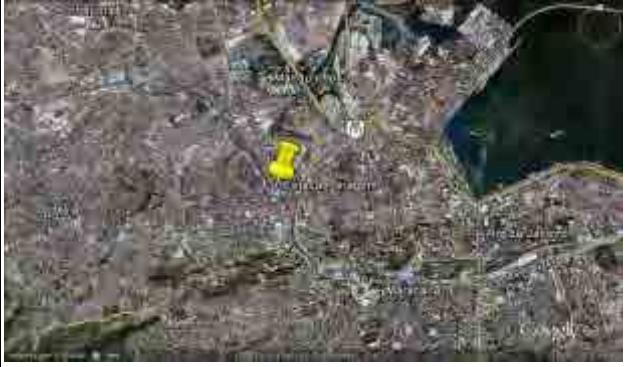
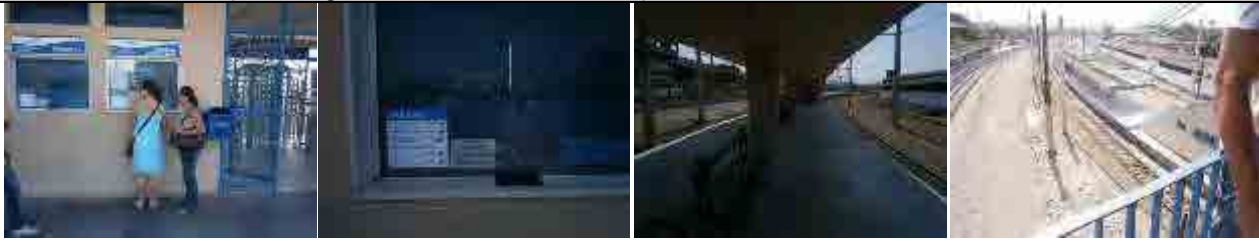
No.	12	Mode	Rail
Survey Date	19/09/12	Name of St.	Triagem
Area	Rocha	Line Name	Belford Roxo
Current Condition			
Entrance/ Approach		Location

Description			
23. Condition		24. Issues	
Entrance/ Exit	No directions for entrance, no exit sign outside station.	<ul style="list-style-type: none"> > Direction signs for entrance; > Lack of map or landmark information for exit; > Add general route mapping and info at platform; > Accessibility for disabled people. 	
Ticketing	Fare info with small letters.		
Platform	No direction signs on the floor, no board, no map, gap between rail and platform.		
Other	No foreign language.

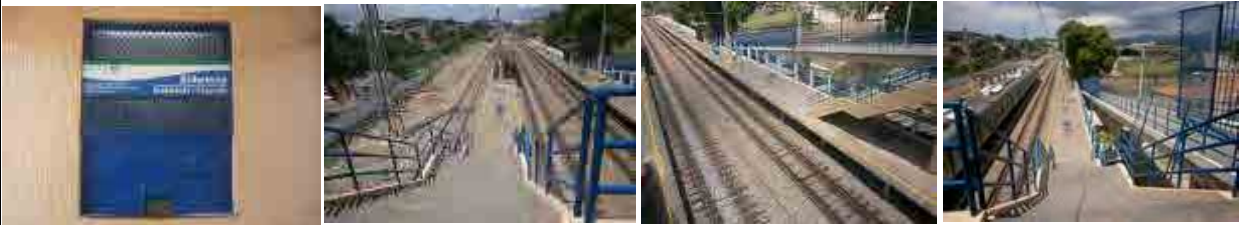
No.	13	Mode	Rail
Survey Date	15/10/12	Name of St.	Barros Filho
Area	Barros Filho	Line Name	Belford Roxo
Current Condition			
Entrance/ Approach		Location

25. Condition		26. Issues	
Entrance/ Exit	No directions for entrance no exit sign outside station.	<ul style="list-style-type: none"> > Lack of map or landmark information for exit > Direction signs for entrance and on the floor of platform > Approaching information or timetable at platform > Accessibility for disabled people. 	
Ticketing	Only one box office, Fare info with small letters		
Platform	No timetable and no approach info; Difficult access for disabled people No direction signs on the floor, no board.		
Other	No foreign language

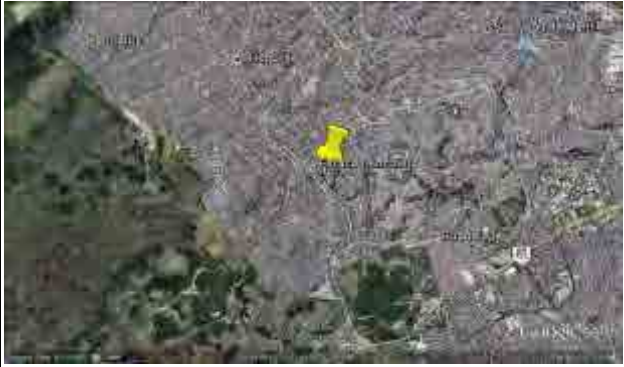
No.	15	Mode	Rail
Survey Date	15/10/12	Name of St.	Anchieta
Area	Mariapolis	Line Name	Japeri
Current Condition			
Entrance/ Approach		Location

Description			
29. Condition		30. Issues	
Entrance/ Exit	No directions for entrance, no exit sign outside station, no identification.	<ul style="list-style-type: none"> > Direction signs for entrance; > Lack of map or landmark information for exit; > Add general route mapping and info at platform; > Accessibility for disabled people. 	
Ticketing	Fare info with small letters.		
Platform	No direction signs on the floor, no board.		
Other	No foreign language.

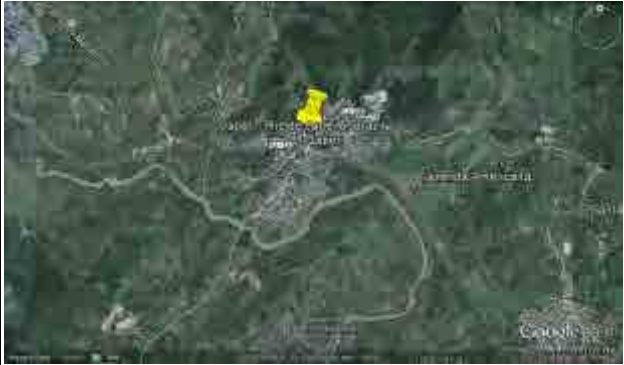
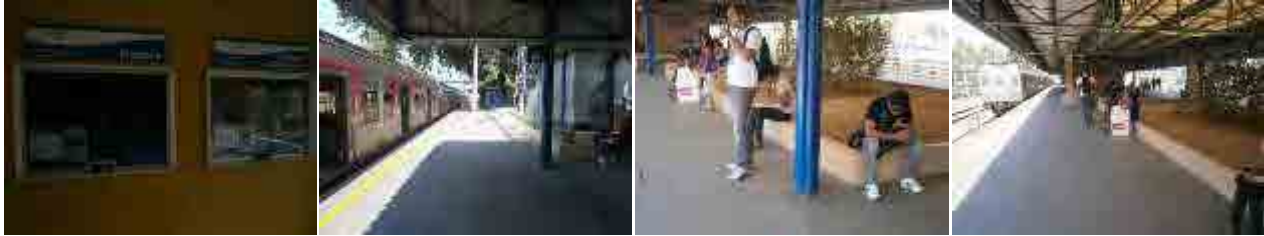
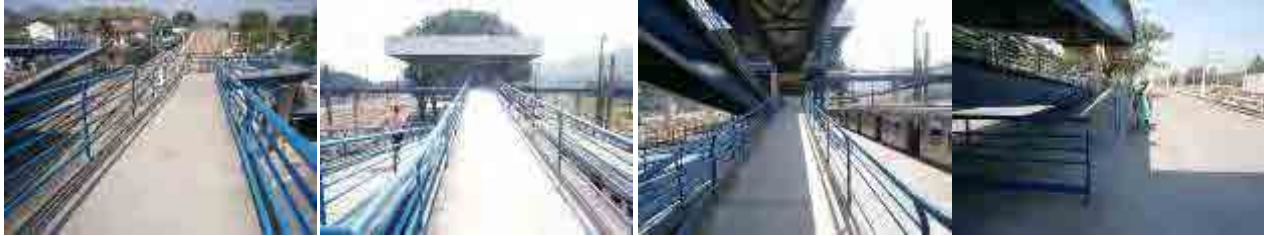
No.	16	Mode	Rail
Survey Date	18/09/12	Name of St.	Japeri
Area	Nova Belem	Line Name	Japeri
Current Condition			
Entrance/ Approach		Location

Description			
31. Condition		32. Issues	
Entrance/ Exit	No directions for entrance, no exit sign outside station.	<ul style="list-style-type: none"> > Direction signs for entrance; > Lack of map or landmark information for exit; > Put more seats on the platform for users; > Add general route mapping and info at platform. 	
Ticketing	Fare info with little letters.		
Platform	No direction signs on the floor, no board, no map, lack of seat.		
Other	No foreign language. No travel time info.

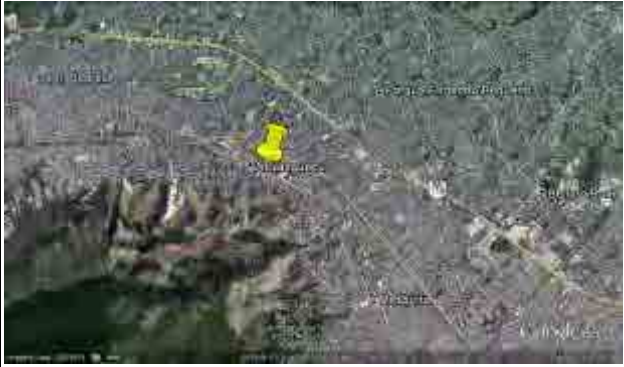
No.	17	Mode	Rail
Survey Date	18/09/12	Name of St.	Nova Iguaçu
Area	Centro	Line Name	Japeri
Current Condition			
Entrance/ Approach		Location

Description			
33. Condition		34. Issues	
Entrance/ Exit	No identification, no directions for entrance, no exit sign outside station.	<ul style="list-style-type: none"> > Direction signs for entrance; > Lack of map or landmark information for exit; > Add general route mapping and info at platform; > Accessibility for disabled people. 	
Ticketing	Fare info with small letters.		
Platform	No direction signs on the floor, no board, no map.		
Other	No foreign language, damaged/irregular surface. No travel time info.

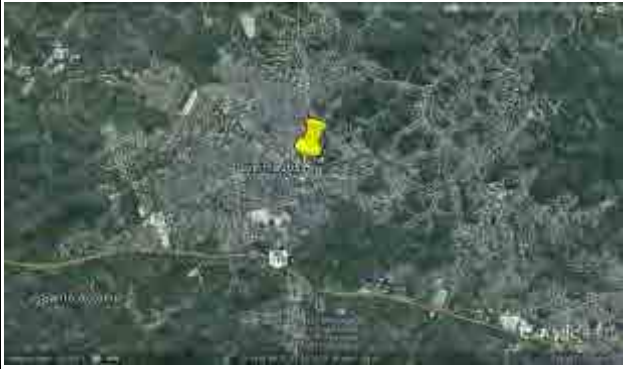
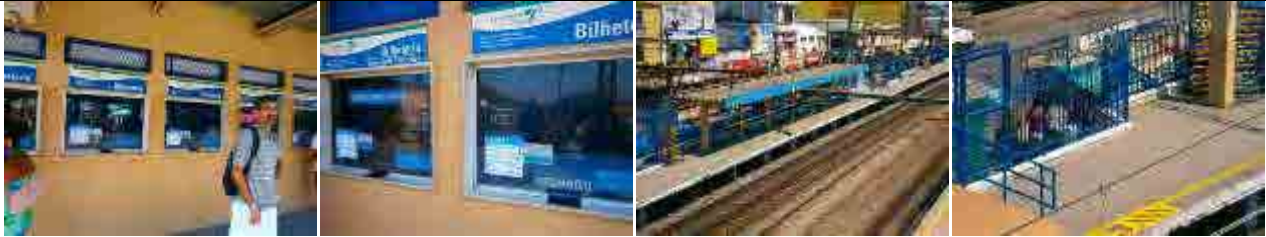
No.	18	Mode	Rail
Survey Date	18/09/12	Name of St.	Queimados
Area	Queimados	Line Name	Japeri
Current Condition			
Entrance/ Approach		Location

Description			
35. Condition		36. Issues	
Entrance/ Exit	No directions for entrance, no exit sign outside station.	<ul style="list-style-type: none"> > No maps; > Missing many Direction signs; > Direction signs for entrance; > Lack of map or landmark information for exit; > Add general route mapping and info at platform; > Accessibility for disabled people. 	
Ticketing	Fare info with small letters.		
Platform	No direction signs on the floor, no board, no map.		
Other	No foreign language. No travel time info and no timetable.

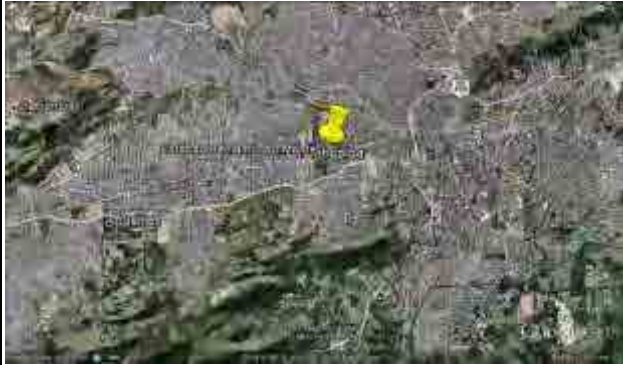
No.	21	Mode	Rail
Survey Date	08/10/12	Name of St.	Benjamin do Monte
Area	Inhoaiba	Line Name	Santa Cruz
Current Condition			
Entrance/ Approach		Location

Description			
41. Condition		42. Issues	
Entrance/ Exit	No directions for entrance, no exit sign outside station.	<ul style="list-style-type: none"> > Map location of difficult visibility; > Direction signs for entrance; > Lack of map or landmark information for exit; > Add general route mapping and info at platform; > Accessibility for disabled people. 	
Ticketing	Fare info with small letters.		
Platform	No direction signs on the floor, no board, no map.		
Other	No foreign language.

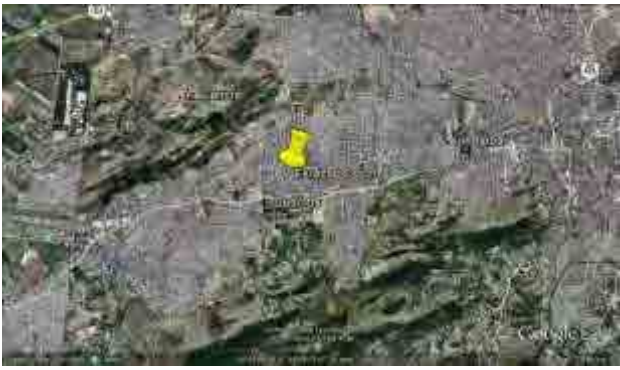
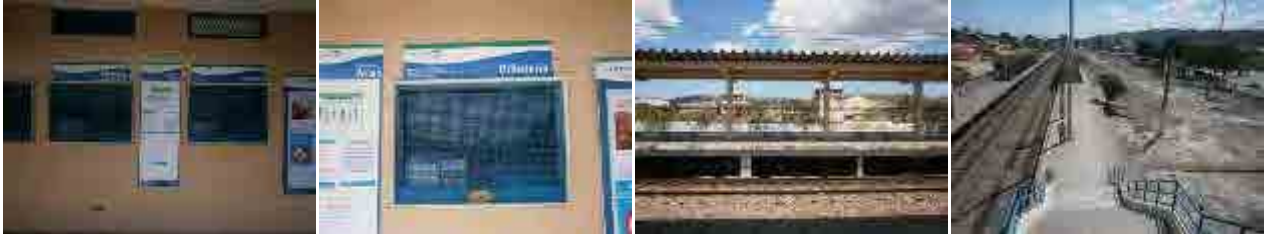
No.	22	Mode	Rail
Survey Date	08/10/12	Name of St.	Cosmos
Area	Cosmos	Line Name	Santa Cruz
Current Condition			
Entrance/ Approach		Location

43. Condition		44. Issues	
Entrance/ Exit	No directions for entrance, no exit sign outside station.	<ul style="list-style-type: none"> > Safety hazard: level and the gap between the platform and the train; > Direction signs for entrance; > Lack of map or landmark information for exit; > Add general route mapping and info at platform; > Accessibility for disabled people. 	
Ticketing	Fare info with small letters.		
Platform	No direction signs on the floor, no board, no map, safety hazard level and gap with train.		
Other	No foreign language.

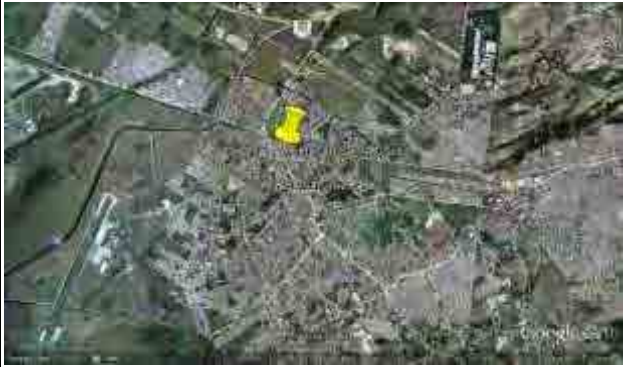
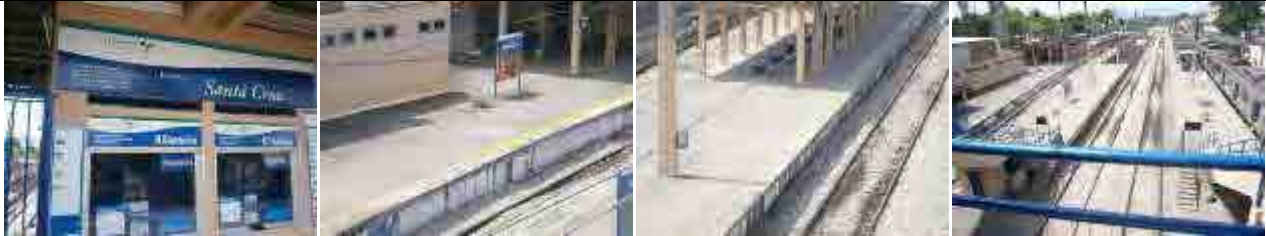
No.	25	Mode	Rail
Survey Date	24/09/12	Name of St.	Santa Cruz
Area	Santa Cruz	Line Name	Santa Cruz
Current Condition			
Entrance/ Approach		Location

49. Condition		50. Issues	
Entrance/ Exit	No exit sign outside station. Poor signalization at station. Accessibility of disable people.	<ul style="list-style-type: none"> > Safety hazard: level and the gap between the platform and the train; > Direction signs for entrance; > Lack of map or landmark information for exit; > Add general route mapping and info at platform; > Accessibility for disabled people. 	
Ticketing	Fare info with small letters.		
Platform	No direction signs on the floor, no board, no map, disable people waiting to be helped.		
Other	No foreign language.

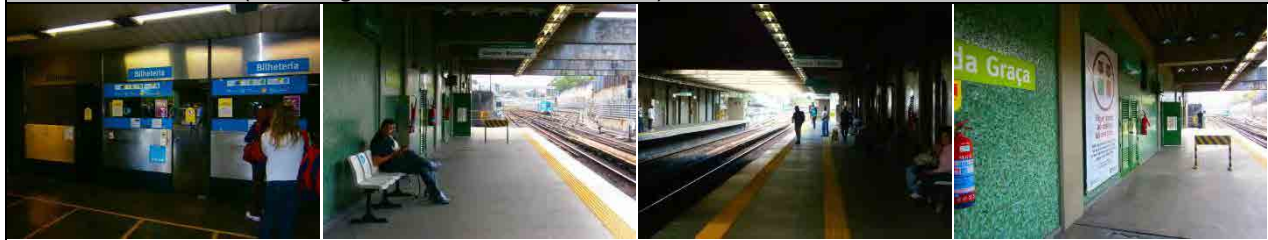
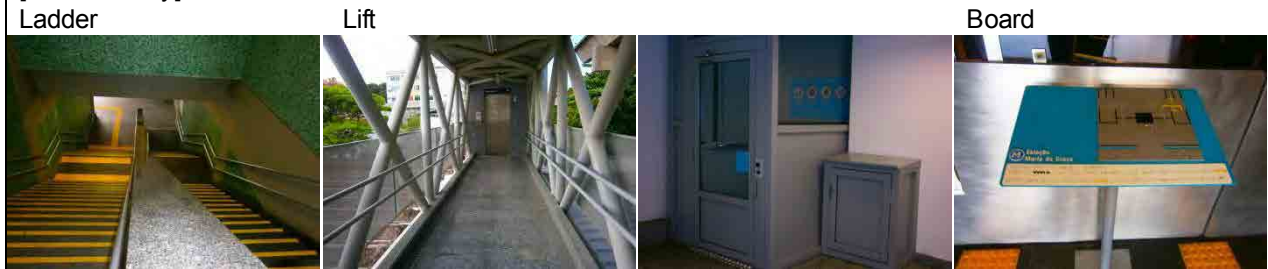
1. Condition		2. Issues
Entrance/ Exit	No directions for entrance, no exit sign outside station.	<ul style="list-style-type: none"> > Direction signs for entrance; > Improve sign visualization at platform; > Lack of map or landmark information for exit; > Add general route mapping, info and train arrival time at platform.
Ticketing	Totem for card recharge. Lack of general route/system info.	
Platform	Lack of maps and direction information. Poor visualization sign.	
Other	Almost no foreign language, Small character size. No travel time info. No fare info outside box office.

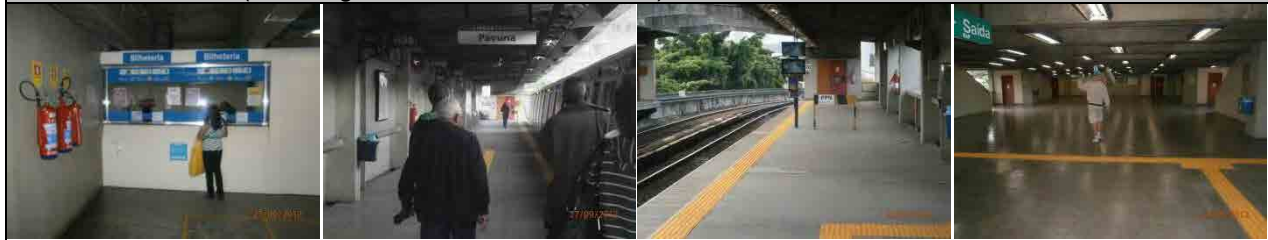
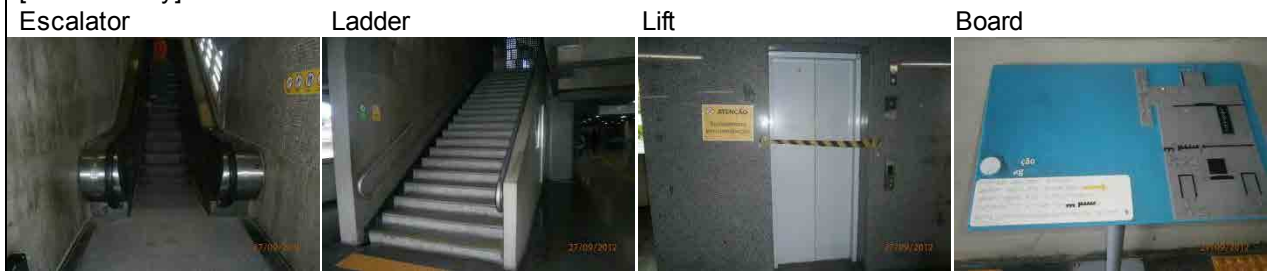
1. Condition		2. Issues
Entrance/ Exit	No directions for entrance, no exit sign outside station.	<ul style="list-style-type: none"> > Improve entrance/exit identification; > Direction signs for entrance; > Improve sign visualization at platform; > Lack of map or landmark information for exit; > Add general route mapping, info and train arrival time at platform.
Ticketing	Totem for card recharge. Lack of general route/system info.	
Platform	Lack of maps and direction information.	
Other	Almost no foreign language, Small character size. No travel time info. No fare info outside box office.
