No.	18	Mode	Metro
Survey Date	26/09/12	Name of St.	Carioca
Area	Centro	Line Name	Orange

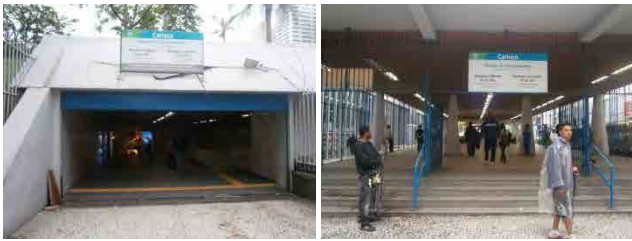
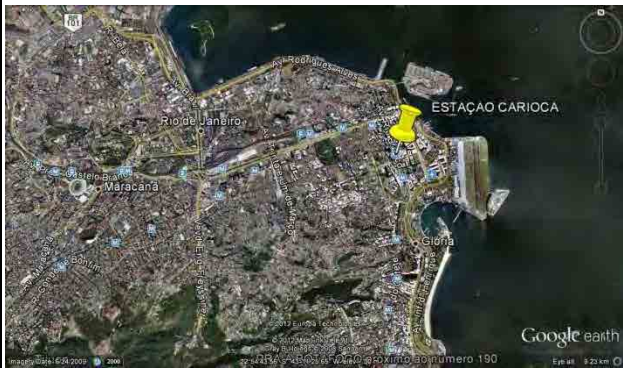
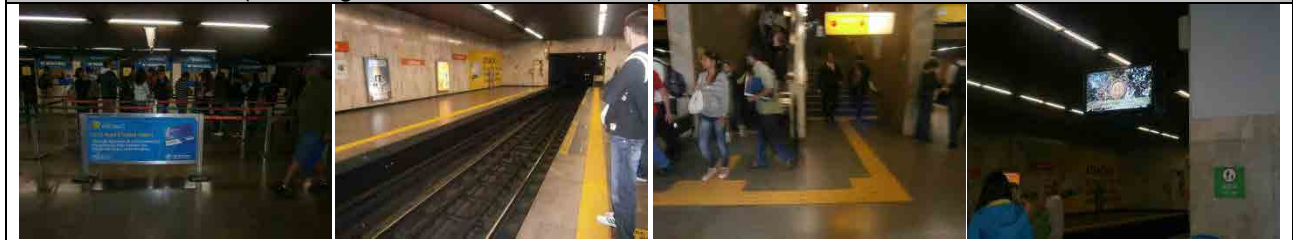
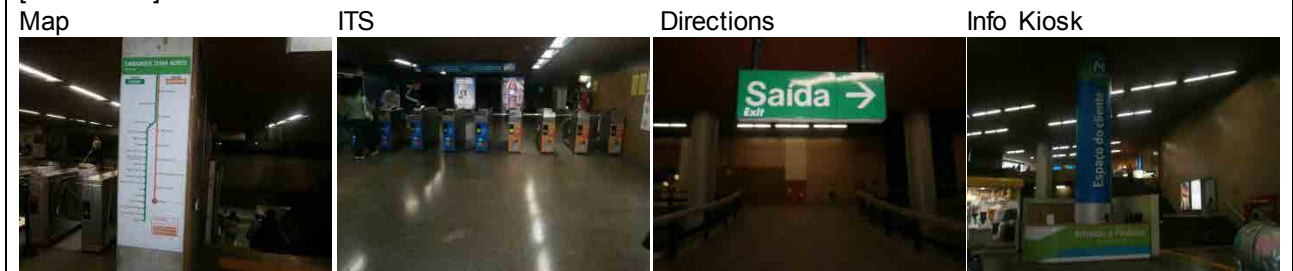
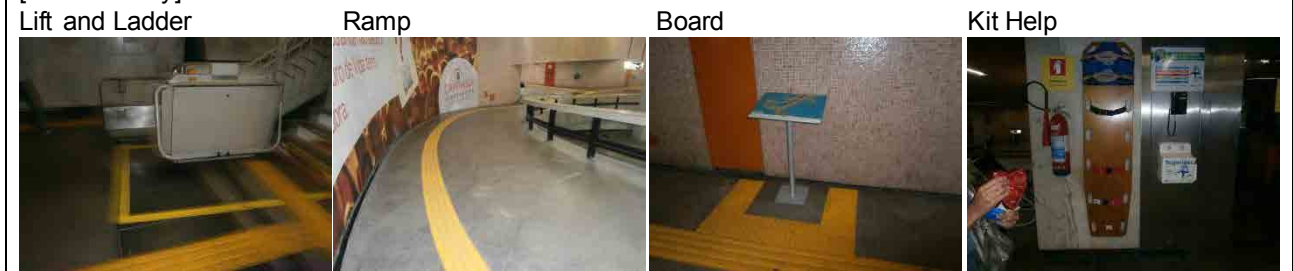
1. Condition		2. Issues
Entrance/ Exit	No directions for entrance, no exit sign outside station.	<ul style="list-style-type: none"> > Improve entrance identification; > Direction signs for entrance; > Lack of map or landmark information for exit; > Add general route mapping, info and train arrival time at platform.
Ticketing	Totem for card recharge. Lack of general route/system info.	
Platform	Lack of maps and direction information.	
Other	Almost no foreign language, Small character size. No travel time info. No fare info outside box office.

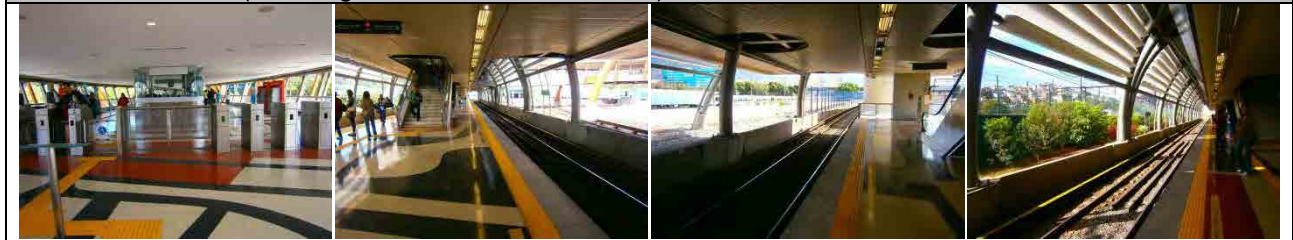
1. Condition		2. Issues
Entrance/ Exit	No directions for entrance, no exit sign outside station.	<ul style="list-style-type: none"> > Improve entrance/exit identification; > Direction signs for entrance; > Improve sign visualization at platform; > Lack of map or landmark information for exit; > Add general route mapping, info and train arrival time at platform.
Ticketing	Totem for card recharge. Lack of general route/system info.	
Platform	Lack of maps and direction information.	
Other	Small character size for foreign language. No travel time info. No fare info outside box office.

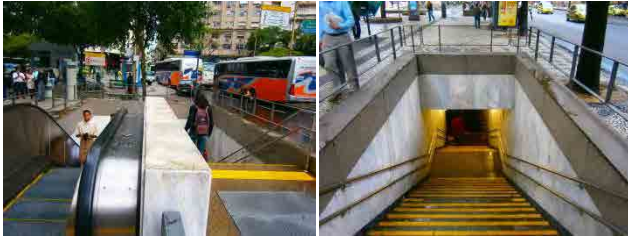
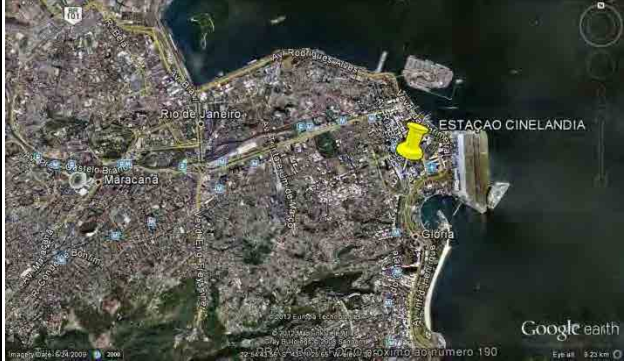
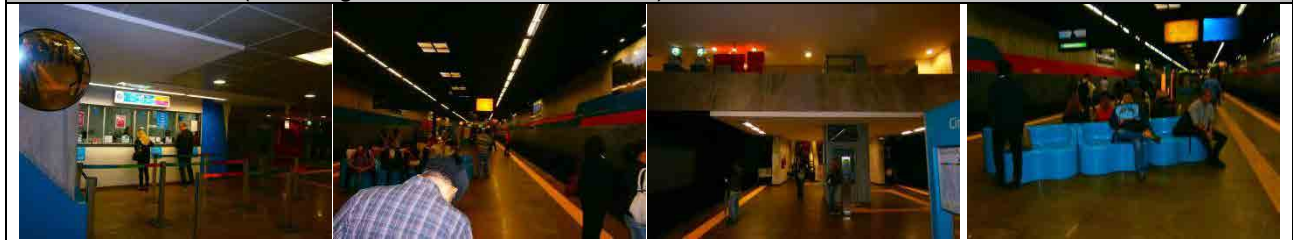
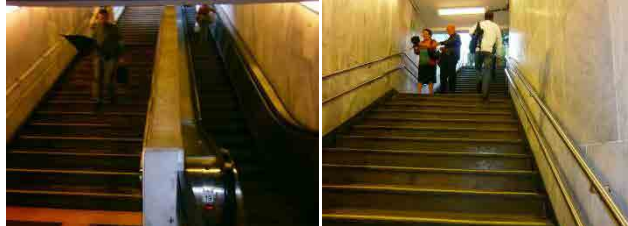
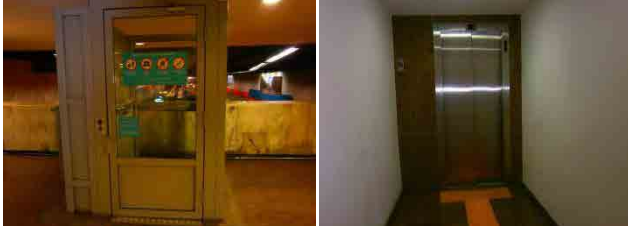
1. Condition		2. Issues
Entrance/ Exit	No directions for entrance, no exit sign outside station.	<ul style="list-style-type: none"> > Improve entrance/exit identification; > Direction signs for entrance; > Improve sign visualization at platform; > Lack of map or landmark information for exit; > Add general route mapping, info and train arrival time at platform.
Ticketing	Totem for card recharge. Lack of general route/system info.	
Platform	Lack of maps and direction information.	
Other	Almost no foreign language, Small character size. No travel time info. No fare info outside box office.

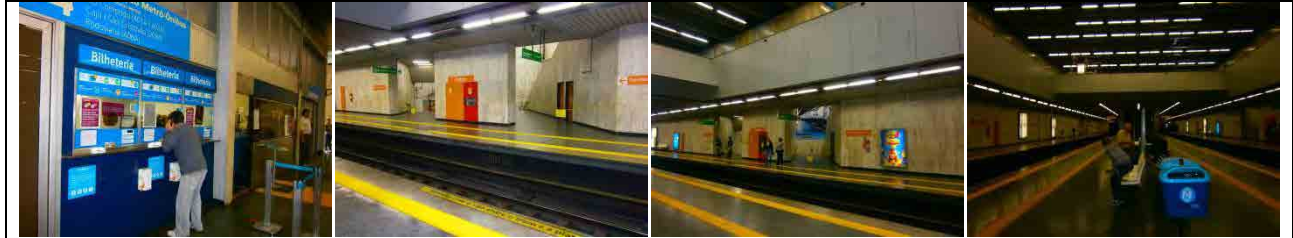
1. Condition		2. Issues
Entrance/ Exit	No directions for entrance, no exit sign outside station.	<ul style="list-style-type: none"> > Improve identification in the entrance; > Direction signs for entrance; > Improve sign visualization at platform; > Lack of map or landmark information for exit; > Add general route mapping, info and train arrival time at platform.
Ticketing	Totem for card recharge. Lack of general route/system info.	
Platform	Lack of maps and direction information.	
Other	Almost no foreign language, Small character size. No travel time info. No fare info outside box office.

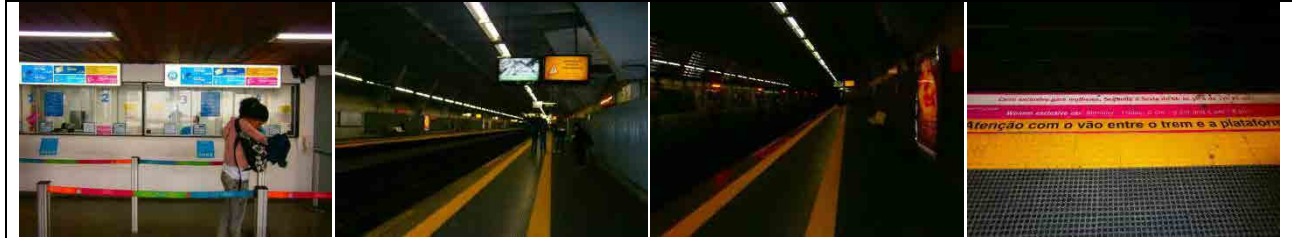
1. Condition		2. Issues
Entrance/ Exit	No directions for entrance, no exit sign outside station.	<ul style="list-style-type: none"> > Improve entrance/exit identification; > Direction signs for entrance; > Lack of map or landmark information for exit.
Ticketing	Totem for card recharge. Lack of general route/system info.	
Platform	Lack of maps and direction information.	
Other	Almost no foreign language, Small character size. No travel time info. No fare info outside box office.

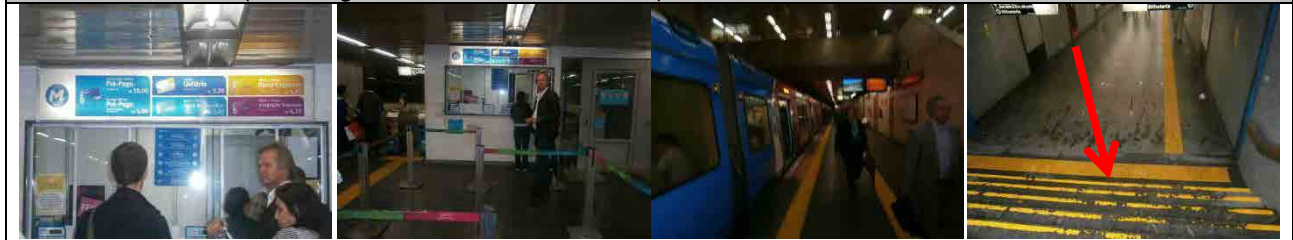
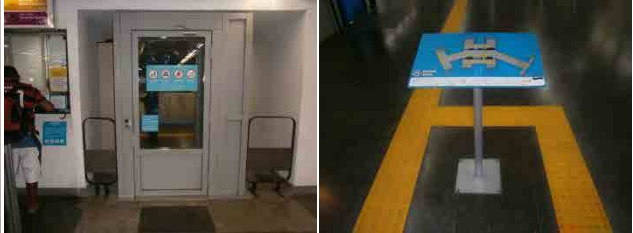
<table><tr> <td>Entrance/ Exit</td> <td>No directions for entrance, no exit sign outside station.</td> </tr><tr> <td>Ticketing</td> <td>Totem for card recharge. Lack of general route/system info.</td> </tr><tr> <td>Platform</td> <td>Lack of maps and direction information.</td> </tr><tr> <td>Other</td> <td>Almost no foreign language, Small character size. No travel time info. No fare info outside box office.</td> </tr></table>

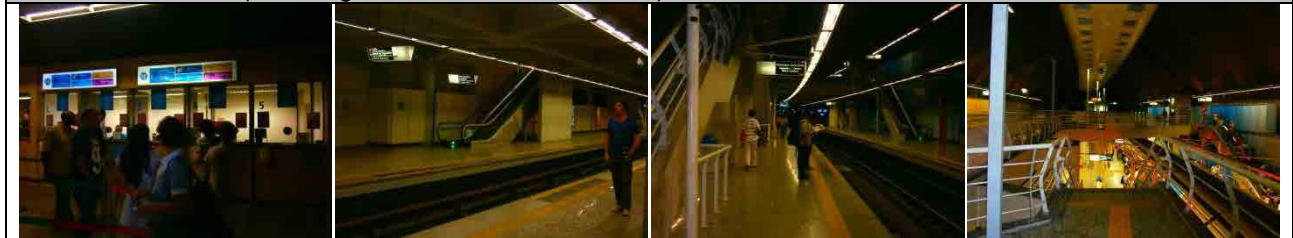
1. Condition		2. Issues
Entrance/ Exit	Good signalization.	<ul style="list-style-type: none"> > Lack of map or landmark information for exit; > Add general route mapping, info and train arrival time at platform. > Good accessibility for disabled users.
Ticketing	Totem for card recharge. Lack of general route/system info.	
Platform	Lack of maps and good direction information.	
Other	Almost no foreign language, Small character size. No travel time info. No fare info outside box office.

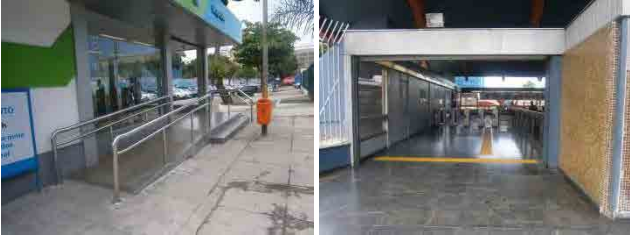
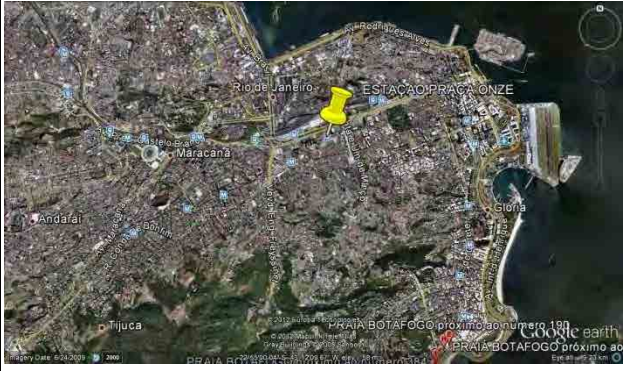
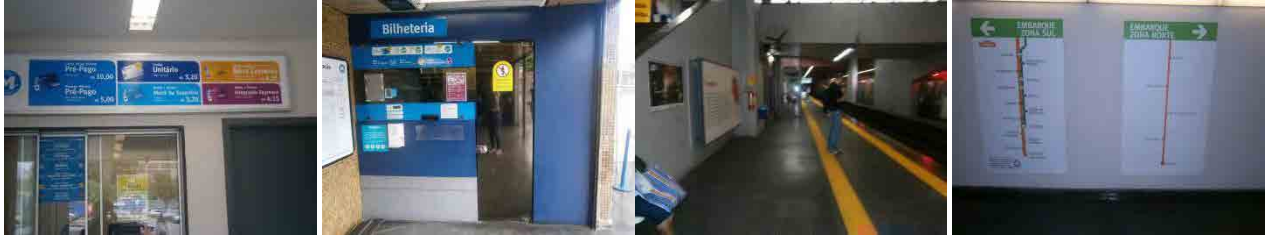
1. Condition		2. Issues	
Entrance/ Exit	No directions for entrance, no exit sign outside station.	<ul style="list-style-type: none"> > Improve entrance/exit identification; > Direction signs for entrance; > Lack of map or landmark information for exit; > Add general route mapping, info and train arrival time at platform. 	
Ticketing	Totem for card recharge. Lack of general route/system info.		
Platform	Good direction information and maps.		
Other	Almost no foreign language, Small character size. No travel time info. No fare info outside box office.

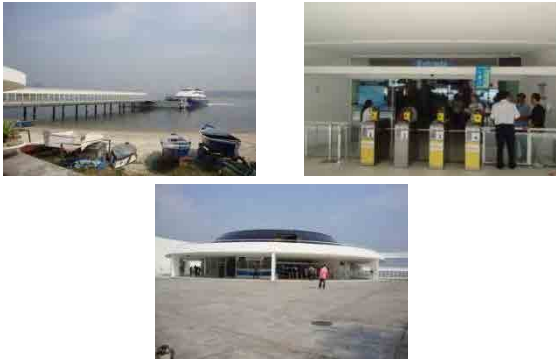
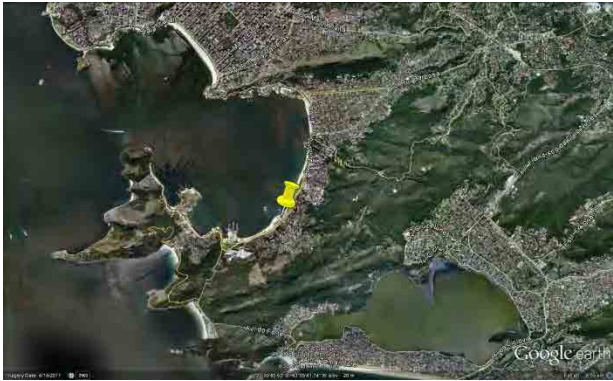
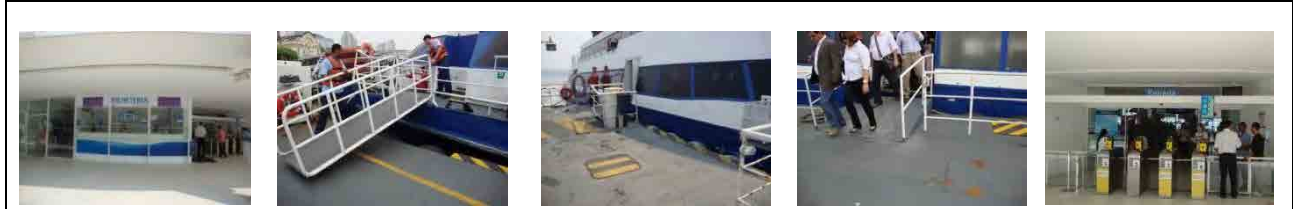
1. Condition		2. Issues
Entrance/ Exit	Station under construction.	>No Time Table;
Ticketing		>Few directions signs of signaling and no maps;
Platform	Damaged sidewalk	>Few Seats.
Other	No messages in foreign language.	>Safety hazard: gap between terry and station.

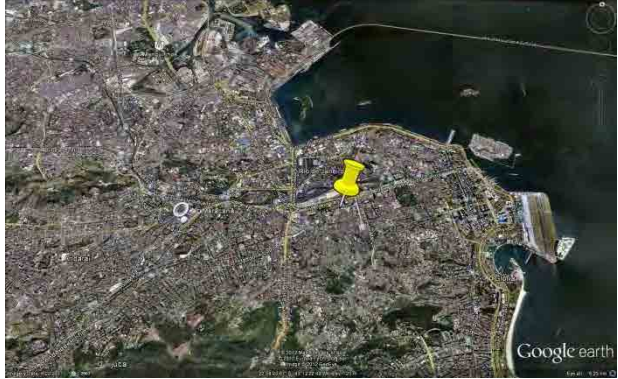
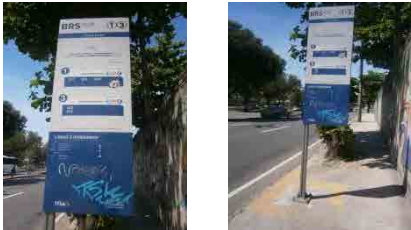
General Condition (Ticketing / Platform / Embankment)			
Sign		Vandalism

Description			
1. Condition		2. Issues	
Approach	>Damaged bus stop and/or info board.	> Dirty Bus Stop; Dirty Boards; Bus Stop Without shelter and seats;	
Ticketing	>No messages/signs in foreign language.	> Segregation of buses is confusing. No information availability;	
Platform	>Lack of maintenance.	> Safety hazard for some users.	
Other
