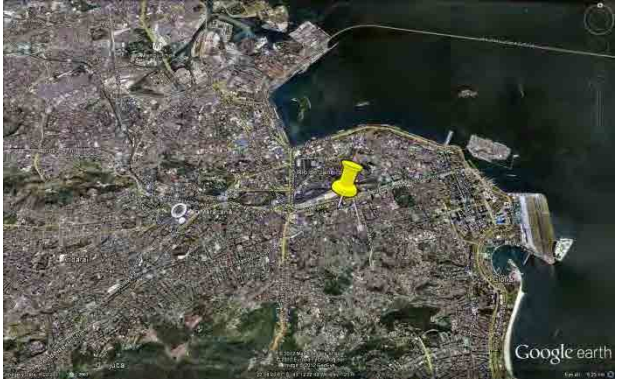
No.	24	Mode	BRS
Survey Date	02/10/2012	Name of St.	Praça Onze
Area	Centro (Downtown) - Presidente Vargas	Line Name	3 A - 5

1. Condition		2. Issues
Approach	Damaged bus stop and/or info board.	> Dirty Bus Stop; Dirty Boards; Bus Stop Without Seats. Sign Orientation ripped; > Segregation of buses is confusing. No information availability.
Ticketing	No messages/signs in foreign language.	
Platform	Lack of maintenance.	
Other

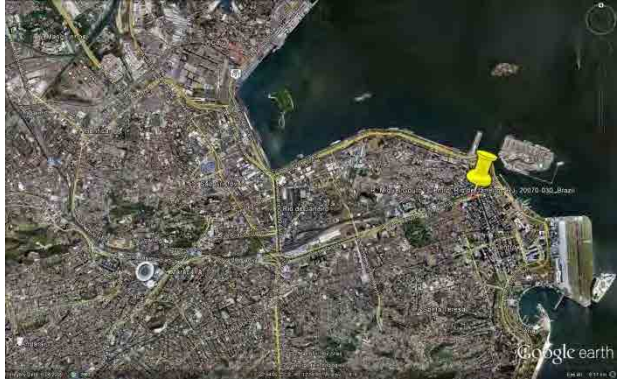
No.	25	Mode	BRS
Survey Date	02/10/2012	Name of St.	Rio Branco
Area	Centro (Downtown)	Line Name	1

1. Condition		2. Issues
Approach	>Damaged bus stop and/or info board.	> Bus Stop without seats and shelter; > Segregation of buses is confusing. No information availability.
Ticketing	>No messages/signs in foreign language.	
Platform	>Lack of maintenance.	
Other	>Safety hazard for some users.

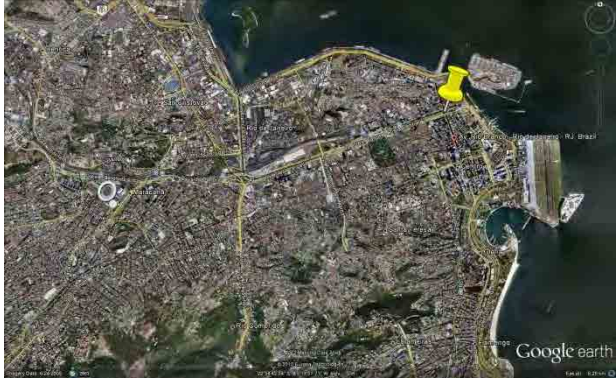
No.	26	Mode	BRS
Survey Date	02/10/2012	Name of St.	Rio Branco
Area	Centro (Downtown)	Line Name	4 A
Current Condition			
Entrance/ Approach		Location

Description			
1. Condition		2. Issues	
Approach	Damaged bus stop and/or info board.	<ul style="list-style-type: none"> > Bus Stop without seats and shelter; > Segregation of buses is confusing. No information availability; > Safety hazard for some users; Construction zone around bus stop. No protection for pedestrian. 	
Ticketing	No messages/signs in foreign language.		
Platform	Lack of maintenance.		
Other	No timetable.

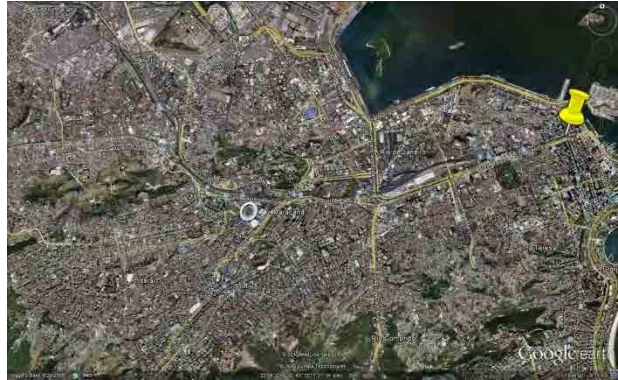
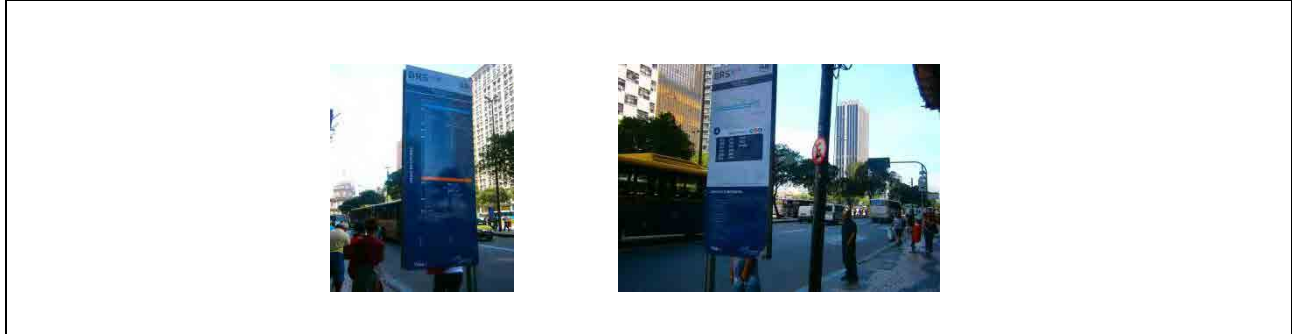
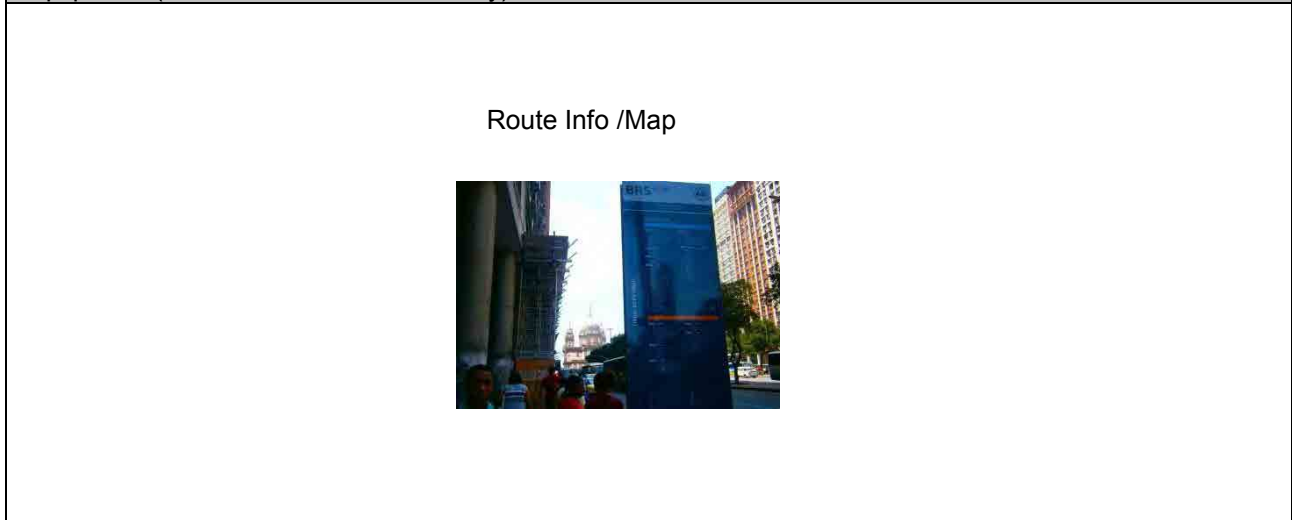
No.	27	Mode	BRS
Survey Date	02/10/2012	Name of St.	Rio Branco
Area	Centro (Downtown)	Line Name	4B

1. Condition		2. Issues
Approach	Damaged bus stop and/or info board.	<ul style="list-style-type: none"> > Bus Stop without seats and shelter; > Segregation of buses is confusing. No information availability; >No Timetable.
Ticketing	No messages/signs in foreign language.	
Platform	Lack of maintenance.	
Other	Safety hazard for some users.

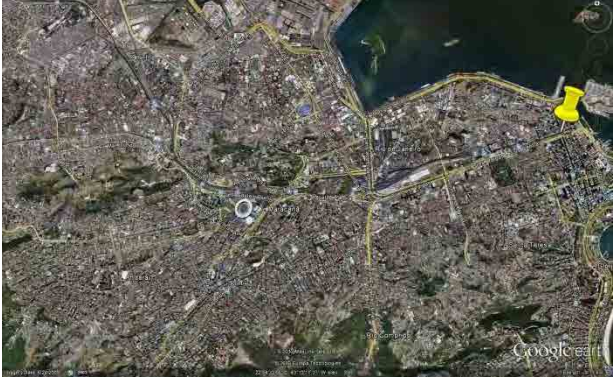
No.	28	Mode	BRS
Survey Date	02/10/2012	Name of St.	Rio Branco
Area	Centro (Downtown)	Line Name	5

1. Condition		2. Issues
Approach	>Damaged bus stop and/or info board.	> Bus Stop without seats and shelter; > Segregation of buses is confusing. No information availability.
Ticketing	>No messages/signs in foreign language.	
Platform	>Lack of maintenance.	
Other	>General route info available.

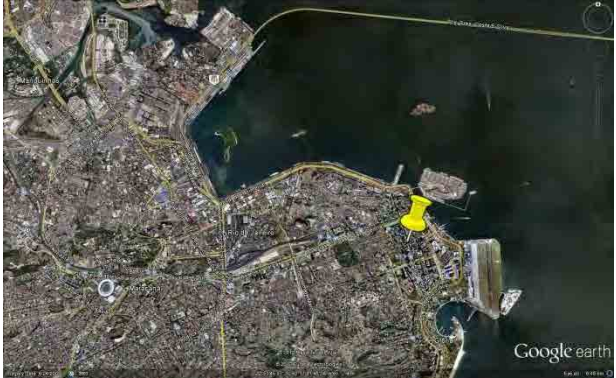
No.	30	Mode	BRS
Survey Date	02/10/2012	Name of St.	Sete de Setembro
Area	Rio Branco	Line Name	4 B

1. Condition		2. Issues
Approach	Damaged bus stop and/or info board.	<ul style="list-style-type: none"> > Dirty Bus Stop; Dirty and Ripped Boards; > Segregation of buses is confusing; > In general, damaged of bus stops.
Ticketing	No messages/signs in foreign language.	
Platform	Lack of maintenance.	
Other

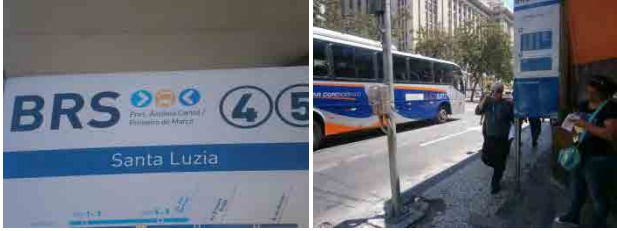
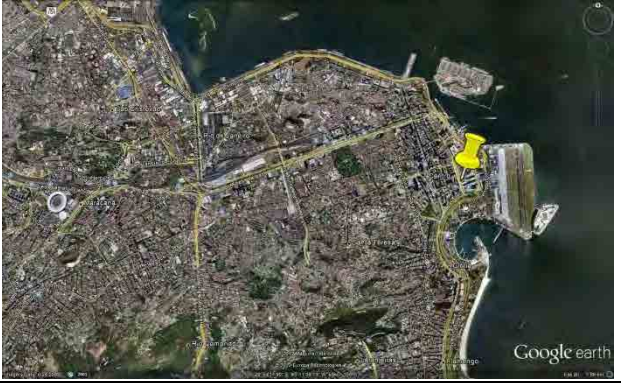
No.	31	Mode	BRS
Survey Date	02/10/2012	Name of St.	Santa Luzia
Area	Centro (Downtown)	Line Name	4 - 5

1. Condition		2. Issues
Approach	Damaged bus stop and/or info board.	<ul style="list-style-type: none"> > Dirty Bus Stop; Dirty and Ripped Boards; > Bus Stop Without shelter; > Segregation of buses is confusing; > In general, vandalism and damaged of bus stops; > Safety hazard for some users.
Ticketing	No messages/signs in foreign language.	
Platform	Lack of maintenance.	
Other

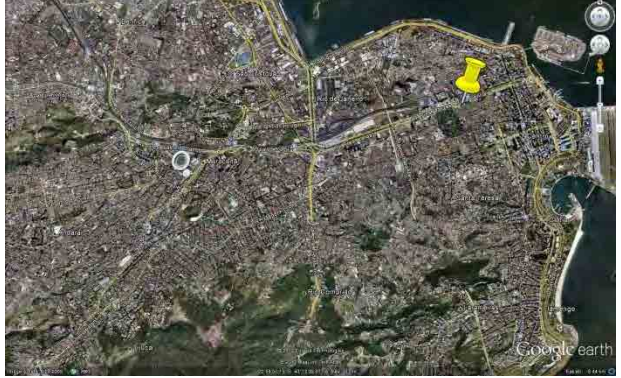
No.	32	Mode	BRS
Survey Date	02/10/2012	Name of St.	Tomé de Sousa
Area	Centro (Downtown)	Line Name	1 - 3

1. Condition		2. Issues
Approach	Damaged bus stop and/or info board.	<ul style="list-style-type: none"> > Segregation of buses is confusing; > In general, vandalism and damaged of bus stops.
Ticketing	No messages/signs in foreign language.	
Platform	Lack of maintenance.	
Other

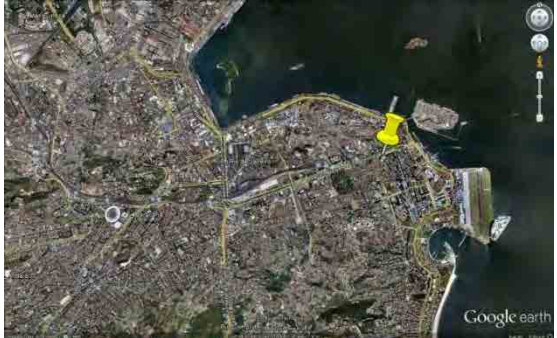
No.	33	Mode	BRS
Survey Date	02/10/2012	Name of St.	Uruguaiana
Area	Centro (Downtown)	Line Name	1 - 3

1. Condition		2. Issues	
Approach	Damaged bus stop and/or info board.	<ul style="list-style-type: none"> > Dirty Bus Stop; Dirty and Ripped Boards; > Segregation of buses is confusing. No specific route and/or timetable info; > In general, vandalism and damaged of bus stops. 	
Ticketing	No messages/signs in foreign language.		
Platform	Lack of maintenance. Bus Stop Without Seats.		
Other	Bus stop with unsafe conditions for disabled people and/or general users.

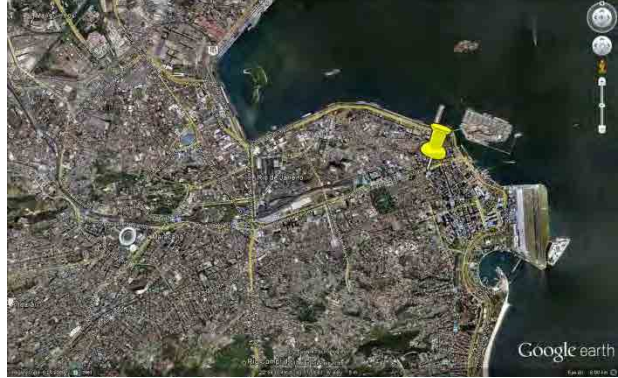
No.	34	Mode	BRS
Survey Date	02/10/2012	Name of St.	Uruguaiana
Area	Centro (Downtown)	Line Name	2 - 3
Current Condition			
Entrance/ Approach		Location

Description			
1. Condition		2. Issues	
Approach	Poor visualization.	<ul style="list-style-type: none"> > Segregation of buses is confusing. No specific route and/or timetable info; > Bus Stop Without shelter. 	
Ticketing	No messages/signs in foreign language.		
Platform	Lack of maintenance. Bus Stop Without Seats.		
Other	Bus stop with unsafe conditions for disabled people and/or general users.

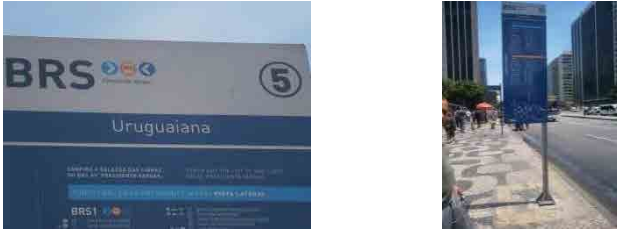
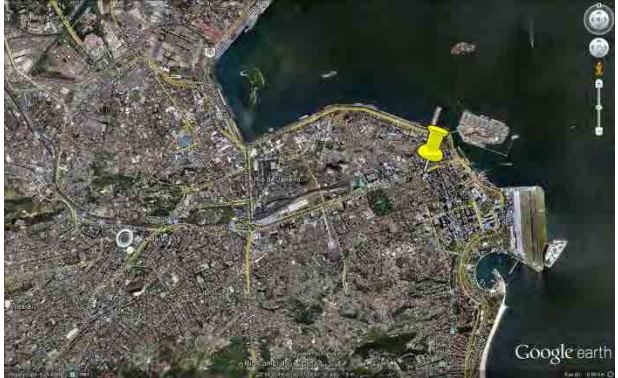
No.	35	Mode	BRS
Survey Date	02/10/2012	Name of St.	Uruguaiiana
Area	Centro (Downtown)	Line Name	5

1. Condition		2. Issues
Approach	Damaged bus stop and/or info board.	<ul style="list-style-type: none"> > Segregation of buses is confusing. No specific route and/or timetable info; > In general, vandalism and damaged of bus stops.
Ticketing	No messages/signs in foreign language.	
Platform	Lack of maintenance. Bus Stop Without Shelter.	
Other	Bus stop with unsafe conditions for disabled people and/or general users.

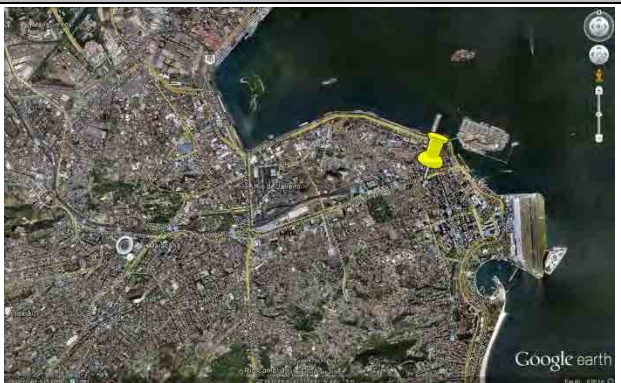
No.	36	Mode	BRS
Survey Date	02/10/2012	Name of St.	Uruguiana
Area	Centro (Downtown)	Line Name	5

1. Condition		2. Issues
Approach	Poor signalization/visibility.	> Segregation of buses is confusing. No specific route and/or timetable info.
Ticketing	No messages/signs in foreign language.	
Platform	Lack of maintenance. Bus Stop Without Shelter.	
Other	Bus stop with unsafe conditions for disabled people and/or general users.

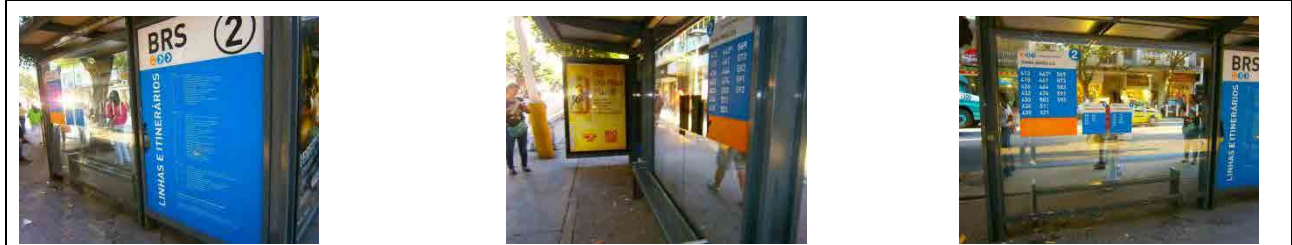
No.	38	Mode	BRS
Survey Date	02/10/2012	Name of St.	Joana Angélica
Area	Ipanema	Line Name	2

1. Condition	2. Issues
Approach	Damaged bus stop and/or info board.
Ticketing	Fare info not available/not visible at bus stop.
Platform	Lack of maintenance. Bus Stop Without Seats.
Other	No messages/signs in foreign language.

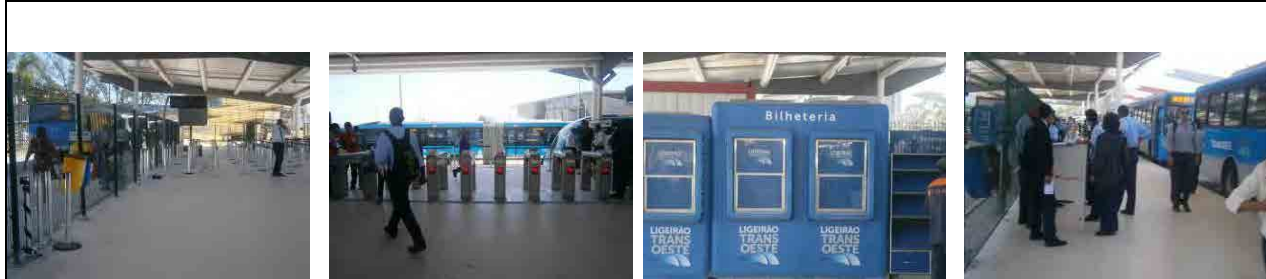
No.	01	Mode	BRT
Survey Date	01/10/2012	Name of St.	Alvorada
Area	West	Line Name	TransOeste

Description	
1. Condition	2. Issues
Approach	>No BRT station signs on vicinity area; >Few direction sign; >Few seats.
Ticketing	
Platform	
Other	
	Station under construction. Damaged sidewalk. No messages/signs in foreign language.

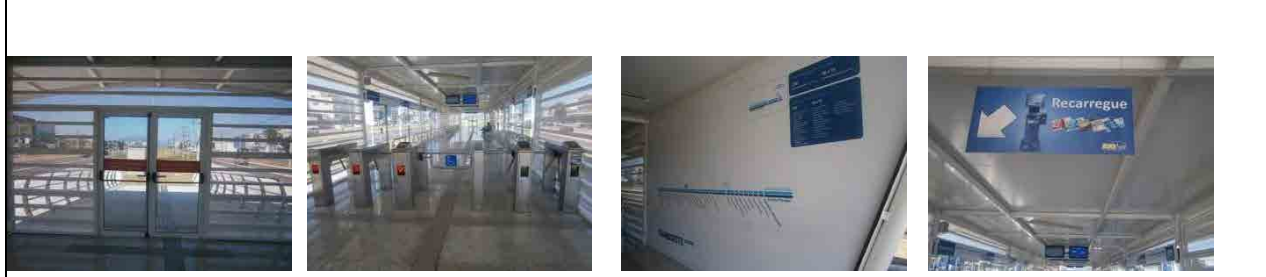
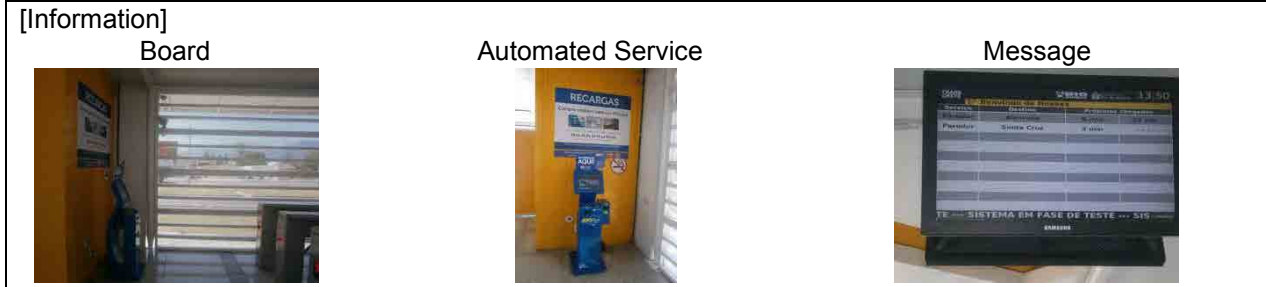
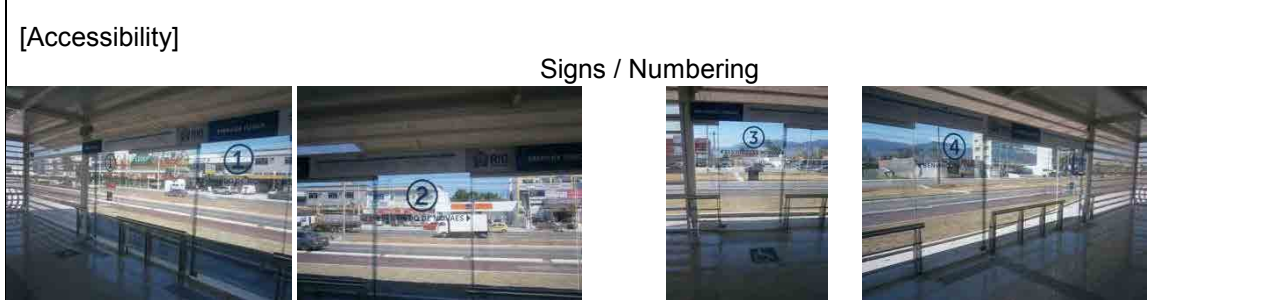
No.	02	Mode	BRT
Survey Date	01/10/2012	Name of St.	Benvindo de Novaes
Area	West	Line Name	TransOeste

Description	
1. Condition	2. Issues
Approach	<ul style="list-style-type: none"> >No BRT station signs on vicinity area; >Few signs and no maps; >Few Seats; >Improve Intermodal connectivity info for users.
Ticketing	
Platform	
Other

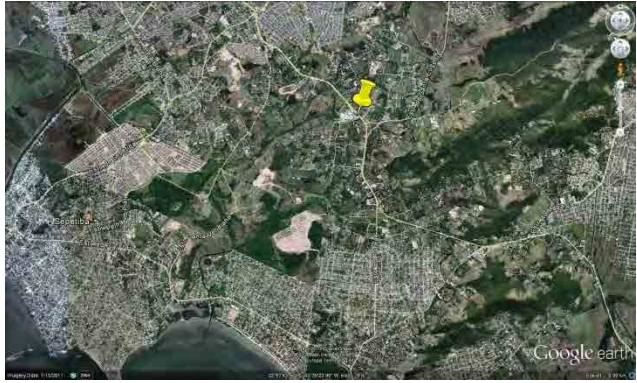
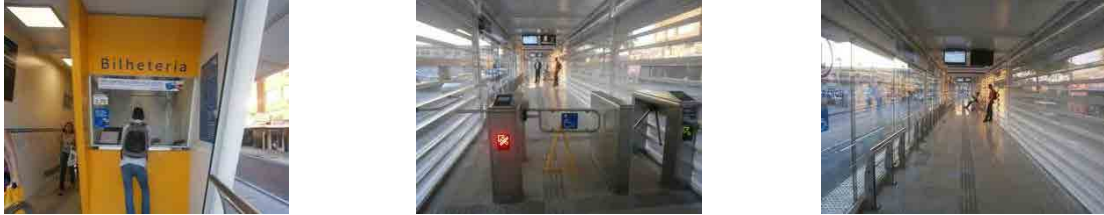
No.	05	Mode	BRT
Survey Date	01/10/2012	Name of St.	Gastão Rangel
Area	West	Line Name	TransOeste
Current Condition			
Entrance/ Approach		Location

Description			
1. Condition		2. Issues	
Approach	Station under construction.	>No BRT station signs on vicinity area; >Few signs and no maps.	
Ticketing			
Platform	Few Seats.		
Other	No messages/signs in foreign language.

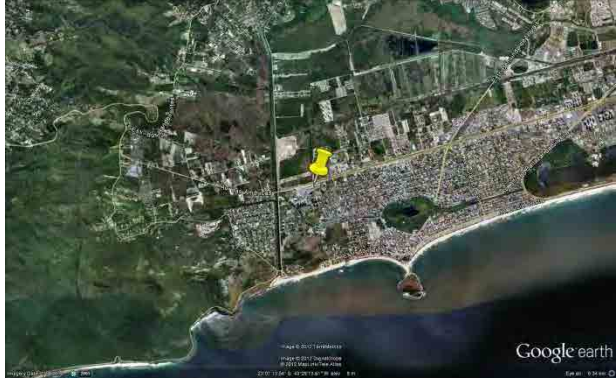
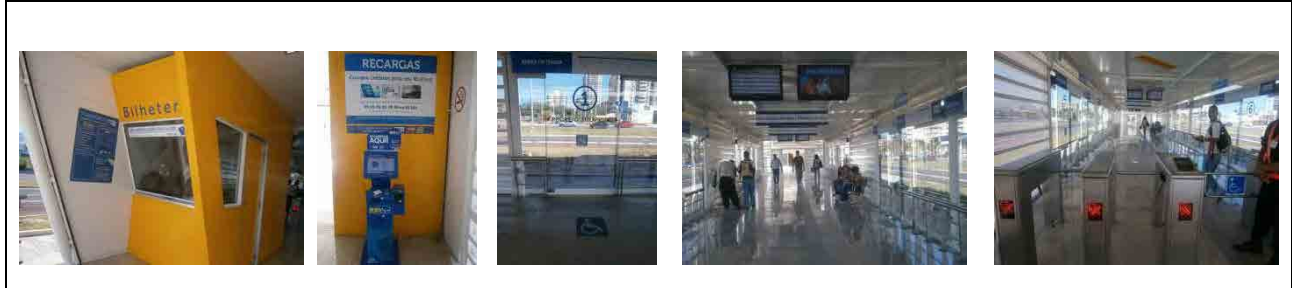
No.	17	Mode	BRT
Survey Date	01/10/2012	Name of St.	Recreio Shopping
Area	West	Line Name	TransOeste

Description	
1. Condition	2. Issues
Approach	>No BRT station signs on vicinity area; >Few signs and no maps; Improve Intermodal Connectivity info for users.
Ticketing	
Platform	
Other

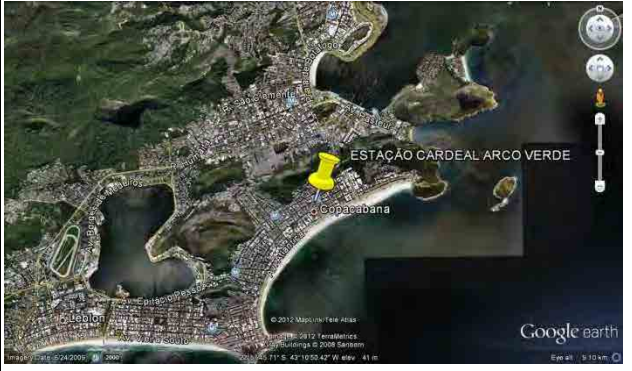
No.	01	Mode	Bike
Survey Date	06/11/12	Name of St.	Cardeal Arco Verde
Area	Copacabana	Line Name	-
Current Condition			
Approach		Location

Description			
1. Condition		2. Issues	
<ul style="list-style-type: none"> > Nearby ped signal; > Adjacent to metro station; > Solar panel; > Station map; > Instructions in Portuguese/English; > Phone service and application; > Ramp. 		<ul style="list-style-type: none"> > Need cell phone/mobile app to unlock bikes; > Multifunction sometime bike liberation.

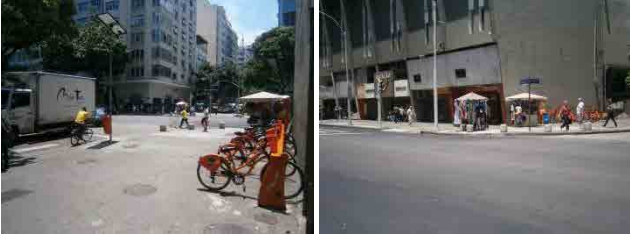
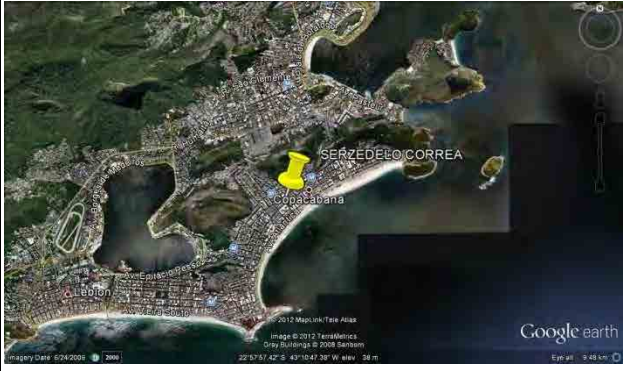
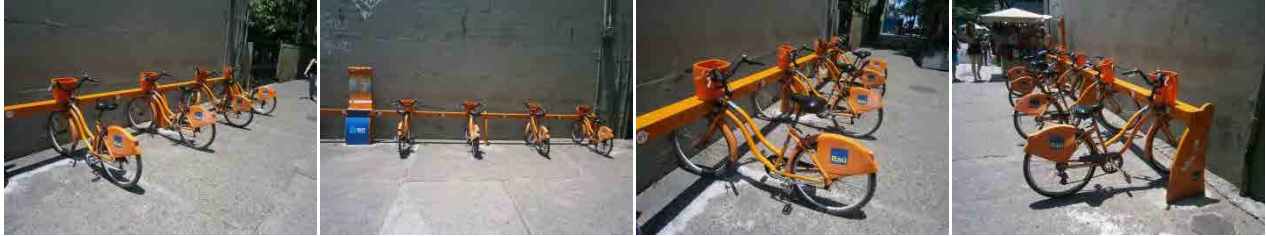
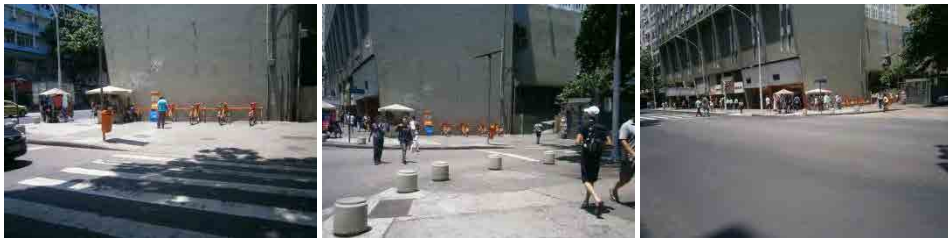
No.	03	Mode	Bike
Survey Date	06/11/12	Name of St.	Praça Serzedelo Correa
Area	Copacabana	Line Name	-
Current Condition			
Entrance/ Approach		Location

Description			
1. Condition		2. Issues	
<ul style="list-style-type: none"> > Ped signal and ramps; > Station map; > Info in English/Portuguese; > Solar Panel. 		<ul style="list-style-type: none"> > Need cell phone/mobile app to unlock bikes; > Bike liberation malfunction sometimes; > Nearby high speed avenue.
