**REPORT**  
**FOR**  
**THE FOLLOW-UP PROGRAMME**  
**ON**  
**THE PROJECT FOR**  
**IMPROVEMENT OF WATER**  
**QUALITY IN LOCAL AREAS**  
**IN**  
**THE REPUBLIC OF THE**  
**PHILIPPINES**

**SEPTEMBER 2011**

**Japan International Cooperation Agency**

**Japan Techno Co., Ltd.**

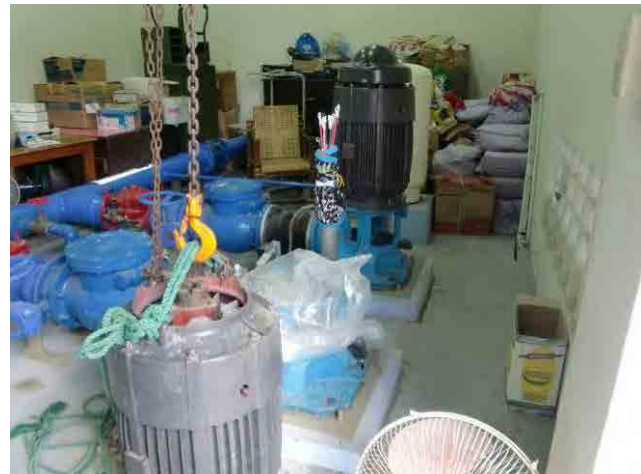
Distribution pumps: Not in use due to a breakdown. Pump No.1 has shaft broken. Pump No.2 has problem with over-current; the motor has no problem, thus the pump is somehow defective.

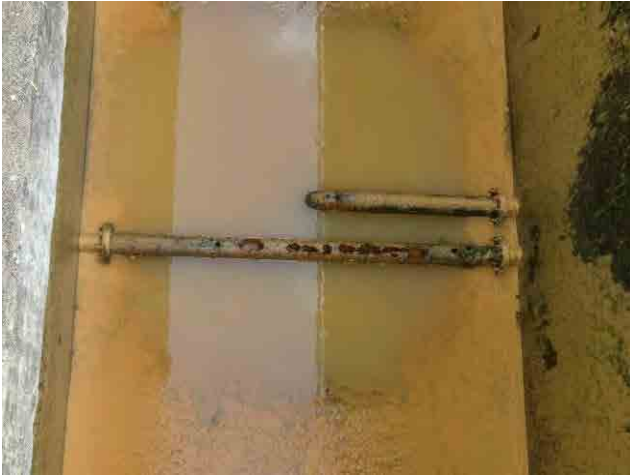
Sedimentation basin, sludge drain pipes: Corrosion makes holes on the pipe.

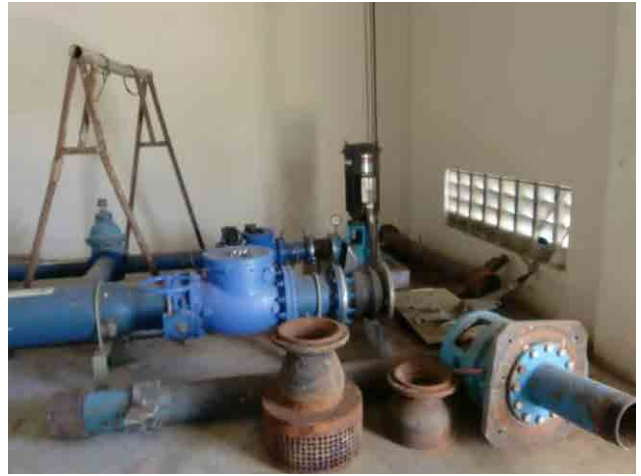
Backwash pump: It has been removed since Oct 2009 because of mechanical failures.

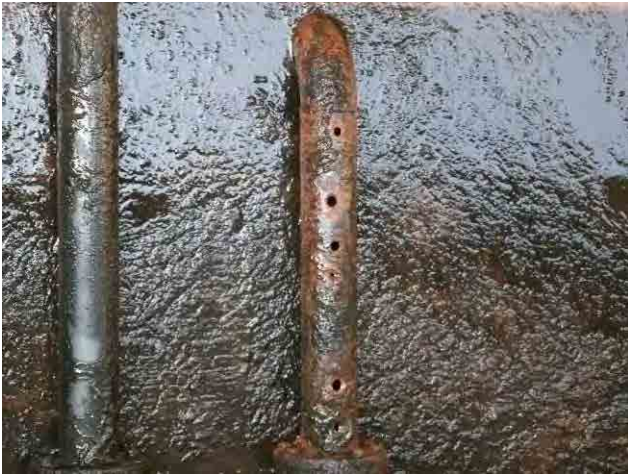
Sedimentation basin: Sludge drain pipe has holes due to corrosion.

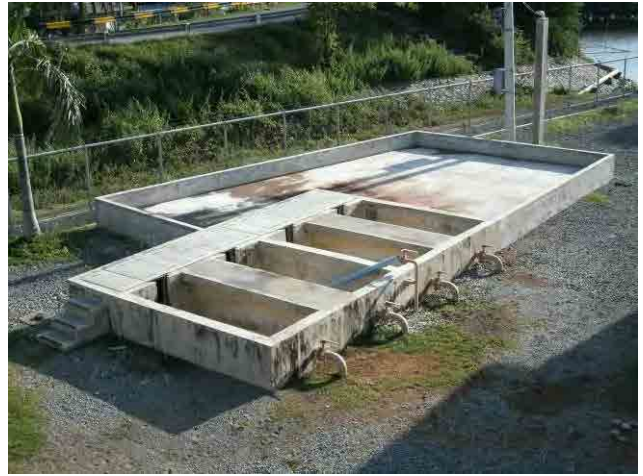
Sludge Drying bed: An additional sludge storage basin was constructed by WD for receiving the excess sludge.

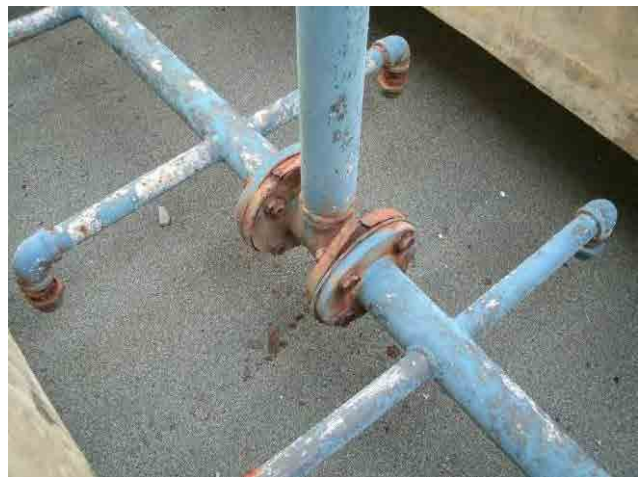
Rapid sand filter: Surface wash pipe needs to be repaired due to rust.

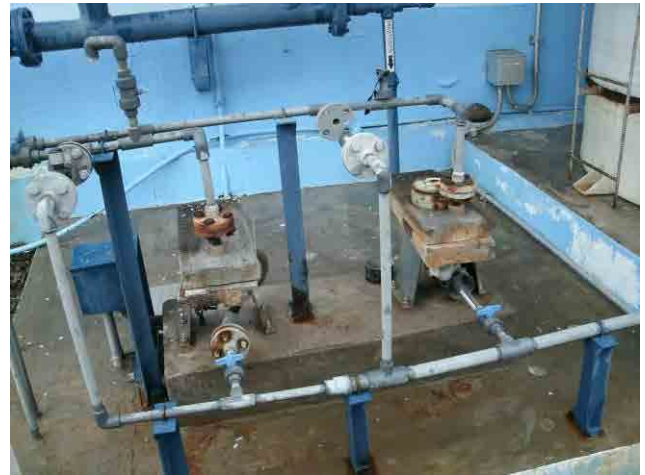
Chlorination pump: Pumps were removed because of Corrosion.

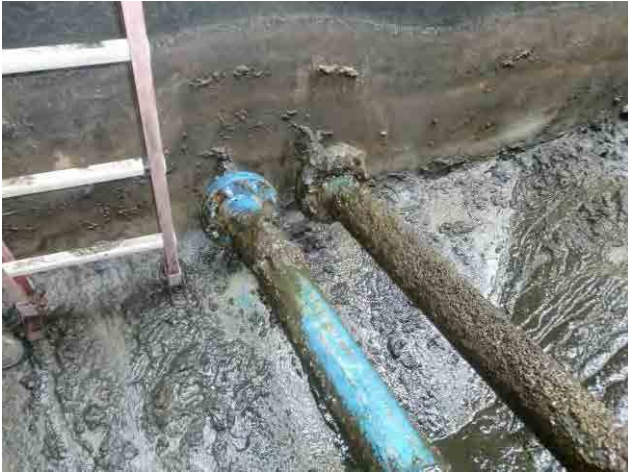
Sedimentation basin, sludge drain pipes: Pipes are not corroded; however, the sludge is attached on the pipes.

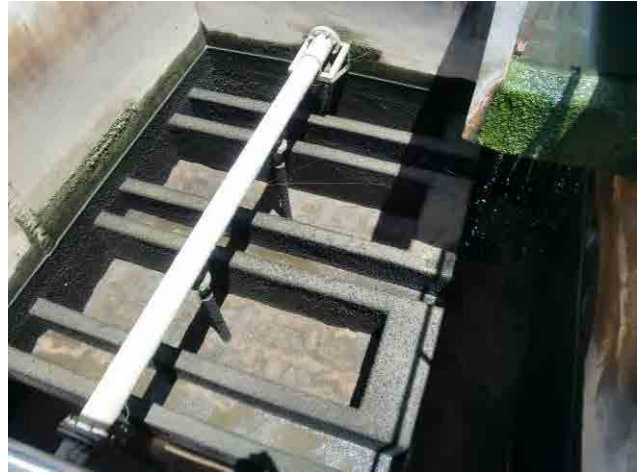
Rapid sand filter: Filter sand is put more than requires, it must be removed.

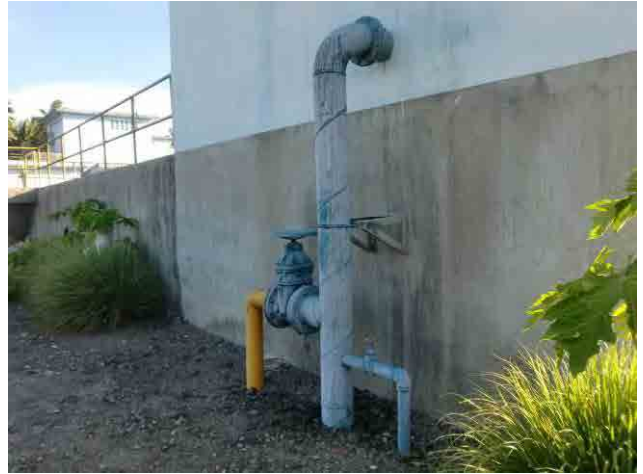
Rapid sand filter, surface-wash pipe: Currently the surface-wash pump is used as transmission pump, thus the surface-wash is not conducted now. This is the major factors that caused the mud ball.

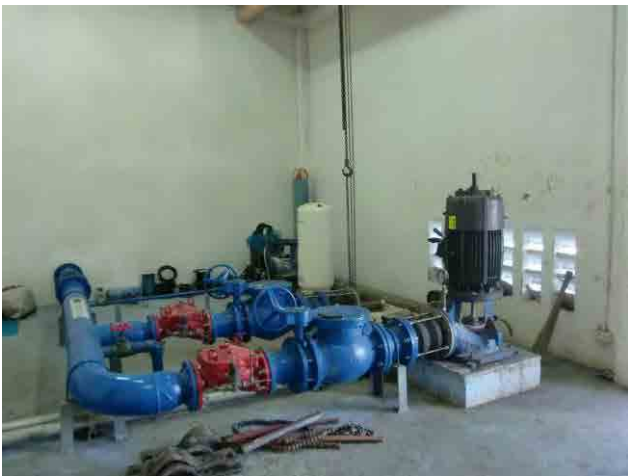
Transmission pump: No.2 pump is not in use due to shaft broken. The moter is no problem. Currently No.1 and surface-wash pump are operated alternatively.

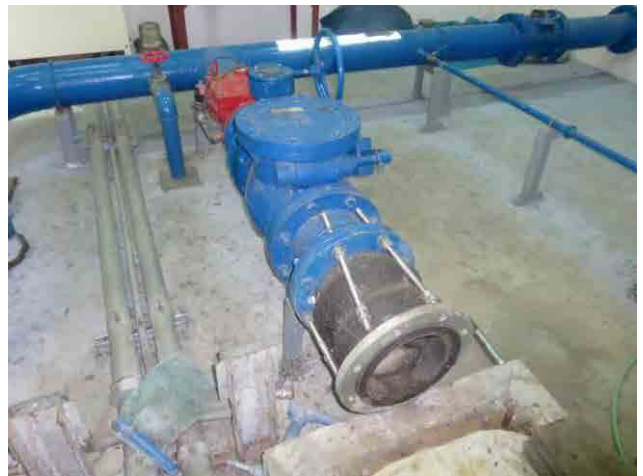
Transmission pump: No.2 has removed due to the mechanical failures.

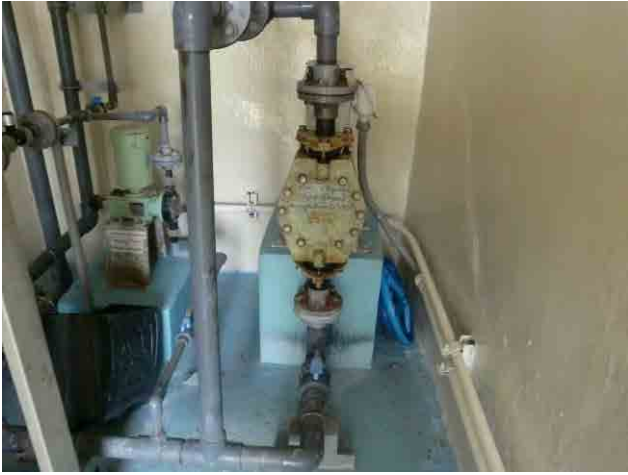
Intermediate chlorination, injection pump: Although it often stops due to mechanical failures, it is decomposed and fixed and so it can be used somehow.

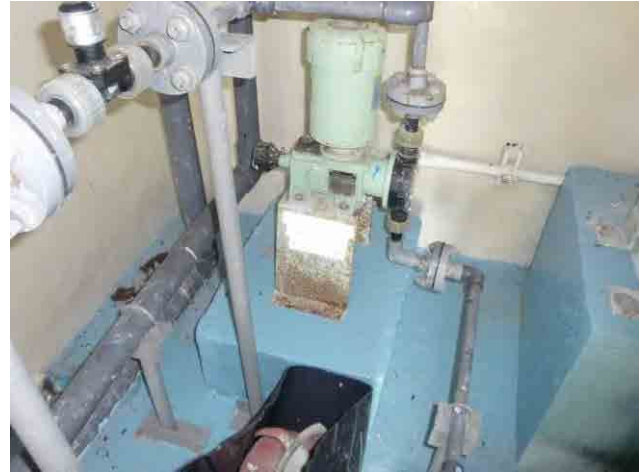
Post chlorination, injection pump: broken down; does not work when it is powered on.

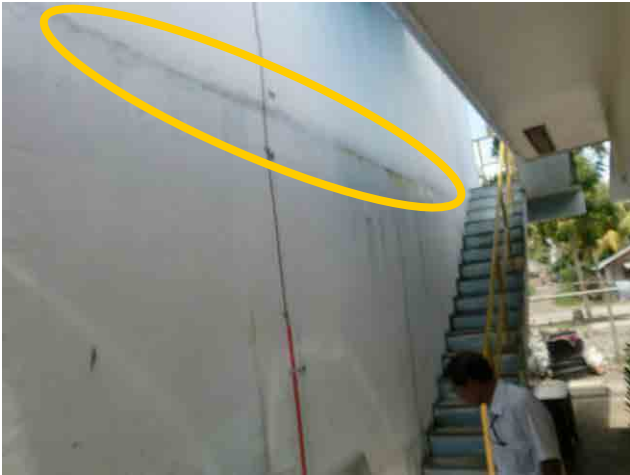
Aeration Tower: Leakage from the concrete joint.

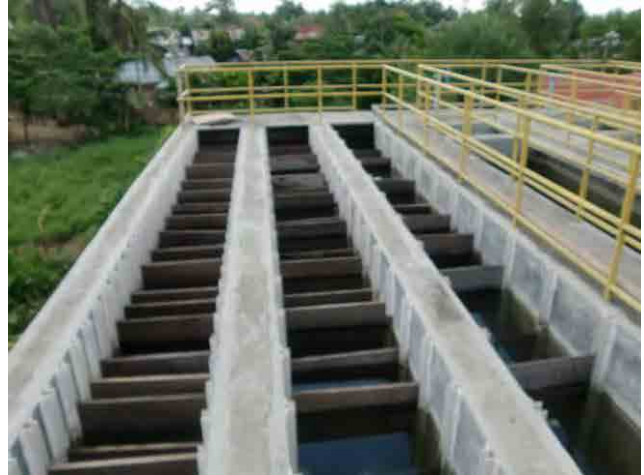
Hydraulic Flocculator: Adjustment of vertical baffles is required.

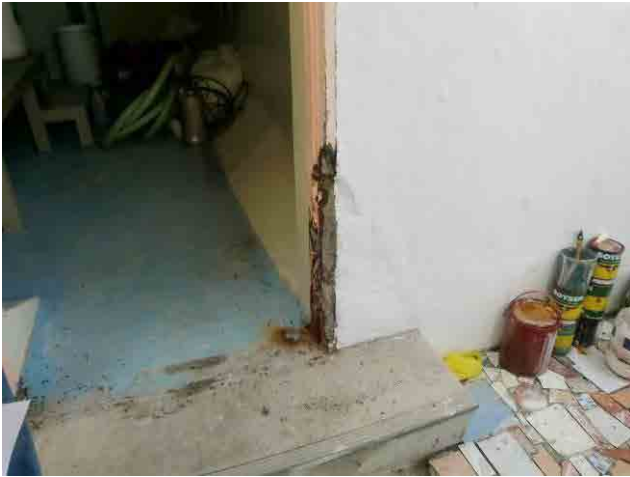
Chlorination room: The entrance door and its frame are corroded.

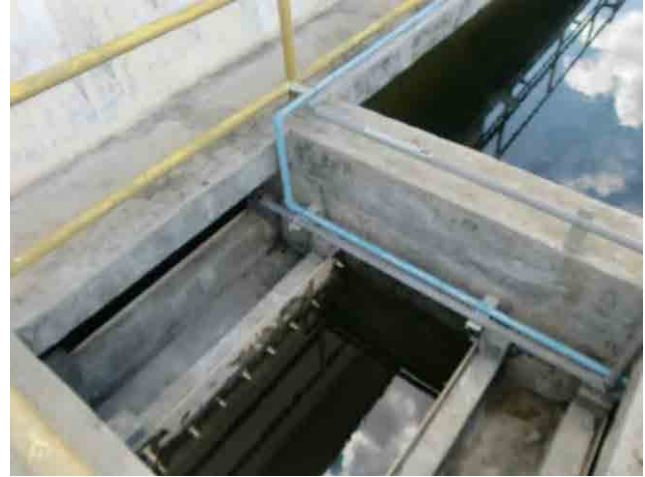
Intermediate chlorination, injection pipe: Chlorine injection at 4 injection points is not even.

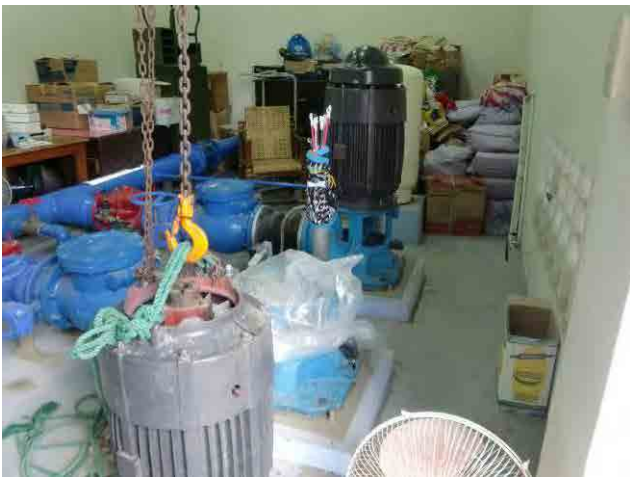
Distribution pumps: Not in use due to breakdown. Pump No.1 has a broken shaft. Pump No.2 has a problem with over-current; the motor has no problem, thus a problem in the pump is presumed.

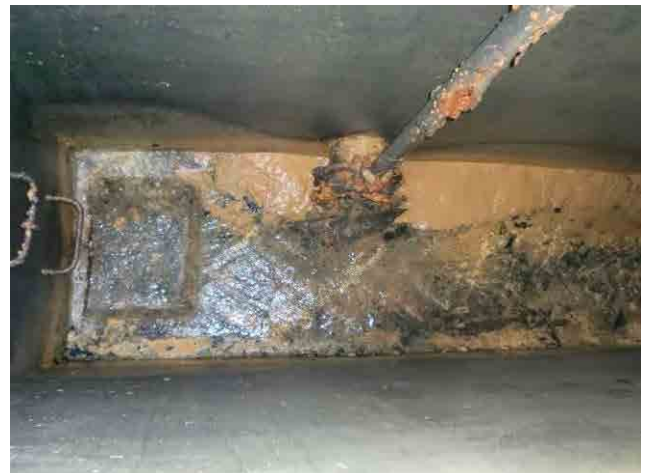
Sedimentation basin, inlet valve: Covered by lumps of rust due to corrosion.

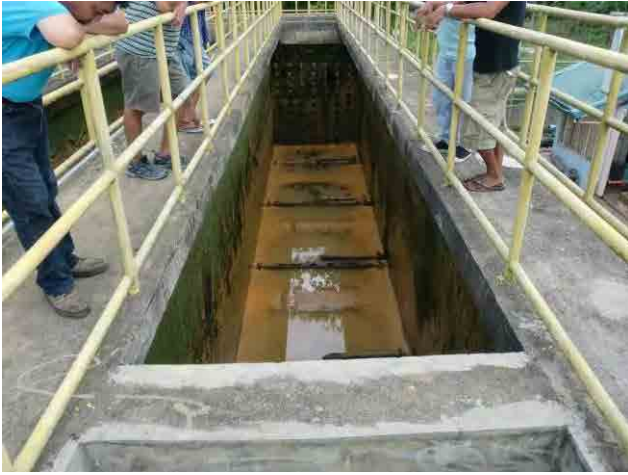
Sedimentation basin, sludge drain pipes: All pipes are corroded by high salinity of the raw water.

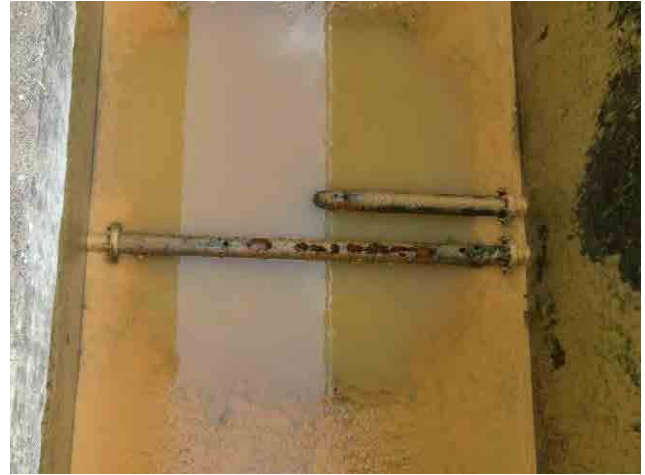
Sedimentation basin, sludge drain pipes: Corrosion makes holes on the pipe.

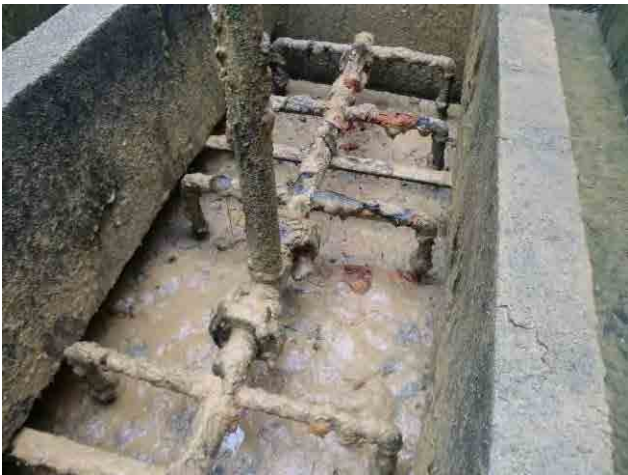
Rapid sand filter, surface-wash pipe: After drainage of water from the filter basin, settled flocs and sludge adhere to the surface-wash pipes.

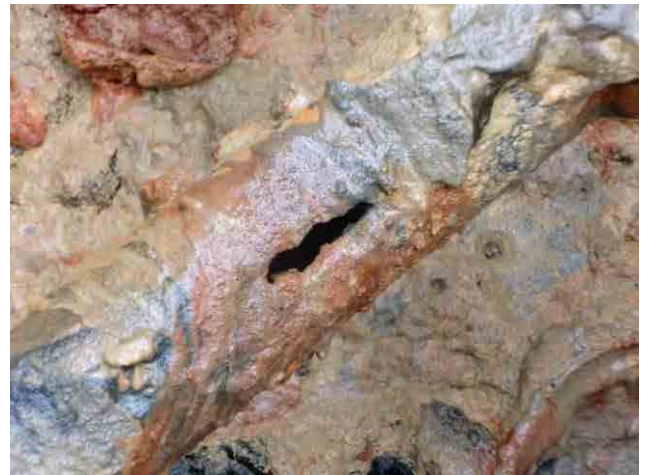
Rapid sand filter, surface-wash pipe: Contact with saline flocs caused corrosion, making holes on the surface-wash pipe.

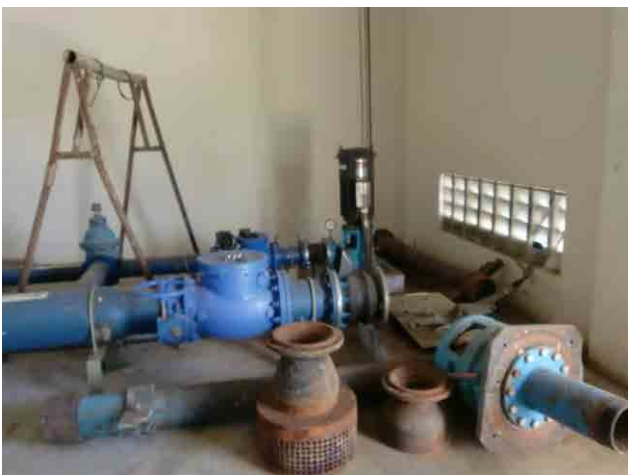
Backwash pump: It has been removed since Oct 2009 because of mechanical failures.

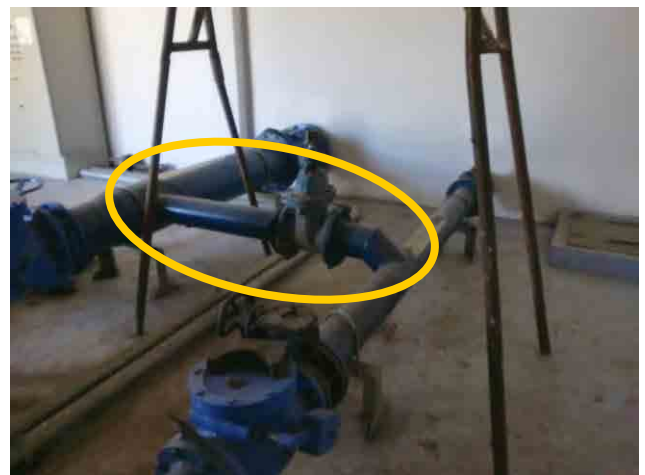
Backwash pipe: Bypass connection from the surface-wash pipe was installed as an emergency measure.

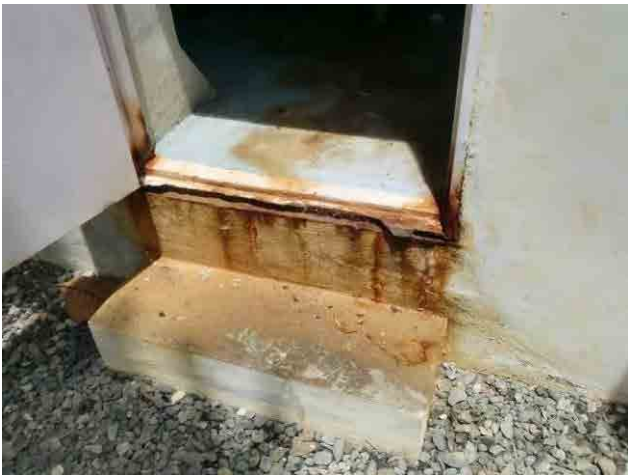
Chlorination room: The entrance door and its frame are corroded and decayed.

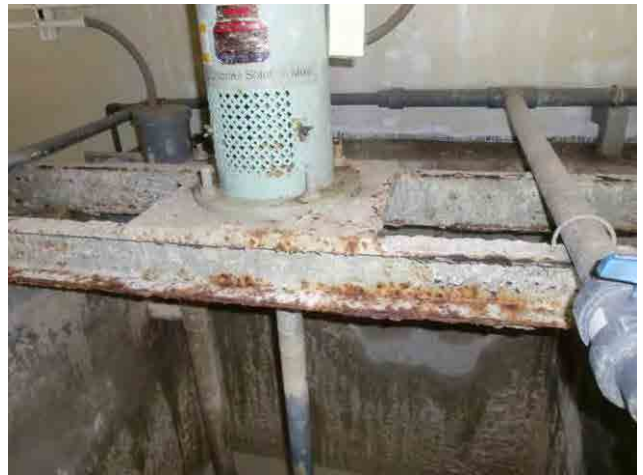
Chlorination agitator support: Covered by rust of corrosion.

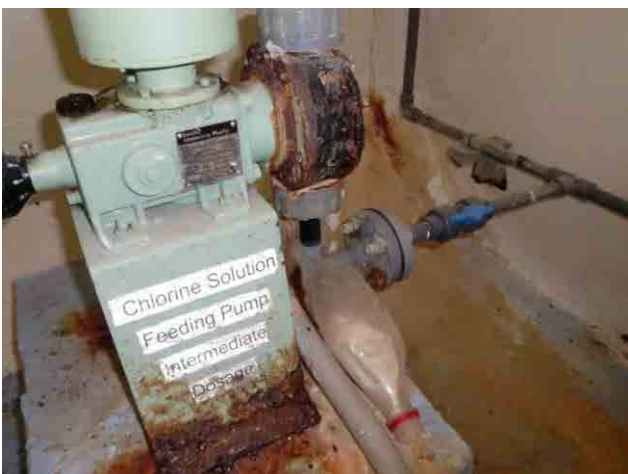
Pre/Intermediate chlorination, injection pump: Leakage from diaphragm of the pump.

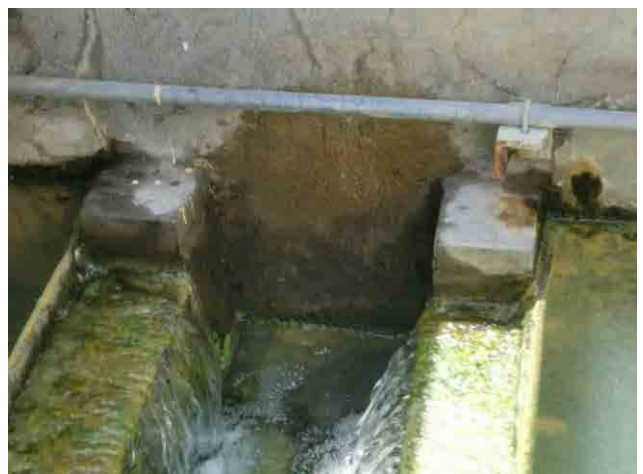
Intermediate chlorination, injection pipe: Chlorine injection at 4 injection points is not even.

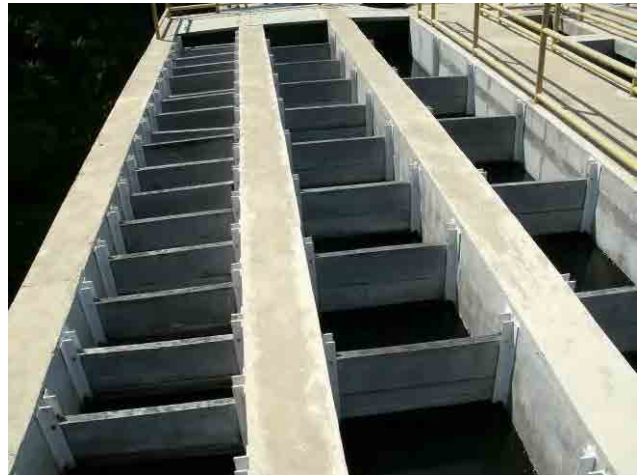
Flocculator: Some baffle plates fell off due to breakage of holding bolts by corrosion.

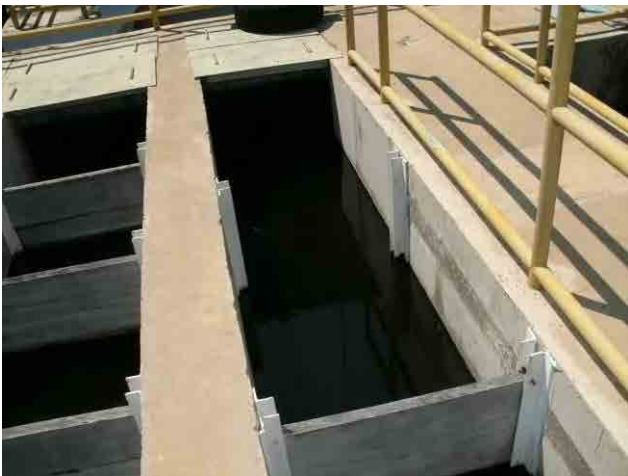
Flocculator: Last two lines of baffle plates were removed for cleaning.

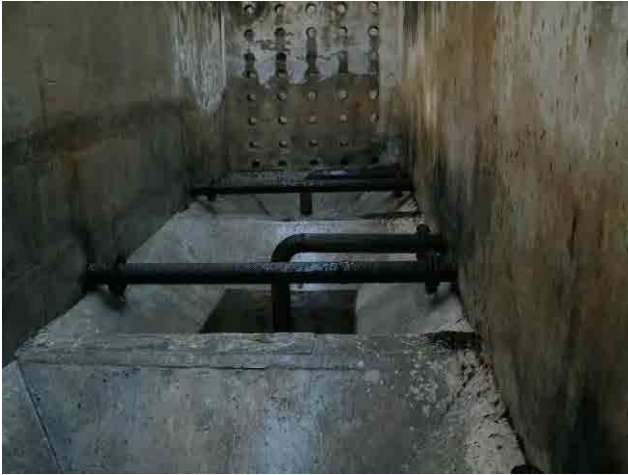
Sedimentation basin: Paint of sludge drain pipe peels off and some pipes are corroded.

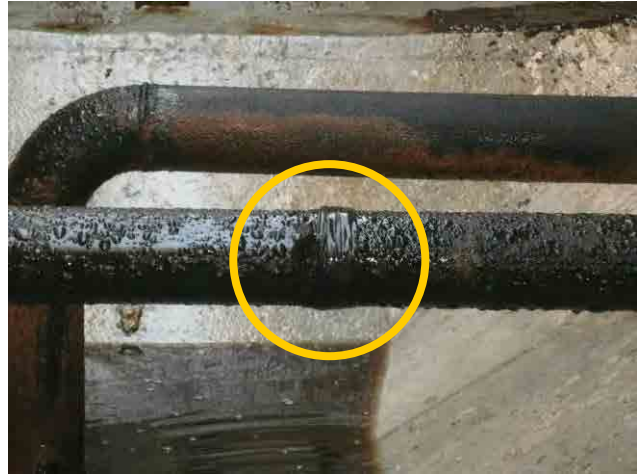
Sedimentation basin: Hole on the sludge drain pipe has been repaired with rubber sheet.

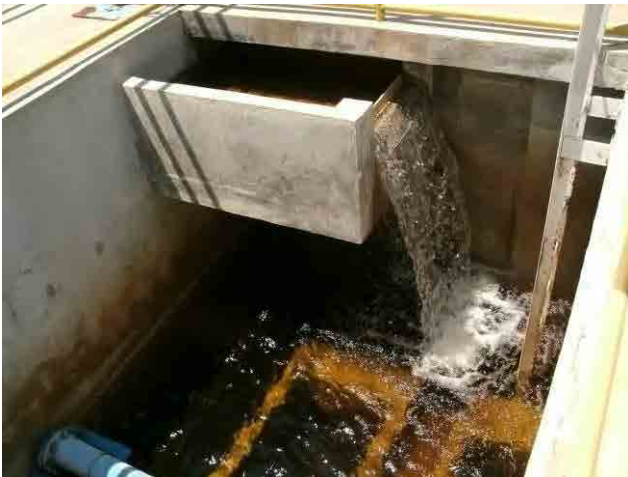
Rapid sand filter: Inlet structure needs to be modified to avoid small flocs breakdown.

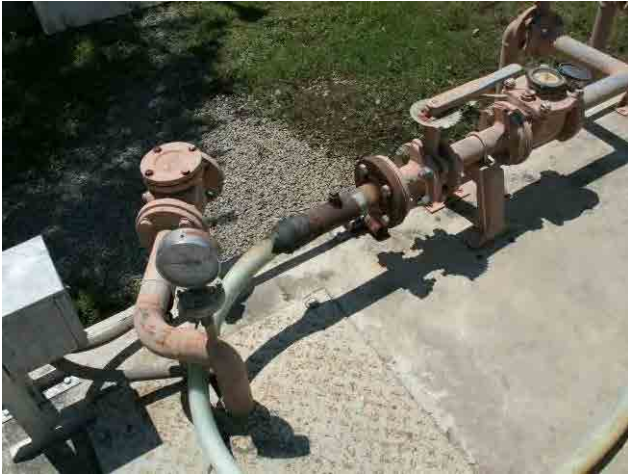
Drainage basin: Recycle pump has been replaced with a single phase pump and connected to existing pipe by WD.

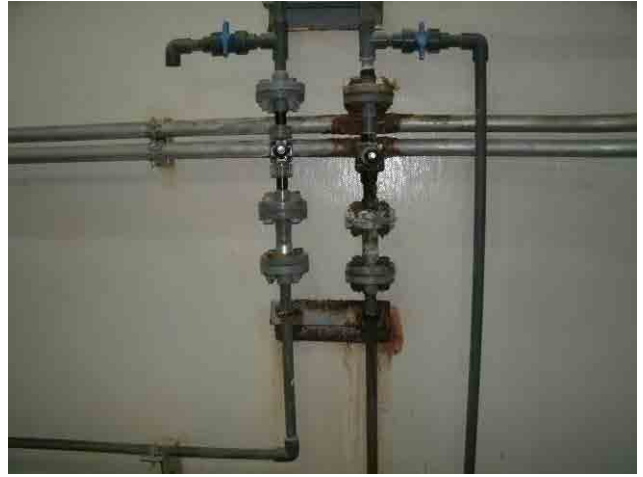
Pre/Intermediate chlorination pipe: Some parts are corroded.

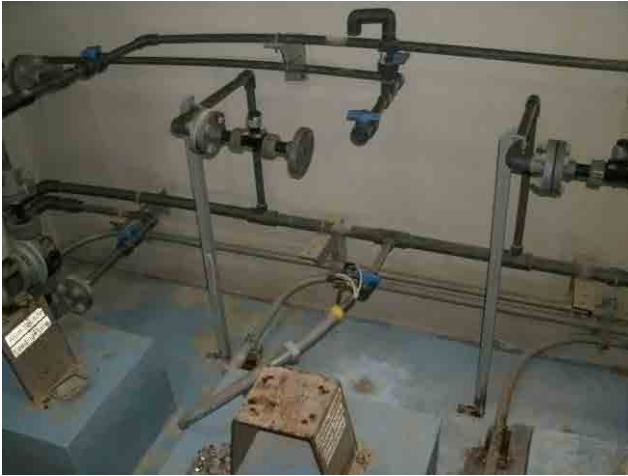
Post chlorination pump: It has been removed due to breakdown.

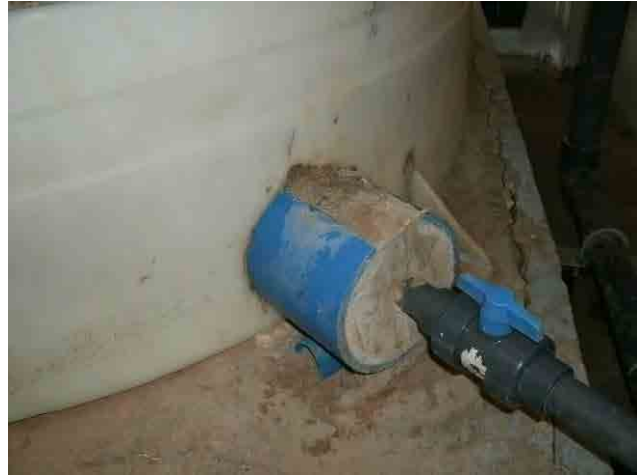
Chlorine tank: Leakage of chlorine solution has been repaired by WD.

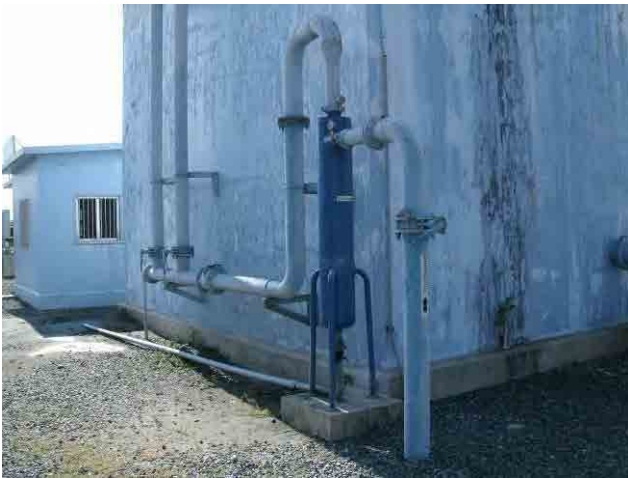
Sand separator: Sand raise is observed.

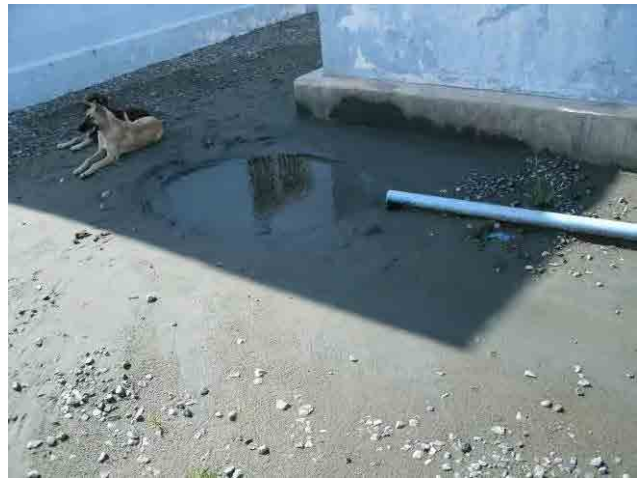
Sand separator: Sand is raised by pumping from the well.

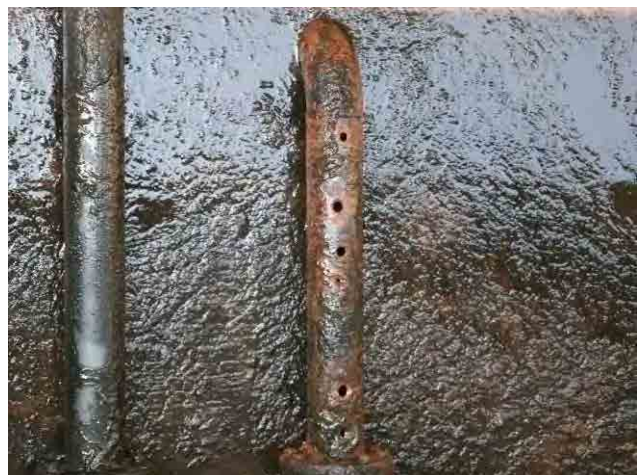
Sedimentation basin: Sludge drain pipe has holes due to corrosion.

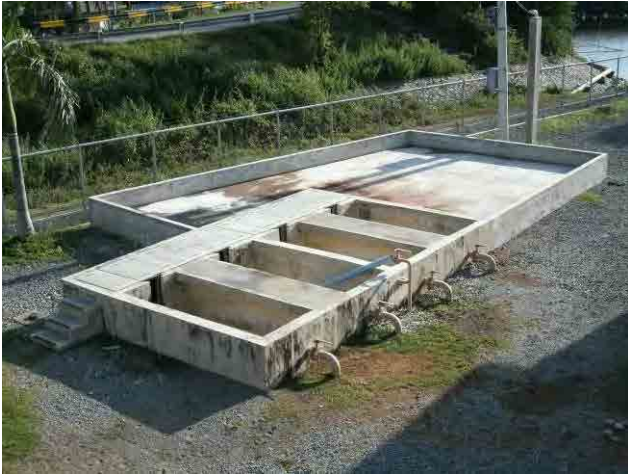
Sludge Drying bed: An additional sludge storage basin was constructed by WD to receive the excess sludge.

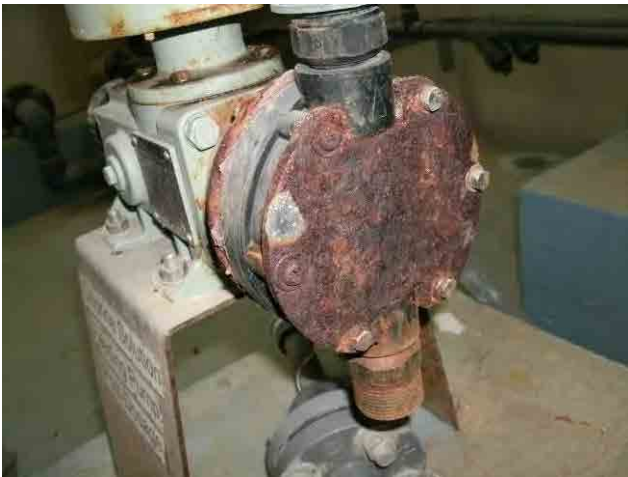
Post chlorination pump: Diaphragm part is malfunction due to corrosion. Post chlorination is missing.

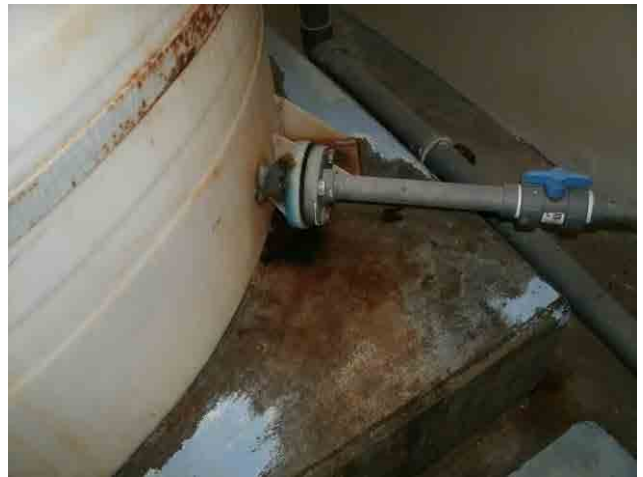
Chlorine tank: Leakage of chlorine solution at the pipe connection is observed.

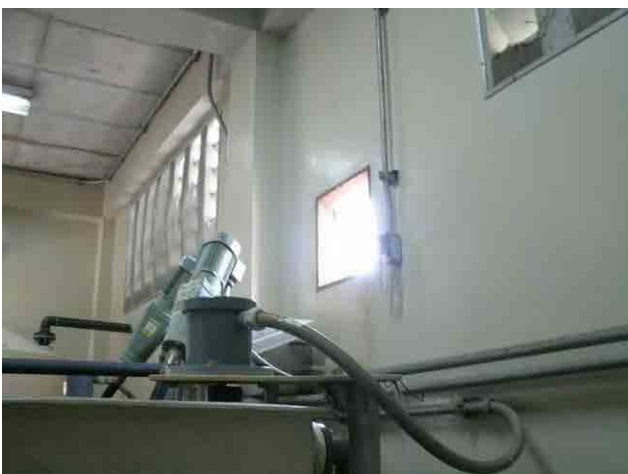
Chlorination room: Ventilation fan has been removed due to breakdown.

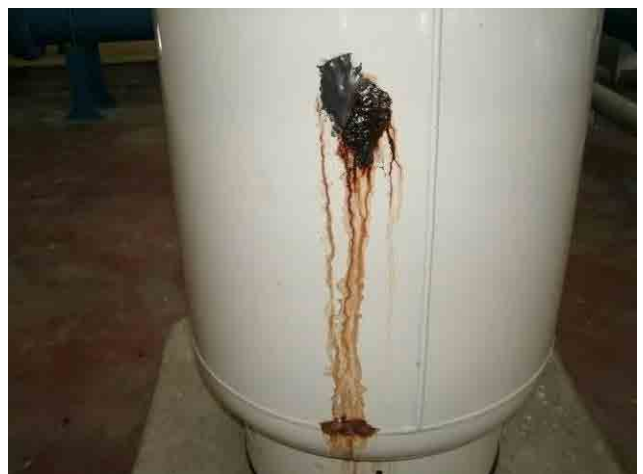
Pressure tank: The trace of leakage is found. It needs to be replaced.

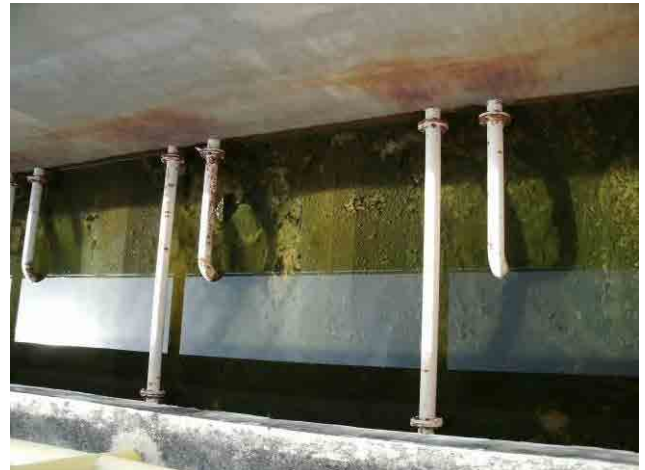
Sedimentation basin: Pipes need waterproof painting due to rust.

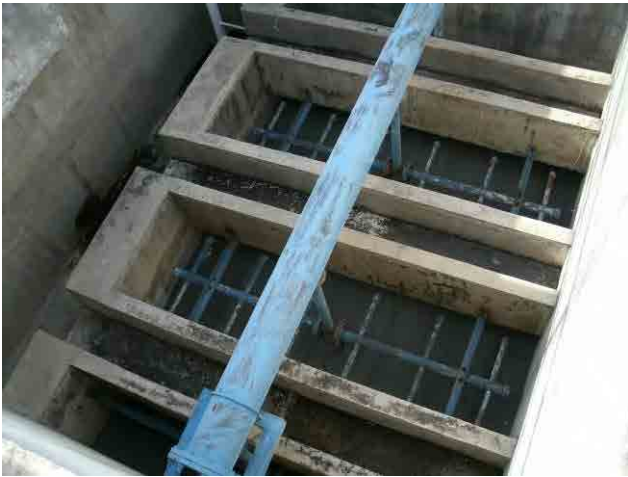
Rapid sand filter: Surface wash pipe needs to be repaired due to rust.

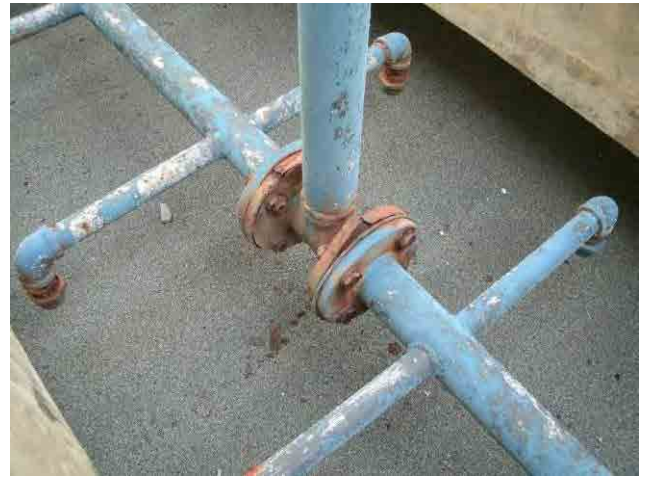
Rapid sand filter: Surface wash pipe needs to be repaired due to rust.

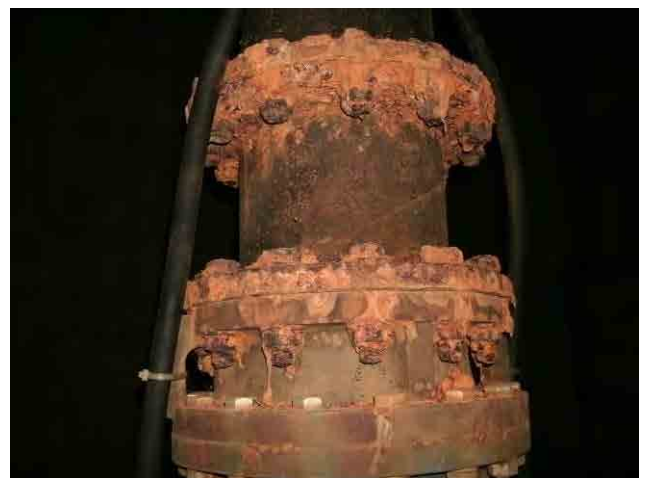
Back wash pump: Rusting but no problem for operation.

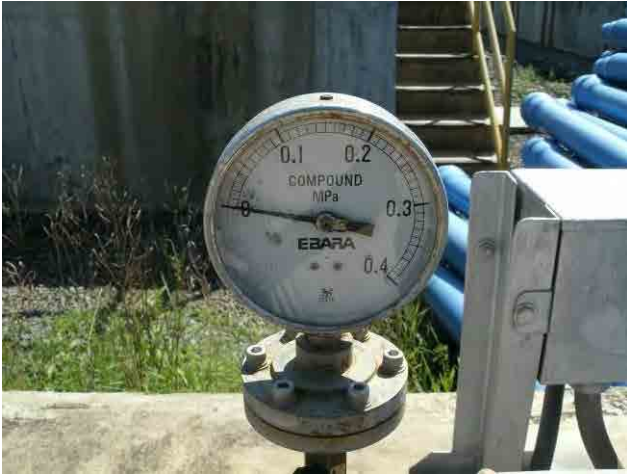
Pressure gauge for Recycle pump: Pressure gauge is broken.

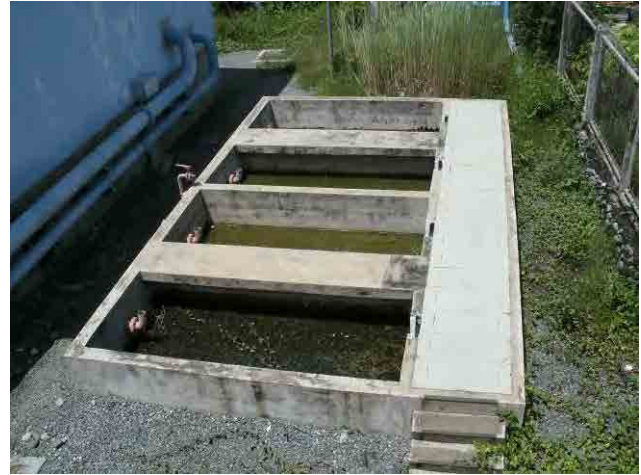
Sludge drying bed: Gravel has been filled but it is not used.

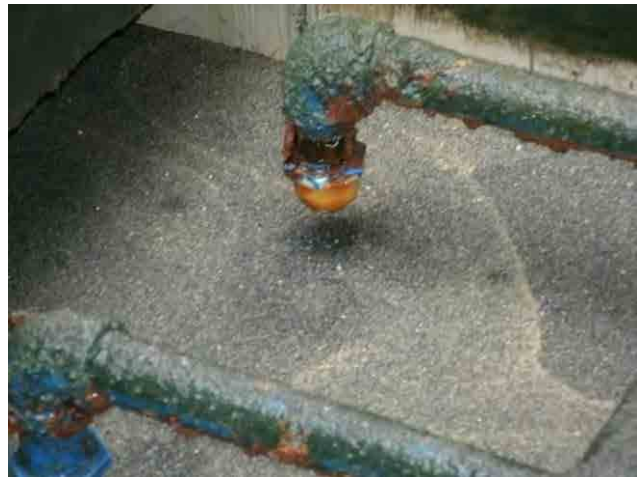
Rapid sand filter: Surface-wash pipes are corroded thus need to be repaired.

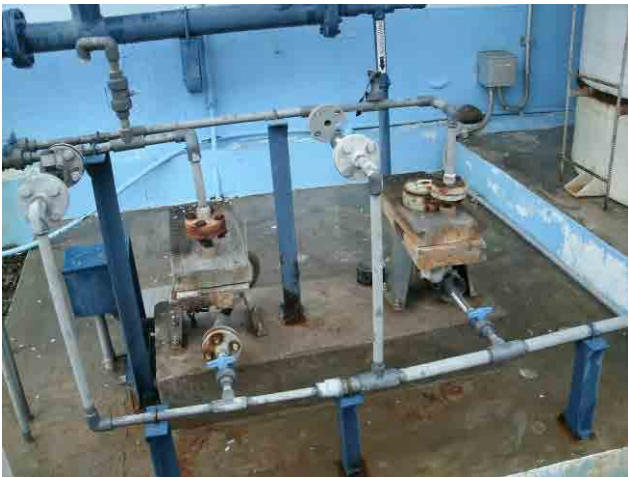
Chlorination pump: Pumps were removed because of corrosion.
