**DATA COLLECTION SURVEY  
ON  
ROAD FRAGILITY  
IN  
TIMOR-LESTE**

**FINAL REPORT**

**AUGUST 2013**

**JAPAN INTERNATIONAL COOPERATION AGENCY  
INGEROSEC CORPORATION**

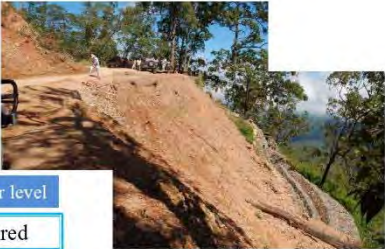
Embankment collapsed due to water, High Groundwater level

Countermeasures are required

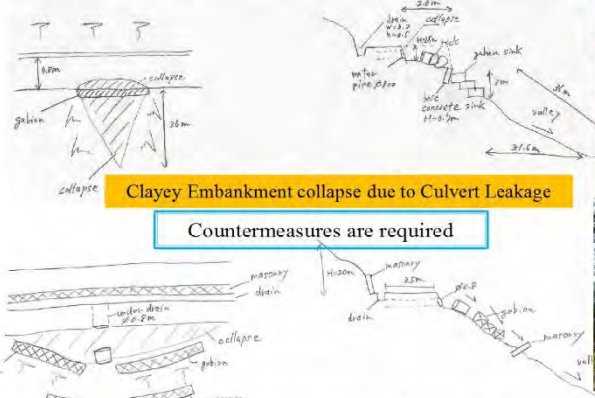
Clayey Embankment collapse due to Culvert Leakage

Countermeasures are required

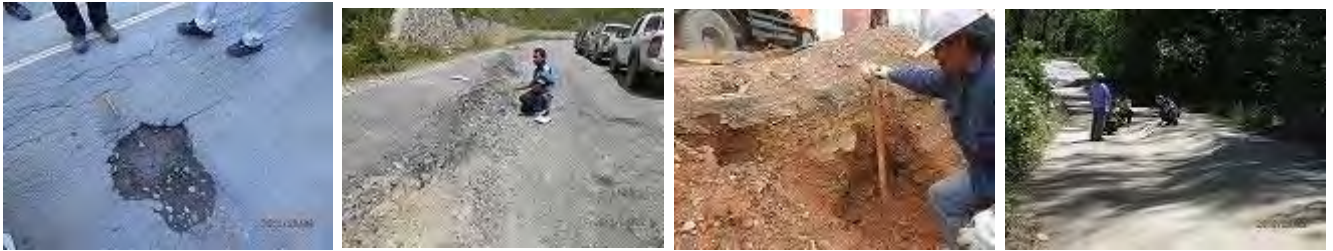
**Photo 2.7 Examples of damage to the pavement in the section of Route A02  
between 0 km and 79 km**

base course caused by water penetration or the volume of traffic load in some places. However, despite repair work to damage including potholes with rehabilitation in 2005, degradation of the road over several years since independence in 2002 is a serious matter with cracks and potholes in the pavement, deformity of the road surface and exemplary base course erosion by natural subgrade found in many locations. Consequently, large numbers of road repair works are urgently required. (See Photo 2.7.)

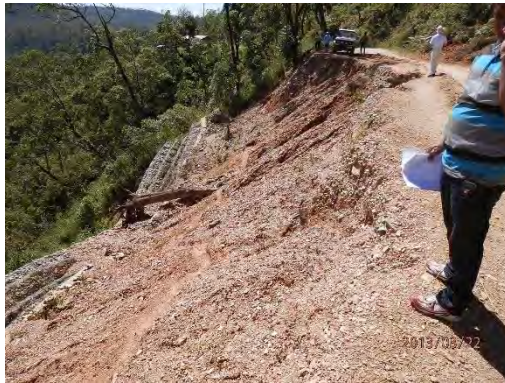
**Photo 2.8 Condition at 27.7 km**

The soil at the site, which mainly consists of weathered schist, is characterized by extreme fragility due to infiltration of water. Because the roadside slope at the site is long and steep, the deep-seated collapse that occurred in the slope on the mountain side spread to the slope on the valley side. As a result, a large-scale collapsed slope was created. The collapsed gabions remain on the valley side of the road (Photo 2.8).

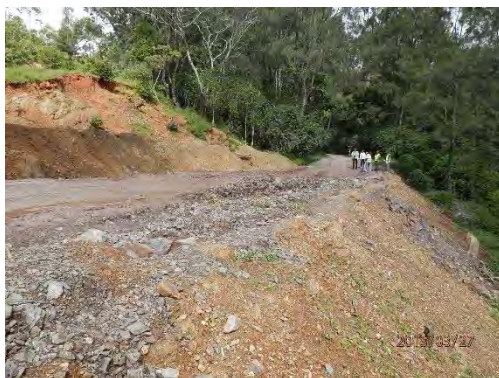
**Photo 2.10 Condition at 68.3 km**

As the deep gully-shaped drain in the upper part of the cut slope on the mountain side is not adequate enough to control the water flow at the end, concentrated runoff of rainwater occurred at this slope. The concentrated runoff caused shallow collapse of the slope. In addition, because of the lack of drainage facilities, water flowed over the road surface. The overflow of water caused the collapse of the embankment slope on the valley side because it had weakened the road surface (Photo 2.10).

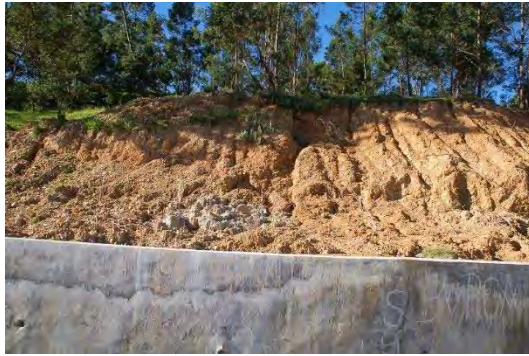
**Photo 2.11 Condition at 81.4 km point**

soil mixed with gravel. Shallow collapse likely occurred in the slope with the progress of gully erosion of the surface (Photo 2.11). The lack of facilities to control the flow of drain water on the valley side at the end of the drainage system, which consists of drains on the mountain side and cross culverts under the road, led to gully erosion of the embankment slope on the valley side (Photo 2.12).

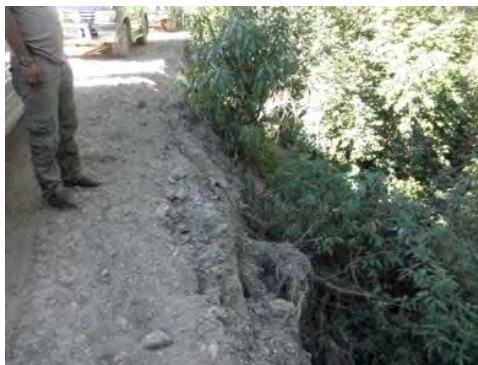
**Photo 2.13 Condition at 83.1 km point**

Collapse of the slope was observed at the road edge on the valley side where rainwater from the slope on the mountain side and water on the road were drained. This concentrated flow of water is assumed to have caused the collapse of the slope on the valley side. Lack of water drainage control was the cause of the collapse (Photo 2.13).

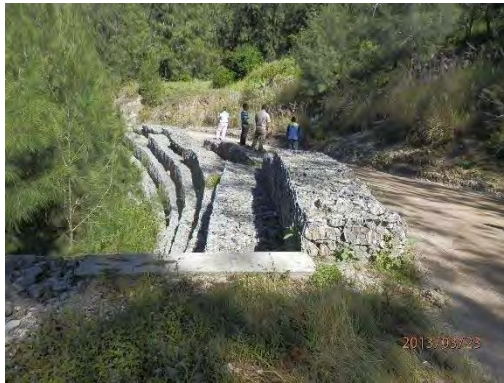
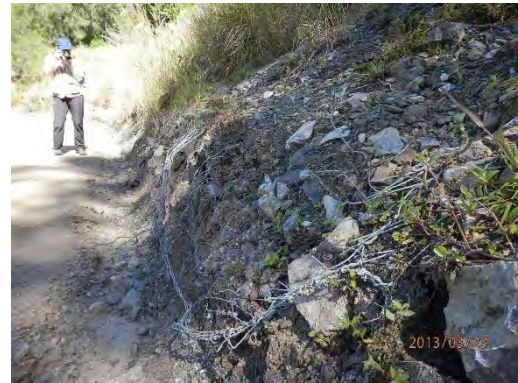
The occurrence of a landslide was confirmed at the site. It occurred approximately 100 meters along the road and approximately 250 meters along the slope. No damage has occurred for the time being. There are cracks in the surface layer in several places on the upper part of the slope. A small stream has developed due to gully erosion in the central part of the slope and surface water has been observed in the stream. The slope is composed of generally clayey soil mixed with gravel. It is thought that groundwater and rainwater that infiltrated the ground created a slip surface. Discharge of groundwater is observed at the base of the road slope edge. Boulders are derived from the collapsed gabion (Photo 2.16). The slope on the valley side is reinforced with multiple layers of gabions (Photo 2.15). Planting of the slope on the mountain side has stopped the erosion.

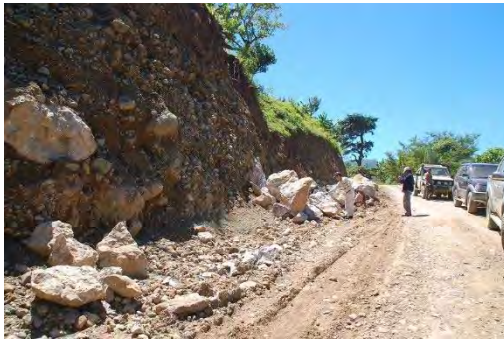
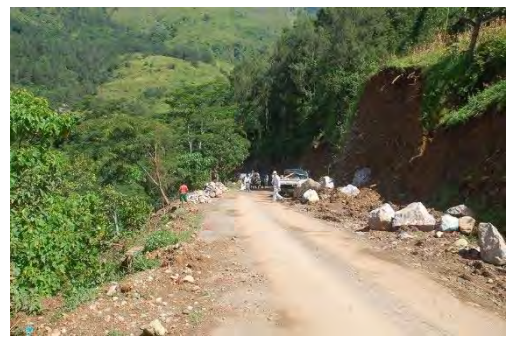
The upper fluvial terrace was observed at the 103.6km point. The upper part of the terrace riser contains boulders with a grain size of 20cm to 30cm and the lower part also contains pieces of limestone with a diameter of 100cm or larger (Photo 2.17). A large volume of water flows from the top of the slope. If the water flow cannot be controlled, it will make the road surface unstable. There is fear of a weakened terrace riser and slope on the valley side (Photo 2.18).

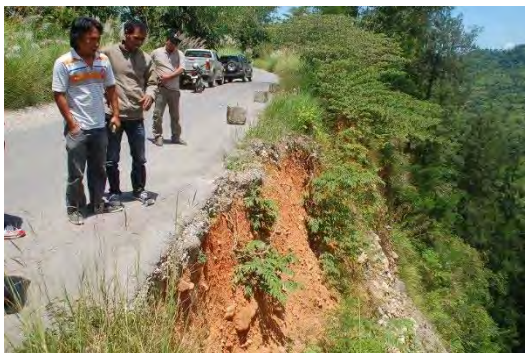
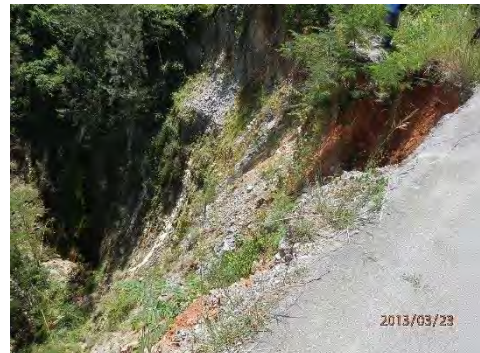
An almost vertical collapsed surface has appeared at the road edge in the fluvial terrace riser (Photo 2.19). The collapse is quite deep and reaches the top of the lower fluvial terrace approximately 100m below (Photo 2.20). It is a naturally created collapse. Nevertheless, as the prevention of collapse will require no load or no vibration of the road surface in the upper terrace surface, re-routing of the road is a possible option.

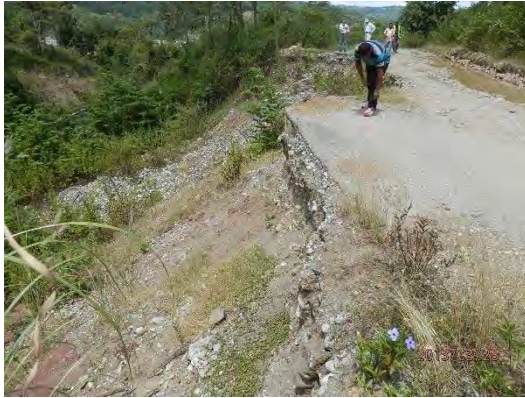
**Photo 2.21 Condition at 125.4 km point**

Collapse of the river revetment is observed at this site (Photo 2.21). A rise in the water level in the hinterland caused by infiltration of water overflowing from the river on the upper side through potholes in the pavement is considered to be a more likely cause of the collapse of the revetment than a rise in the water level in the river on the lower side.

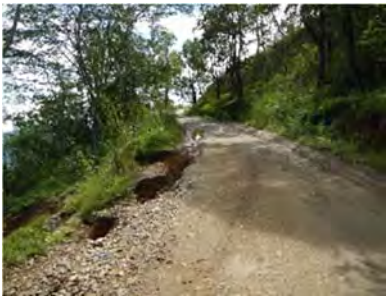
<p>Embankment Collapse due to Culvert Leakage</p>

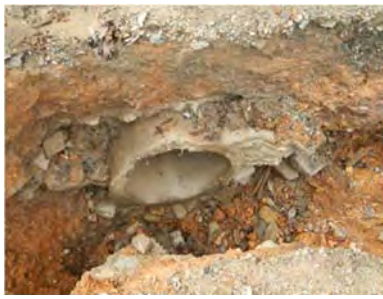
<p>Clayey Embankment Collapse due to Water</p>

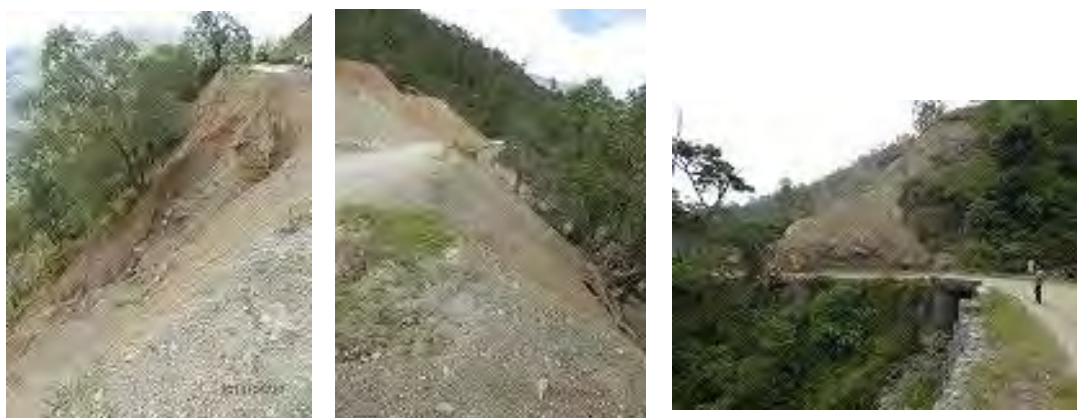
The pavement of these sections has been completely damaged and the road has turned into road sand. (See Photo 3.9.)

**Photo 3.9 Large-scale collapse and pavement condition of Route A05**

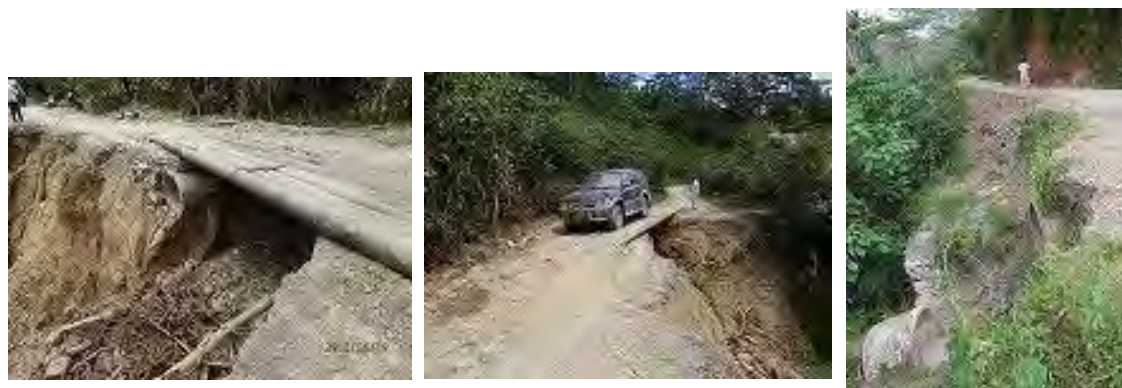
The pavement of Route A10, which passes through the mountains in the west and links Ermera on Route A04 with Lorba on Route A12, is significantly damaged and the IRI for almost the entire route except some sections is 11 or higher. As this route runs through steep mountains, it is difficult to develop a detour, so in this case, it is essential to develop or maintain the existing road. In addition, a chain of private houses exists along the route and the residents are actively engaged in farming, so it is essential to ensure the transport of daily commodities by land using the road. Repair of the damaged sections is particularly necessary for the reasons described above. Regarding the sections affected by damaged embankment caused by culvert failure as described below (the natural subgrade was swept away due to water leaking from the joints caused by inadequate coverage of backfilling soil materials and lack of concrete protection of the culvert joints), the natural subgrade and pavement should be repaired as soon as possible not only on Route A10 but also on other routes and countermeasures taken. (See Photo 3.10)

**Photo 3.10 Road swept away due to culvert failure  
and pavement condition of Route A10**

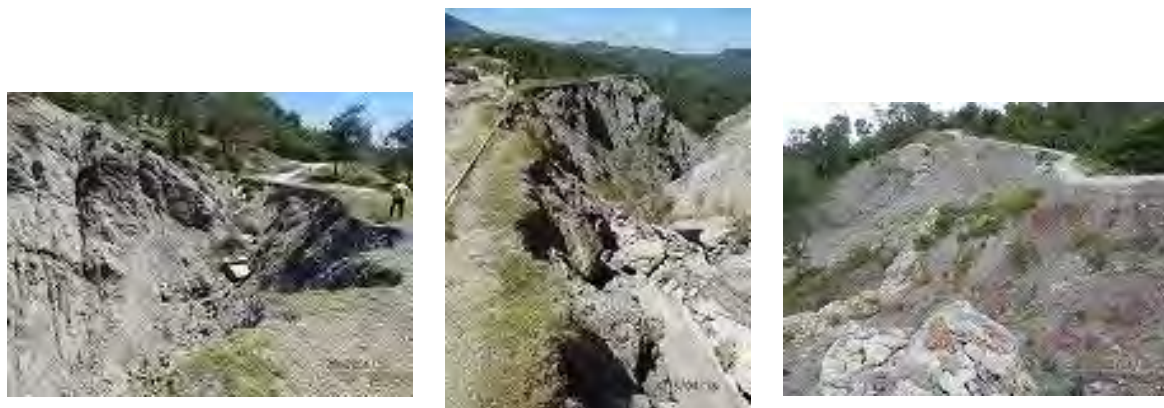
Because of the scale of the collapse, extensive natural measures are required to protect the improved section. However, since the traffic volume on this route is small, it is difficult to justify the cost of extensive repairs. In addition, it may be appropriate to consider countermeasures to detour or bypass the section for improvement

**Photo 3.11 Large-scale collapse and pavement condition of Route A12**
