**IMPLEMENTATION REVIEW STUDY REPORT  
ON  
THE PROJECT FOR THE REHABILITATION OF  
THE EAST DEMERARA WATER  
CONSERVANCY( II )  
IN  
THE REPUBLIC OF GUYANA**

**October 2013**

**JAPAN INTERNATIONAL COOPERATION AGENCY**

**SANYU CONSULTANTS INC.**

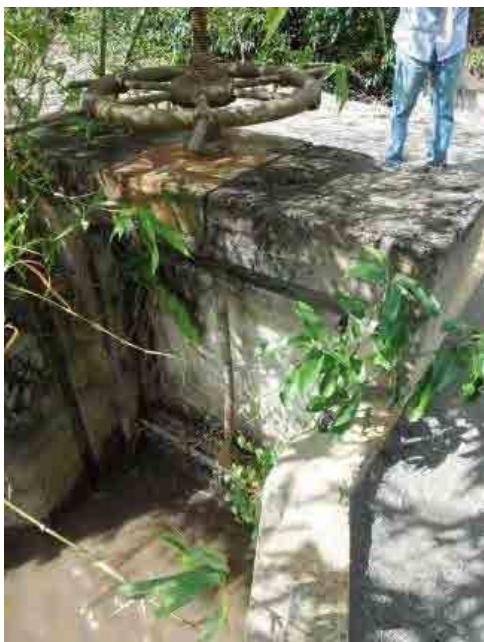
Part	Conditions
Main body	A bent on the gate spindle (PH 2-1-1)
Wooden pile revetment	Almost normal except the left side of the inlet mouth (The disordered row of piles does not mean necessarily the aging condition because of the piles being not driven straight into the hard ground.) (PH 2-1-2)
Surrounding embankment	A step caused by a land slide extends on the upstream side embankment crest. (PH 2-1-4)
Operation	The gate has been out of use for the last 3 years. Leakage water through the opening and the foundation - an old pipe left in the foundation - has been used as irrigation water. (PH 2-1-3)

PH 2-1-1 Bent of the spindle

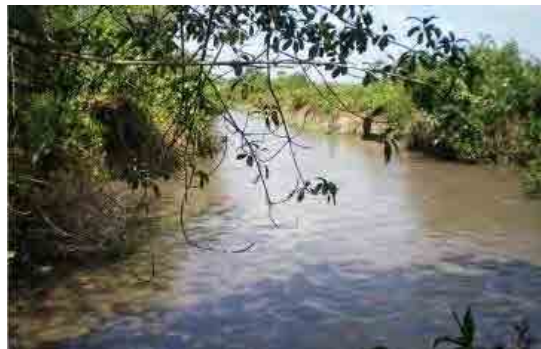
PH 2-1-3 Canal flow maintained by leakage water

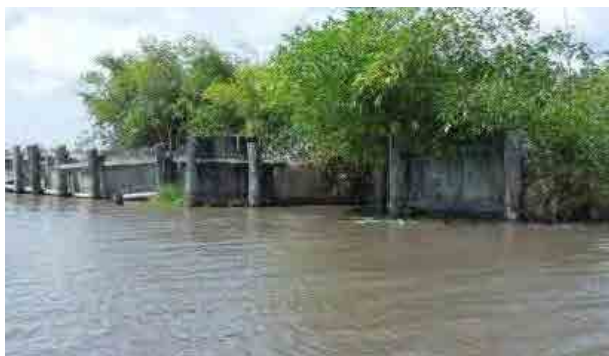
PH 2-1-2 Revetments at the inlet mouth

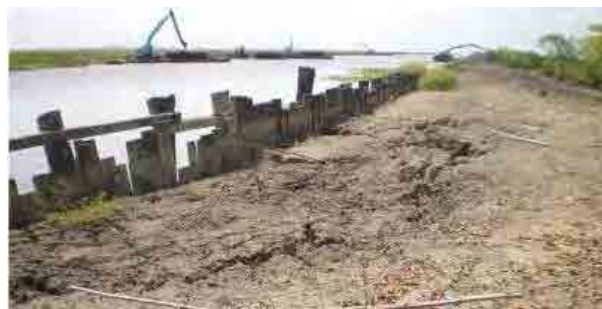
PH 2-1-4 Step, cracks and inclined revetments

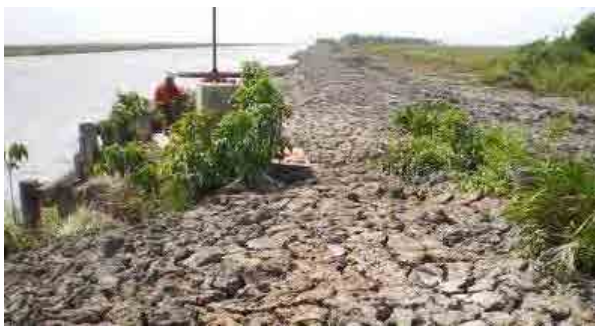
PH 2-1-5 Embankment crest and the spindle

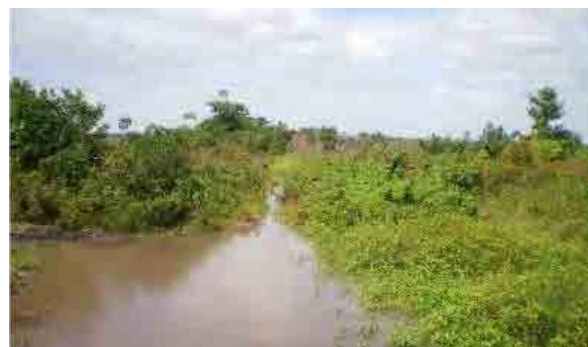
PH 2-1-9 Marshy condition, and the canal

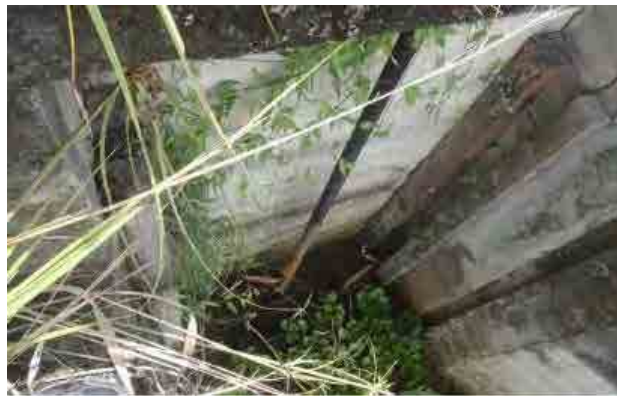
PH2-1-10 Spindle attached to the gate

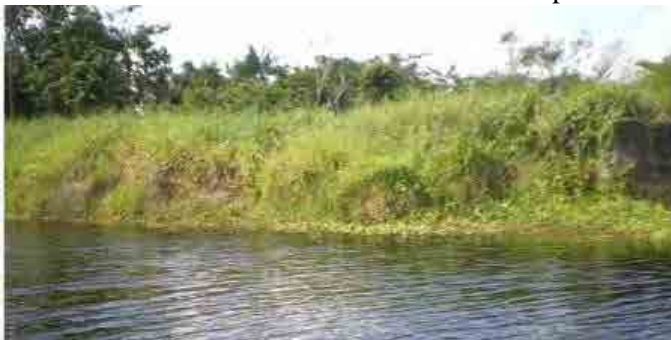
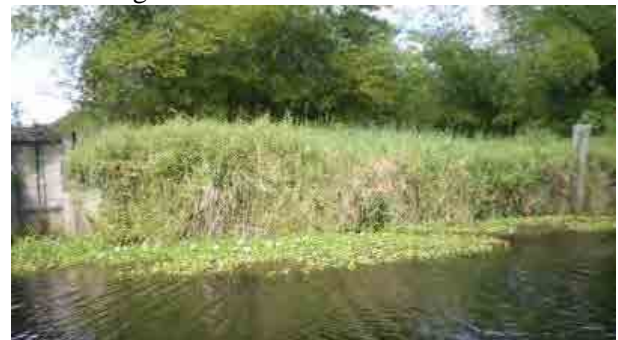
PH2-1-11 Condition at the upstream side

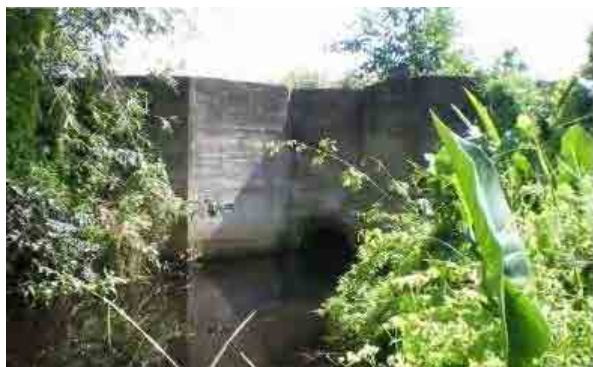
PH2-1-12 Retaining walls at the outlet

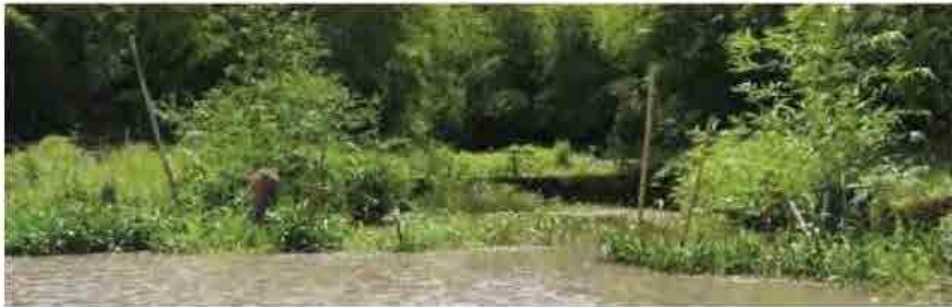
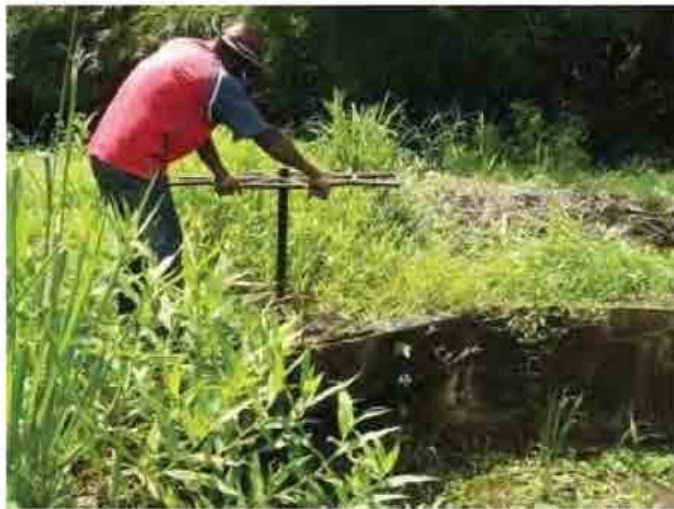
PH2-1-14 Gate operation and the retaining walls

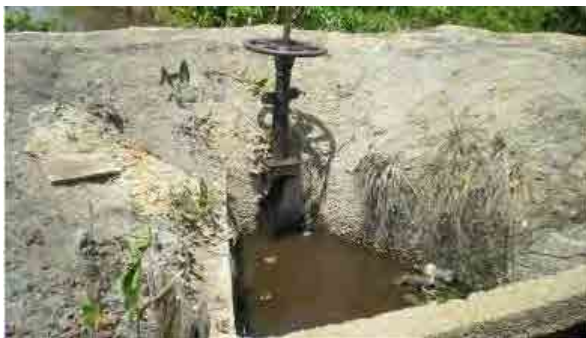
Part	Conditions
Main body	At present, functioning almost normally without problems, though there is a doubt in future operation due to the inclined spindle. (see PH 2-1-16)
Wooden pile revetment	Revetment works at the upstream side are rather irregular with having only temporary treatments (see PH 2-1-17). Disturbed condition is not seen in the downstream side revetment, but the range of revetment coverage is quite limited (see PH 2-1-19).
Surrounding embankment	Crest of the embankment has narrow width because it has been dwindled (see PH 2-1-18). At the right hand point of about 20m distant from the inlet, a terrace was formed as a result of sliding over the slope of upstream side (see PH 2-1-20).
Operation	The gate is operated by the staff of Flagstaff Office four times a year. This facility is the most important headwork in northern irrigation network, and downstream canal is of a large scale (see PH 2-1-21).

PH2-1-16 Gate functions without problems

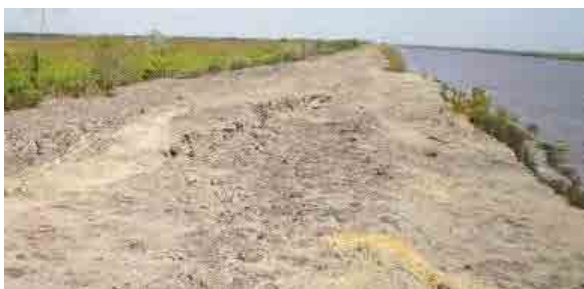
PH2-1-20 Steps caused by sliding

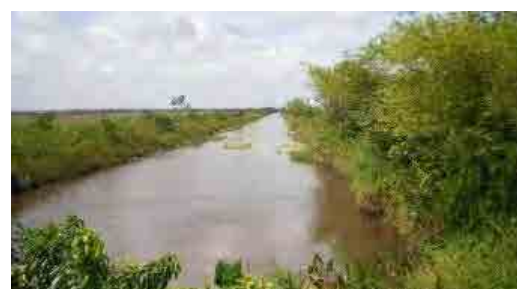
PH2-1-21 Wide canal extending downward

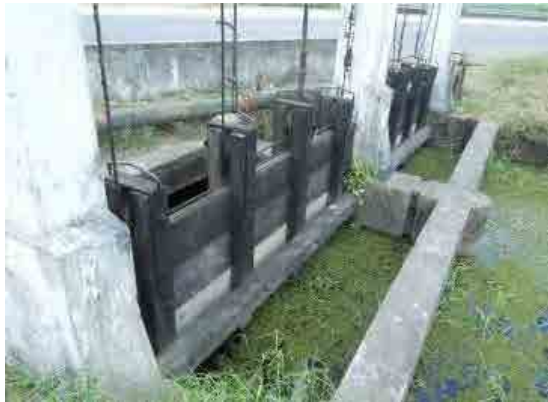
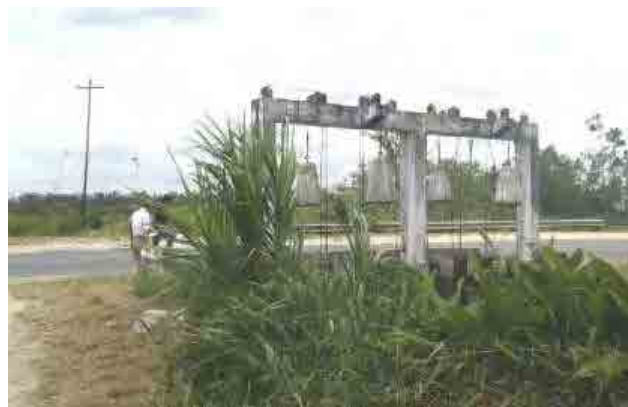
PH2-1-22 Culvert channels, gates and winch systems

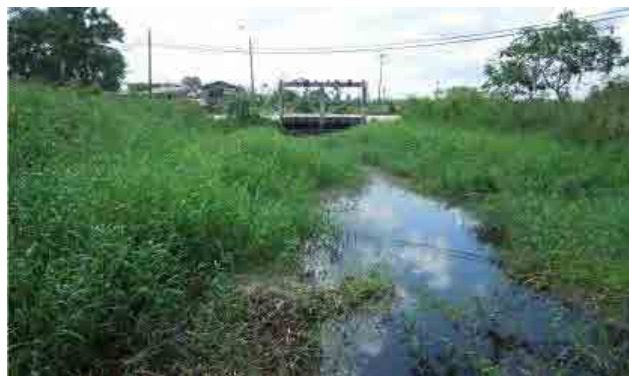
PH2-1-23 Canal condition at the upstream of the Johanna regulation gate

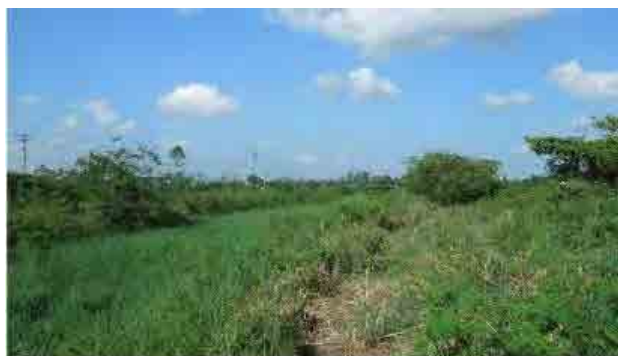
PH2-1-24 Connecting canal

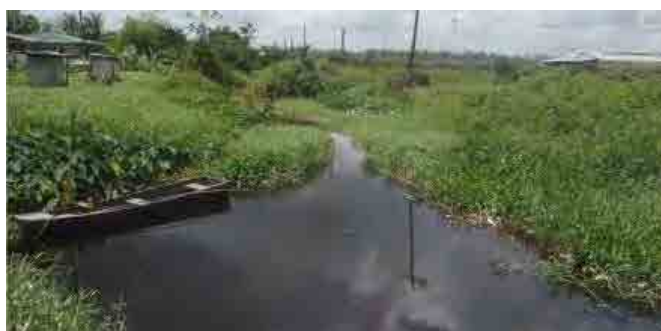
Downstream canal	Water weeds thrive in the canal, lowering flow capacity of the canal. Collapse etc is not seen on both banks of the canal (see PH 2-1-26).

PH2-1-26 Canal condition at the downstream of the regulation gate

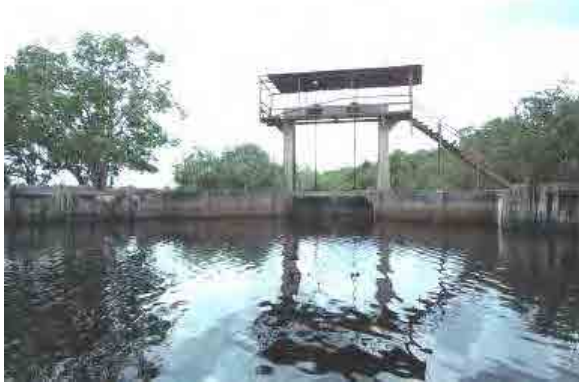
PH2-1-27 Gate and the retaining walls

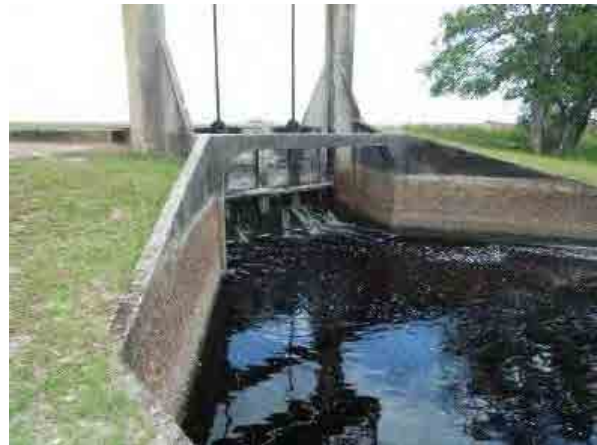
PH2-1-28 Leakage condition through the gate

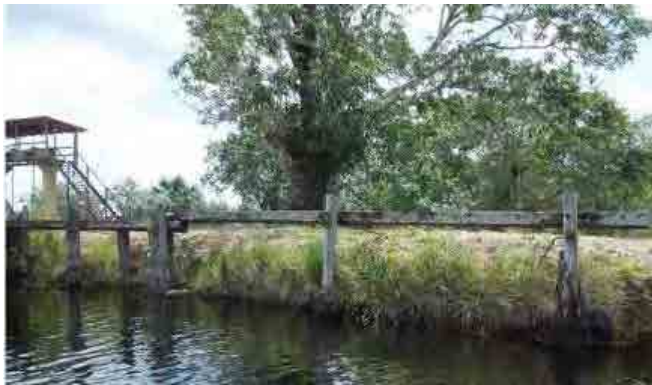
Field survey results indicate that wooden piles and sheet-piles have been rotten, while no abnormal conditions are observed on concrete walls. Hence, soil-cement is to be adopted for slope protection work taking durability/ economy into consideration.

PH21-29 Rotten wooden sheet piles and the self-standing embankment slope
