VOLUME 3

RESULTS OF EXISTING CONDITION  
SURVEY

## APPENDIX 3-B

# DETAILED RESULTS FOR FIRST SCREENING OF CANDIDATE BRIDGES

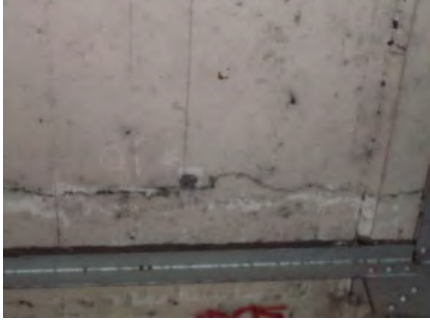
Most of cracks are less than width 0.3mm but several cracks are long and more than 1mm are observed.
	Water leaking

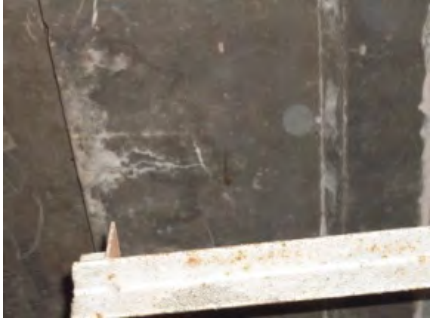
At several cracks portion or cold joints, water leaking is observed.
Steel Beam/ Truss Member (Bracings, etc.) (Primary)	Corrosion

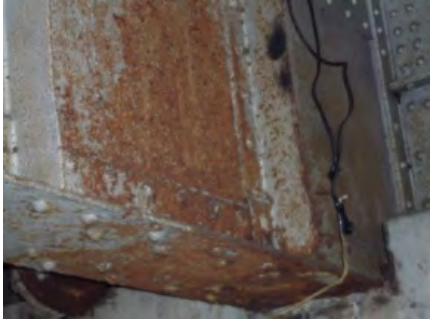
Corrosion is occurred at end girder portion.
	Paint Peel off

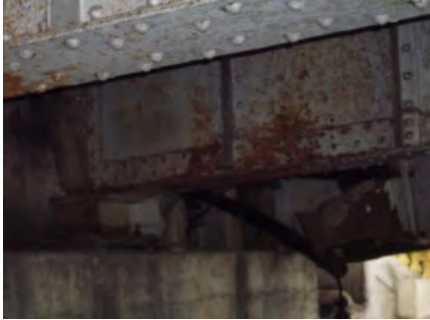
Paint peel off is entirely progressing on steel girders.

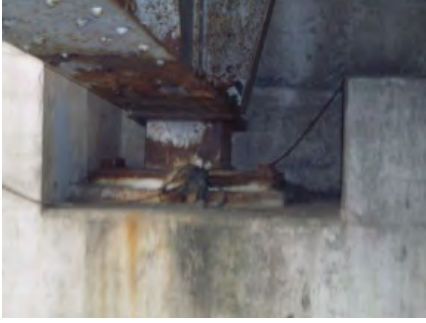
All steel bearings are considerably corroded.
Abutments	Cracking concrete

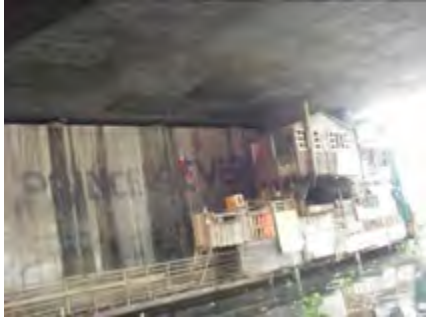
Many vertical clacks are observed.
Piers	Cracking concrete

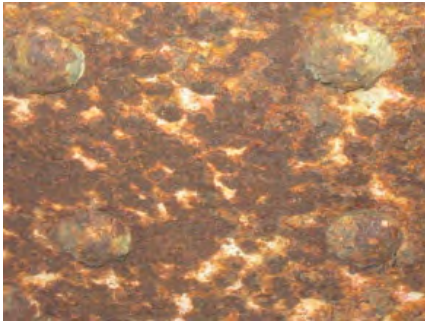
Corrosion on steel members is progressing, especially; Gusset plates and lower flanges are severely corroded.
	Deformation/B uckling

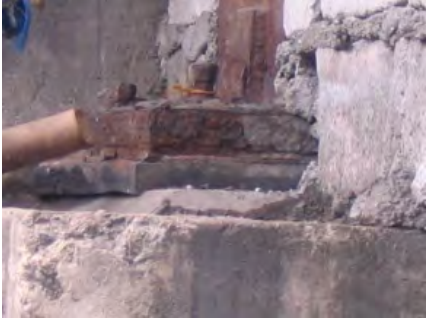
Steel bearings are severely corroded and stopped sliding function properly.
	Abnormal Displacement

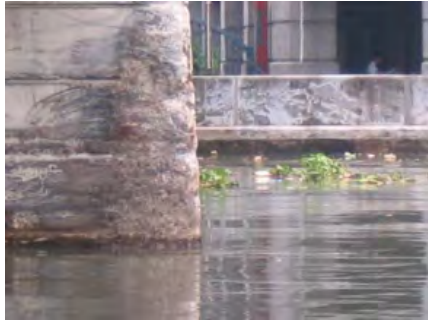
Scaling due to scratching by ship on the pier concrete surface is observed.
	Cracking concrete

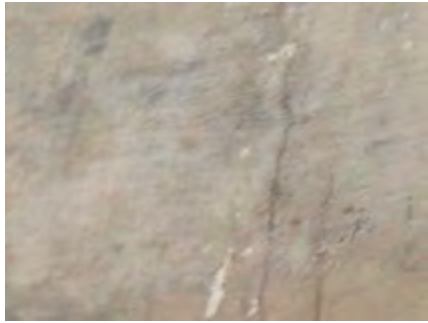
Many cracks with width less than 1mm are observed vertically.
	Exposure/Corrosion of Reinf.

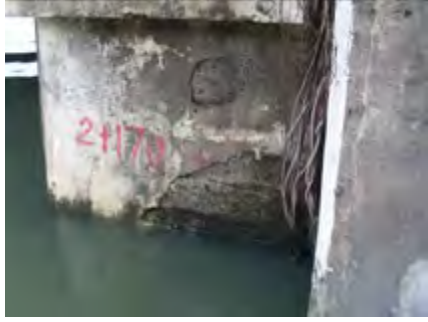
At some parts of spalling, Exposure/ Corrosion of Rebars is observed.
Expansion Joint (Primary)	Water leaking

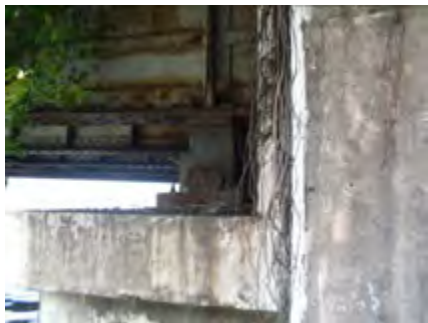
Water leaking is observed at expansion joints.

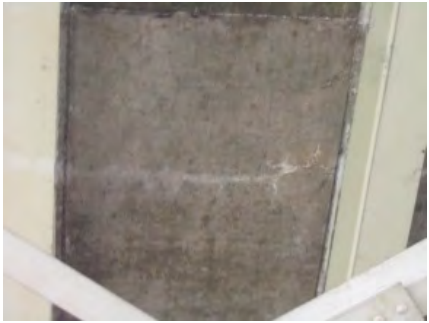
Deck slab on main bridge is quite good condition but some cracks are detected.
	Waterleaking

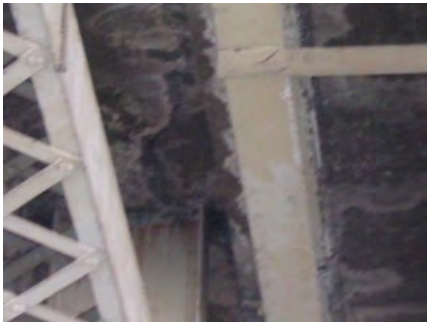
At end portion of deck slab, waterleaking is detected.
Concrete Beam/ Girder (Approach Bridge) (Primary)	Cracking

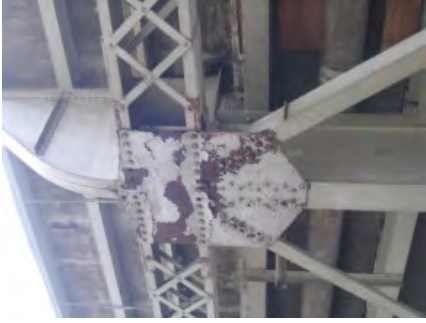
Gusset plate is deformed due to impact of bridge.
	Loose Connection

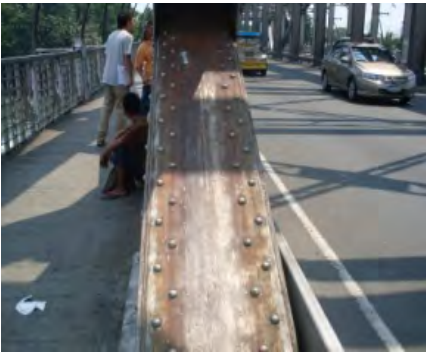
Paint peels off on some arch members are deserved.
Abutments	Cracking concrete

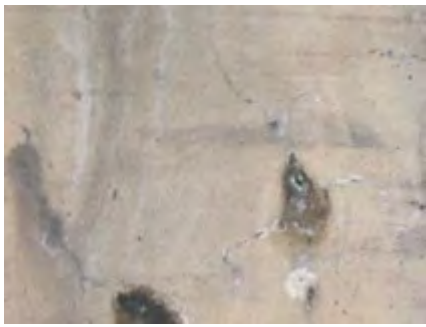
Several small spallings are observed on the deck slab.
	Water leaking

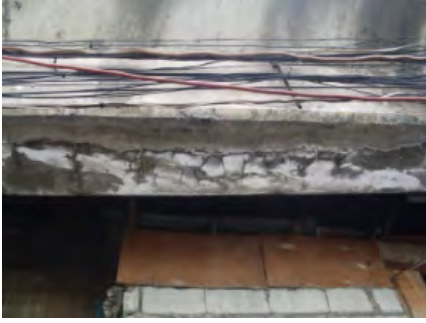
Some delaminations are observed at the bottom of girders.
Steel Beam/ Truss Member (Bracings, etc.) (Primary)	Corrosion

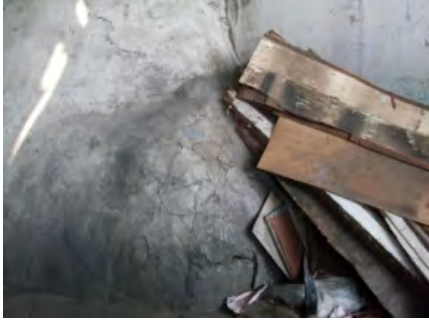
Many cracks are occurred on concrete facing slope.
Approach Road	Cracking

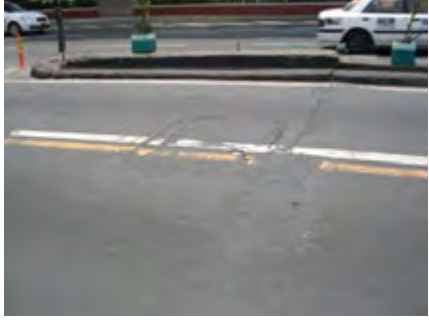
Many asphalt cracks are observed.
River Condition (Secondary)	Others

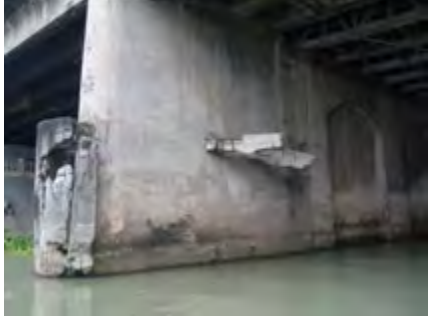
River course is slightly bent so ships are often hit pier body. Strong protects are necessary.

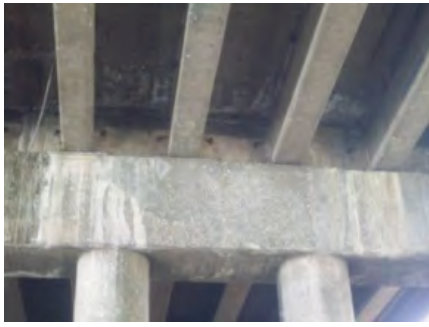
Cracks with water leaking are at end of slab but only one place.
Concrete Beam/ Girder (Primary)	Exposure/Corrosion of Rebars

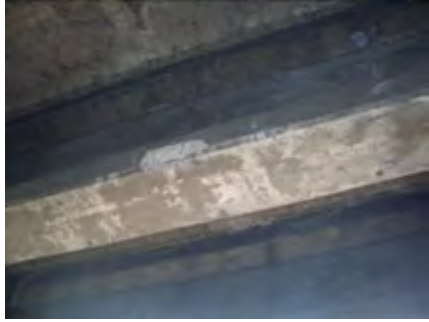
Several spalling are observed on girders.

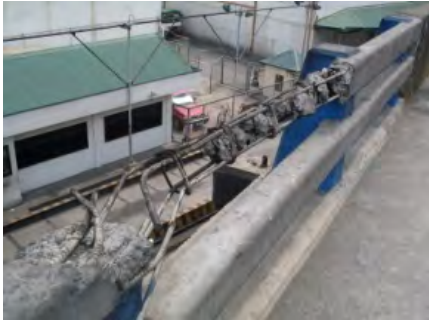
One hand railing is damaged due to impact of car.
Expansion Joint (Primary)	Water leaking

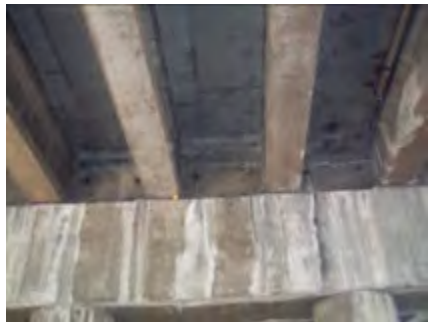
Water leaking from expansion joint is observed.
	Abnormal Space/Noise

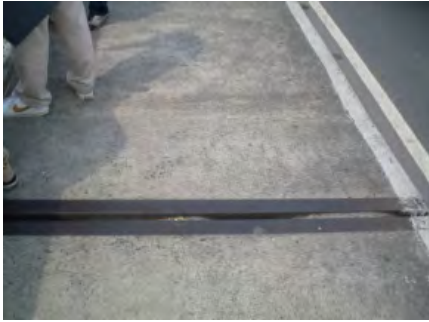
Abnormal space is occurred which should be covered.
	Displacement

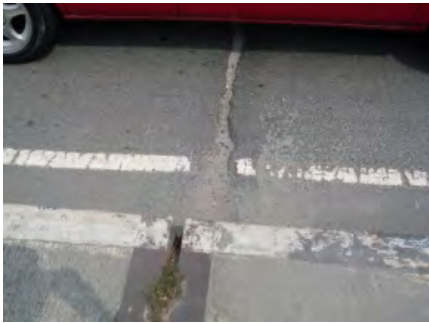
Covers of expansion joint are displaced. It is caused by water leaking.

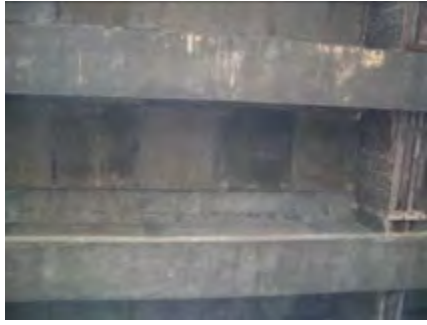
Small cracks are visible but deck slab is good condition.
	Scaling/Spalling

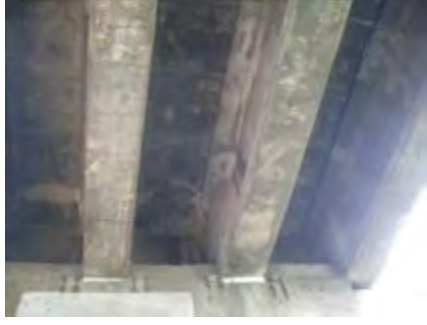
Small spillings are visible but deck slab is good condition.
Abutment	Cracking concrete

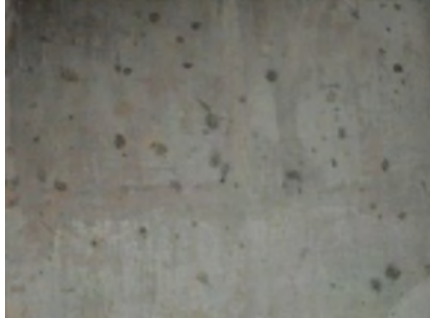
A few Cracks with width less than 0.3mm are observed
Pier	Cracking concrete

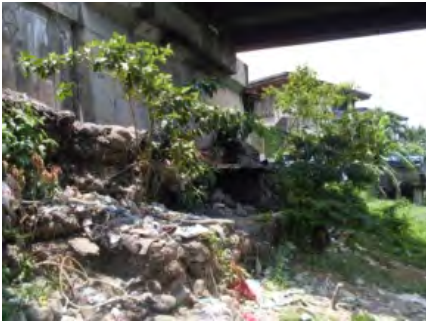
Slope protection is maintained properly but material losses are observed.
Approach Road	Settlement

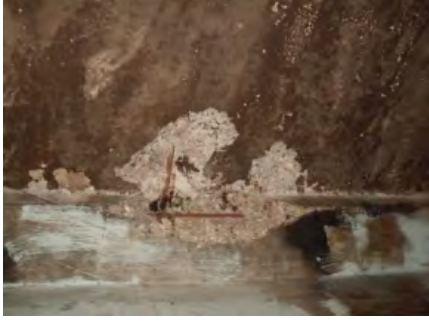
Exposure/Corrosion of Rebars is detected at the deep spallings.
	Delamination

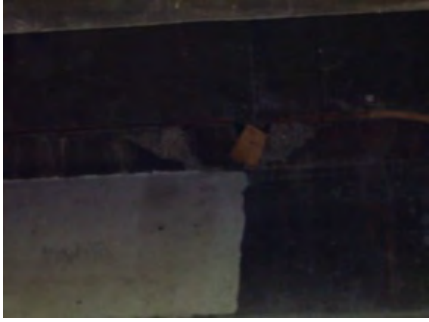
Delamination is observed at hunch.
Abutments	Spalling, Scaling, Disintegration

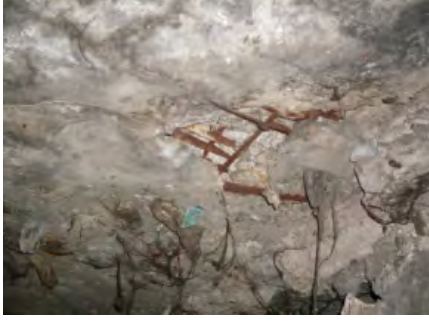
Spallings caused by unskilled workmanship are observed.
	Cracking concrete

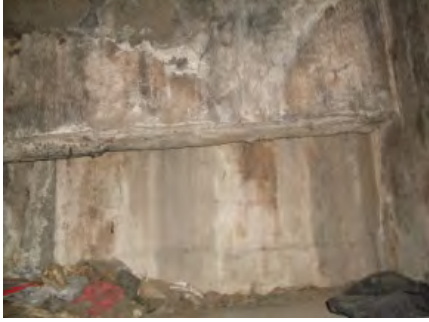
Many cracks are detected on abutment.

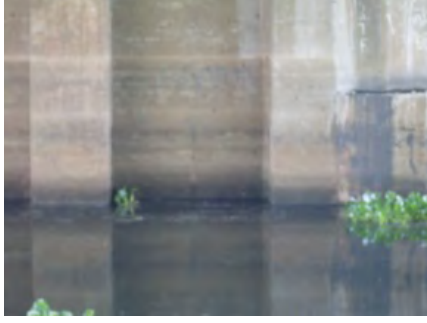
A few Cracks are observed on the interval wall of pier.
	Exposure/Corrosion of Reinf.

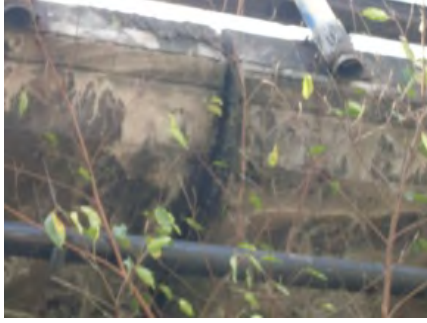
Water leaking from expansion joint is observed.

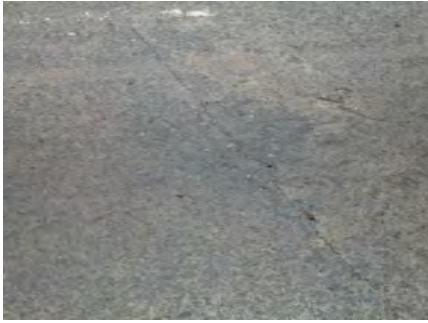
Cracks with width less than 1mm observed entirely on deck slab. Some cracks are over 1mm. (Poor condition)
	Scaling/Spalling

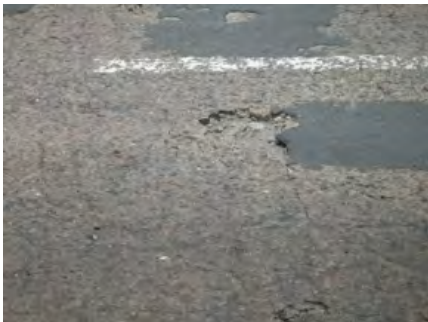
Many but small spalling are observed on the deck slab.
	Water leaking

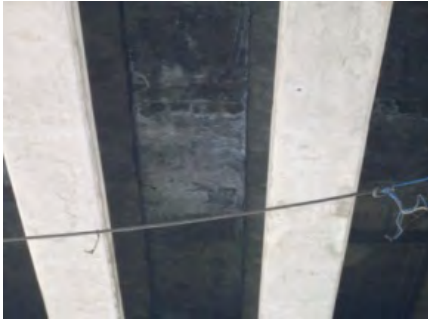
Cracks combined water leaking are observed at several parts.
Concrete Beam/ Girder (Primary)	Exposure/Corrosion of Rebars

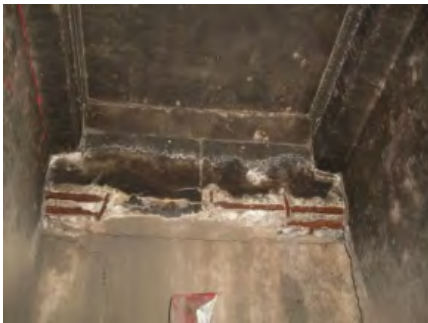
Exposure/Corrosion of Rebars is observed on cross beams.
