(2) Package C

1) Badiwan Bridge

BRIDGE SEISMIC INVENTORY DATA									
A. GENERAL									
(1) Bridge Name:		<i>Badiwan Bridge</i>				(2) Posted Load Limit		<i>15</i>	tons
(3) Location:	km.: <i>276+885</i>	Route:	<i>Marcos Highway</i>			Prov./ City	<i>CAR, Baguio City</i>

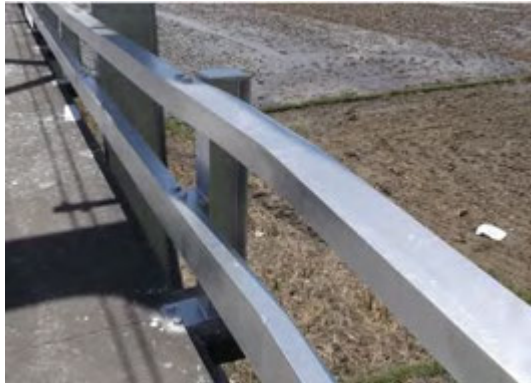
Impact damage is observed at the part of railing.
Slope Protection (Secondary)	Pot-holes

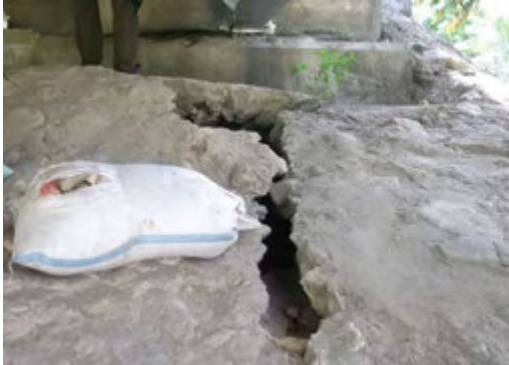
Pot-holes are observed at the slope protection of A2.

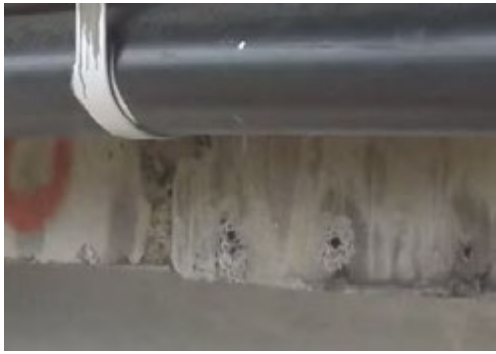
Exposure of rebar due to spalling is observed at the part of overhanging deck slab.
Steel Beam/ Truss Members (Bracings, etc.) (Primary)	Deformation/ Buckling

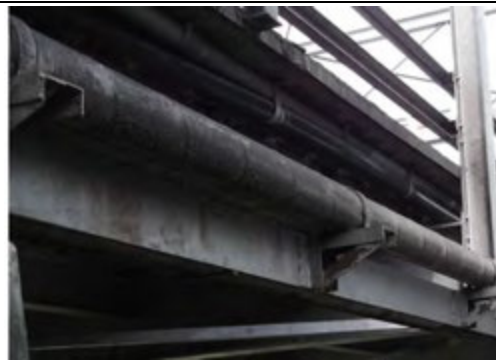
Corrosion & paint peel off is observed at the part of steel members.
Shoe/Bearing (Primary)	Bed (support) damage by debris flow

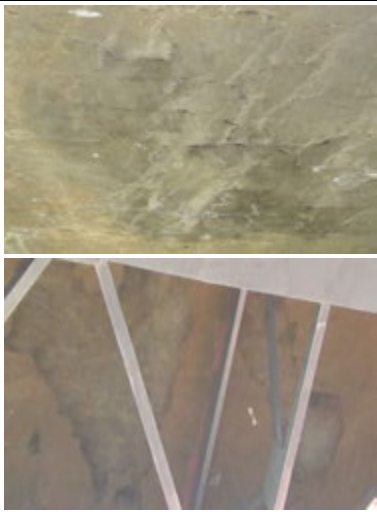
Water leaking is observed at the part of the deck slab.
Steel Beam/ Truss Members (Bracings, etc.) (Primary)	Corrosion/ Section loss

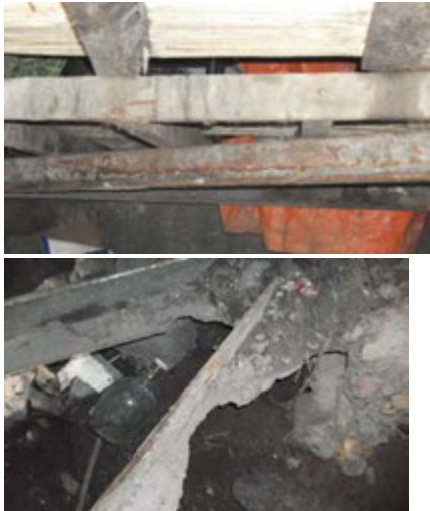
Corrosion and section loss due to corrosion is observed at the part of secondary steel members.
Shoe/Bearing (Primary)	Corrosion	 	Corrosion is observed at bearings.

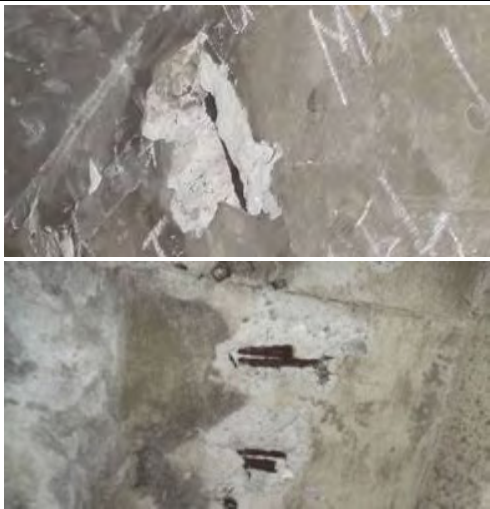
Rebar exposure due to spalling is observed at the overhanging deck slab.
	Hanycomb/ Spalling, Scaing, Disintegration

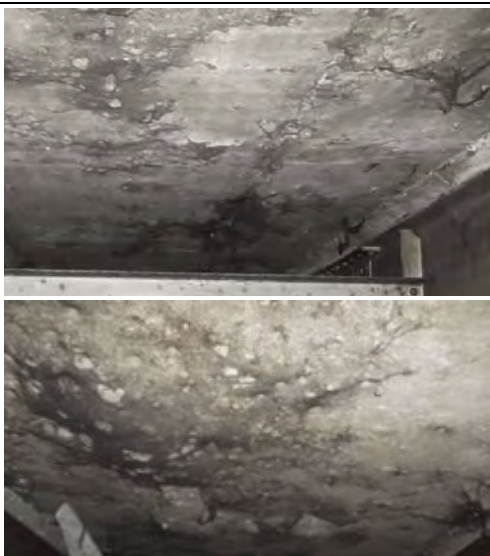
Hanycomb and disintegration due to spalling are observed at the deck slab.

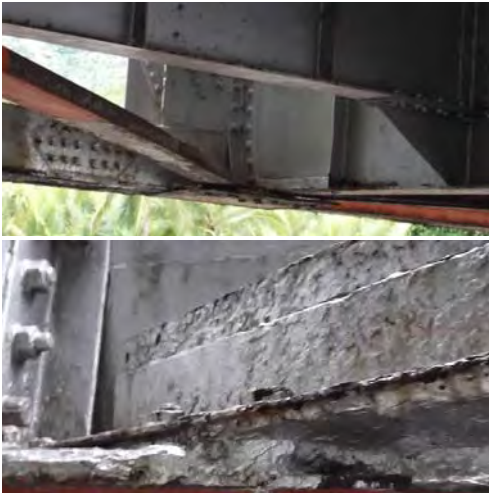
Corrosion is observed at steel members.
	Section loss

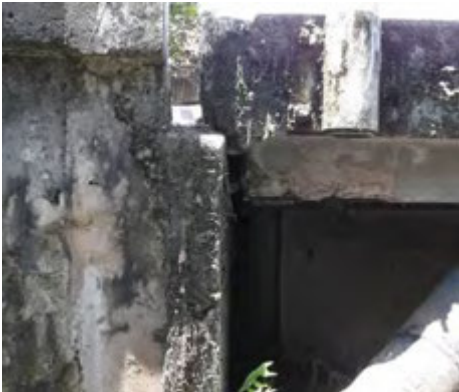
Hanycomb is observed at abutments.

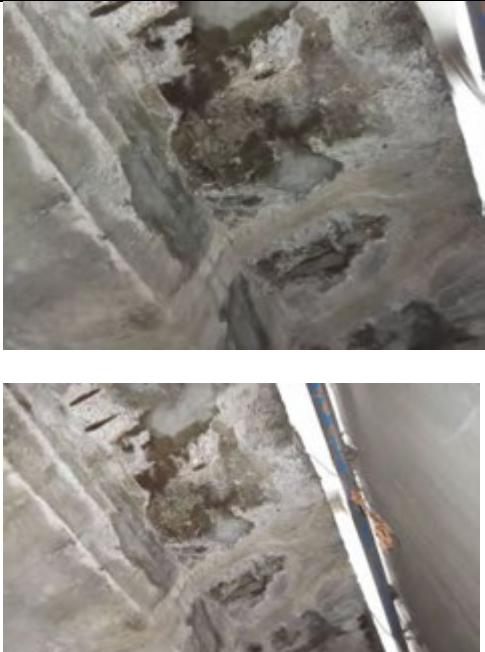
Exposure of rebar due to spalling is observed at the part of the overhanging deck slab.
	Hanycomb

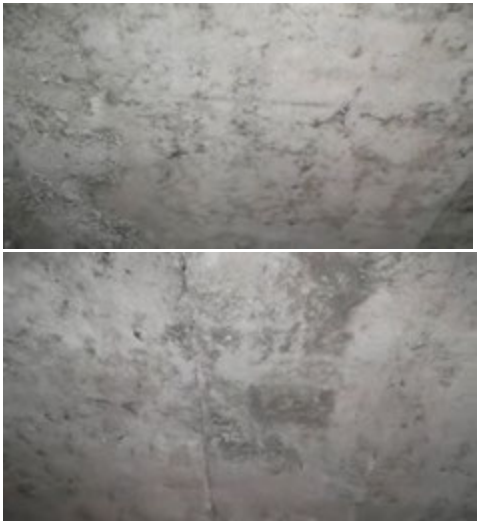
Hanycomb is observed at the part of the deck slab.
	Water leaking

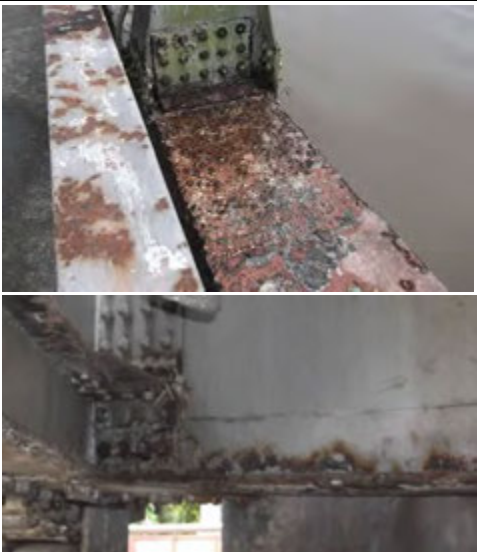
Corrosion is observed at the overall steel members.
	Paint Peel Off

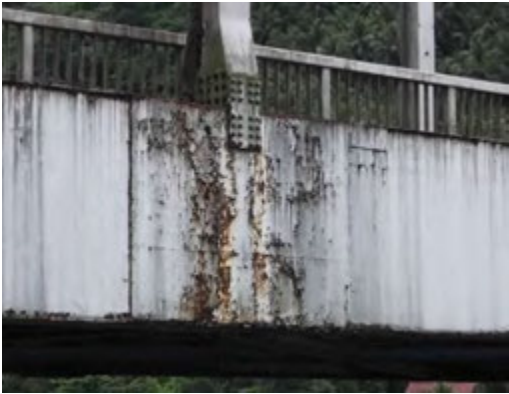
Paint peel off and corrosion is observed at the side of primary steel members.
Steel Beam/Truss Members (Bracings, etc.) (Primary)	Abnormal vibration

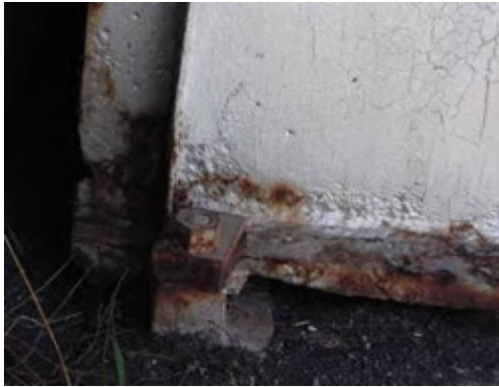
Corrosion is observed at bearings.
Piers (Primary)	Hanycomb/ Free lime

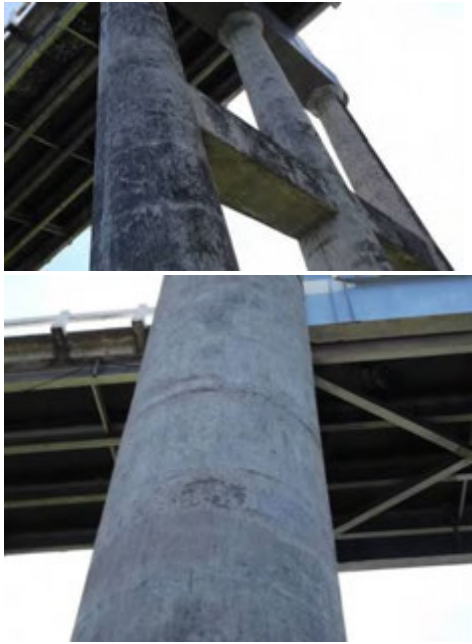
Hanycomb & free lime are observed at the part of piers
	Settlement

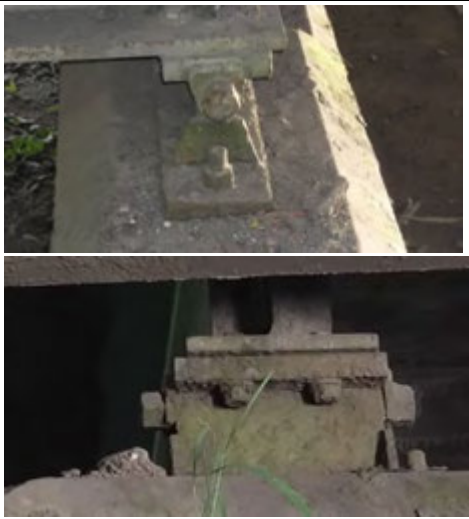
Corrosion is observed at bearings.
	Abnormal displacement

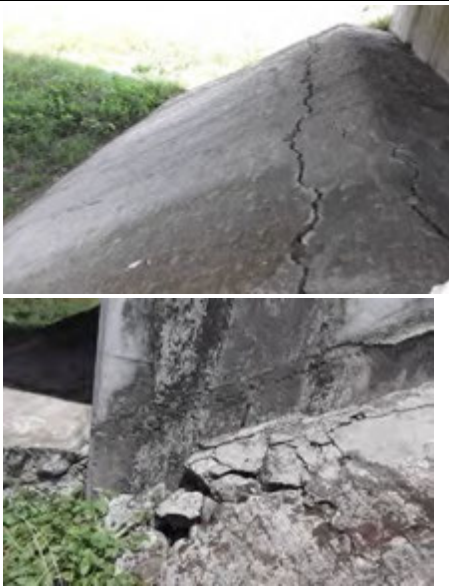
Major cracks due to ground settlement are observed at slope protection of A2.
Approach Road (Secondary)	Settlement
