**REPUBLIC OF THE PHILIPPINES
SPECIAL ASSISTANCE FOR PROJECT
SUSTAINABILITY (SAPS)
FOR
KAMANAVA AREA FLOOD CONTROL AND
DRAINAGE SYSTEM IMPROVEMENT
PROJECT
FINAL REPORT**

FEBRUARY 2014

**ORIENTAL CONSULTANTS CO., LTD. (OC)
PACIFIC CONSULTANTS CO., LTD.**

FINAL REPORT

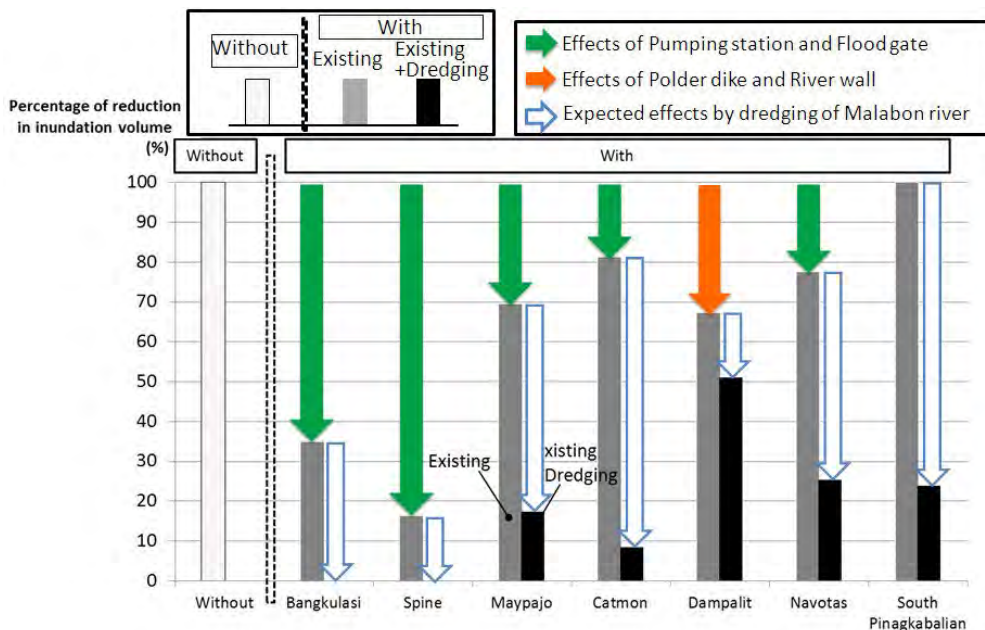
Figure S.1 Effectiveness of the KAMANAVA Project in 2009 Typhoon “Ondoy”

This figure shows by each sub-drainage area, the ratio (%) of inundation volume for the “with” condition to that for the “without” condition. Also in the figure, the extent of such reduction rate is shown by arrow marks.

For Bangkulasi and Spine sub-drainage areas, the pumps can reduce the inundation volume by 60-80 % compared with “without” conditions. For Maypajo, Catmon, Dampalit, Navotas and South Pinagkabalian sub-drainage areas, the reduction by the pumps is only 30 % or less. Especially in South Pinagkabalian and Dampalit, there is no effect from the pumps. While in Catmon there is a pumping station, but the reduction rate is small because of the overflow volume from the Malabon River. In Dampalit, the polder dike is effective to reduce the flood water volume.

This figure also shows the effectiveness of dredging of the Malabon River. By improvement of the Malabon River, the overflow from the river can be eliminated, so that Bangkulasi and Spine sub-drainage areas could become free from flooding. For Maypajo, Catmon, Navotas and South Pinagkabalian sub-drainage areas, the reduction by the dredging is large as 50 % or so.

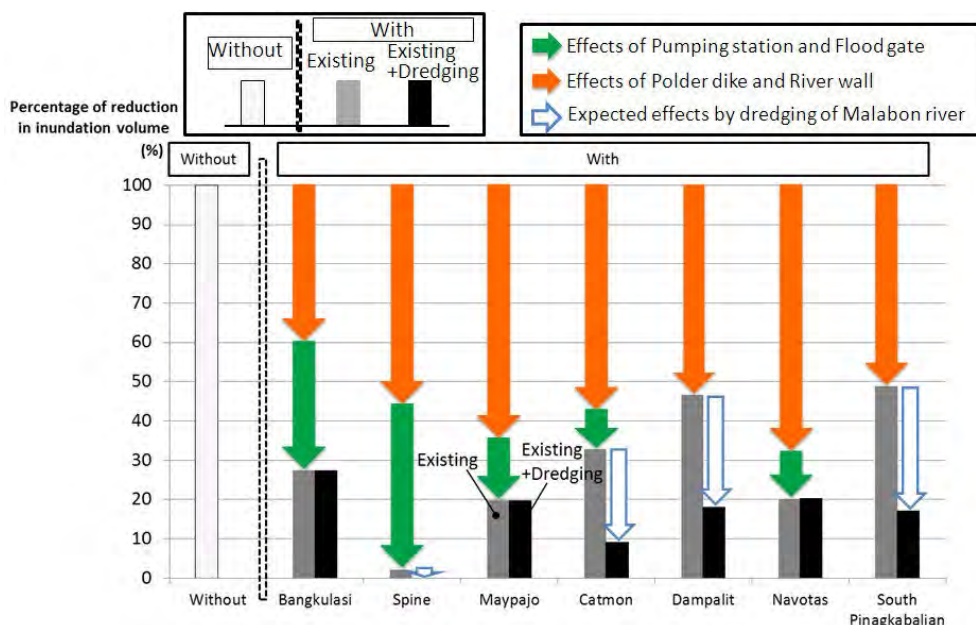
This figure shows each sub-drainage area, the ratio (%) of inundation volume for the “with” condition to that for the “without” condition. Also in the figure, the extent of such reduction rate is shown by arrow marks.

For Bangkulasi, Spine and Maypajo sub-drainage areas, the pumps can reduce the inundation volume by 20-30 % compared with “without” conditions. For Catmon, Dampalit, Navotas and South Pinagkabalian sub-drainage areas, the reduction by the pumps is only 10 % or less. Especially in South Pinagkabalian and Dampalit, there is no effect from the pumps. While in Catmon there is a pumping station, the reduction rate is small because of the overflow volume from the Malabon River. In Dampalit, the polder dike is effective to reduce the flood water volume.

This figure also shows the effectiveness of dredging of the Malabon River. By improvement of the Malabon River, the overflow from the river can be eliminated, so that Spine sub-drainage areas could become free from flooding. For Catmon, Dampalit and South Pinagkabalian sub-drainage areas, the reduction by the dredging is as large as 20 to 30 % or so.

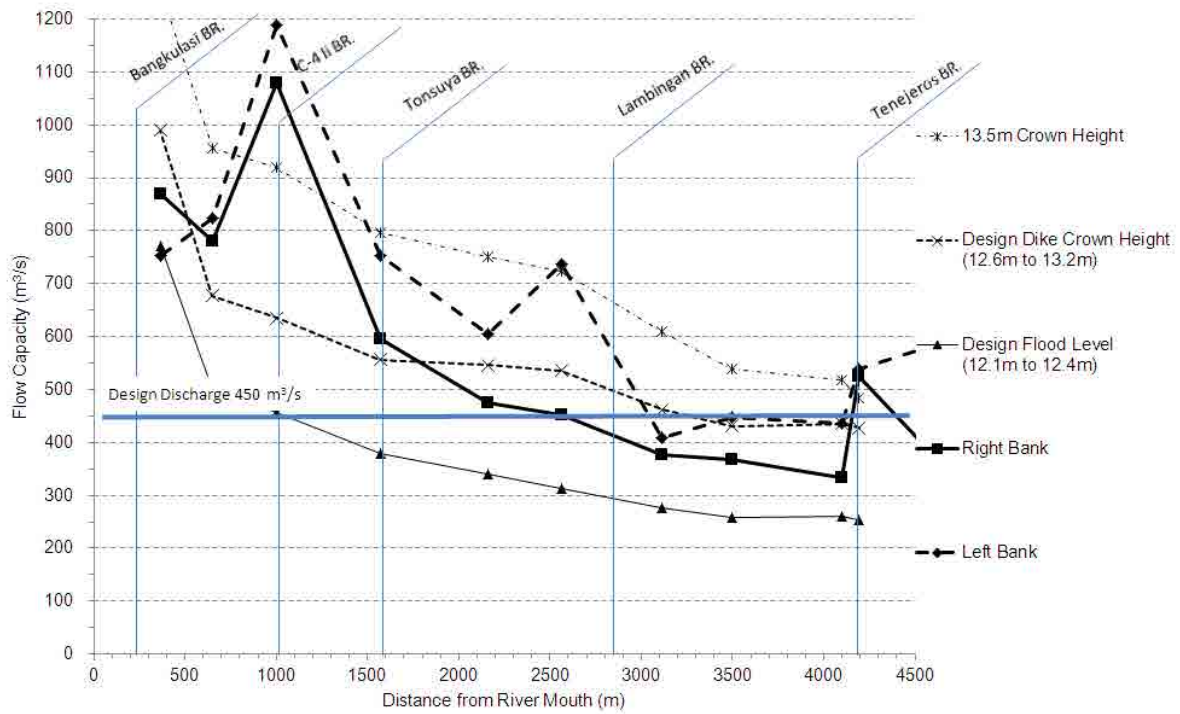
Figure 3.4.8 Flow Capacity of Cross Section Conditions in 2013

Next, based on the non-uniform calculation shown in Figure 3.4.7, the channel flow capacity for each cross section was evaluated. Figure 3.4.8 and Figure 3.4.9 are the profiles of channel flow capacity for the cross sections in 2013 and the dredged riverbed, respectively. The figures include not only flow capacities for the left bank and right bank heights but also those of design flood level, design dike crown height and raising crown height to 13.5m (DPWH Datum).

In order to let the design discharge pass under DFL, the riverbed dredging is necessary.

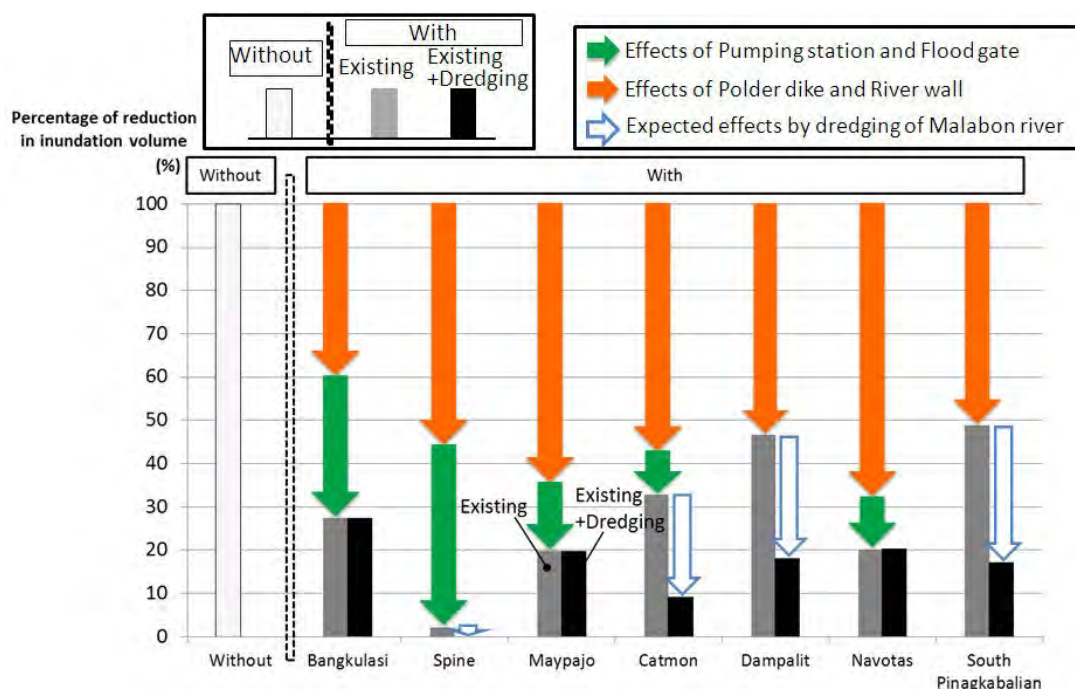
This figure also shows the effectiveness of dredging of the Malabon river. By improvement of the Malabon river, the overflow from the river can be eliminated, so that Bangkulasi, Spine and Maypajo sub-drainage areas could become free from flooding. For Catmon, Dampalit and South Pinagkabalian sub-drainage areas, the reduction due to dredging is as large as 20 to 30 % or so.

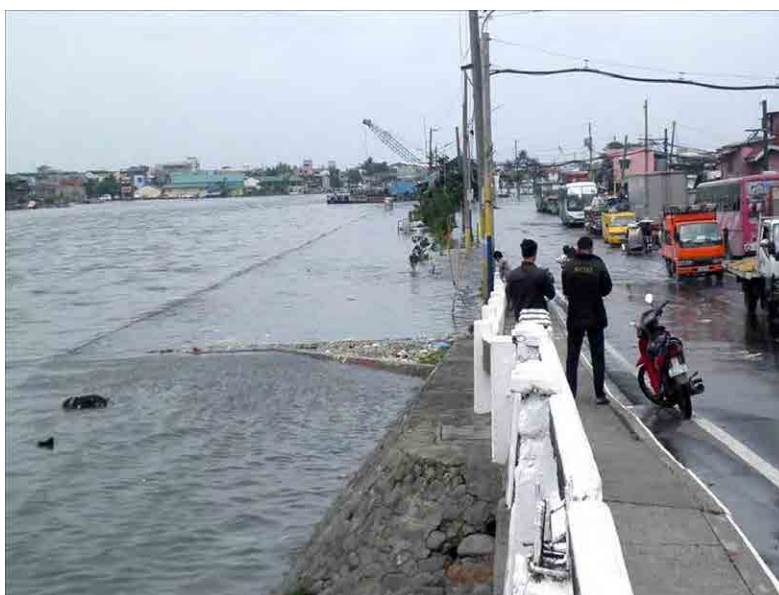
Figure 5.4.1 High Tide on August 2, 2012 at C-4 Bridge of Malabon River Right Bank

Figure 5.4.1 (Photo) shows a picture of the high tide condition taken on August 2, 2012 by Malabon City Engineer. The location is the right bank downstream of C-4 Bridge, whose distance from the river mouth is 1 km. The top elevation of the submerged river wall was 12.60 m (DPWH Datum). It is understood that the highest tide level exceeded the 12.60 m (DPWH Datum).

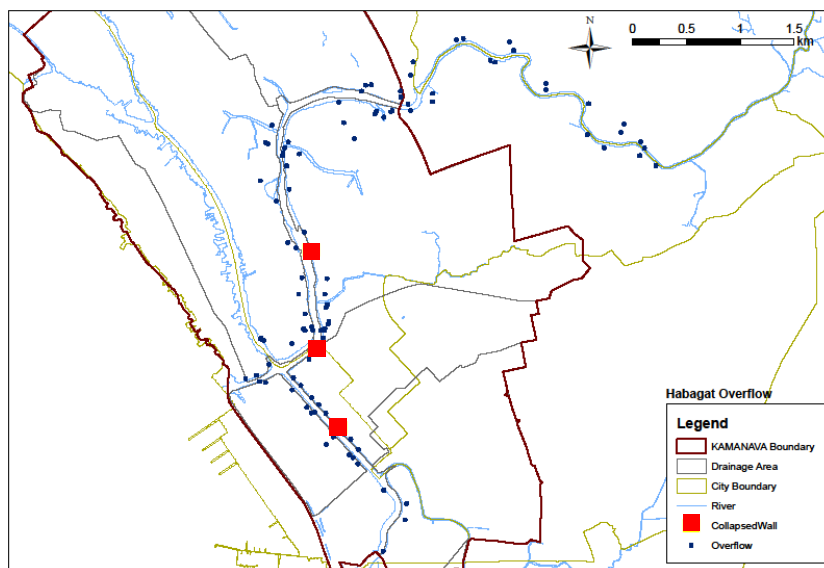
Such overflow from the river side to the protected area was not considered in the KAMANAVA Project design, especially for the inland flood protection area. Therefore, the flooding extent in the project area was made worse.
