**フィリピン共和国
パナイ島エスタンシアにおける
重油流出事故に対する
国際緊急援助隊(専門家チーム)派遣
活動報告書**

独立行政法人国際協力機構
国際緊急援助隊事務局

緊 援
J R
13-001

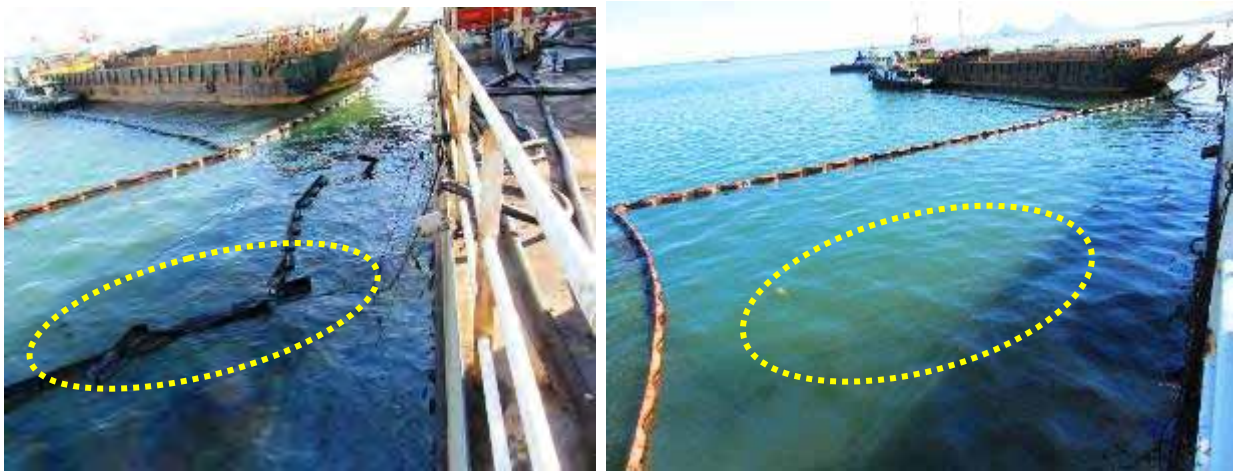
改善前（左）と改善後（右）の様子

アドバイスdに対し、1次オイルフェンスが撤去、陸揚げされ完全に回収された。改善前（左）と改善後（右）の様子を比べると汚染された一次オイルフェンスが回収されたことが分かる。

- a. オイルフェンスの不足分について、追加の調達を考慮すること。
- b. 現状の改善策として、拡散防止範囲を狭め、十分に囲い込める範囲で拡散防止策をとること。
- c. オイルフェンス型吸着材のみを拡散防止策の資器材として使用しないこと。
- d. 1次オイルフェンスは十分な数量もなく、損傷して汚染が著しいため撤去すること。

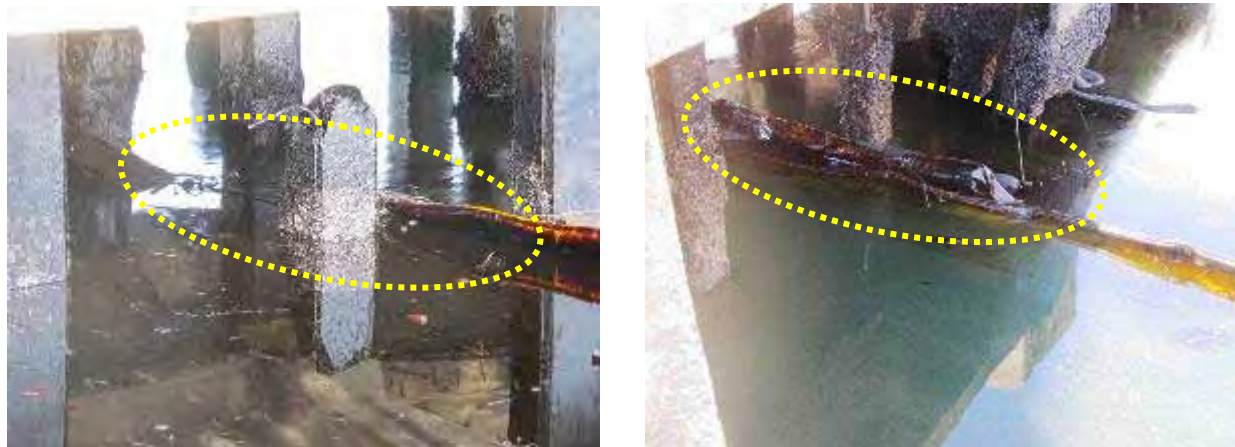
改善前(左)と改善後(右)の様子

アドバイスgに対し、異種のオイルフェンス同士を重ねて接続する修正がなされた。改善前(左)と改善後(右)を比べると接続部分からの更なる油の流出を防いでいるのが分かる。

g. 異種や損傷によってオイルフェンス同士がファスナーで正規に接続できない場合、ロープのみでつなげるのではなく、オイルフェンス同士をおおむね5節程度重ね合わせ固縛して接続する。

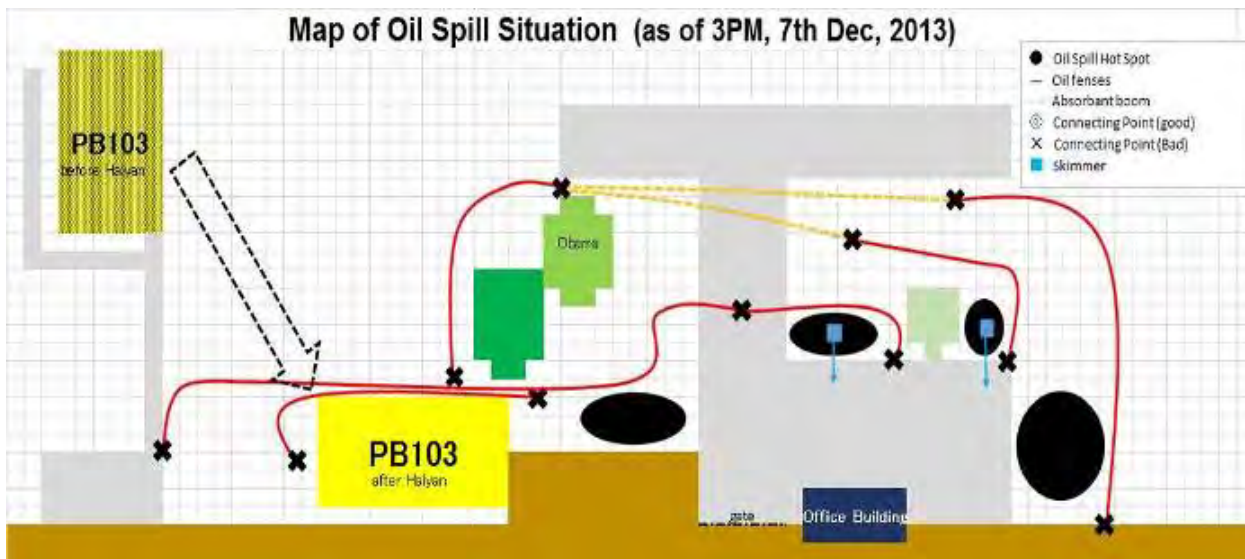
図 4 - 1 12月7日（土）現場到着後の現状調査時点

(1)～(3)の助言を踏まえ、PCGにより適切な修正が行われた結果、短期間で図4-1～4-3のとおり油流出の拡散防止措置について改善が図られた。なお、オイルフェンスの新規購入が可能となった場合を想定し、PCGに対しては図4-4を理想形として指導助言した。

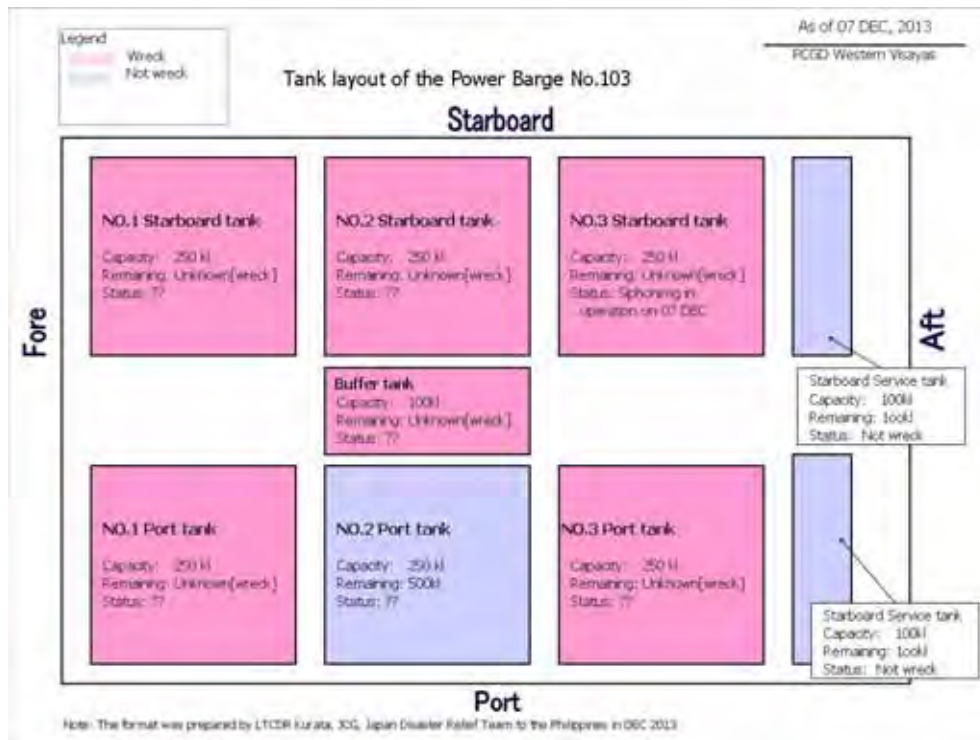
図 4 - 6 PB103燃料タンクの配置図（援助隊：倉田作成）

船体が海岸に乗り揚げられている状態であることから、今後、気象・海象が悪化した場合等、現時点では損傷していない燃料タンクにも新たに損傷が発生する可能性がある。その場合、更に大量の重油が海上に流出することとなり、海洋汚染や海岸汚染の拡大につながるおそれがある。このため、損傷していない燃料タンクを含め、PB103の全燃料タンクから残存油を迅速かつ完全に抜き取る必要があることを指導した。

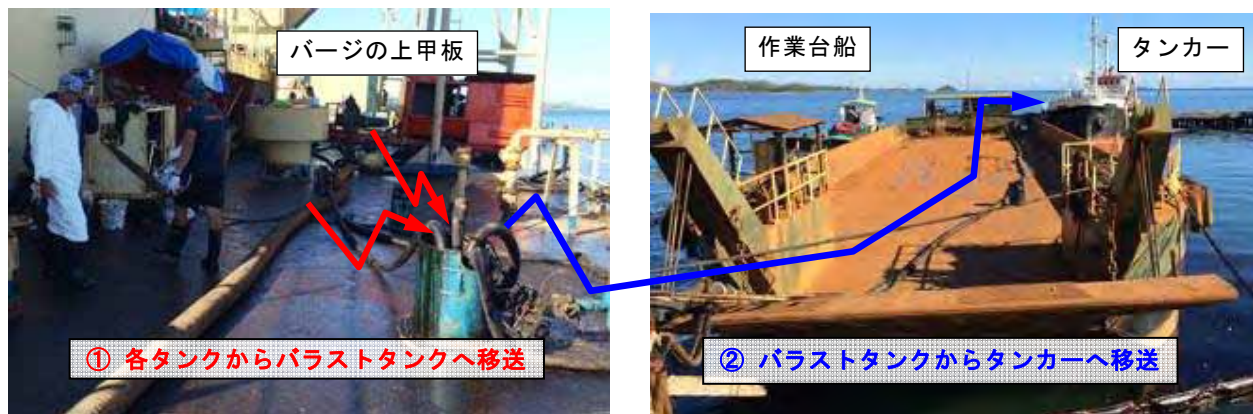
12月7日にPB103の燃料タンクに残っている油の抜き取り作業を開始、PCGとKKYGTI 保有のポンプとホースを結集し、指導内容に沿って作業をした結果、12月7日中に約60kℓの残存油を回収。その後、同様の作業が続けられている。

PB103燃料タンクからの残存油の抜き取り作業状況

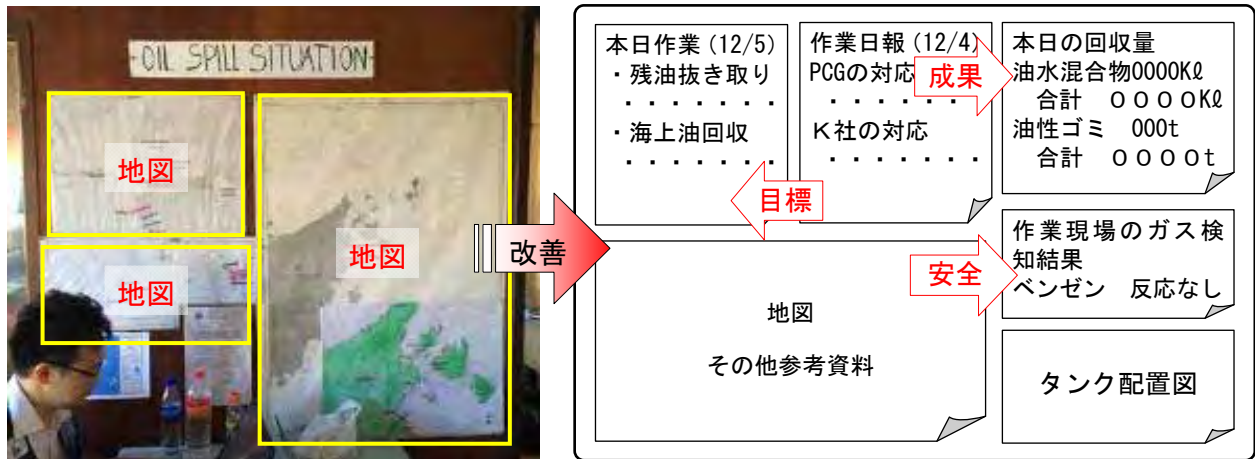
事故対処にあたる関係者間で共通の目標が欠如し、成果が見えないことから、モチベーションが下がり作業効率が低下するおそれがある。

現地指揮所の掲示板（左）と掲示物の改善提案（右）

業務（防除作業）記録に関する書類の書式化、特に作業要員に対する目標と成果の見える化について、指揮所の掲示板の改善を例として提言した。

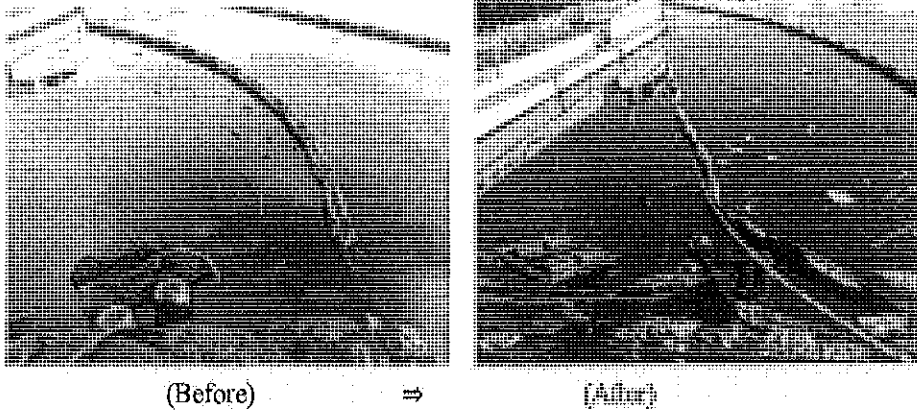
The end part of oil containment booms that contacts/touches the quay-wall or beach was not handled properly. Because of this, oil has been leaked from the gap between end parts of booms and quay-wall or beach.

- e. To fold back the oil containment boom and eliminate the gap/opening and use anchor to ensure the tight contact with the quay-wall/beach.

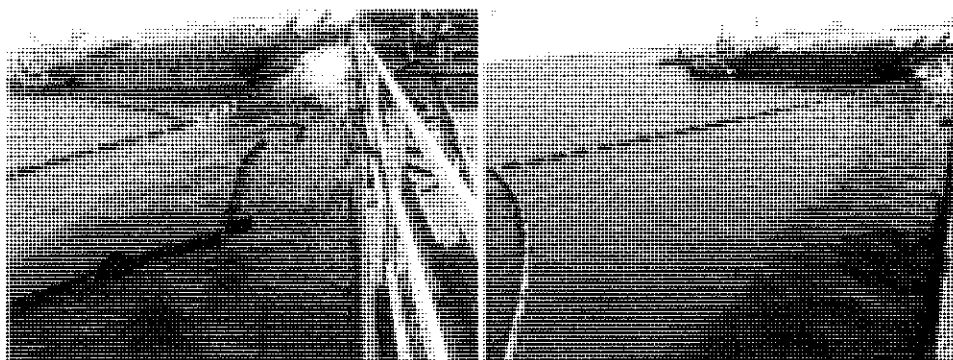
Remove the first oil containment booms .
There are insufficient number of them, they
are already damaged, and causing
significant pollution/contamination.

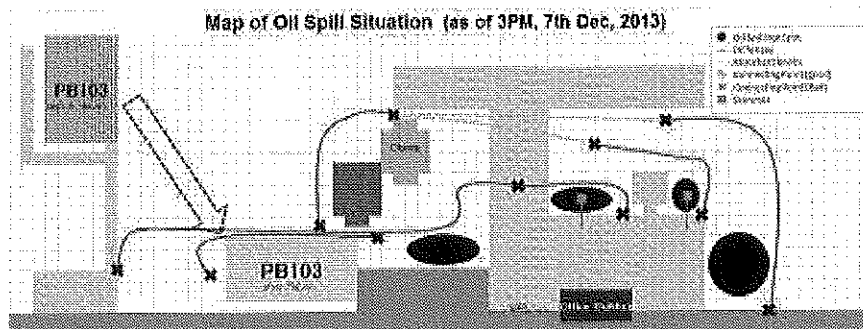
- ・ 現地では油まみれの廃材、瓦礫の回収のため運搬船「LCM DIVINE GLORY II」号が岸壁に対して船首を接する態勢で係留されていた。
- ・ 専門家チームは、PB103 に残留していると推測される 550klの残存油の全量を抜き取ることを推奨。
- ・ K社責任者の説明によると、タンカーオバマ号は、容量 400kl、これに加えてバージ VARENTINA 号と VARENTINA2 号の合計 3 隻体制で 550klの油を回収する計画。
- ・ 専門家チームが PB103 を取り囲むオイルフェンスを中心に、また、現地詰所の作業管理状況を調査、観察したところでは、
- ・ ①全体的な防除対策の考え方、オイルフェンスの展張の考え方は正しく、評価できるが、オイルフェンスの接続方法や、端末の処理、スキミングネット（ソーセージ形状の油吸着材）の設置方法に要改善点を見いだした（下図）。

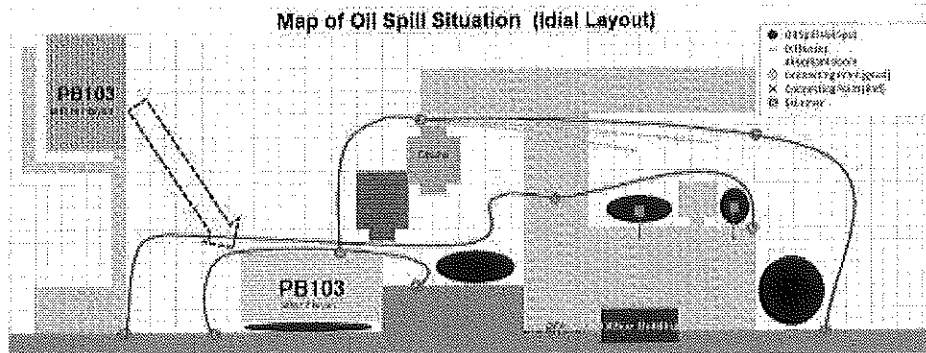
滞留する流出油を確実にオイルフェンスで囲み、更なる外洋への漏出を防ぐ
必要があり、次のようなオイルフェンスの配置が望ましいと史料する。

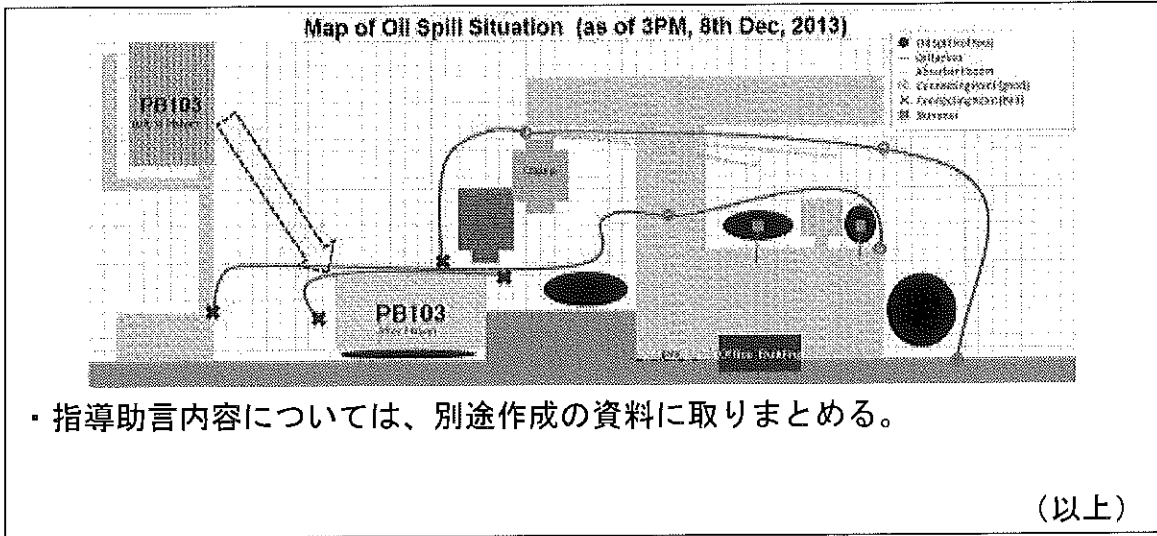
- (3) 1300~1430 BFAR 船に同乗して海上の浮流油調査を PCG とともに実施。
 - ・ PCG は、BFAR (漁業水産資源庁) が所有し、PCG が運航を担当している監視船 MSC3006 号を用意していた。通常は PCG 士官、下士官ら 10 名と BFAR 職員 4 名が同乗し、漁業監視を中心業務としているが、海難救助や災害救援などにも活用されている。
 - ・ 7 日に上空から確認した海上の浮流油について、PCG 職員らとともに海上から、更に状況を確認し、対処法について指導助言を行った。
 - ・ 指導助言内容について、別途作成の資料に取りまとめる。
- (4) 1300~1615 オイルフェンス展張作業について指導助言。オイルフェンスの接続や端末処理について修正を指示。
 - ・ 12月8日に修正できた箇所は下図 (○印で表示) のとおり。

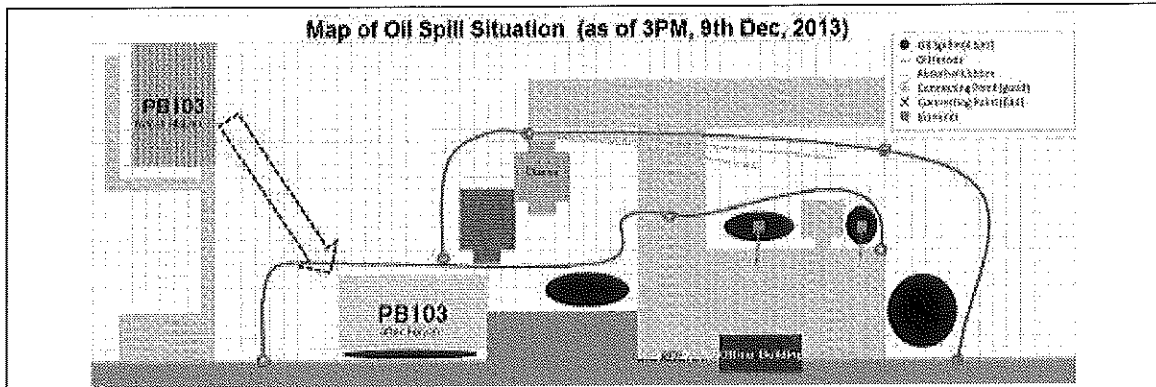
- ・ 詳細は、別途作成の資料に取りまとめる。最終的に次図のようにオイルフェンスの展張修正を確認。今後この状態を維持できるよう、確認すべきポイントについて現場指導。
