Supporting Report
Appendix D
Assessment on Existing
Flood Mitigation Facilities

PREPARATORY SURVEY
FOR
FLOOD RISK MANAGEMENT PROJECT
FOR
CAGAYAN DE ORO RIVER (FRIMP-CDOR)
IN
THE REPUBLIC OF THE PHILIPPINES

FINAL REPORT

Appendix D
ASSESSMENT ON EXISTING FLOOD MITIGATION FACILITIES

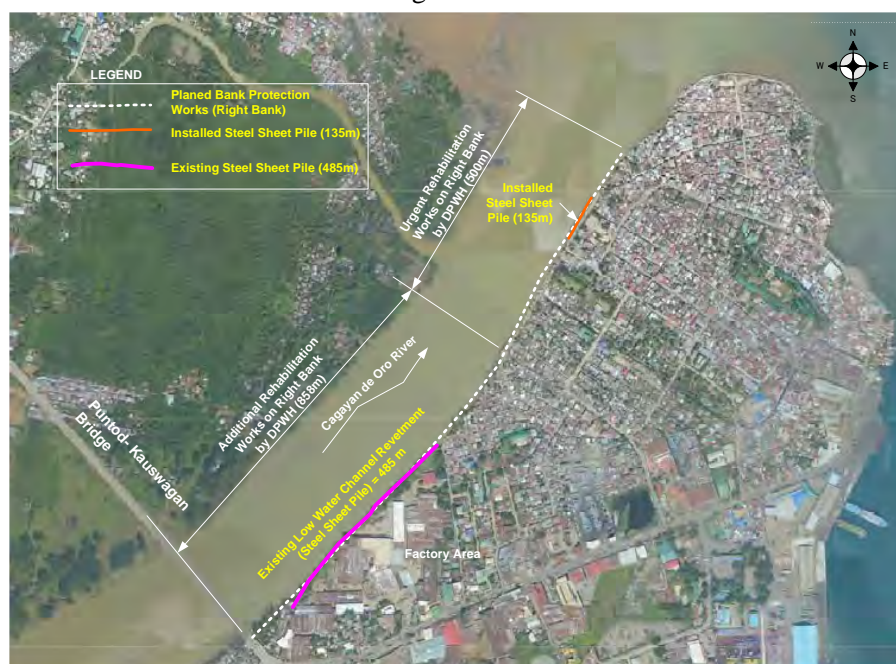
River Bank Improvement Works at Right Bank at River Mouth of the Cagayan de Oro River (As of Dec. 2012)

- Rehabilitation works on damaged concrete faced dry masonry dike are undertaken by DPWH Region-X to protect density populated residential areas and some factories located at right bank of river mouth.

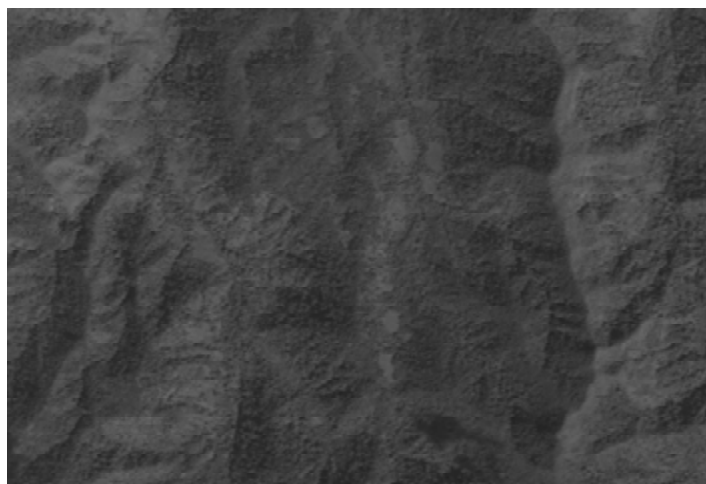
Photo 2.1.4 Condition of the upstream of Bubunawan River

The other photos show also the similar results.

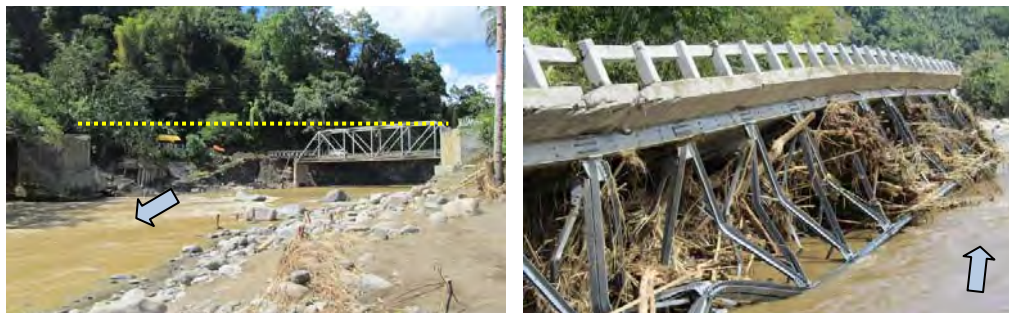
The main cause of the washout of the bridge is presumed to be the position of the truss.

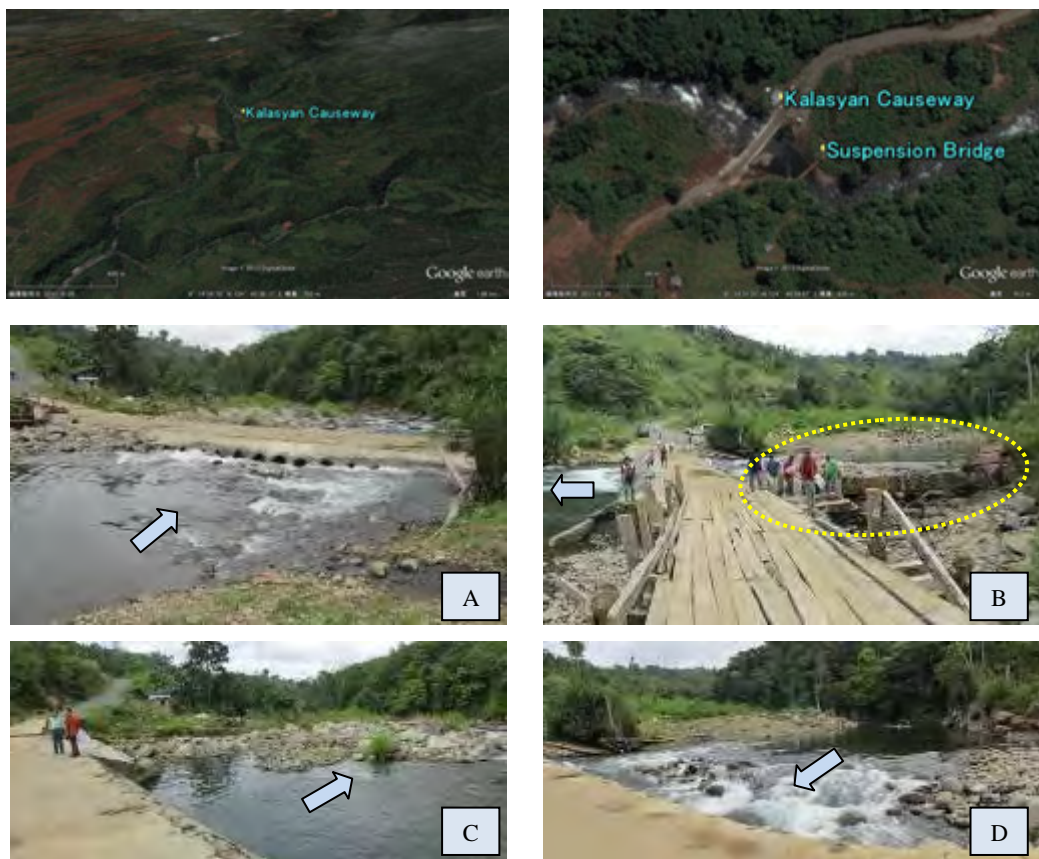
Photo 3.2.15 Kalasyan Causeway

In fact, according to observation after Pablo, the river water flows over the road surface of the causeway due to obstruction of the drainage pipes as shown in Photo 3.2.16, therefore the riverbed fluctuation is considered to be caused every severe flooding.

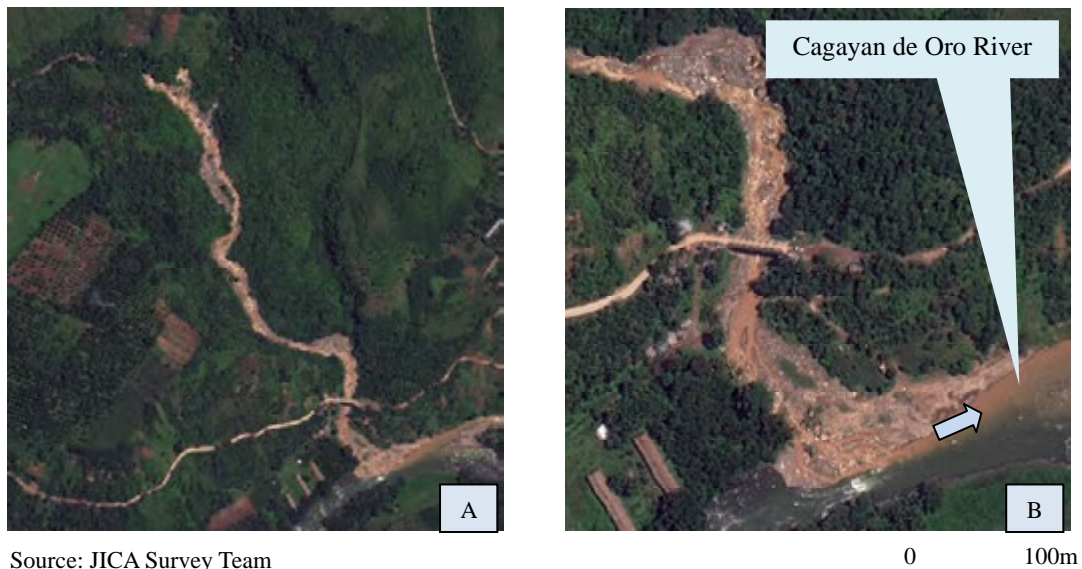
Photo 3.2.20 Condition of the Debris Flow (Bitanog River) (1/2)

According to nearby residents, the debris flow of this river is the first phenomenon observed.

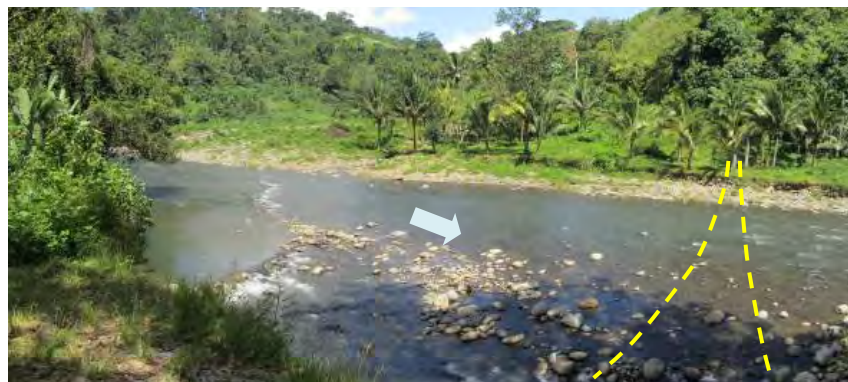
Photo 4.3.5 No Debris flow Deposit around Broken Mand Steel Bridge

According to the condition of flood deposit in the riverbed, the deposit consists of mainly gravel and cobble. The movement form is presumed to be “bed load”.

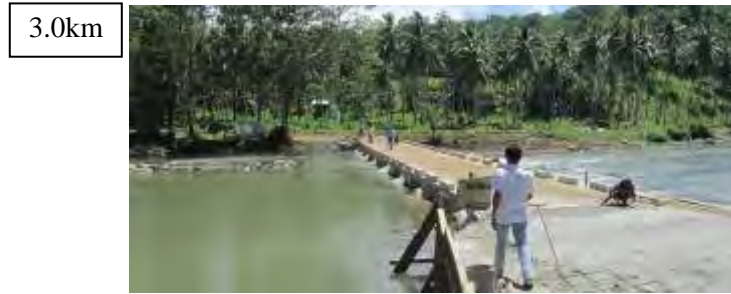
Tumalaong Causeway (No Debris Flow Deposit)

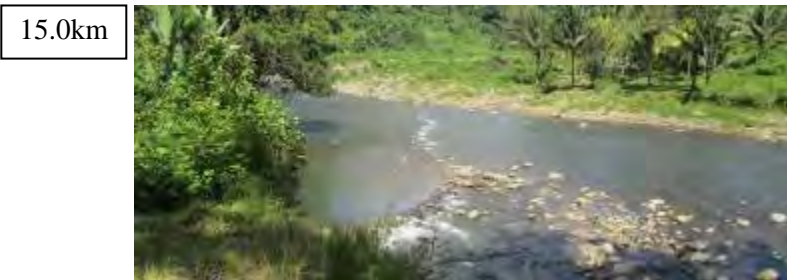
Mand Steel Bridge (No Debris Flow Deposit)

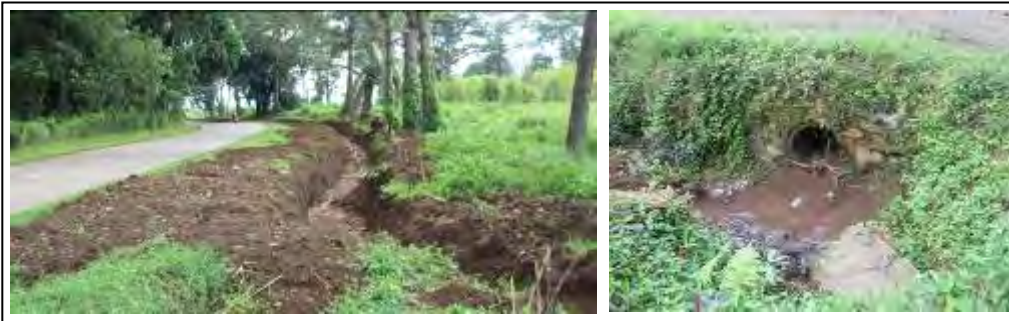
**Photo 4.6.2 Unlined Side Ditch along the Road Outflow
of the fine materials are observed in the Ditch**

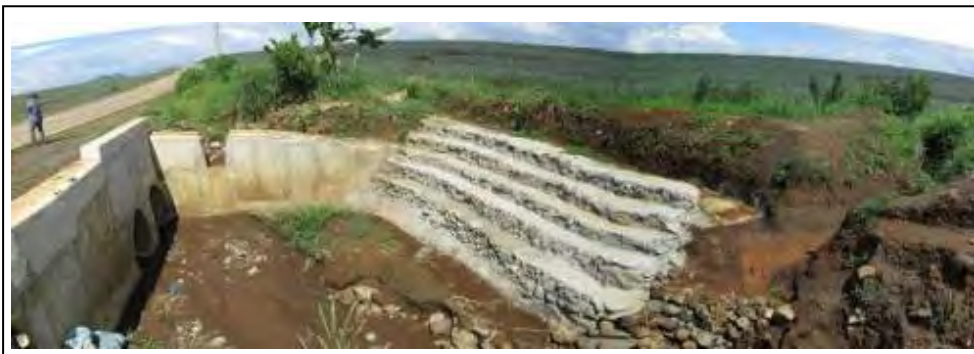
**Photo 4.6.3 Retaining Wall and Drainage Culvert Deposit
of Fine Materials is observed**

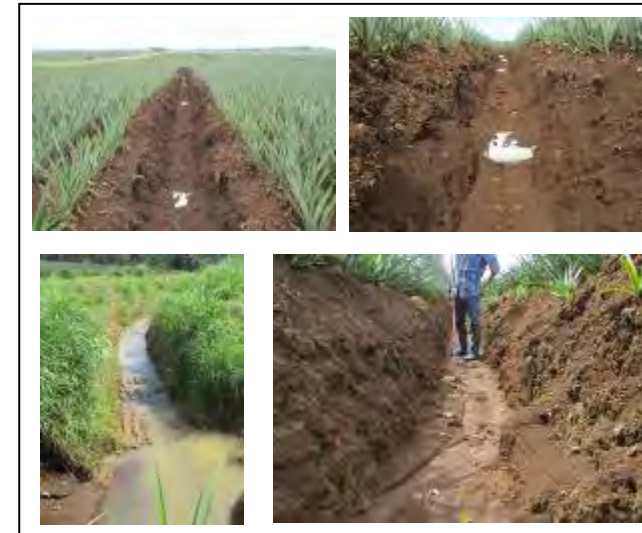
**Photo 4.6.4 Channel entrenched in the Field
(width : about 40cm)
Upper: The Sandbags are put in the Channel
for the sake of Erosion Prevention
Lower (right): Trace of Outflow
Lower (left): Water contains Fine Materials**

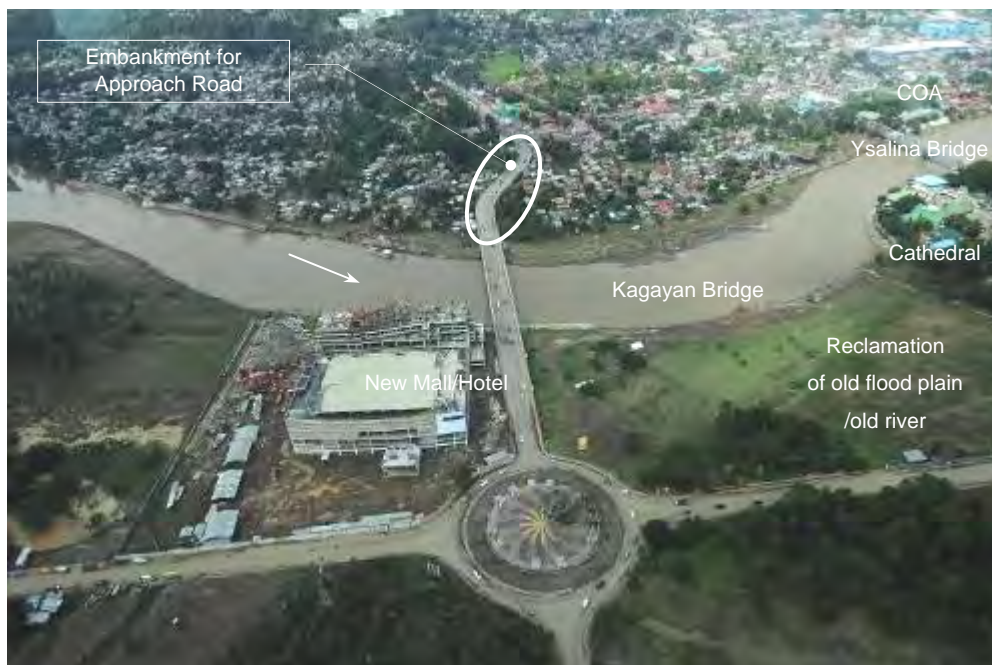
Photo 1.4.3 Present River Condition upstream of Bottleneck Section

The potential flood risk in the upstream is increased due to narrowing the river channel.
