橋梁の目視点検結果

Bridge Survey Record (1/8)

Bridge No.	1	Location (State)	Assam
Bridge Name	Jia-Bharali Bridge	Road Name	NH 15 (old NH 52)
Station	Km166	Road Category	National Highway
GPS Data	N 26 ° 48 ' 36.0 "	Management Authority	State PWD
	E 092 ° 52 ' 23.6 "	Year of Construction	1962

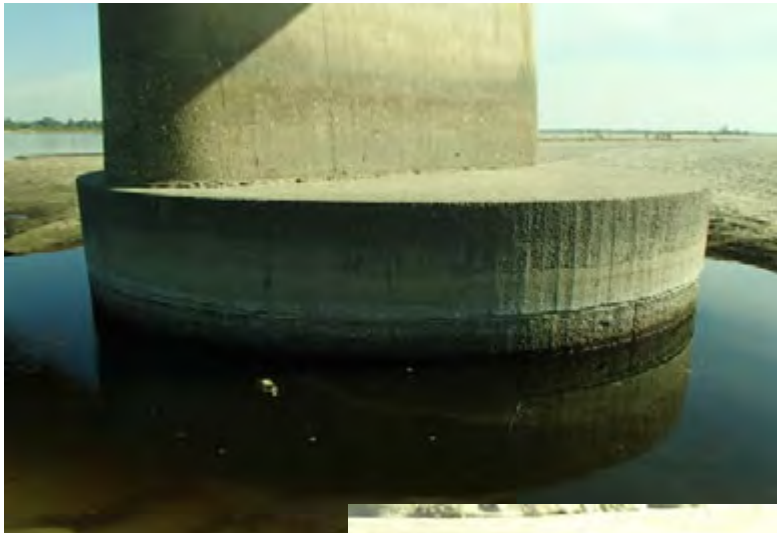
Object Member	Foundation (P3)
Kind of Damage	Cracks on well cap
Sketch or Photo

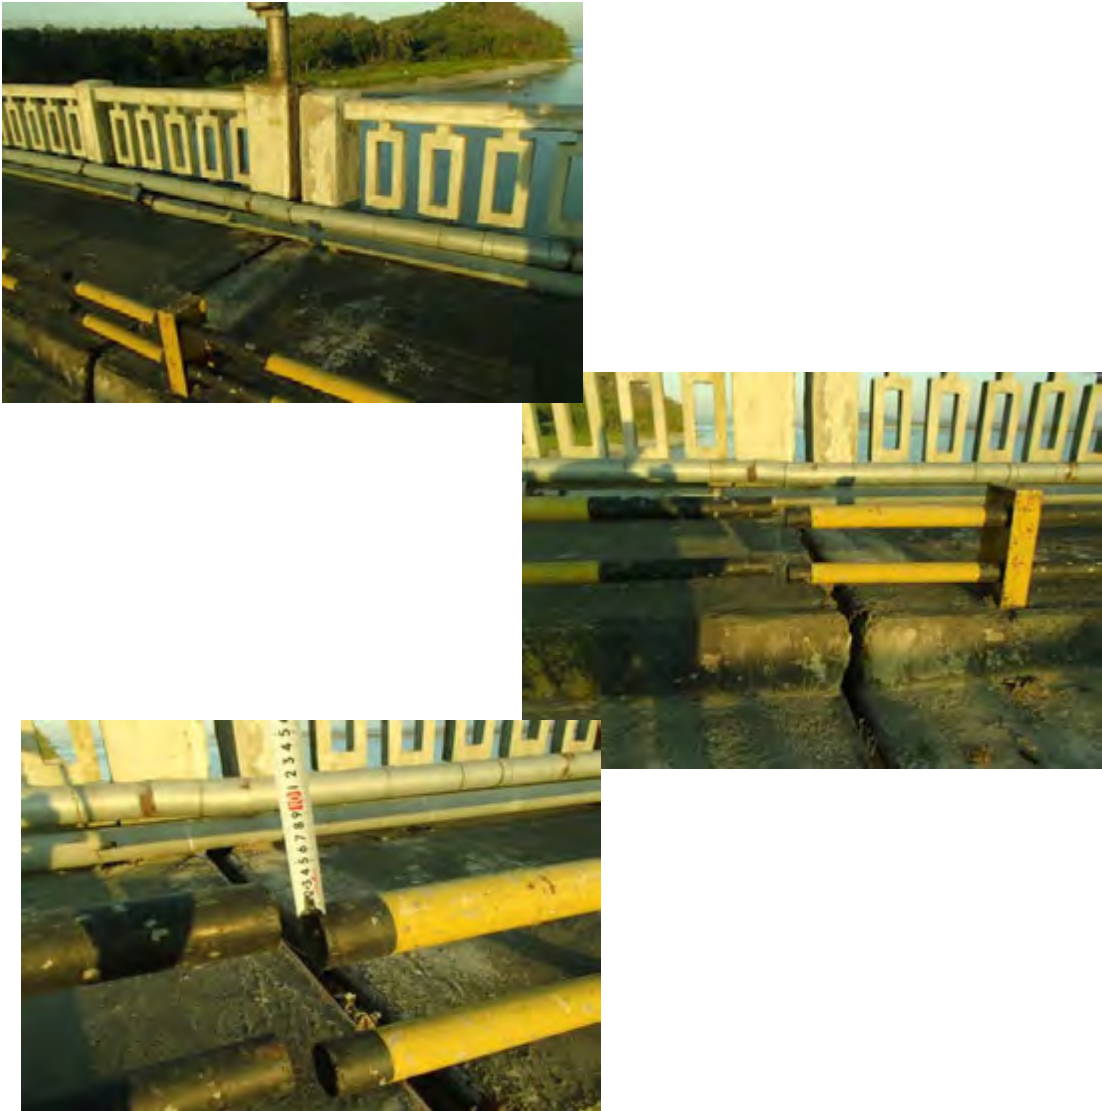
Object Member	Gerber Girder (at some spans)
Kind of Damage	Unequal level in deck slab of Gerber Girder
Sketch or Photo

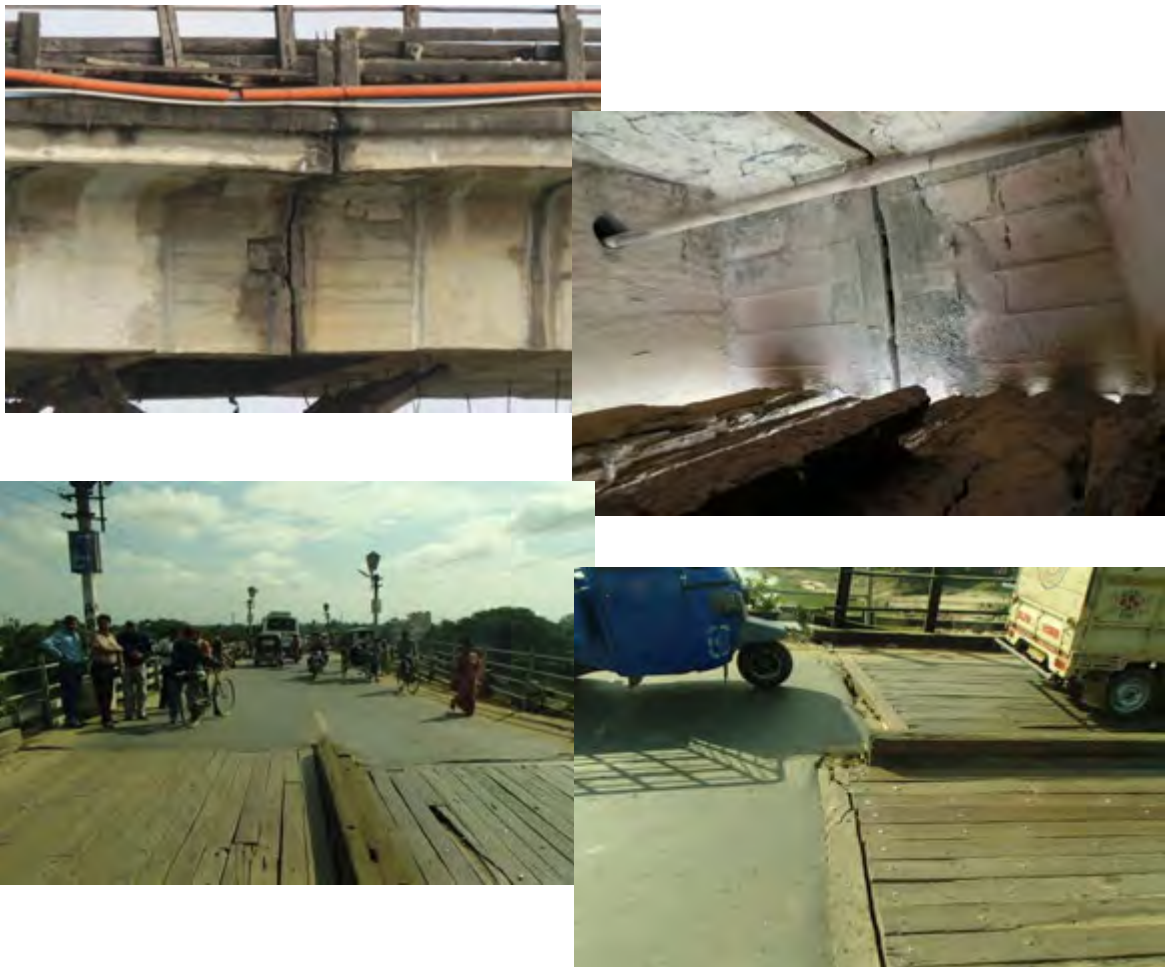
Object Member	Main Girder (at centre hinge)
Kind of Damage	End point of girders damaged at several locations. Abnormal deflection at center hinge, and 10m span timber bridge are provided over the centre hinge.
Sketch or Photo

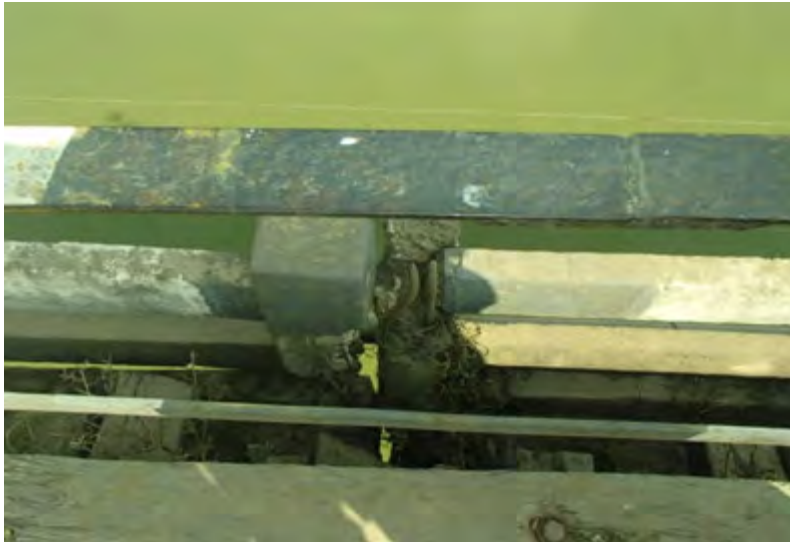
Object Member	Handrail at centre hinge
Kind of Damage	CC crumbling
Sketch or Photo

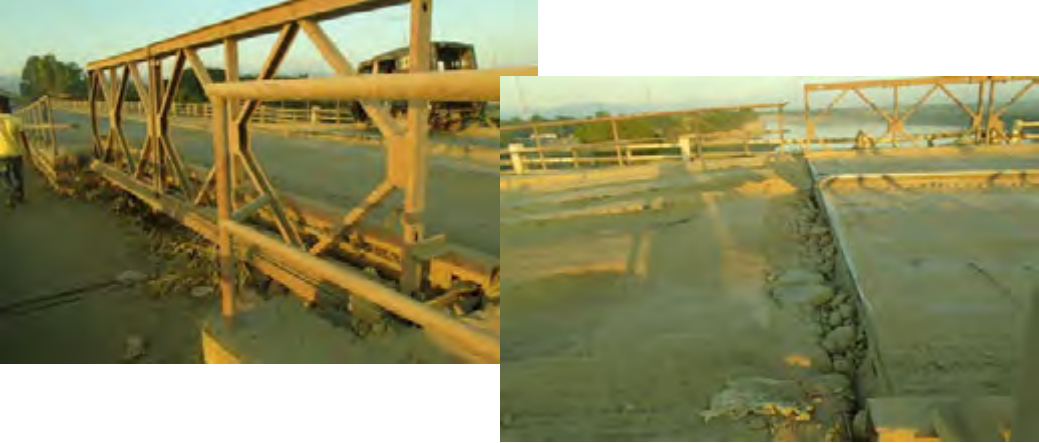
Object Member	Centre Hinge (P1-P2)
Kind of Damage	End point of girders damaged. Abnormal deflection, and 10m span steel bridge are provided over the centre hinge.
Sketch or Photo

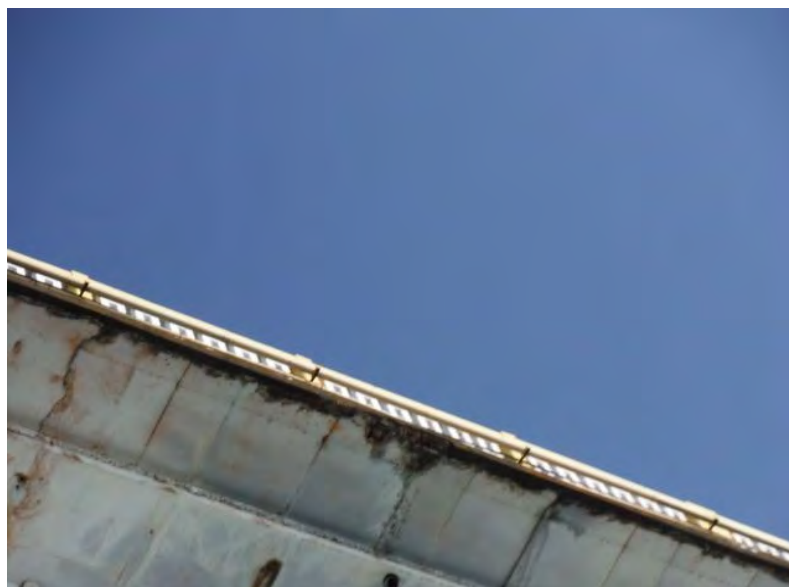
Object Member	PC Box Girder
Kind of Damage	Concrete Peeling, Re-bar exposed and Corroded
Sketch or Photo

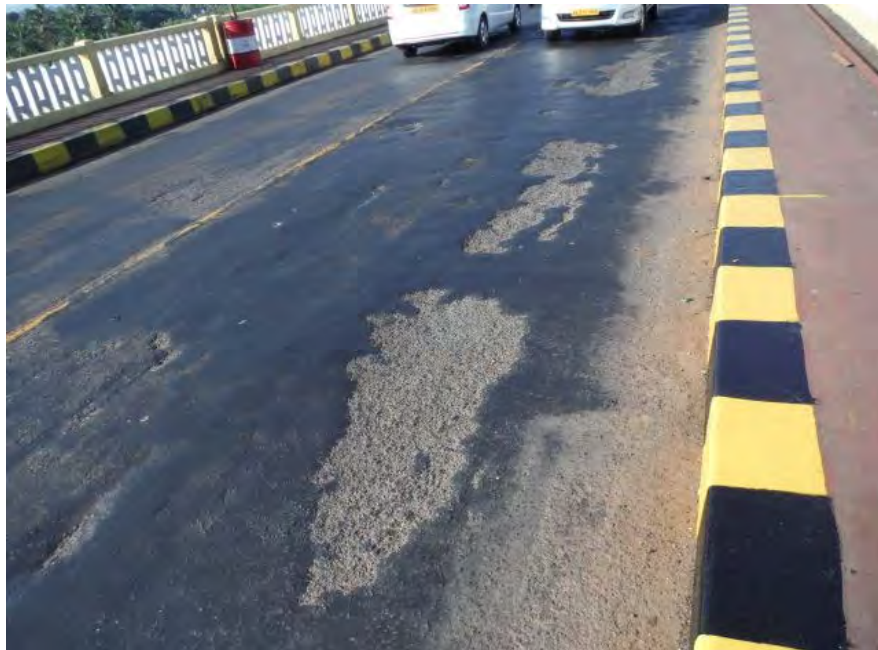
Object Member	Pavement
Kind of Damage	Abrasion
Sketch or Photo

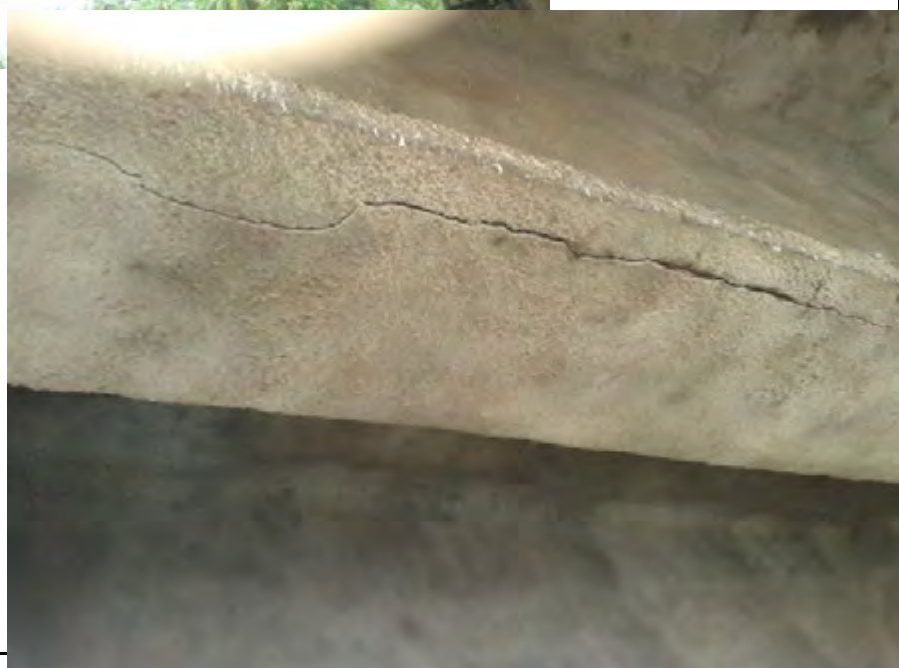
Object Member	Girder
Kind of Damage	Cracks on lower flange (P4-A2)
Sketch or Photo

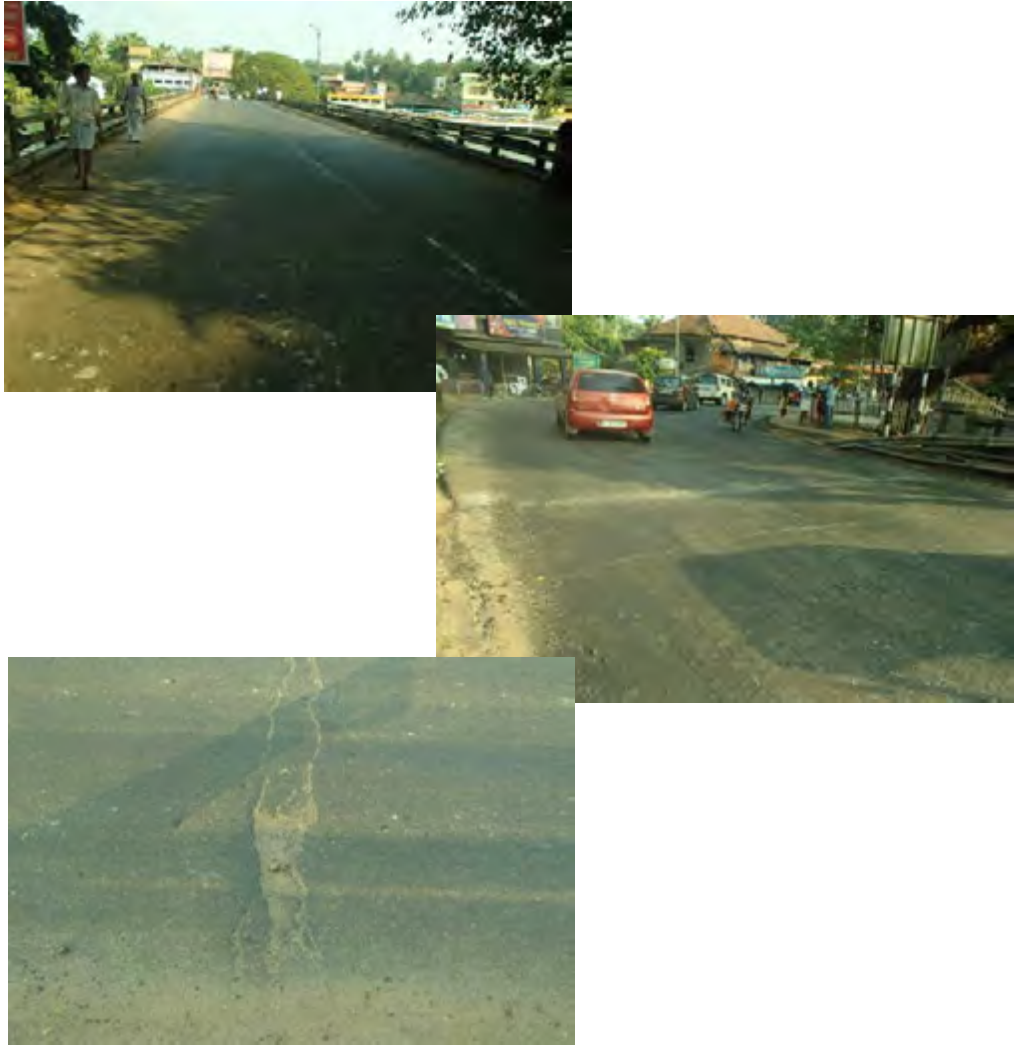
Object Member	All EXP joints
Kind of Damage	EXP joints are plugged with asphalt or bituminous material
Sketch or Photo

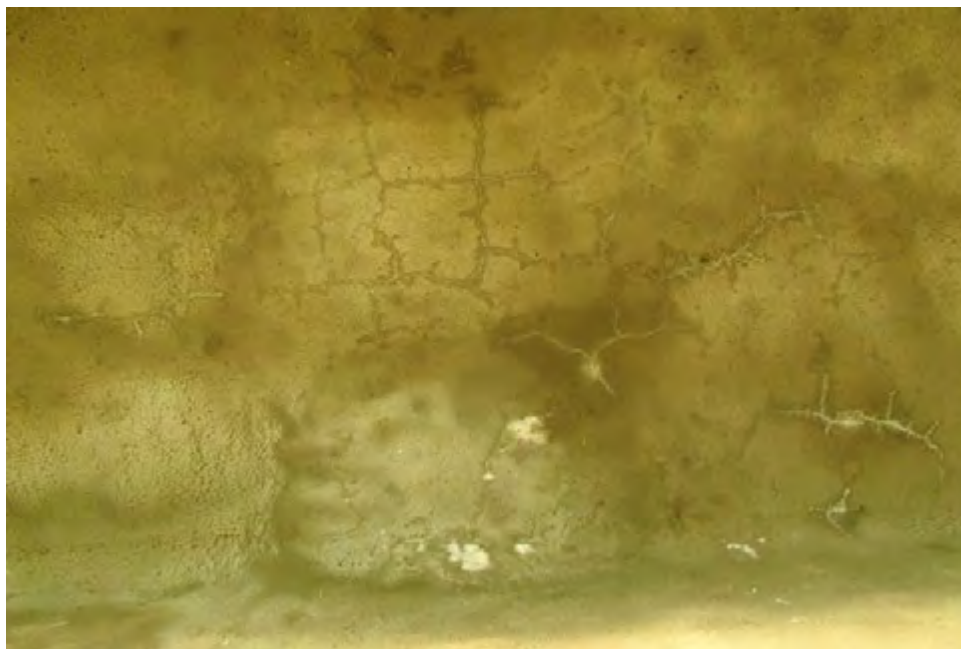
Object Member	Deck slab (P4-A2)
Kind of Damage	Some cracks are observed in the bottom of the deck slab
Sketch or Photo

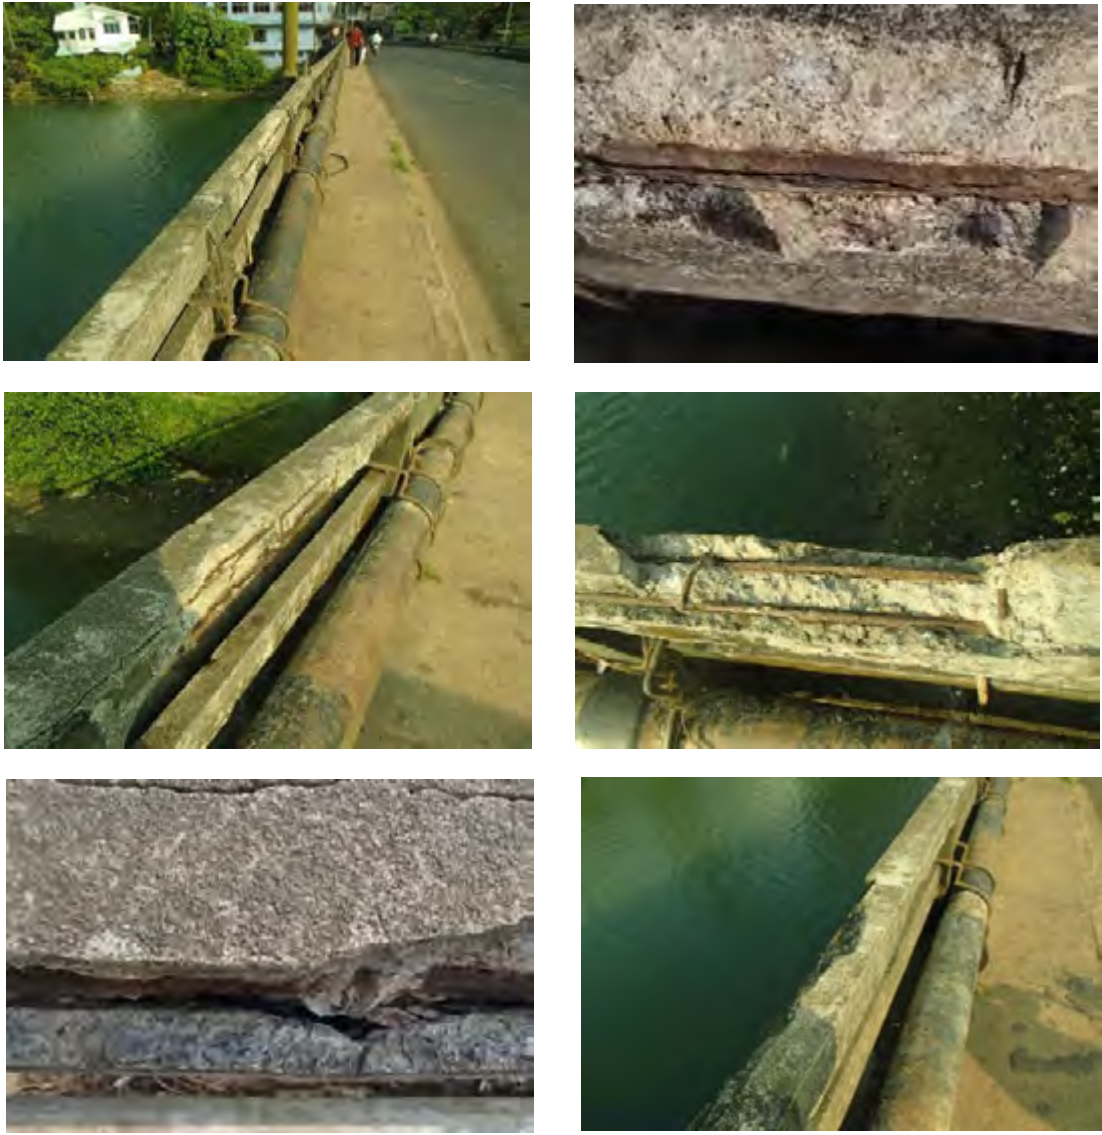
Object Member	Hand railing (all spans)
Kind of Damage	CC spalling and re-bar corroded
Sketch or Photo

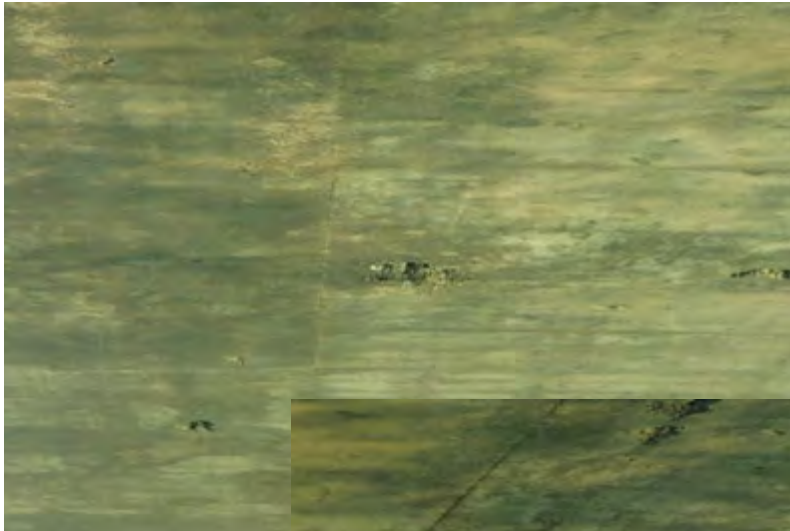
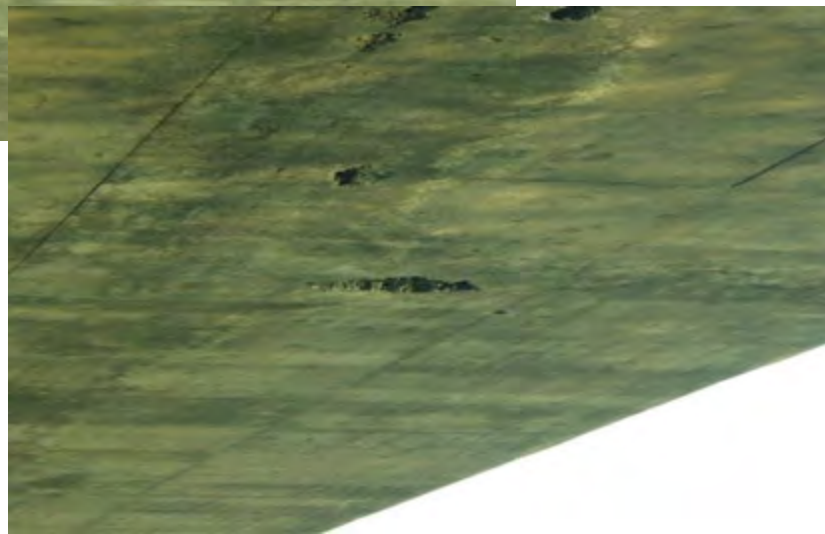
Object Member	Deck Slab (P14-A2)
Kind of Damage	Honeycomb
Sketch or Photo

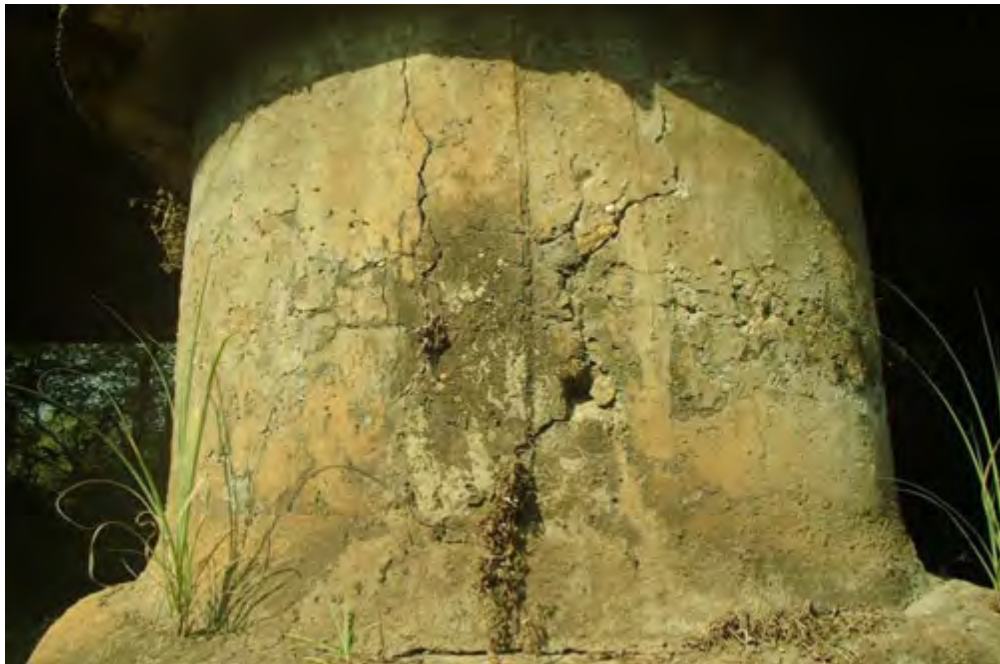
Object Member	P2 upstream side
Kind of Damage	Crack
Sketch or Photo

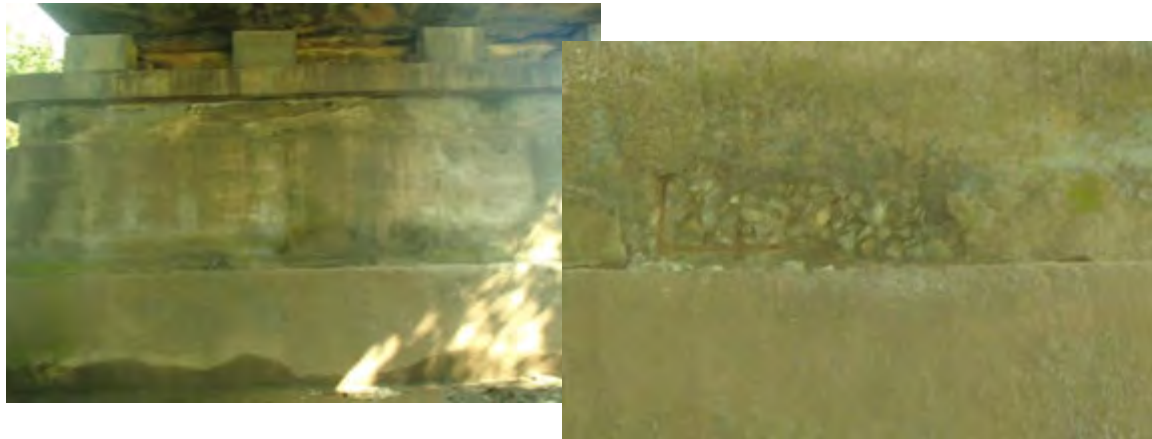
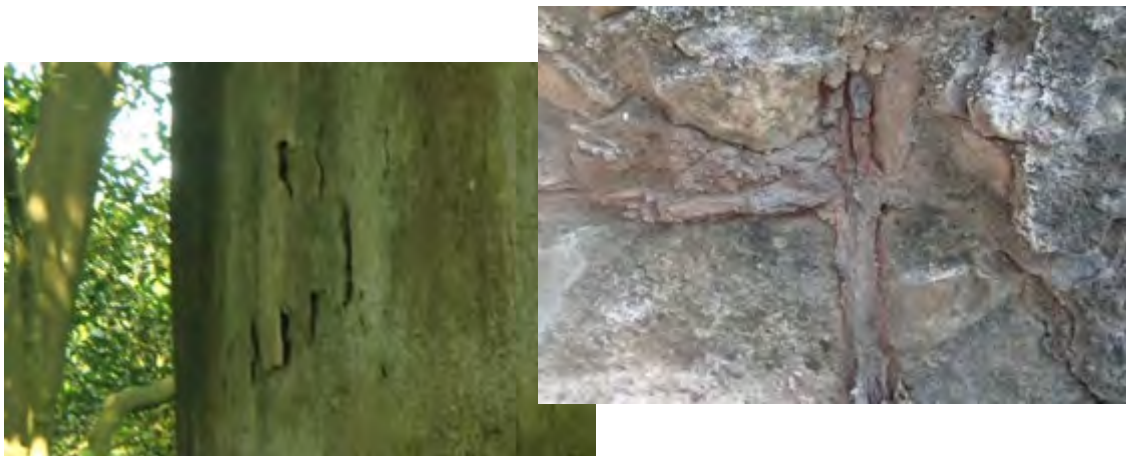
Object Member	P4
Kind of Damage	CC peeling and corroded re-bar exposed
Sketch or Photo

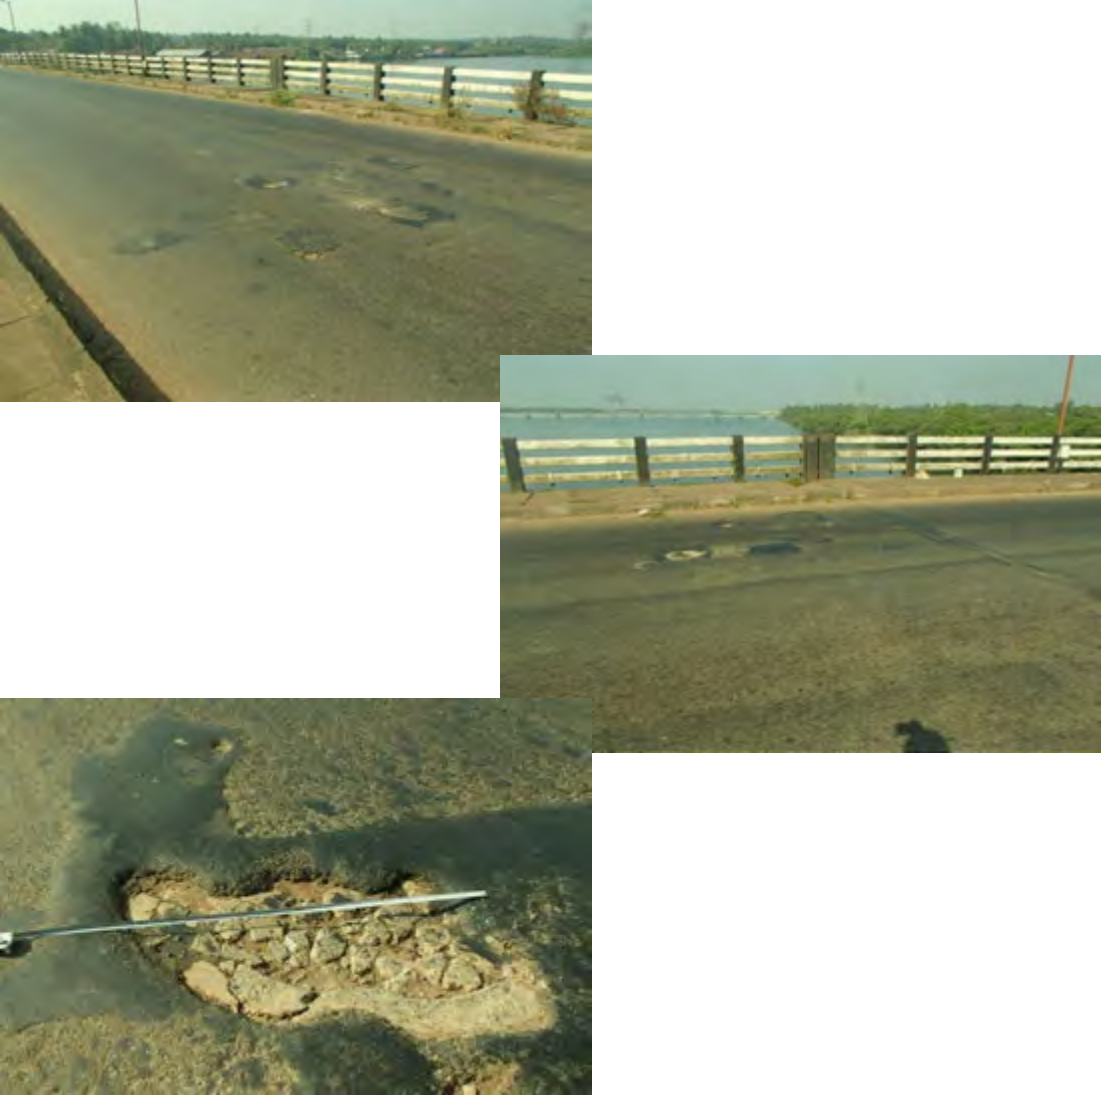
Object Member	Pavement
Kind of Damage	Mamy potholes
Sketch or Photo

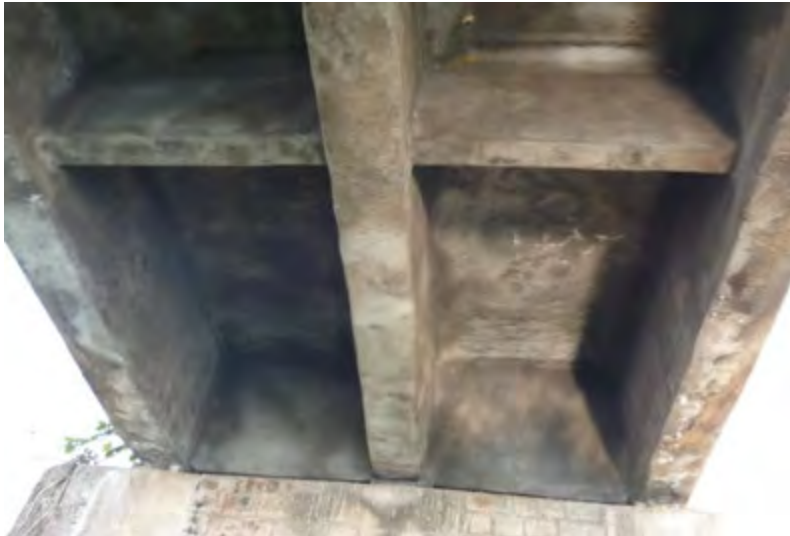
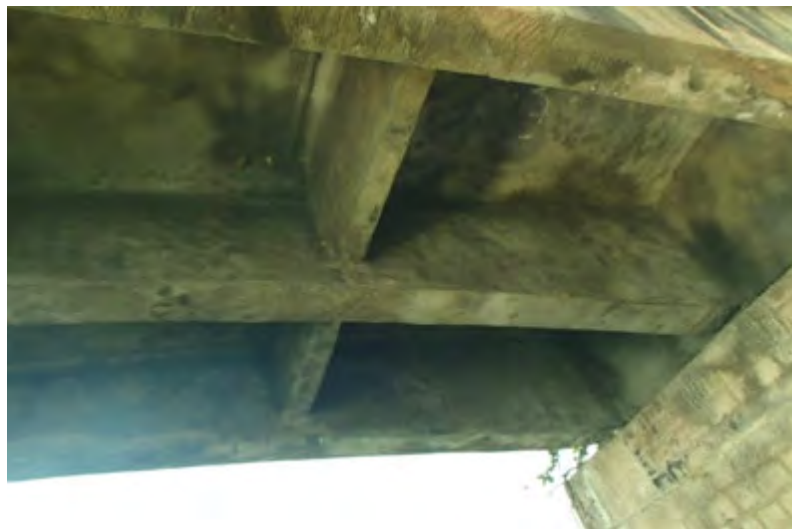
Object Member	Girder (all spans)
Kind of Damage	Many cracks and efflorescence are observed on the girder web.
Sketch or Photo

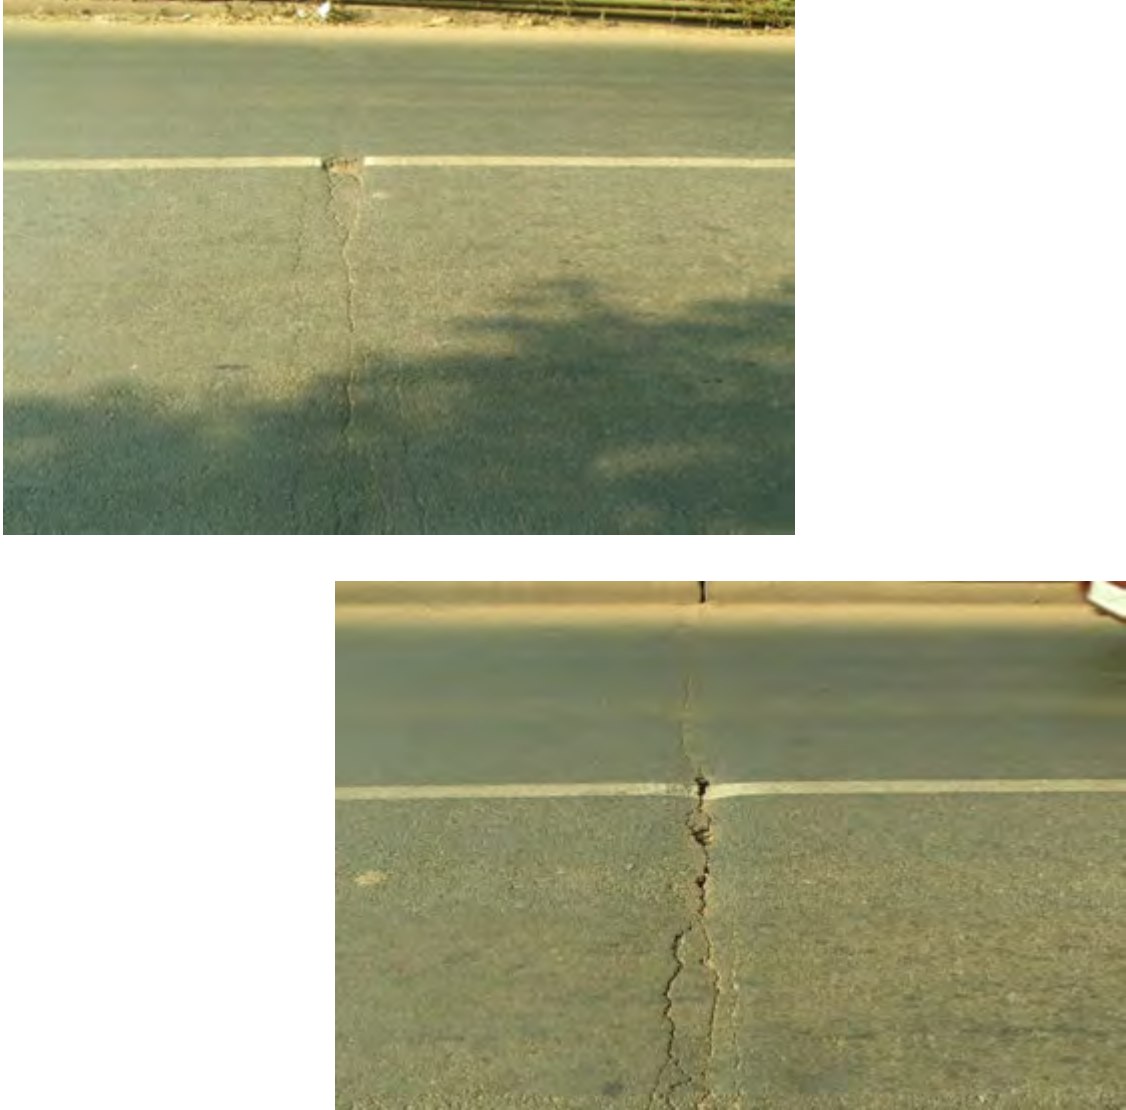
Object Member	EXP Joints
Kind of Damage	EXP Joints are plugged and non functional
Sketch or Photo

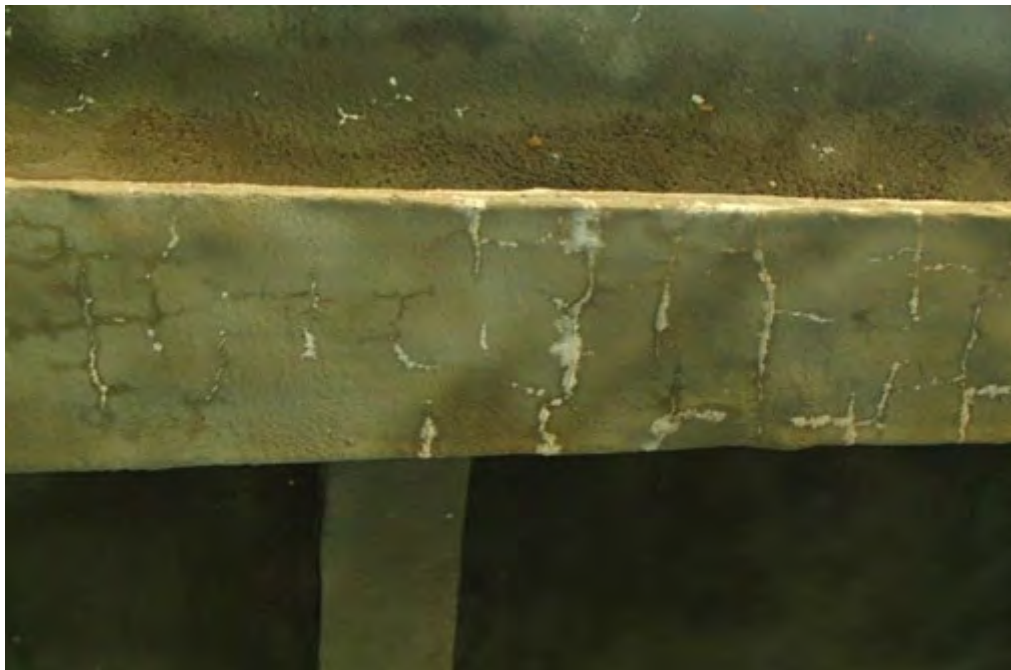
Object Member	Girder (A1-P1)
Kind of Damage	Some cracks are observed in the bottom girder
Sketch or Photo

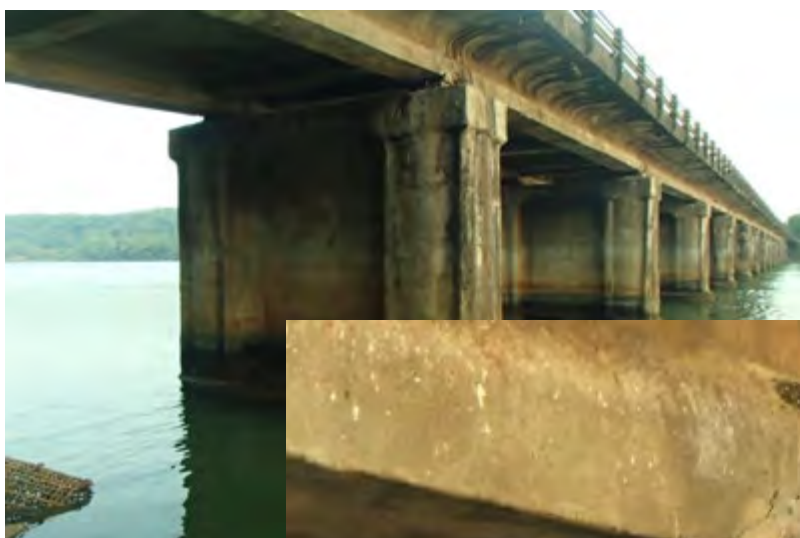
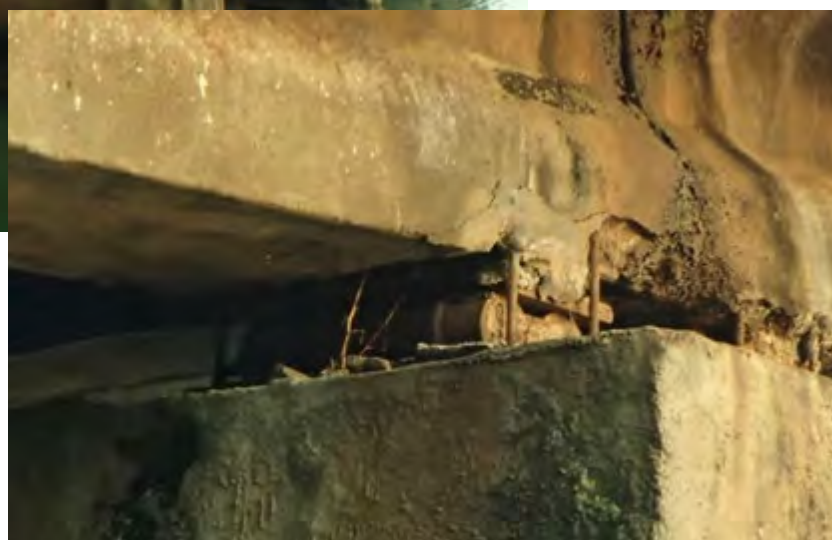
Object Member	Bearing Shoe (P1)
Kind of Damage	Peeling of mortar concrete and cracking
Sketch or Photo

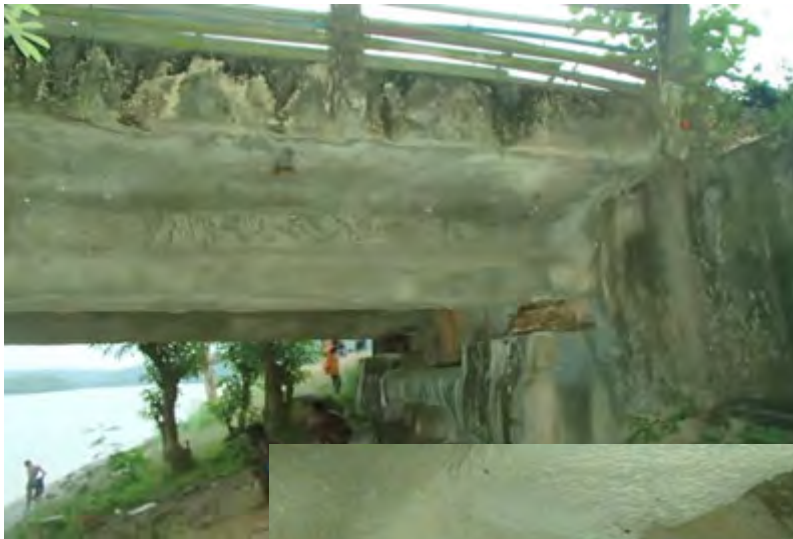
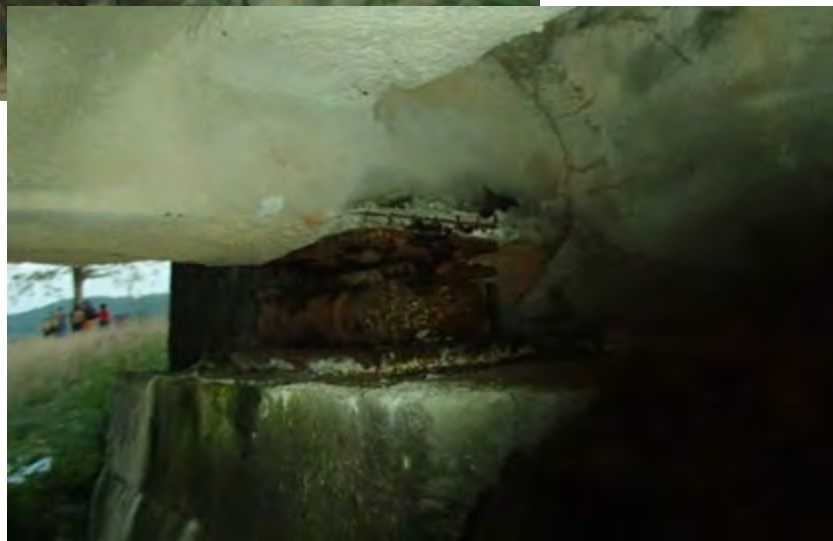
Object Member	Bearing Shoe (A2)
Kind of Damage	Peeling of mortar concrete and corrosion
Sketch or Photo

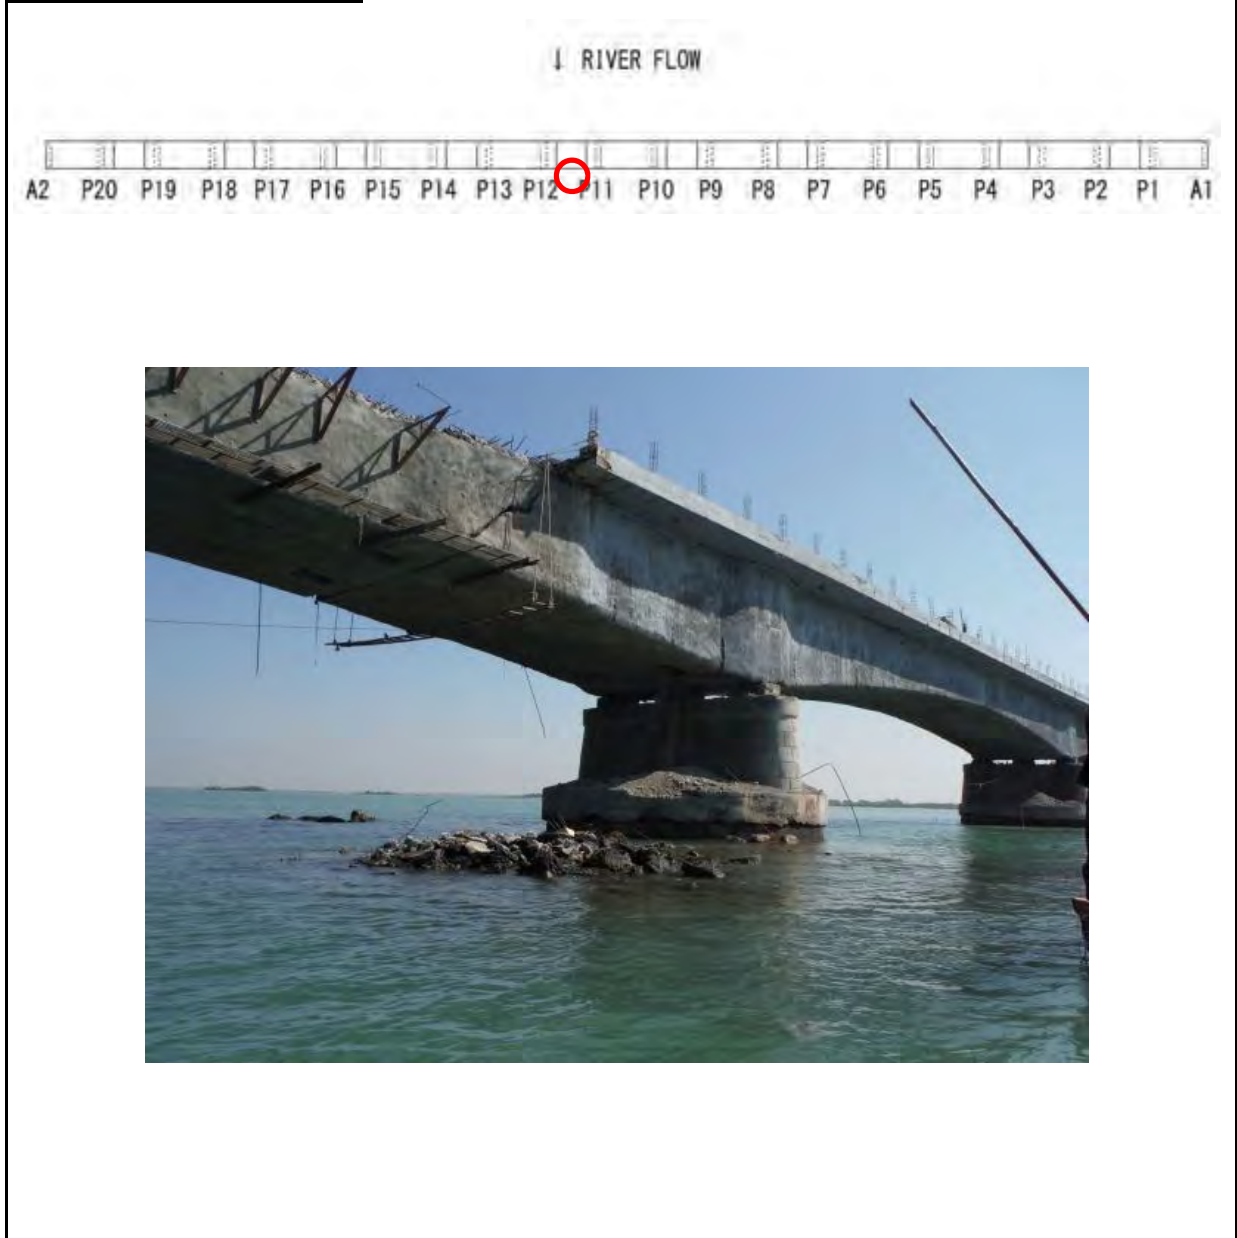
Object Member	RC Box Girder
Kind of Damage	Under Repairing
Sketch or Photo

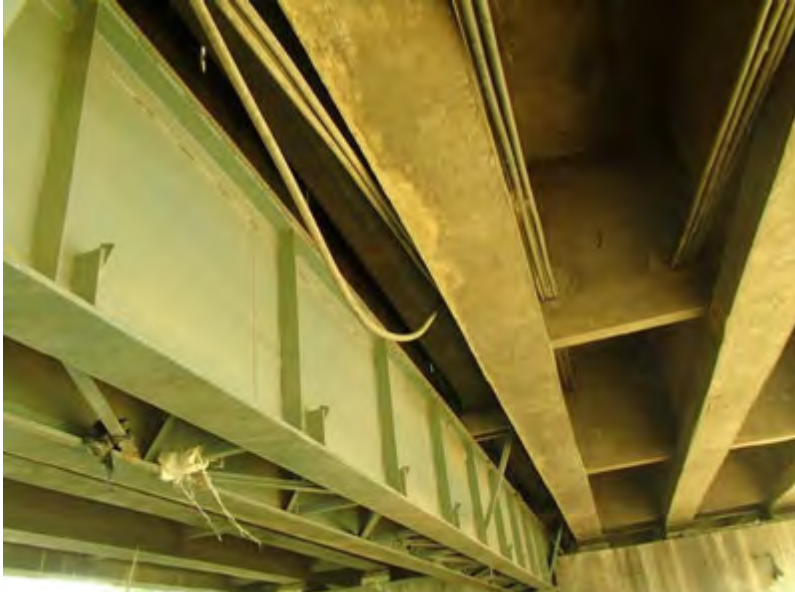
Object Member	Girder outcable (P2P3)
Kind of Damage	Slack of outcable
Sketch or Photo	<div style="text-align: center; margin-bottom: 10px;">↓ RIVER FLOW</div>

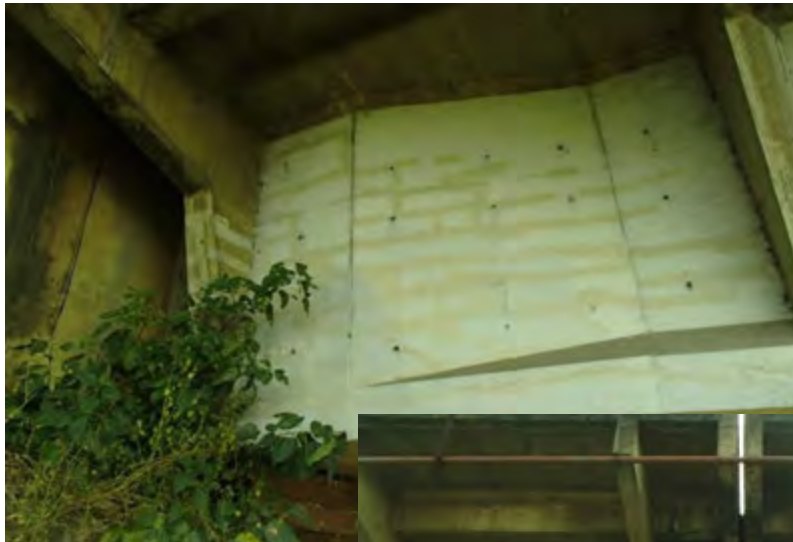
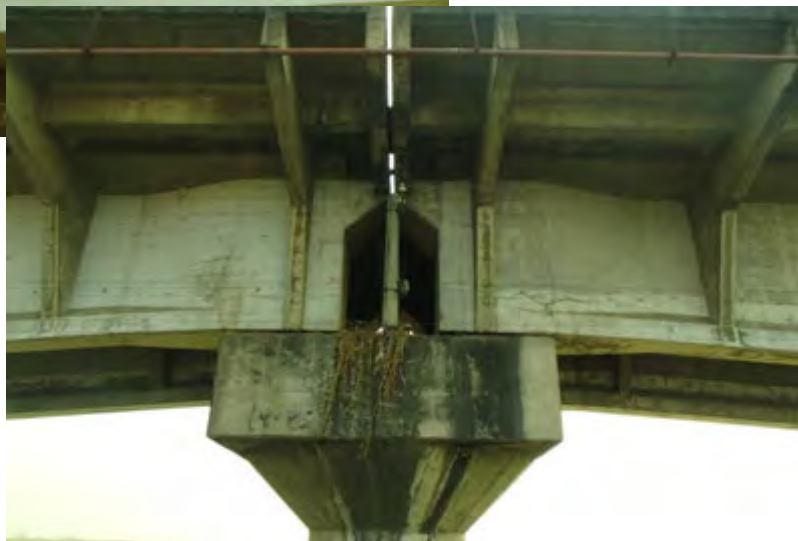
Object Member	Girder end
Kind of Damage	Small cracks on web. Some of them were already repaired in 1981
Sketch or Photo

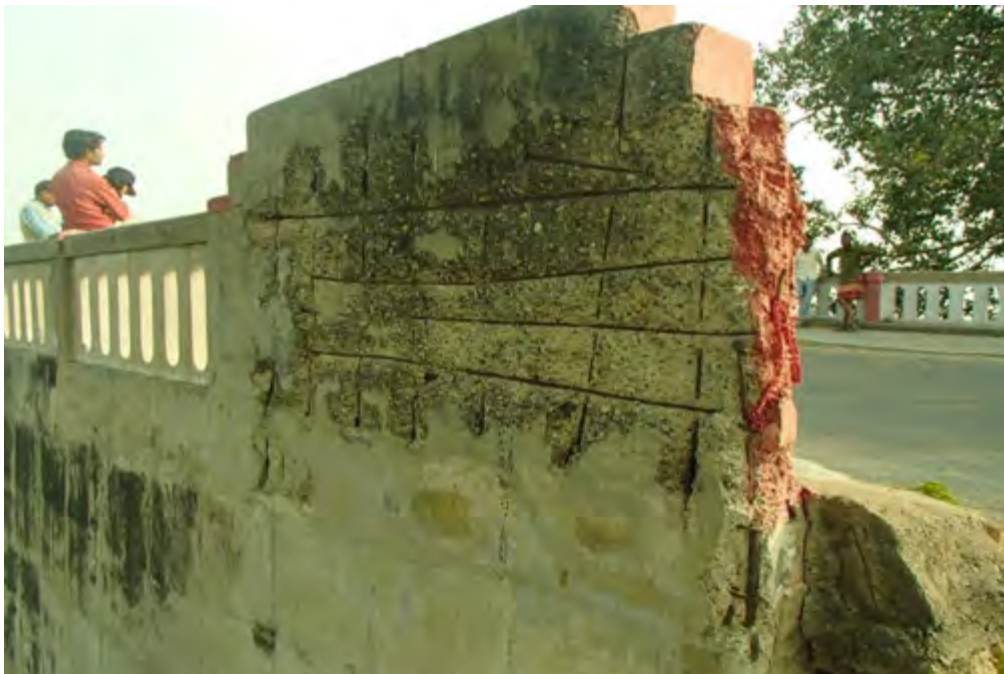
Object Member	Handrail (A1)
Kind of Damage	CC peeling and corroded re-bar exposed
Sketch or Photo

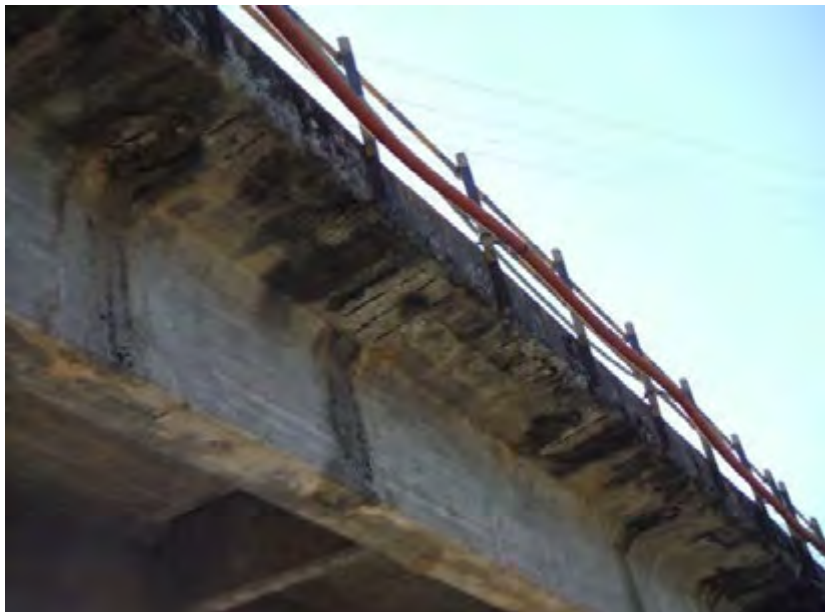
Object Member	RC T Girder
Kind of Damage	Re-bar exposed and corroded
Sketch or Photo	<div data-bbox="606 806 909 862" data-label="Text"> <p>↓ RIVER FLOW</p> </div> <div data-bbox="343 963 1244 1120" data-label="Diagram"> </div>
