APPENDIX

Bridge Survey Record by Visual Inspection

Bridge No.	1	Location (State)	Assam
Bridge Name	Jia-Bharali Bridge	Road Name	NH 15 (old NH 52)
Station	Km166	Road Category	National Highway
GPS Data	N 26 ° 48 ' 36.0 "	Management Authority	State PWD
	E 092 ° 52 ' 23.6 "	Year of Construction	1962

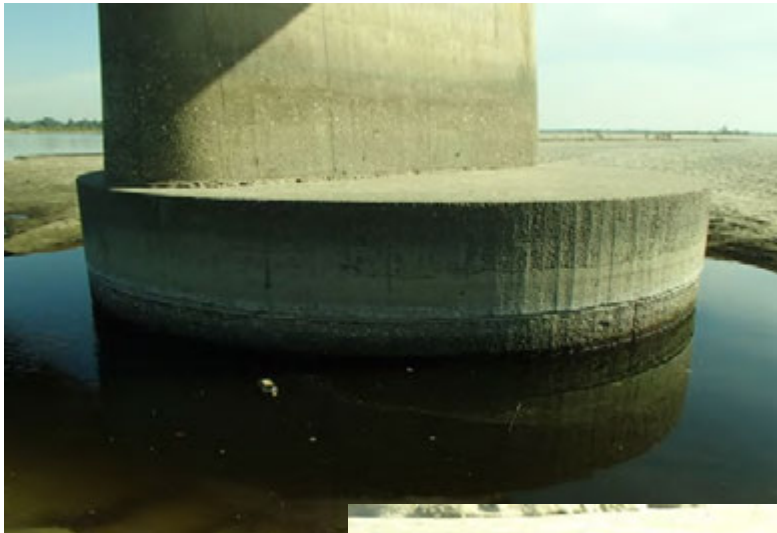
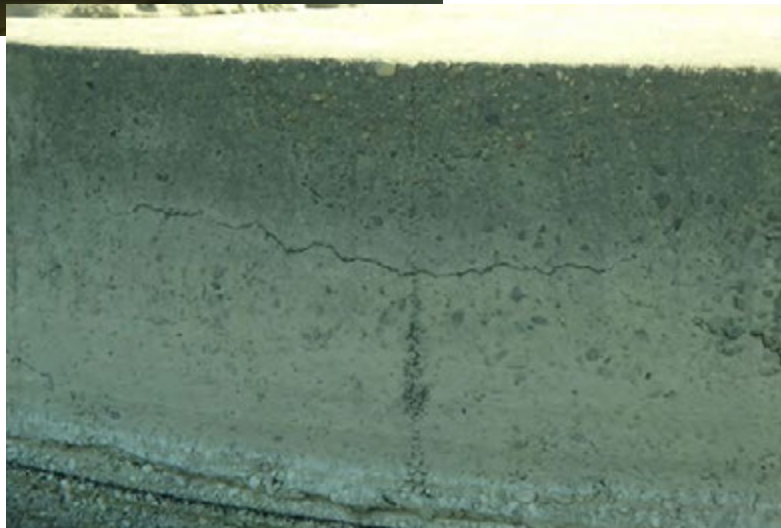
Object Member	Foundation (P3)
Kind of Damage	Cracks on well cap
Sketch or Photo

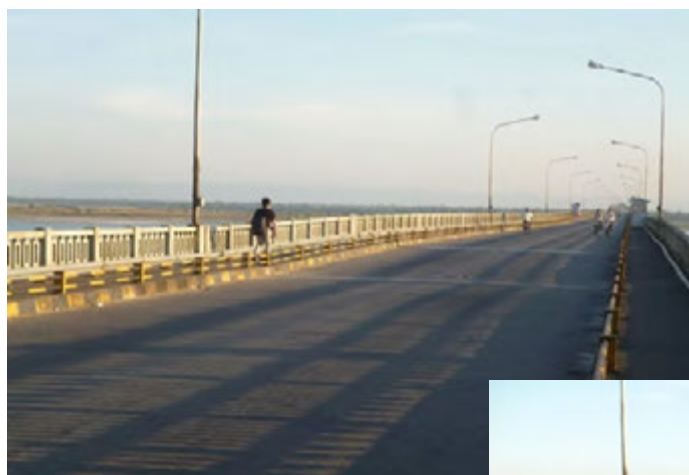
Object Member	Gerber Girder (at some spans)
Kind of Damage	Unequal level in deck slab of Gerber Girder in some spans
Sketch or Photo

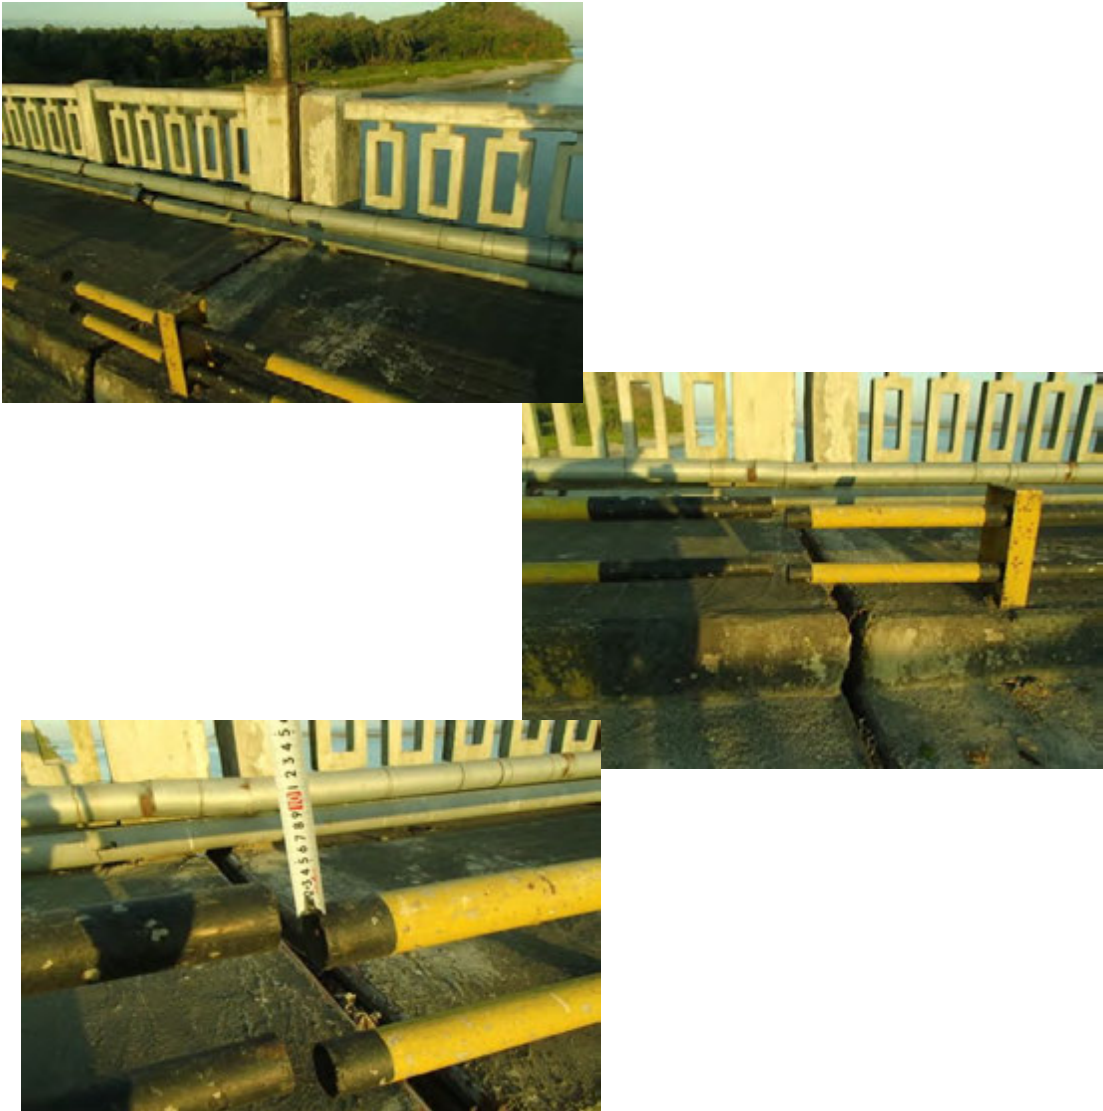
Object Member	Gerber Girder (at some spans)
Kind of Damage	Unequal level in deck slab of Gerber Girder
Sketch or Photo

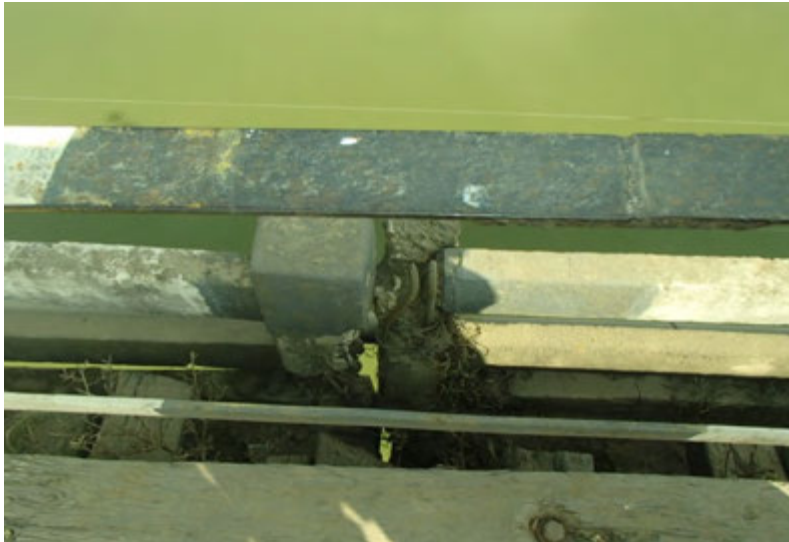
Object Member	Handrail at centre hinge
Kind of Damage	CC crumbling
Sketch or Photo

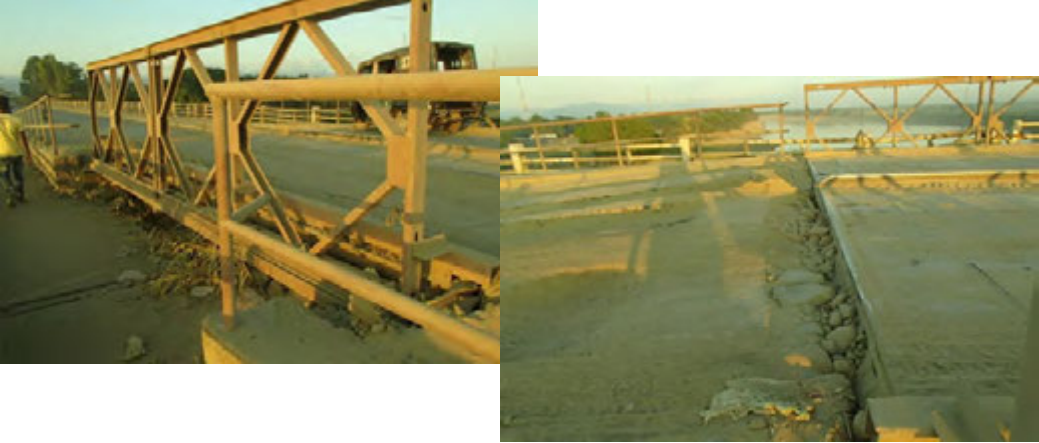
Object Member	Centre Hinge (P1-P2)
Kind of Damage	End point of girders damaged. Abnormal deflection, and 10m span steel bridge are provided over the centre hinge.
Sketch or Photo

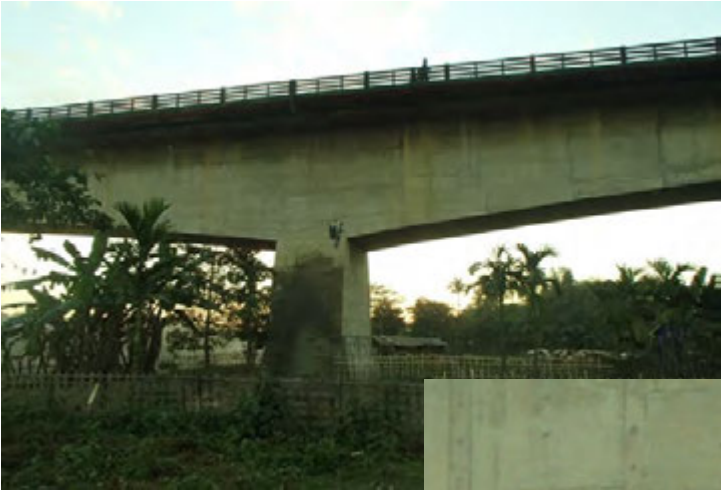
Object Member	Girder (P1, downstream side)
Kind of Damage	Cracks
Sketch or Photo

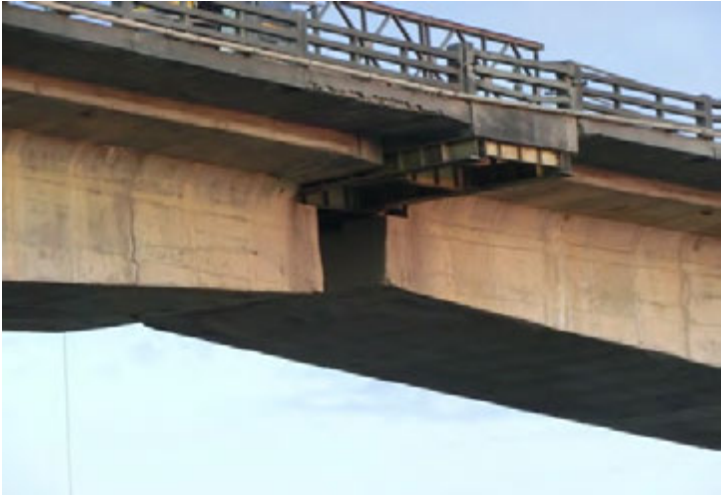
Object Member	Kerb
Kind of Damage	Peeling off finishing layer
Sketch or Photo	<div style="text-align: center;">

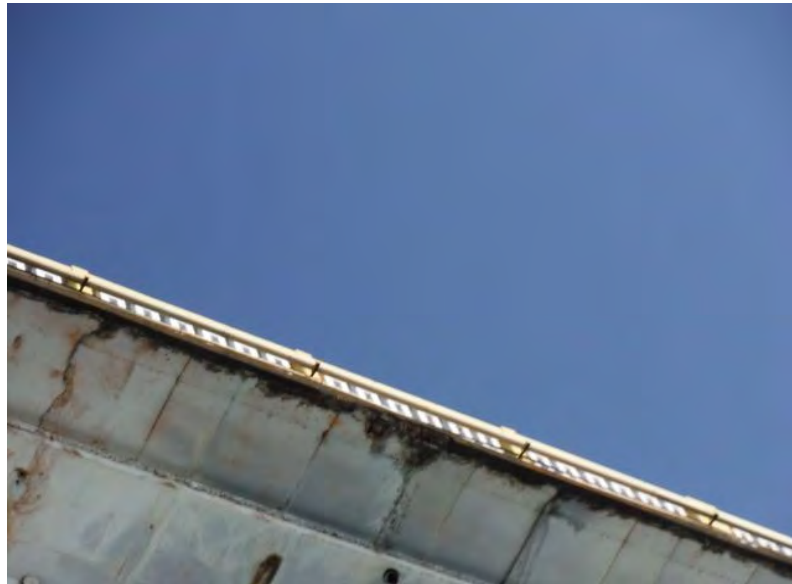
Object Member	PC Box Girder
Kind of Damage	Concrete Peeling, Re-bar exposed and Corroded
Sketch or Photo

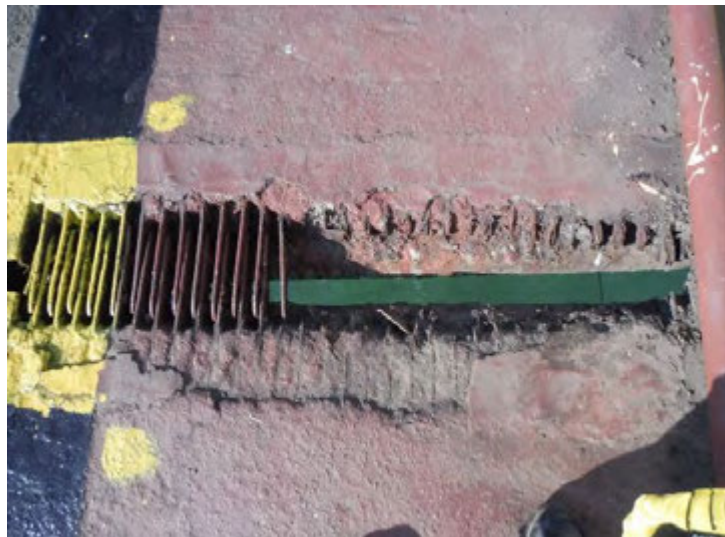
Object Member	EXP Joint (P7)
Kind of Damage	Broken
Sketch or Photo

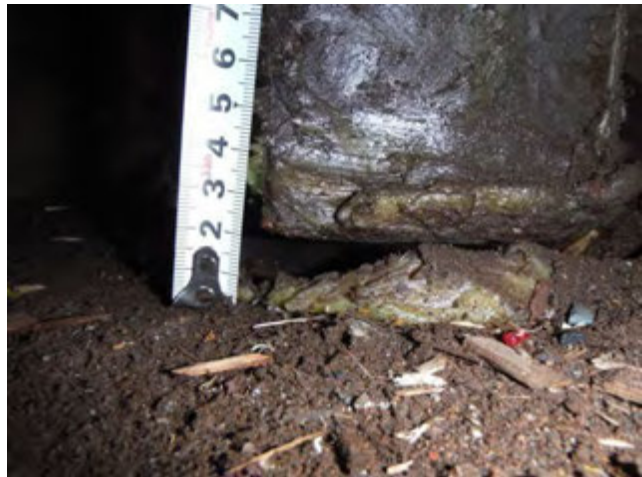
Object Member	Girder (P1P2)
Kind of Damage	There are some level difference at centre hinge
Sketch or Photo

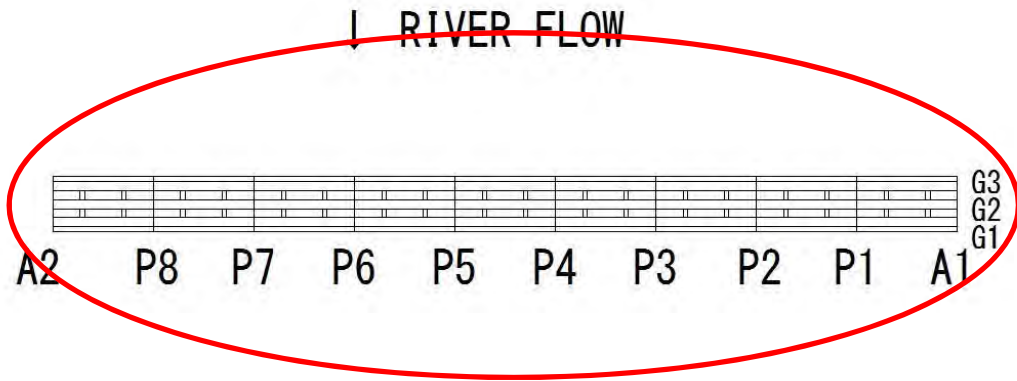
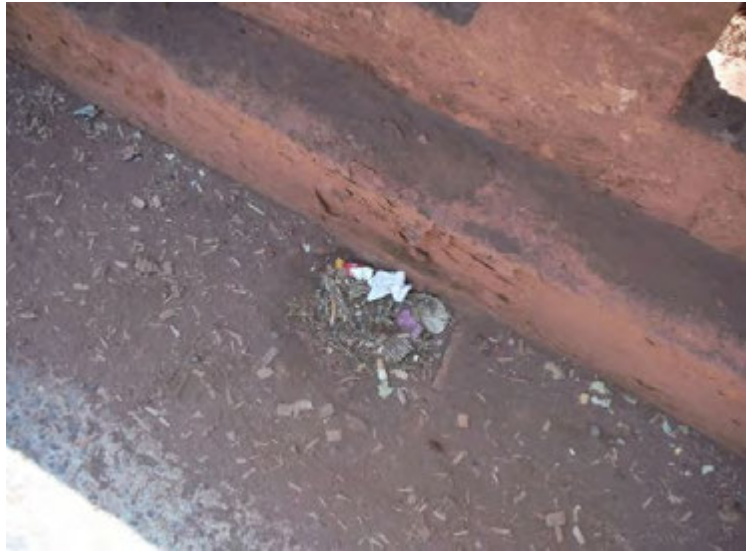
Object Member	Drainage Pipe
Kind of Damage	Filling
Sketch or Photo

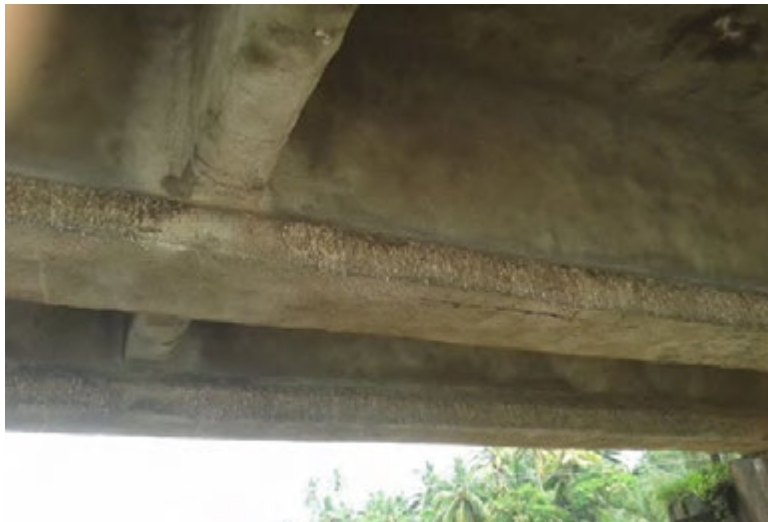
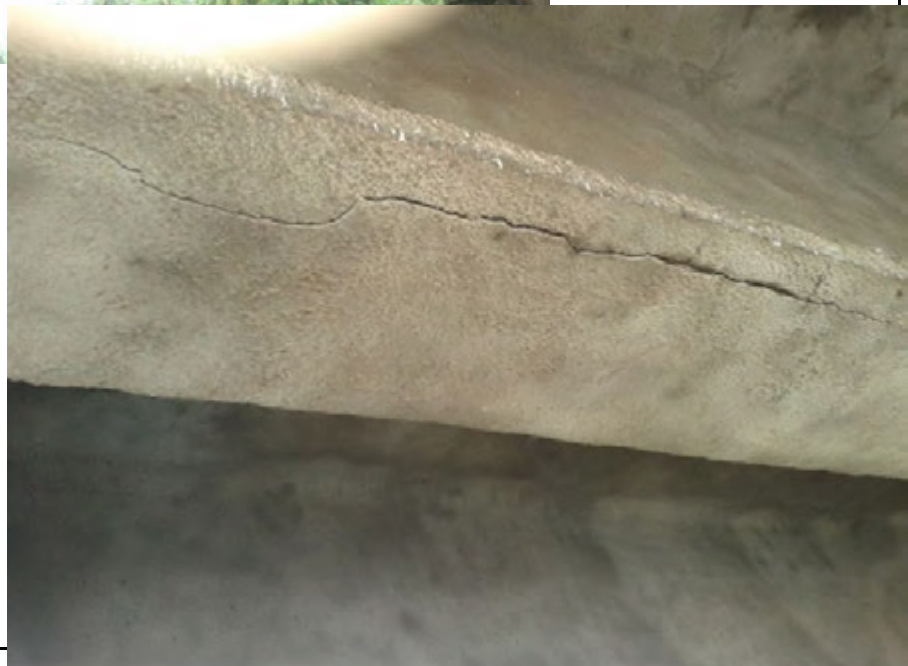
Object Member	Girder
Kind of Damage	Cracks on lower flange (P4-A2)
Sketch or Photo

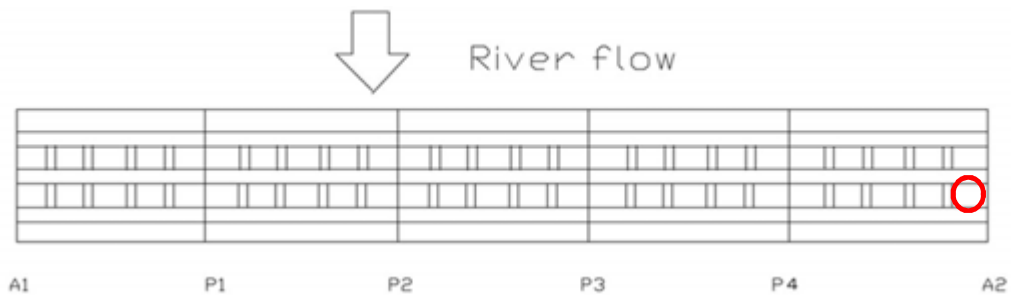
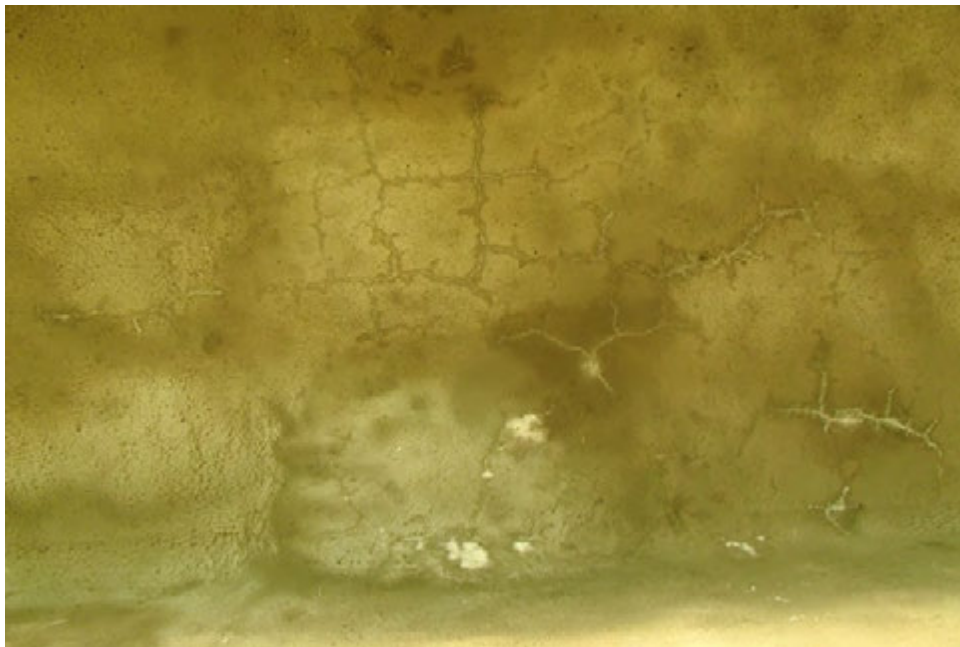
Object Member	Deck slab (P4-A2)
Kind of Damage	Some cracks are observed in the bottom of the deck slab
Sketch or Photo

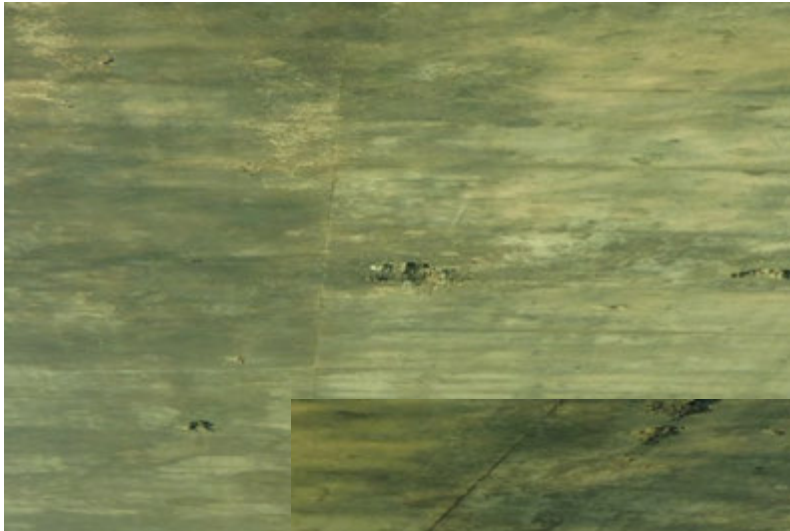
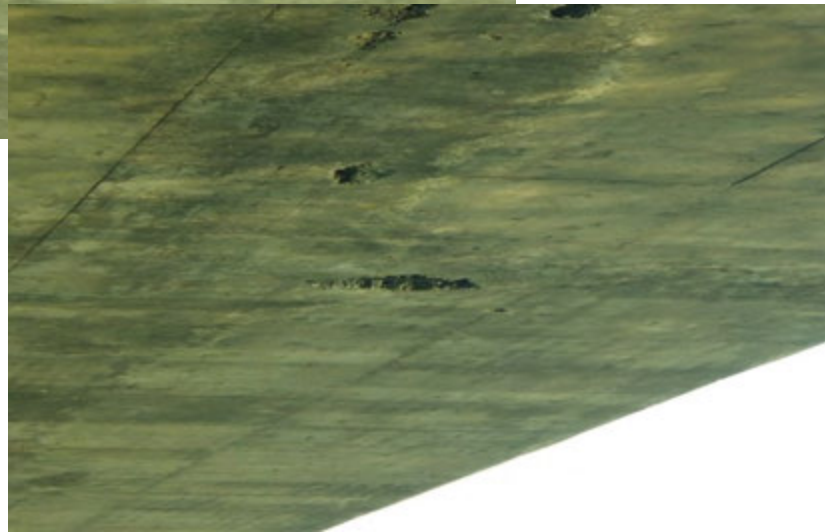
Object Member	Deck Slab (P14-A2)
Kind of Damage	Honeycomb
Sketch or Photo

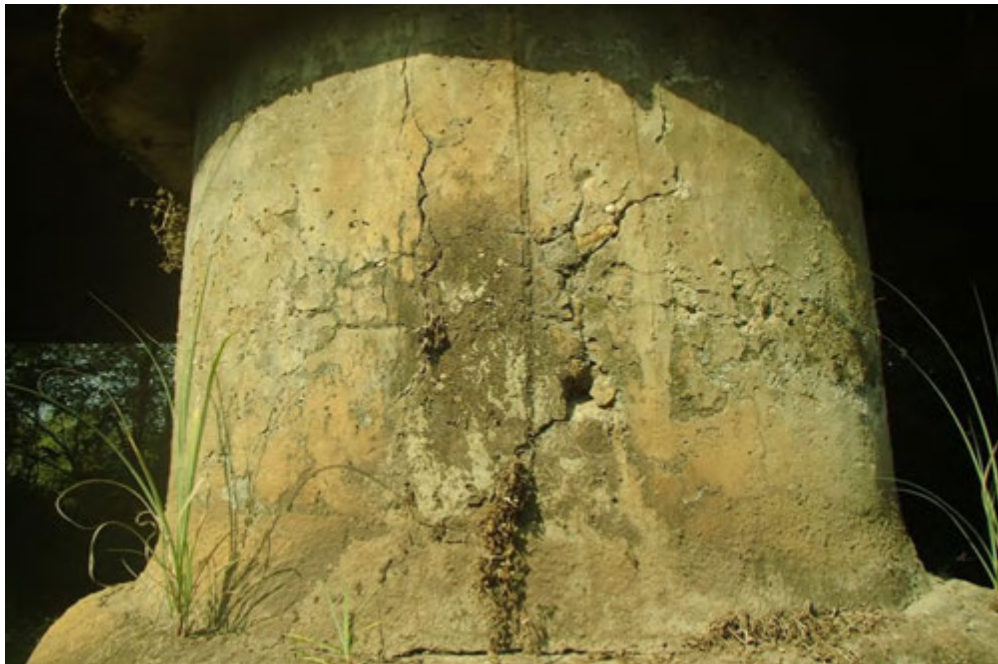
Object Member	P2 upstream side
Kind of Damage	Crack
Sketch or Photo

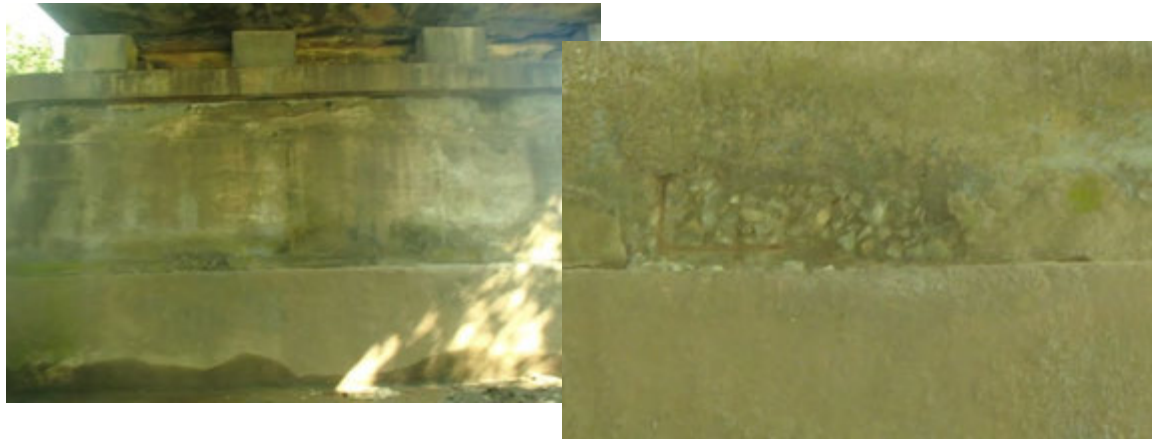
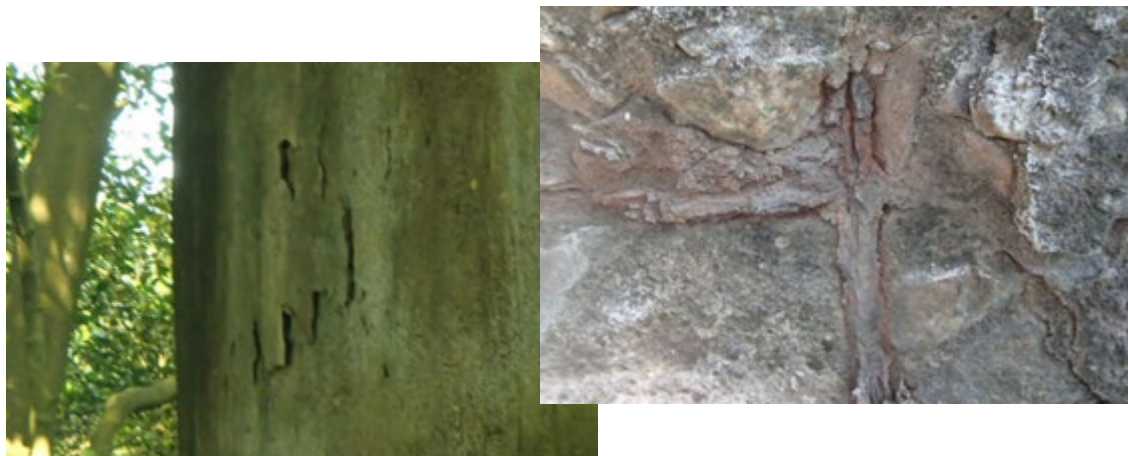
Object Member	P4
Kind of Damage	CC peeling and corroded re-bar exposed
Sketch or Photo

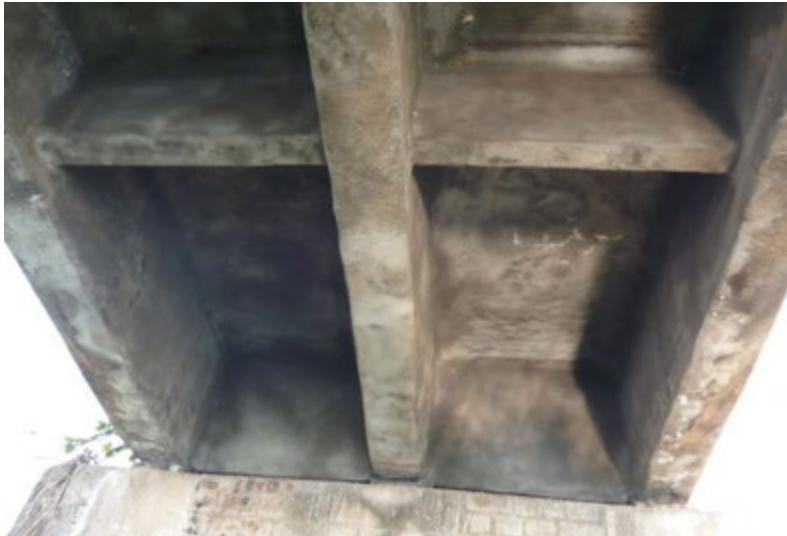
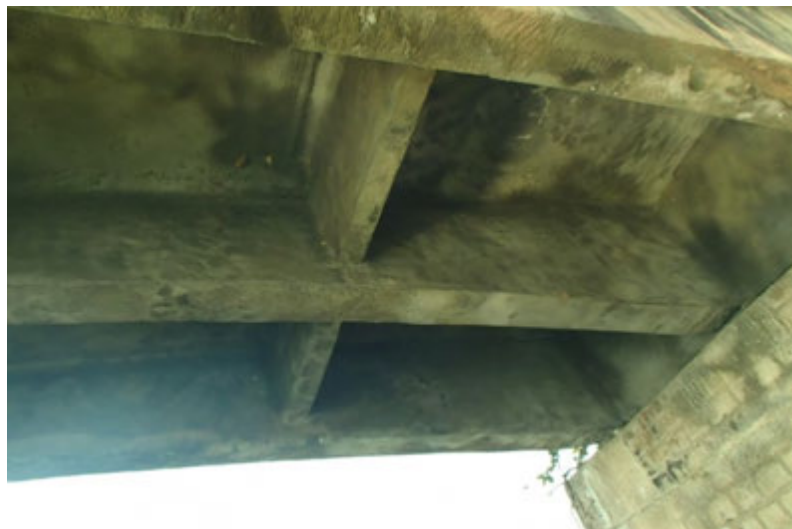
Object Member	Girder (all spans)
Kind of Damage	Many cracks and efflorescence are observed on the girder web.
Sketch or Photo

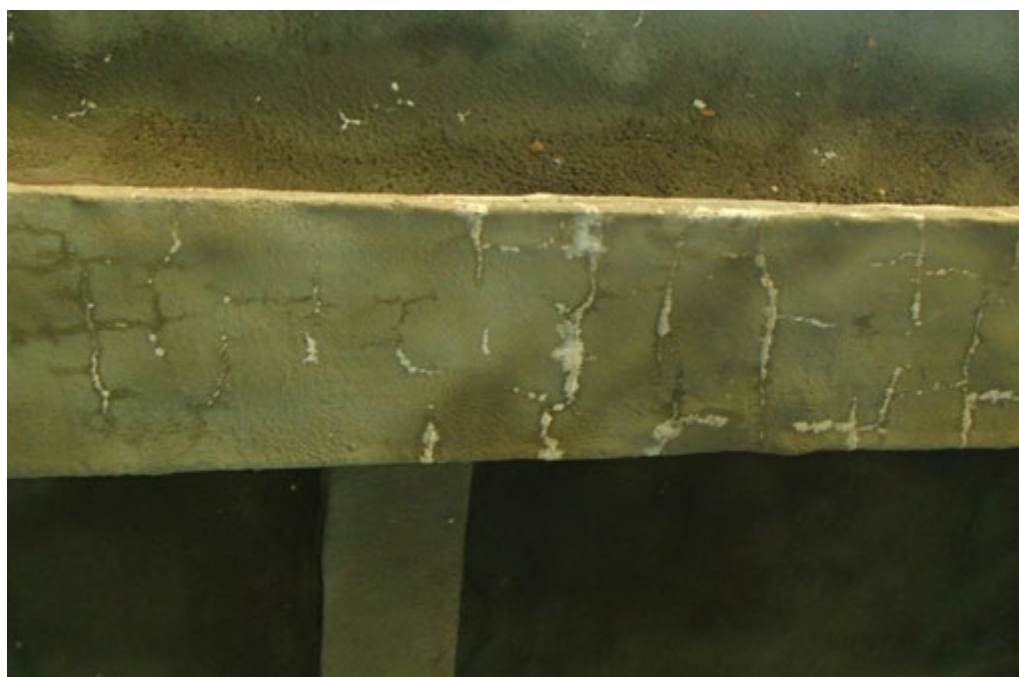
Object Member	Girder (A1-P1)
Kind of Damage	Some cracks are observed in the bottom girder
Sketch or Photo

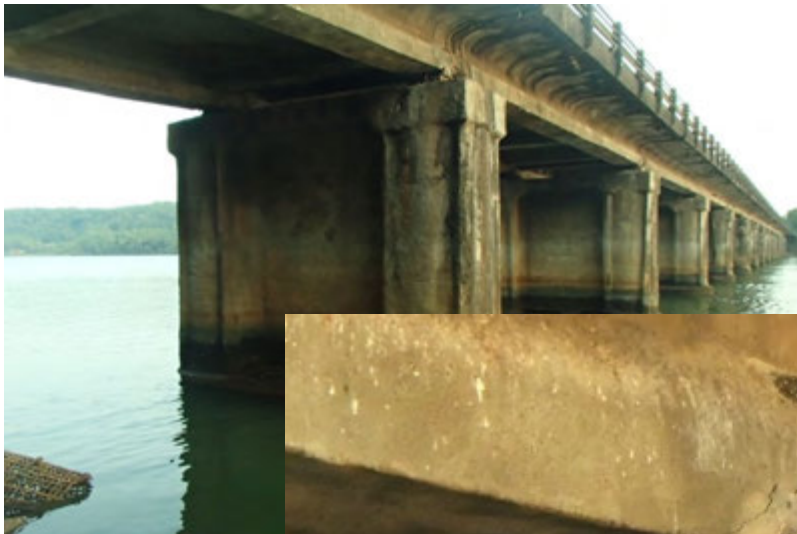
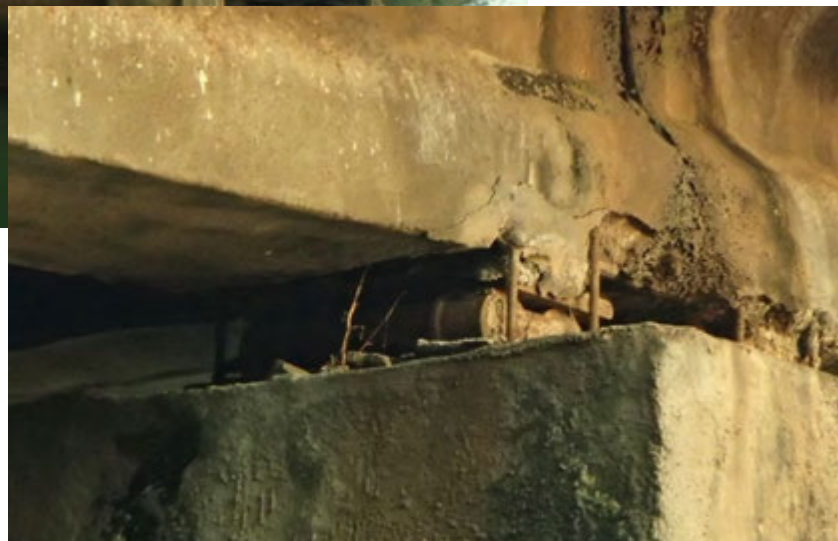
Object Member	Bearing Shoe (P1)
Kind of Damage	Peeling of mortar concrete and cracking
Sketch or Photo

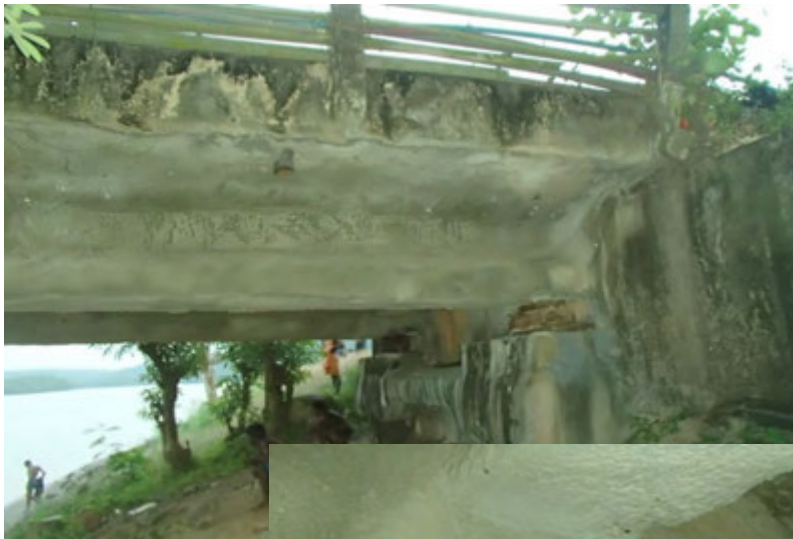
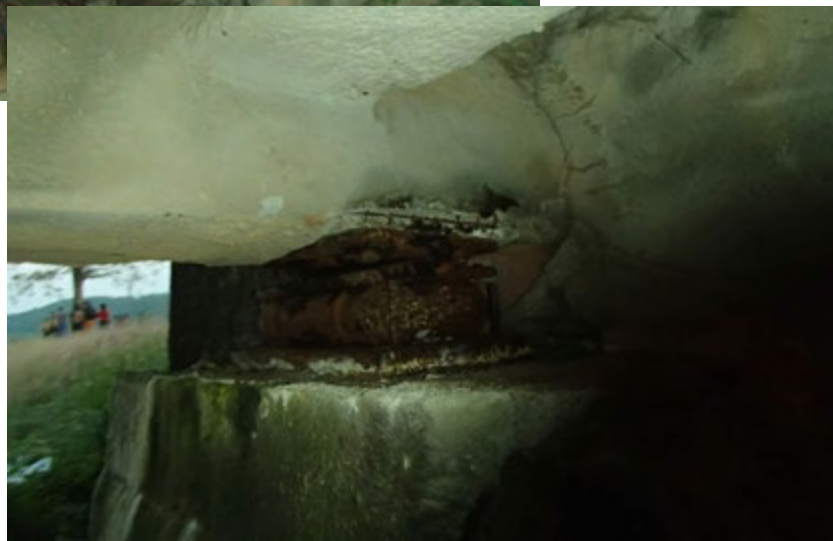
Object Member	Bearing Shoe (A2)
Kind of Damage	Peeling of mortar concrete and corrosion
Sketch or Photo

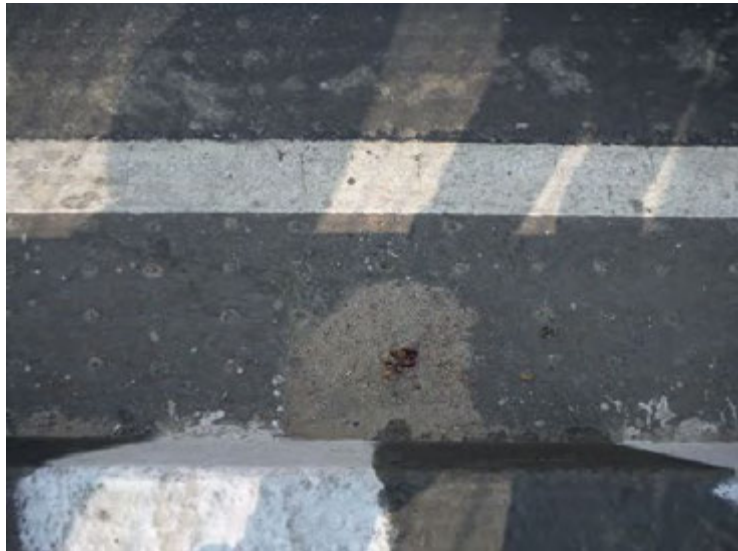
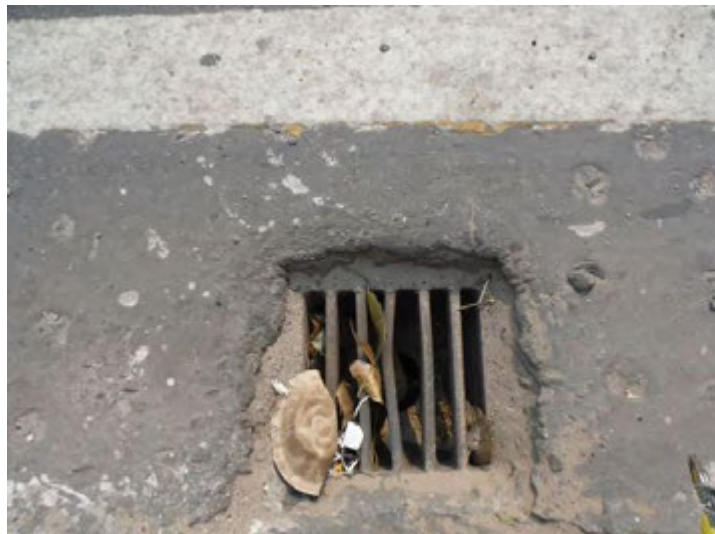
Object Member	Drainage Pipe
Kind of Damage	filling
Sketch or Photo

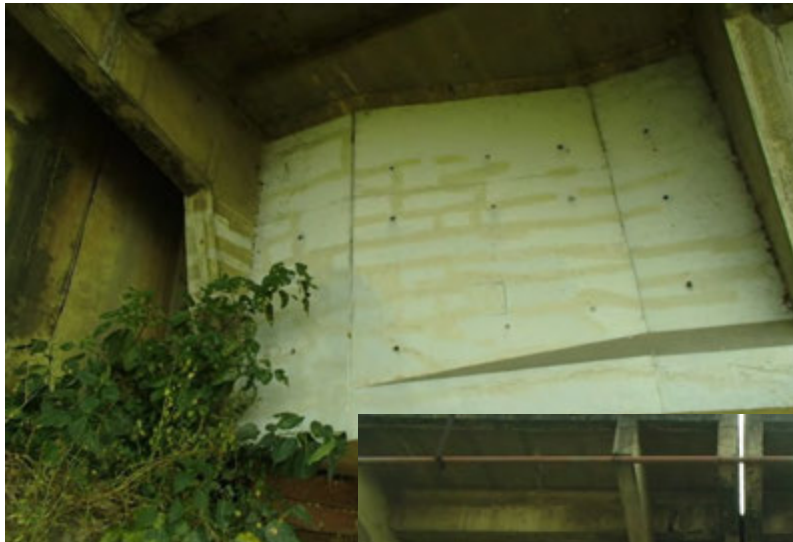
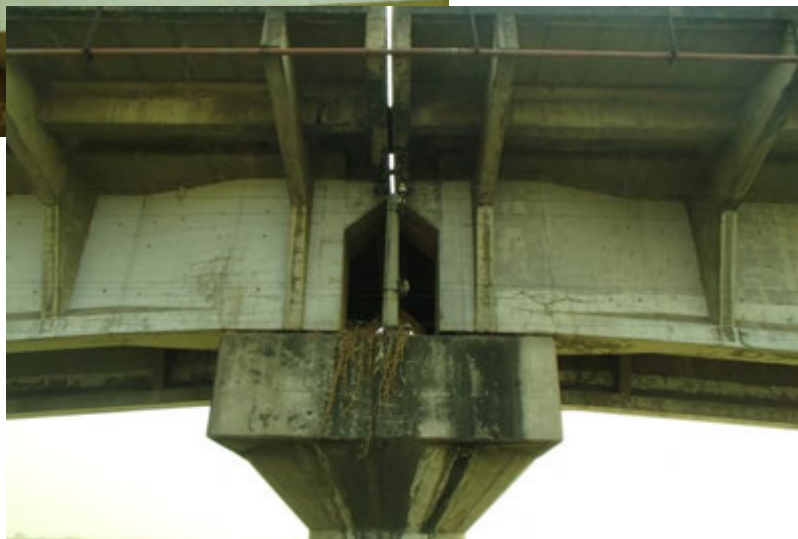
Object Member	Girder end
Kind of Damage	Small cracks on web. Some of them were already repaired in 1981
Sketch or Photo

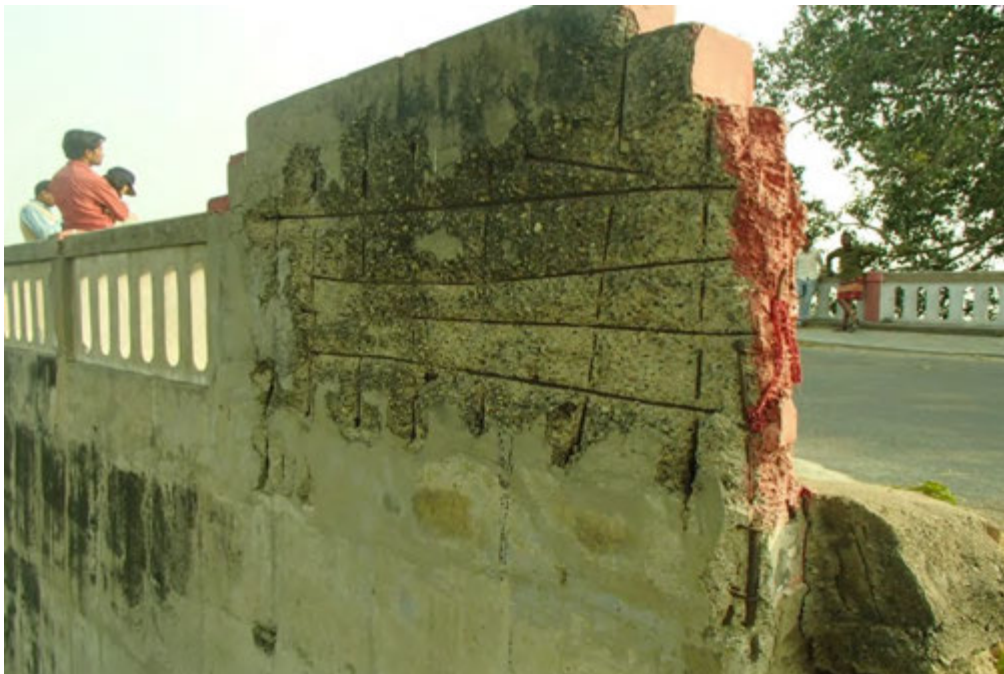
Object Member	Handrail (A1)
Kind of Damage	CC peeling and corroded re-bar exposed
Sketch or Photo

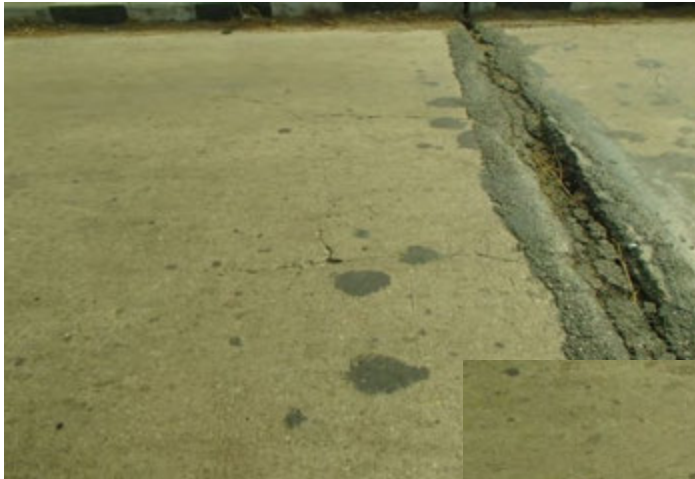
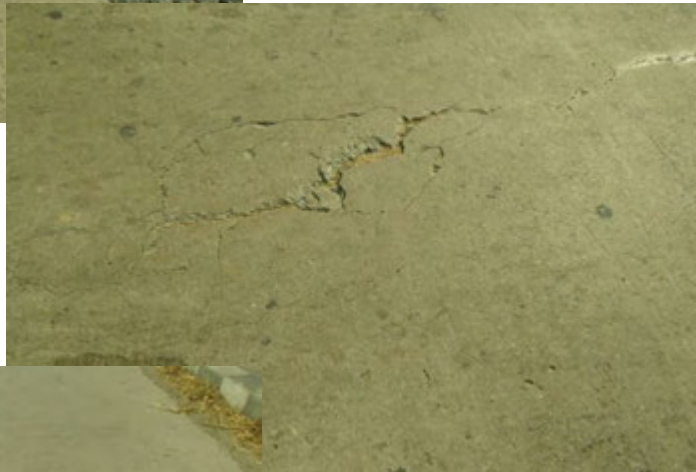
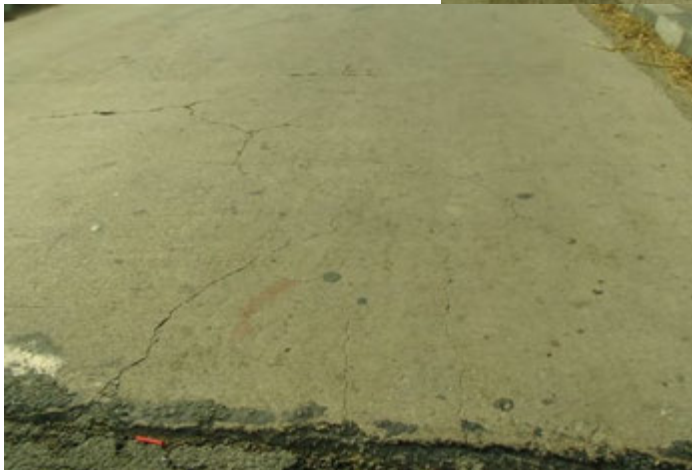
Object Member	Pvement (all portions)
Kind of Damage	Many cracks on concrete pavement
Sketch or Photo

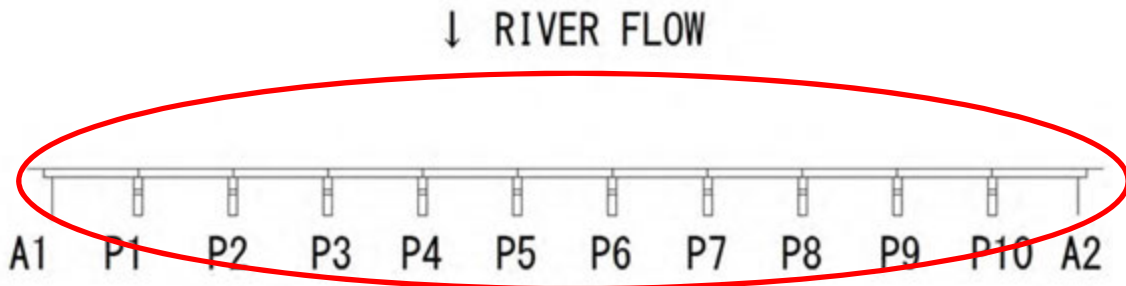
Object Member	Pavement
Kind of Damage	Cracking
Sketch or Photo
