Chapter 8 Summary of the Direction of Japan's Future Cooperation

8-1. Summary by Assistance Scheme

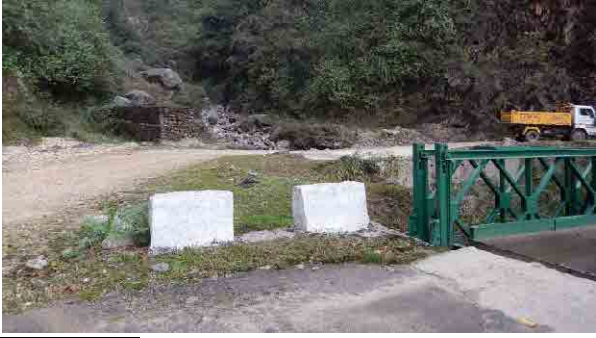
Member	Detour			Member			
Type of damage	Other	Damage level	-	Type of damage		Damage level	
Condition	Restriction (use former road) of heavy vehicles			Condition

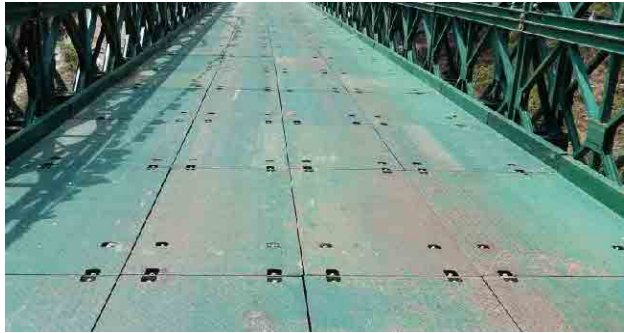
Bridge Name		A-4.Gektong zam		PNH	No.1 Nangar-Ura bypass	Date	2014/4/16	
Damage photo	Member	Surface		Member	Truss			
	Type of damage	-	Damage level	a	Type of damage	-	Damage level	a
	Condition	Soundness		Condition	Soundness

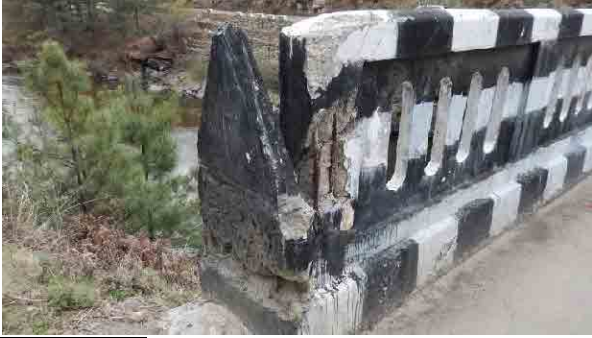
Bridge Name		A-5.Tangchu zam			PNH	No.1	Date	2014/4/17
Damage photo	Member	Railing			Member	Abutment wall		
	Type of damage	Loss of concrete	Damage level	c	Type of damage	Peeling off	Damage level	d
	Condition	Peeling off/rebar exposure			Condition	Partly rebar exposure

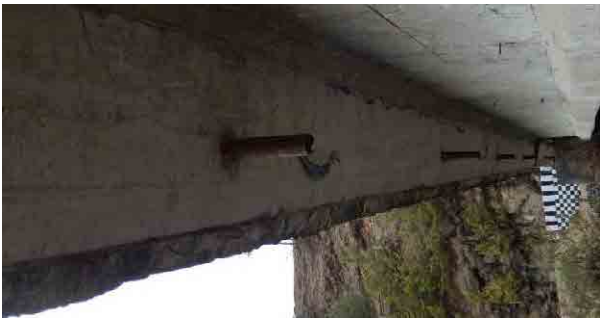
Member	Drainage facilities			Member	Body wall		
	Type of damage	-	Damage level	a	Type of damage	-	Damage level	a
Condition	Soundness			Condition	Soundness

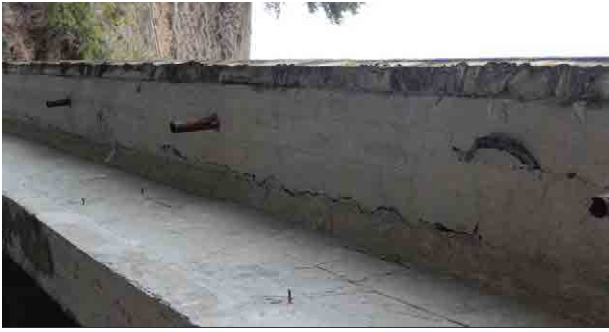
Member	Railing			Member				
Type of damage	Crack	Damage level	c	Type of damage		Damage level		
Condition	Partly cracking			Condition

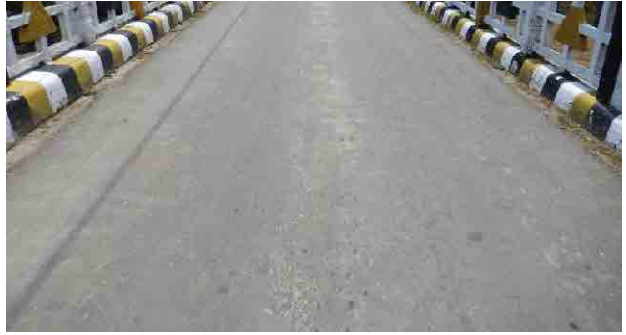
Member	Bearinmg shoe		Member	Pavement			
	Type of damage	-	Damage level	a	Type of damage	-	Damage level	a
	Condition	Soundness		Condition	Soundness

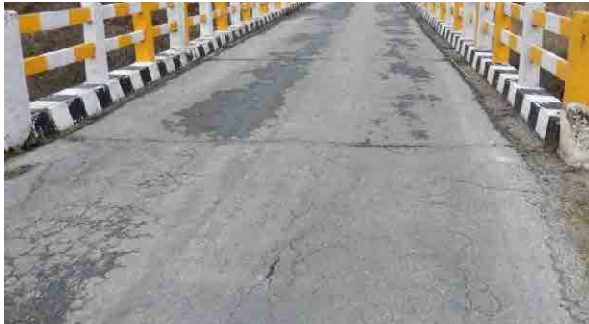
Member	Pavement surface			Member	Parapet wall		
	Type of damage	Crack	Damage level	c	Type of damage	-	Damage level	a
	Condition	Cracks on Joint and Approach road			Condition	Soundness but moss

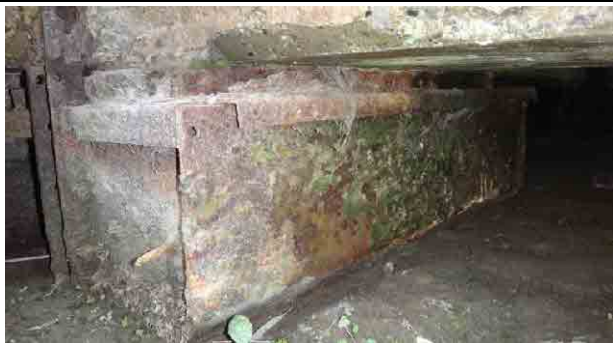
Member	Bering shoe			Member	railing		
Type of damage	Dysfunction	Damage level	e	Type of damage	Deformation	Damage level	e
Condition	Corrosion			Condition	-

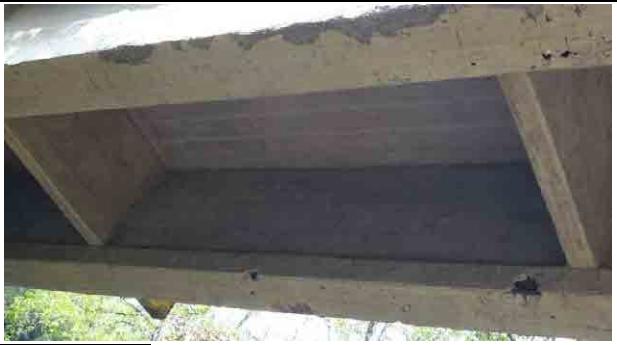
Bridge Name		B-7.Telegangchu zam			PNH	No.4	Date	2014/4/16
Damage photo	Member	Deck slab			Member	Main girder		
	Type of damage	Repar exposure	Damage level	e	Type of damage	Repar exposure	Damage level	d
	Condition	Peeling off/rebar exposure at edge of deck slab			Condition	Caused by poor constructio

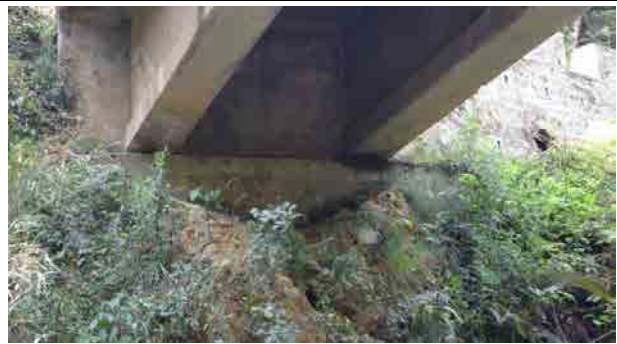
Member	Abutmnt			Member	Bearing shoe		
	Type of damage	-	Damage level	a	Type of damage	Dysfunction	Damage level	e
	Condition	Soundness			Condition	Dysfunction after water leakage

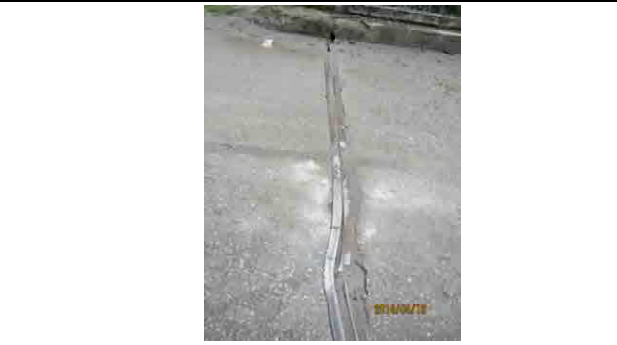
Member	Railing			Member	Pavement/Expansion joint		
	Type of damage	Deformation	Damage level	c	Type of damage	Unevenness	Damage level	c
Condition	-			Condition	Unevenness on pavement surface

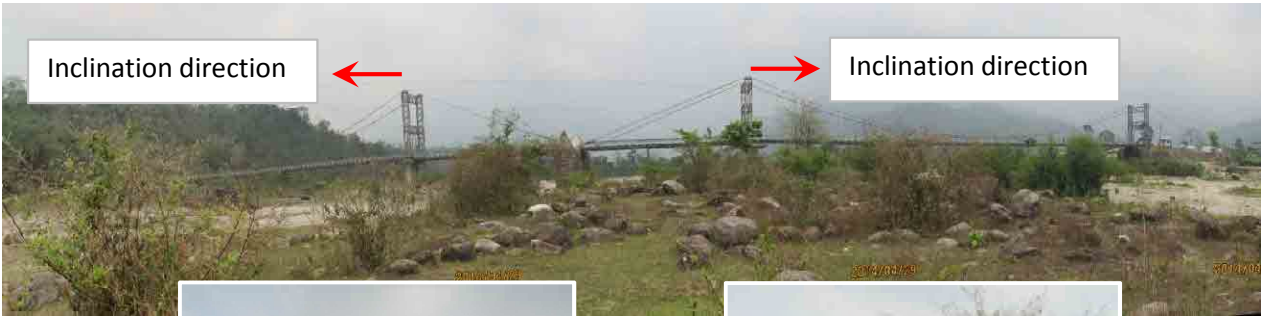
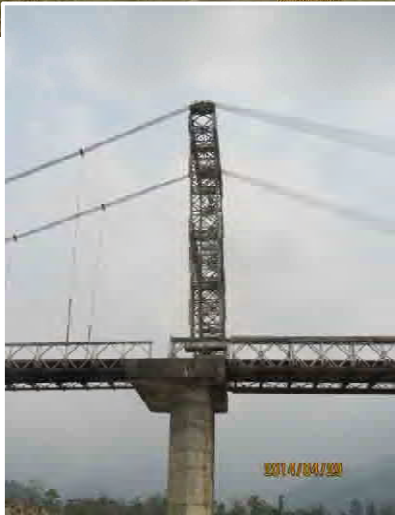
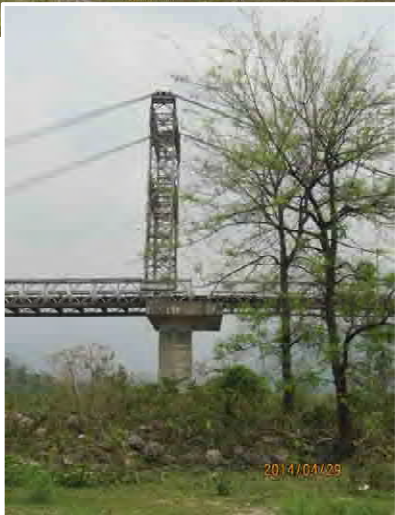
To enhance the quality control capacity for bridge construction, factorial analysis of damage is performed using heavily-damaged Diana Kuenphen zam Bridge in Samtse Dzongkhag as educational material. OJT is provided to engineers in DoR H.Q., field engineers and researchers.

Member	Entire bridge			Member			
Type of damage	Incline	Damage level	e	Type of damage		Damage level	
Condition	Each main tower inclines			Condition

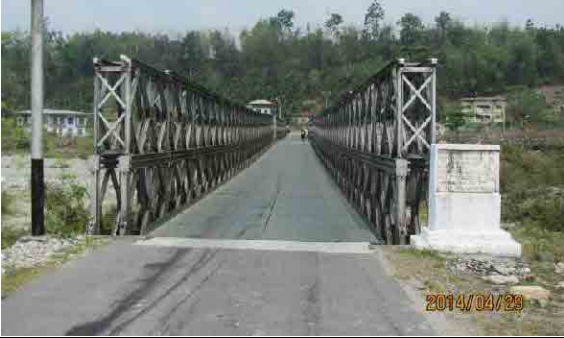
Bridge Name		C-2.Dramzang zam		PNH	Samtse-Sipsu	Date	2014/4/29	
Damage photo	Member	Deck slab/main girder		Member	Abutment			
	Type of damage	-	Damage level	-	Type of damage	Crack/free lime	Damage level	d
	Condition	Soundness		Condition	-
