APPENDICIES

APPENDIX 2-1

Number of Freight Train of Myanmar Railways

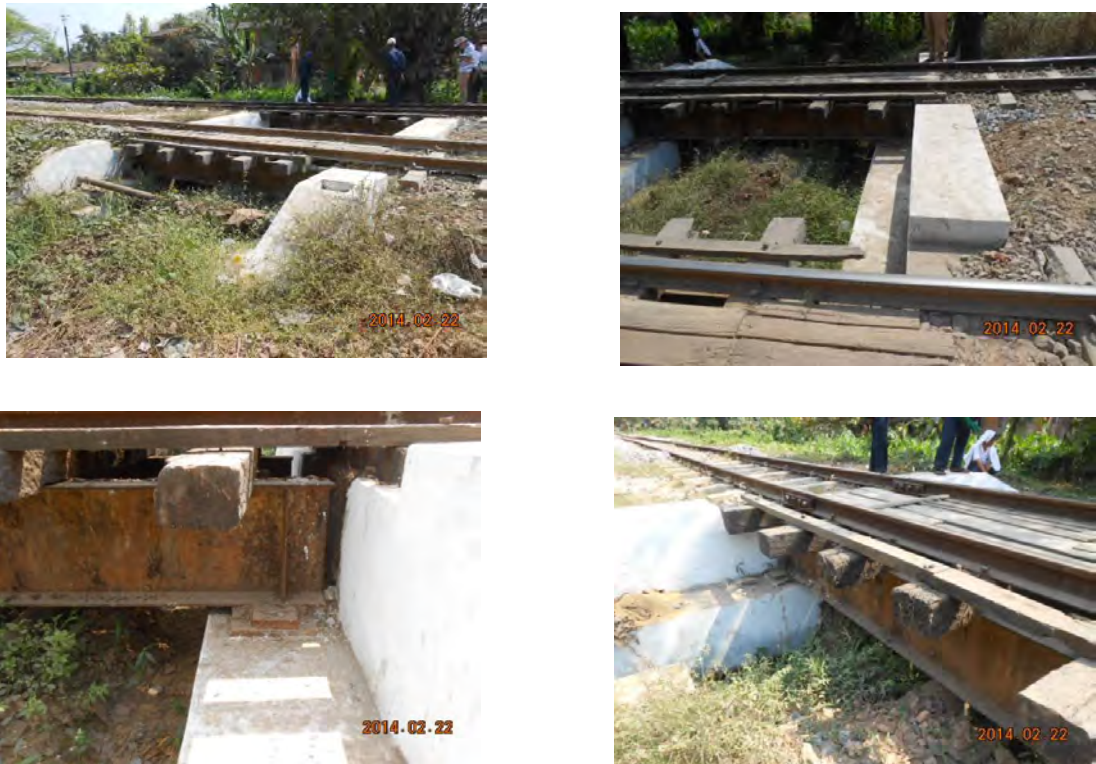
Remarks	Bridge No.43 There are water pipe and gas pipe.

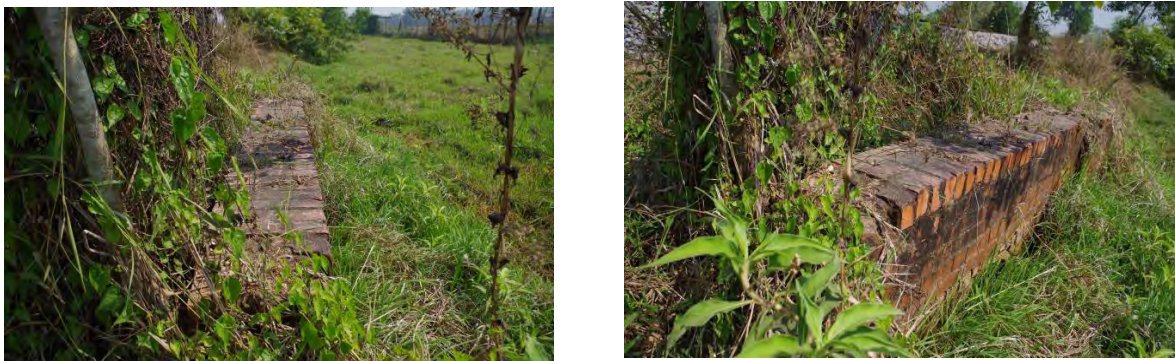
Remarks				
This is not bridge and culvert Not across the rail track

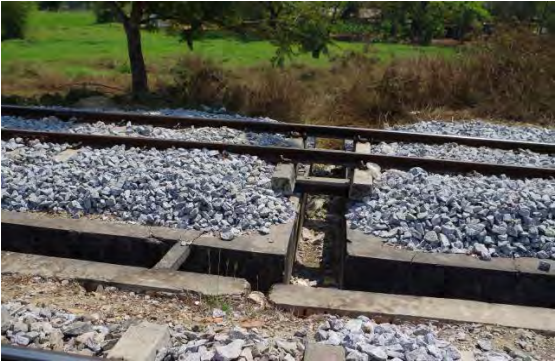
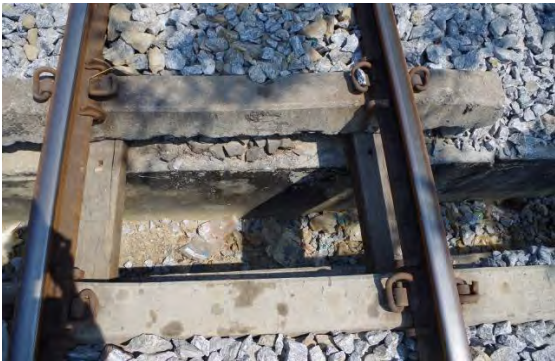
</div>				
Remarks Same as sleeper interval

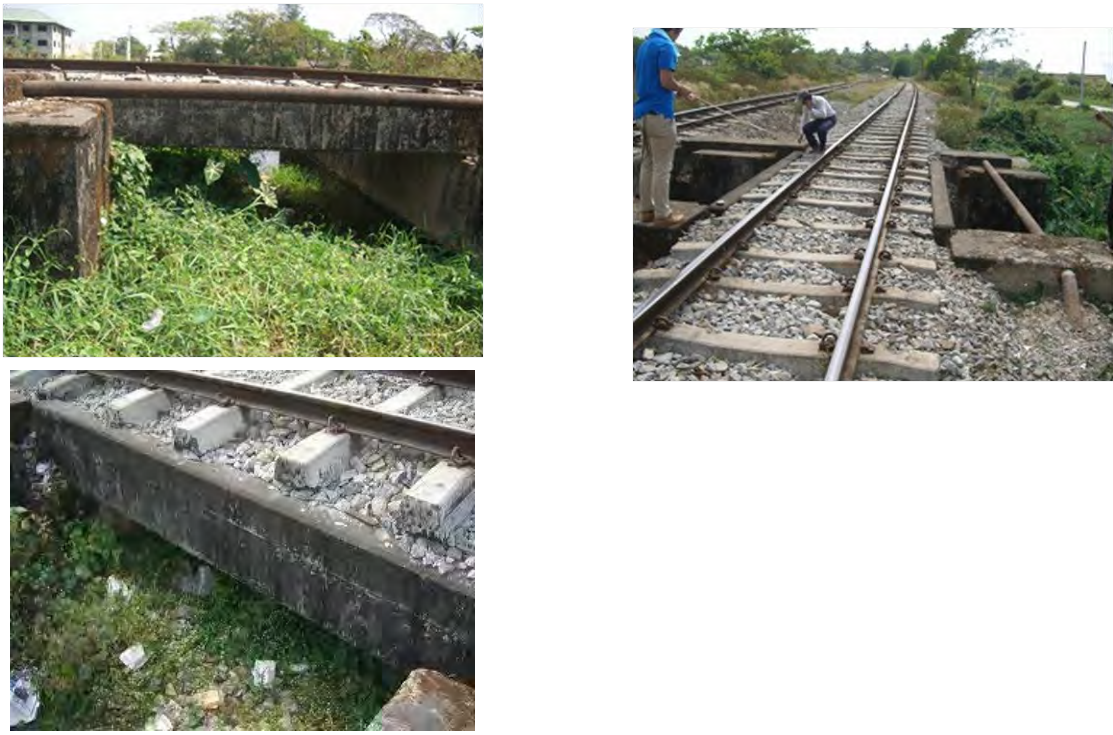
Remarks	Same as sleeper interval

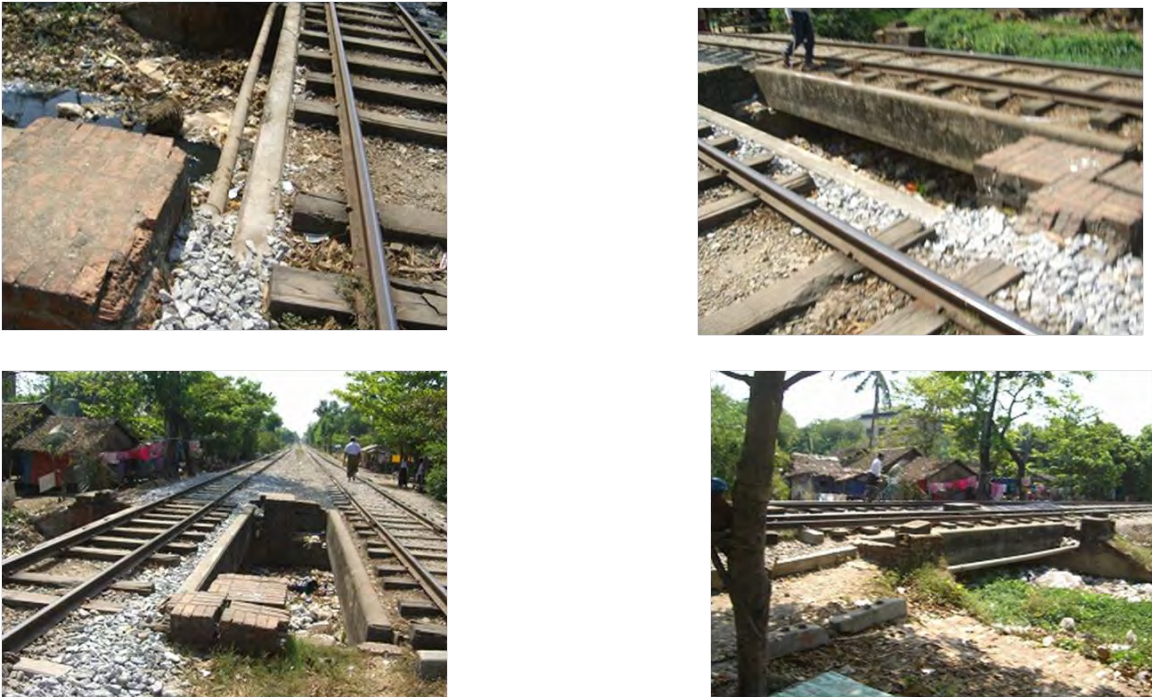
Remarks	Not listed from MR, but existed

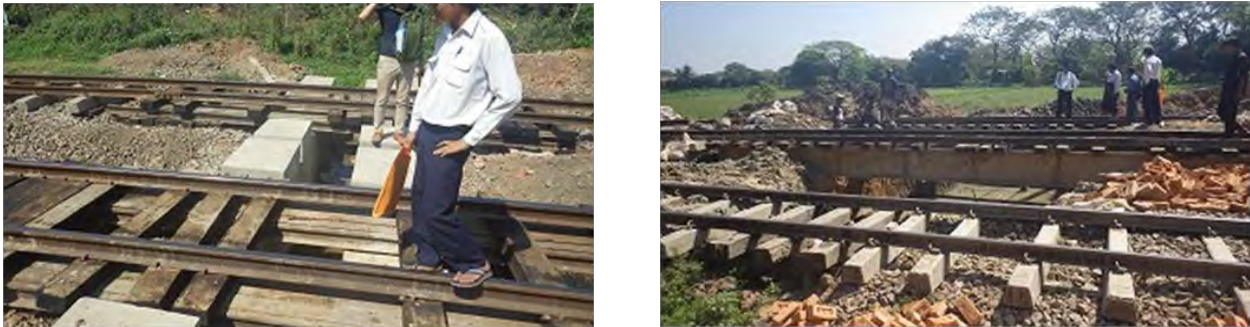
Remarks Not listed from MR Under construction

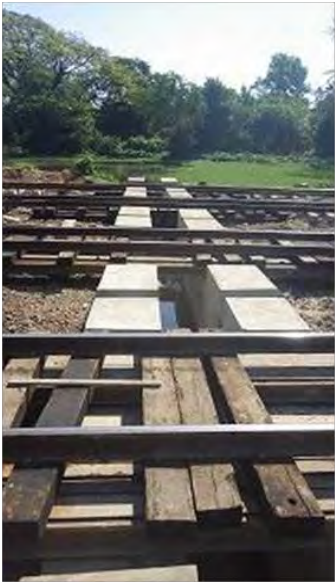
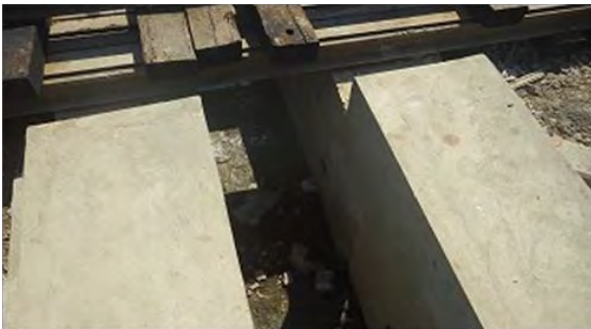
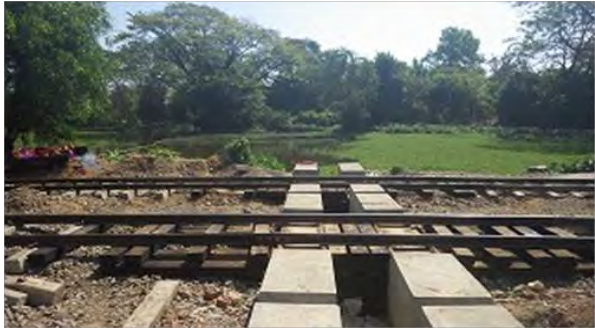
</div>			
Remarks Not listed from MR

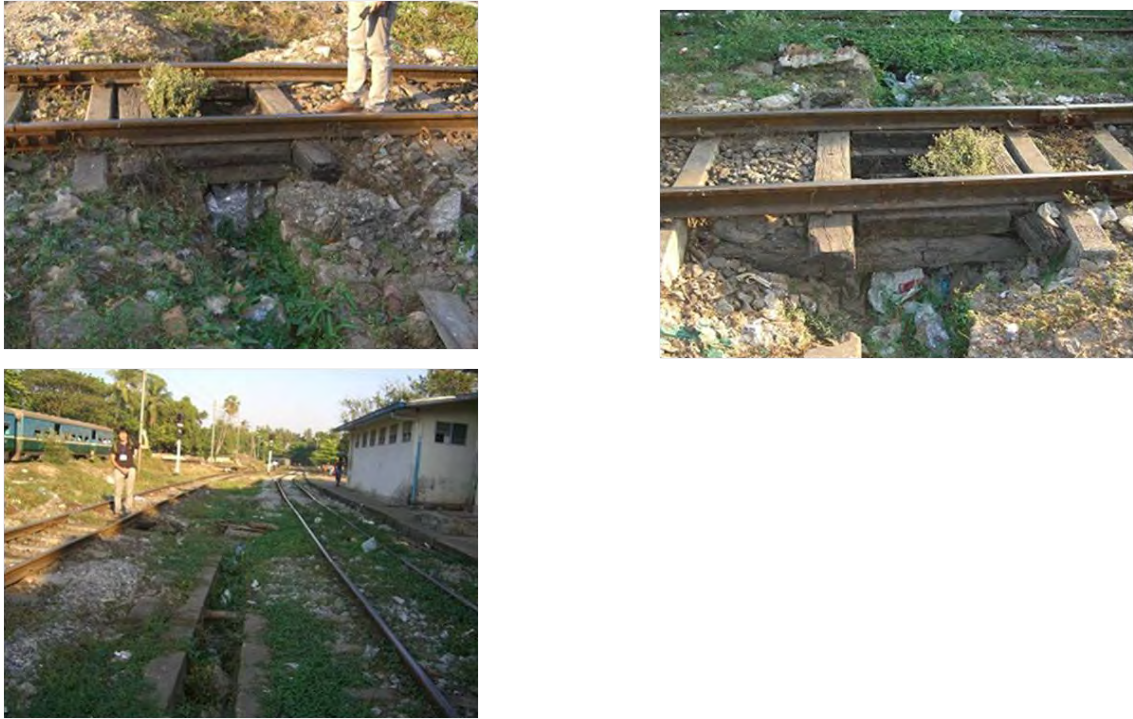
Remarks				
Side drainge

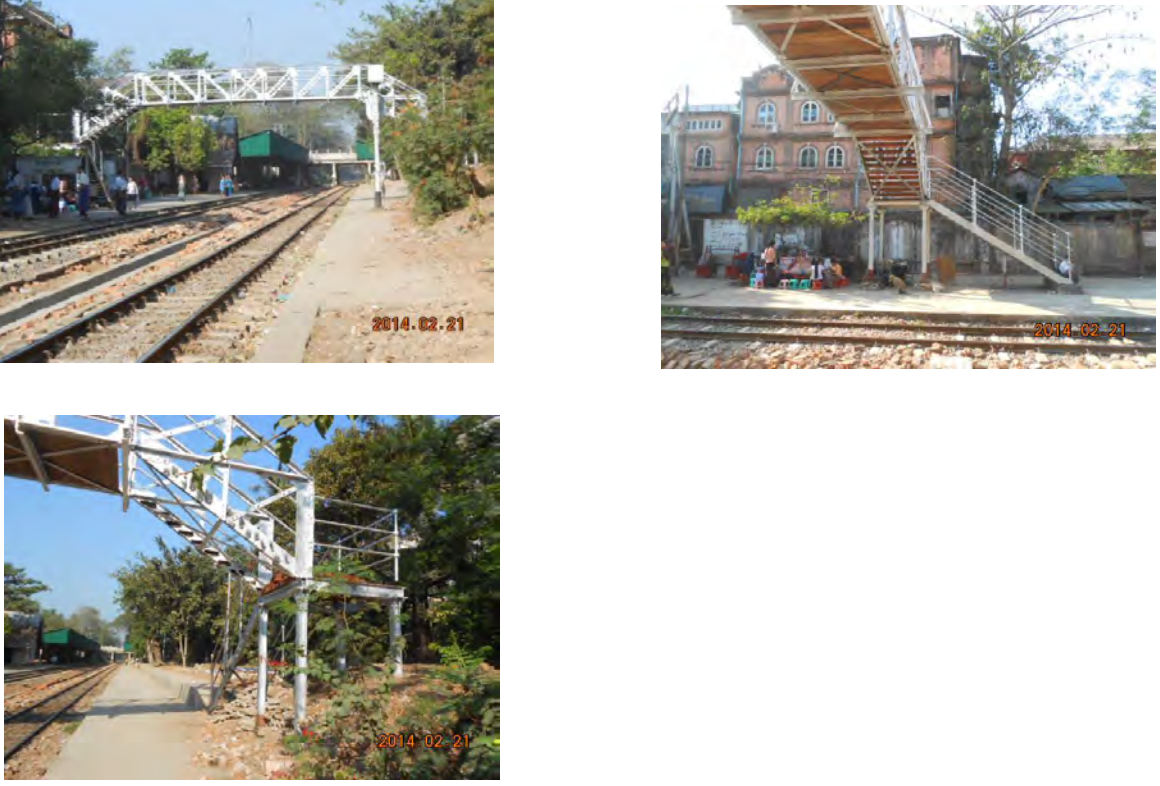
Remarks			
Under girder is repairing now

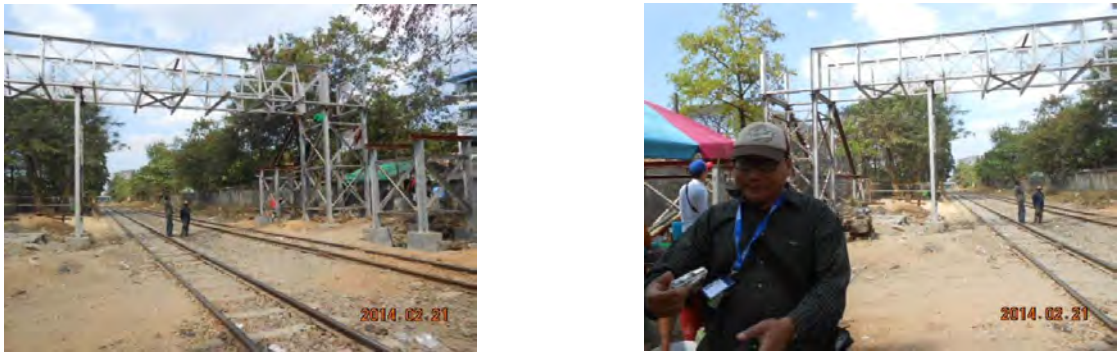
Remarks					
New FOB, Under construction

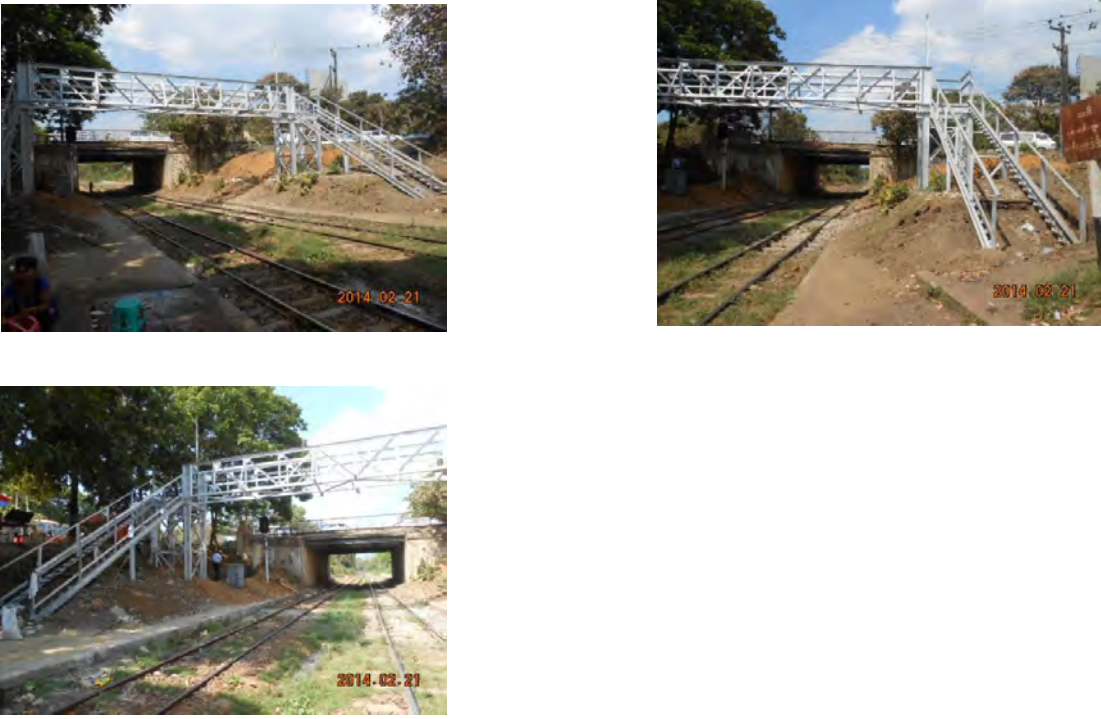
Remarks	Repair now

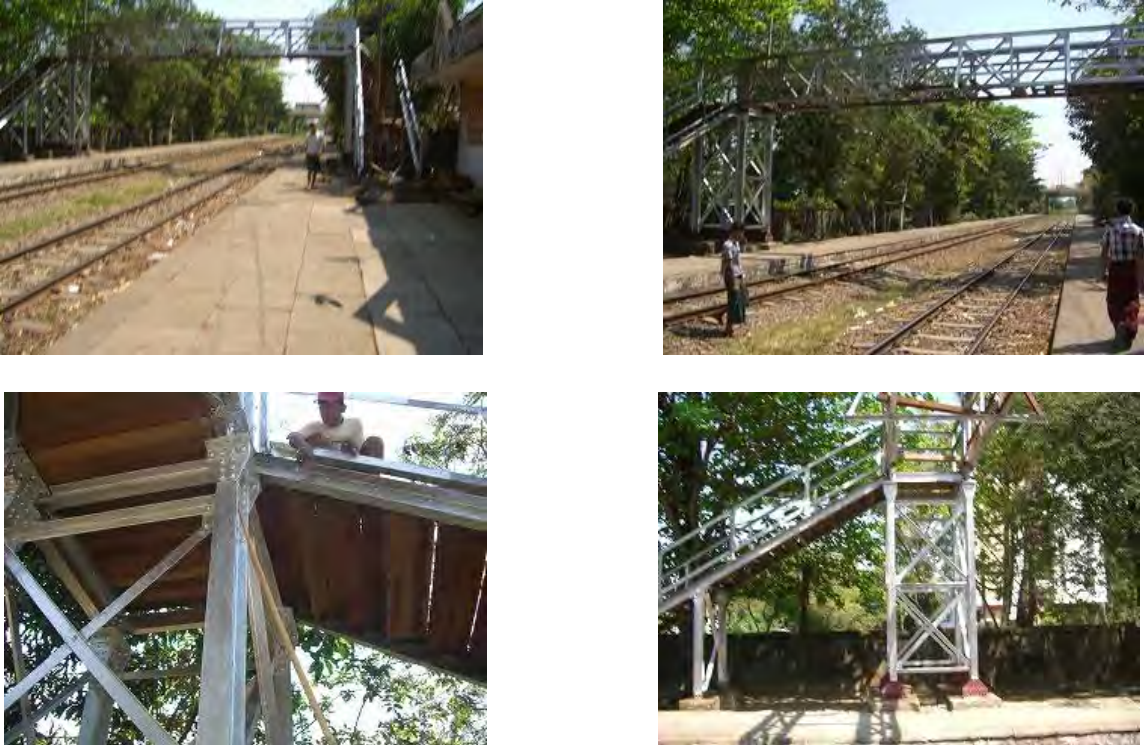
Remarks			
Under construction
