APPENDIX 2

橋梁検査台帳

INVESTIGATION RECORD SHEET FOR BRIDGE

Line Name		Western Line		Date of Survey		03/10/2012			
Bridge No.		1		Mileage		1 1/4 + 1208'			
Chief Civil Engineer		William Acken		Inspector		GRCL: Mr.Amissah JICA Study Team: Osamu Ohkawa			
Type of Superstructure (Bridge Length & Number of Spans)		Steel deck plate girder 66' 00" × 1(span) = 66' 00"							
Type of Substructure		Plain concrete abutment							
Photograph

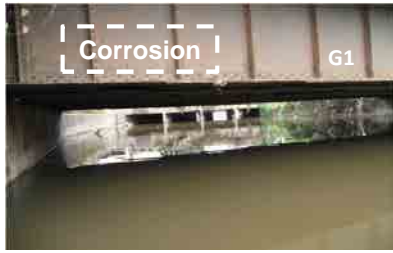
Comment		<p>鋼橋全体が錆びている。桁下空間が低い為の下フランジの腐食が激しく、断面欠損が見られる。 リベットの欠落は見られない。 下部工は錆汁が見られない。 パラペットのひび割れに対して、幅および長さを継続的に観察して、記録をとる必要がある。 基礎の洗掘に対してフトン籠により基礎を保護すべきである。</p>							
Overall Evaluation		Level-1 (Ordinary)		Level-2 (Notice)		Level-3 (Small Emergency)		Level-4 (Large Emergency)

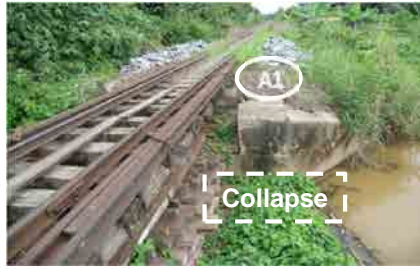
Comment		<p>洗掘によりTakoradi方の橋台(A1)が倒壊している。 上部工は、木枕木を使用して盛り替え、レール桁により軌道を保護している。 鋼橋全体が錆びている。リベットの欠落は見られない。 下部工は錆汁が見られない。 河川の切り回しはすでに完了していることから、早急に桁を撤去し、盛土により復旧することが望ましい。</p>							
Overall Evaluation		Level-1 (Ordinary)		Level-2 (Notice)		Level-3(Small Emergency)		Level-4(Large Emergency)

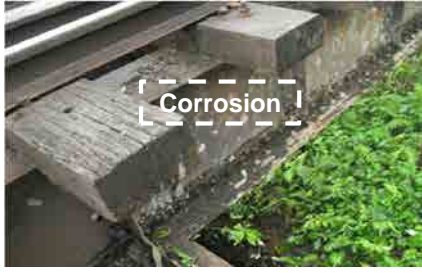
Comment		<p>鋼橋全体が錆びている。 リベットの欠落は見られない。 A1,A2橋台ともにパラペット前面、躯体前面に乾燥収縮と思われる大きな水平のクラックが見られる。 下部工は錆汁が見られない。</p>							
Overall Evaluation		Level-1 (Ordinary)		Level-2 (Notice)		Level-3 (Small Emergency)		Level-4 (Large Emergency)

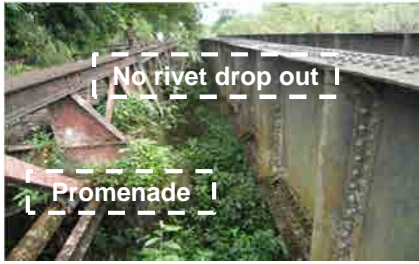
Comment		<p>鋼橋全体が錆びている。 リベット、添接板のボルトの欠落は見られない。 A1,A2橋台ともにパラペット前面、躯体前面に乾燥収縮と思われる大きな水平のクラックが見られる。 P1,P2橋脚には水平力が微小であり、部材寸法が比較的大きいので特に問題は無い。 下部工は錆汁が見られない。</p>							
Overall Evaluation		Level-1 (Ordinary)		Level-2 (Notice)		Level-3(Small Emergency)		Level-4(Large Emergency)

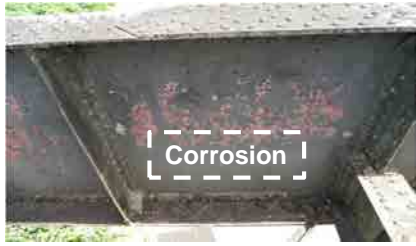
Comment		<p>鋼桁全体が錆びている。 リベットの欠落は見られない。 A1,A2橋台ともにパラペット前面、躯体前面に乾燥収縮と思われる大きな水平のクラックが見られる。 沓の移動によりパラペット前面側で、コンクリートの破壊が見られる。ボルトの緩みを改善する必要がある。 下部工は錆汁が見られない。</p>							
Overall Evaluation		Level-1 (Ordinary)		Level-2 (Notice)		Level-3 (Small Emergency)		Level-4 (Large Emergency)

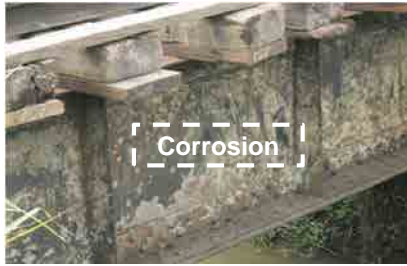
Comment		<p>鋼橋全体が錆びている。 リベットの欠落は見られない。 A1,A2橋台ともにパラペット前面、躯体前面に乾燥収縮と思われる大きな水平のクラックが見られる。 P1橋脚には水平力が微小であり、部材寸法が比較的大きいので特に問題は無い。 下部工は錆汁が見られない。</p>							
Overall Evaluation		Level-1 (Ordinary)		Level-2 (Notice)		Level-3 (Small Emergency)		Level-4 (Large Emergency)

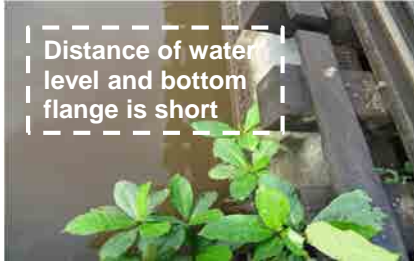
Comment		<p>桁下空間が低い為、洪水時に桁下面が水に浸かっている可能性がある。</p> <p>鋼橋全体が錆びている。</p> <p>リベットの欠落は見られない。</p> <p>A1,A2橋台ともにパラベット前面、躯体前面に乾燥収縮と思われる大きな水平のクラックが見られる。</p> <p>下部工は錆汁が見られない。</p>							
Overall Evaluation		Level-1 (Ordinary)		Level-2 (Notice)		Level-3 (Small Emergency)		Level-4 (Large Emergency)

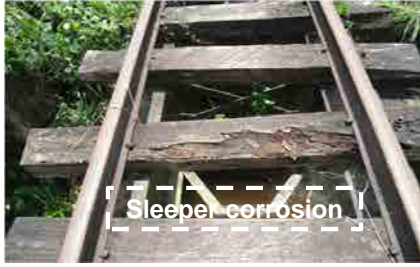
Nothing							
Comment		<p>鋼橋全体が錆びている。 リベットの欠落は見られない。 A1,A2橋台ともにパラペット前面、躯体前面に乾燥収縮と思われる大きな水平のクラックが見られる。 下部工は錆汁が見られない。</p>							
Overall Evaluation		Level-1 (Ordinary)		Level-2 (Notice)		Level-3(Small Emergency)		Level-4(Large Emergency)

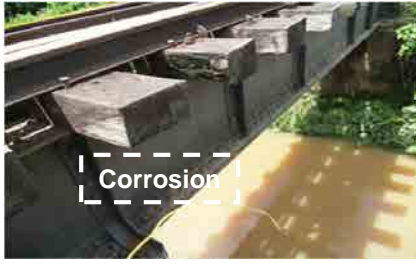
Comment		<p>鋼橋全体が錆びている。 リベットの欠落は見られない。 A1,A2橋台ともにパラペット前面、躯体前面に乾燥収縮と思われる大きな水平のクラックが見られる。 下部工は錆汁が見られない。</p>							
Overall Evaluation		Level-1 (Ordinary)		Level-2 (Notice)		Level-3 (Small Emergency)		Level-4 (Large Emergency)

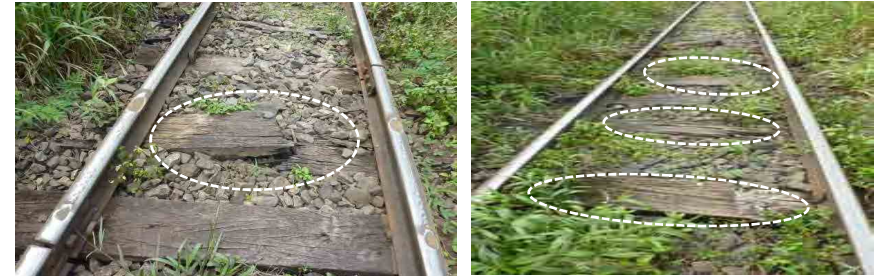
- Broken sleeper by the past derailment of vehicles.
- Rotten sleepers.

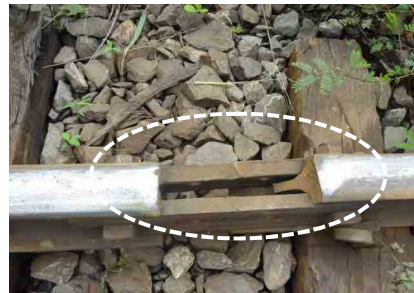
Joint gap is wider than 100mm, and end of right side rail is chipped(Kojokrom ~ Angu section)

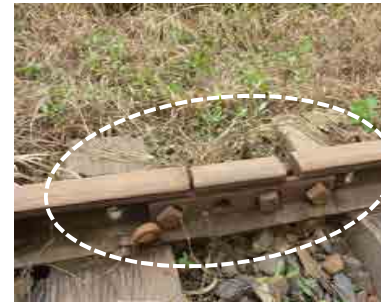
The rail joint structure is not correct (Dunkwa ~ Awaso section)

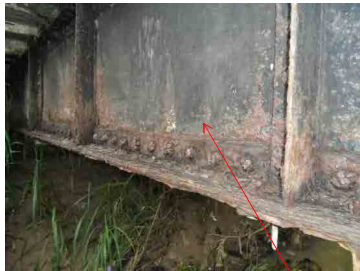
Corrosion

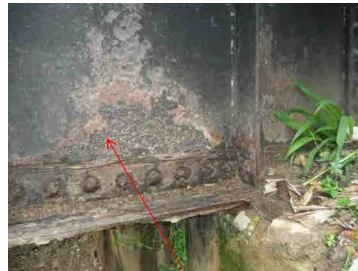
Corrosion

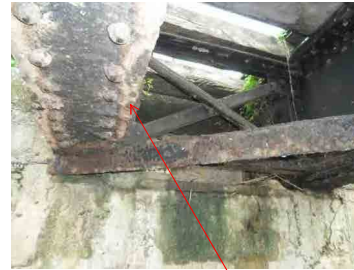
Corrosion

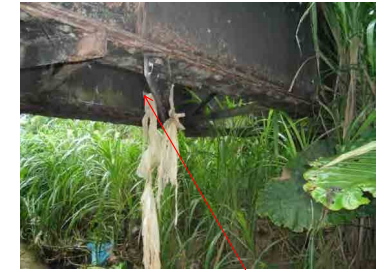
Corrosion

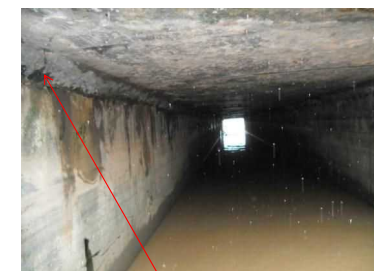
Crack

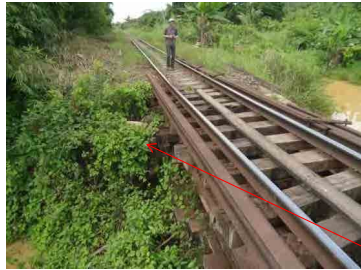
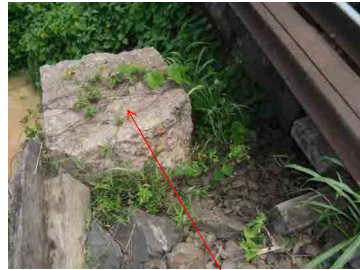
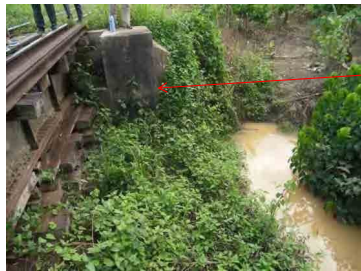
Collapse

- For the abutment of Manso, construct a temporary support and pile sand bags to prevents the inflow of water.
- For cracks and flaking of the concrete, carry out the injection method.

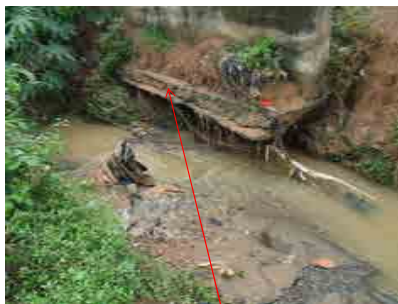
Scouring
