**STUDY FOR  
SAFETY OPERATION AND MANAGEMENT  
OF  
RAILWAY IN GHANA

FINAL REPORT**

**JULY 2014**

**JAPAN INTERNATIONAL COOPERATION AGENCY**

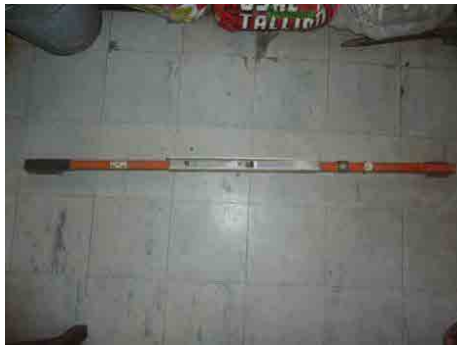
The machinery used for track maintenance, such as measuring instruments, high-speed rail cutters, and tie tampers, are often left in defective condition because replacement parts are unavailable due to the tight maintenance budget. Presently, track maintenance is done manually with simple tools (Photos 2.2.2, 2.2.3 and 2.2.4). There are no established control criteria for these machines.

**Photo 2.2.2 Track Investigation Tools  
Left in a Defective Condition**

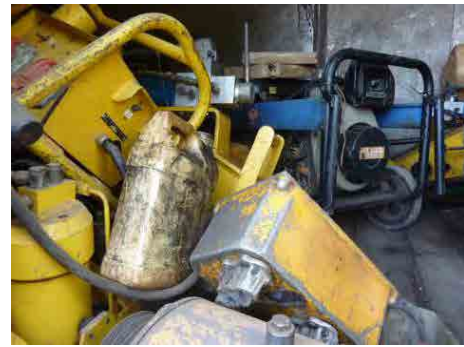
**Photo 2.2.3 Track Maintenance  
Equipment Left in a Defective  
Condition (in Wagon at Dunkwa  
Station Yard)**

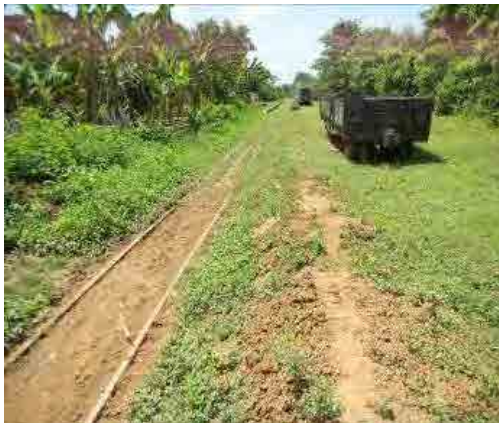
The climate is tropical. There are two seasons, rainy season and dry-season in a year. There are some places that are swamped by heavy downpours. There are some bridges which are damaged by flood. There are some sections with poor visibility by overgrown with weeds beside the tracks in the jungle. The development of the railway has a long history. There are many curves because the line ran parallel to the river on lowland to avoid constructing tunnels. The roadbeds are soft ground near ponds or rivers. Some cuts along the line are dangerous because the cliffs of the cuts are ready to collapse. It is easy for them to be eroded by rain water because the tracks are lower than the surroundings.

**Photo 2.3.1 Damage by Heavy Rain (1)**

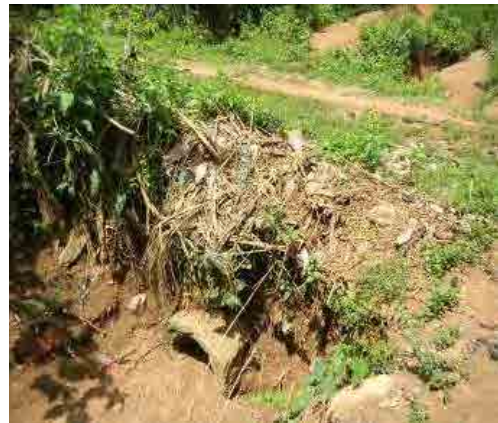
**Photo 2.3.2 Damage by Heavy Rain (2)**

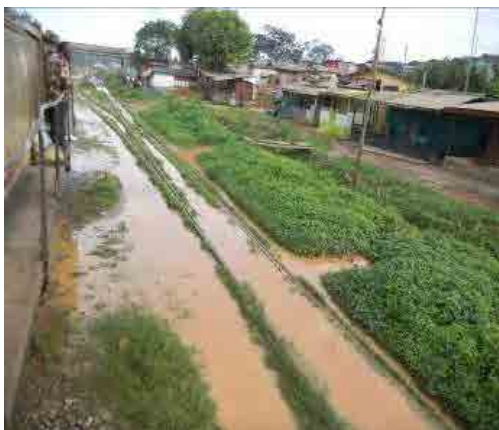
**Photo 2.3.3 Damage by Heavy Rain (3)**

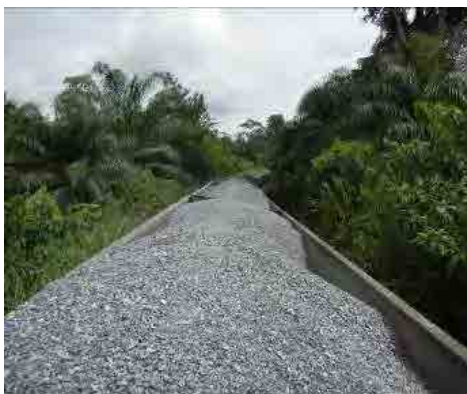
**Photo 2.3.17 Wagon Condition**

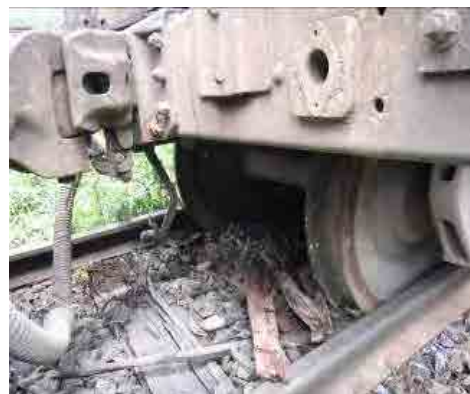
**Photo 2.3.18 Over Width Gauge**

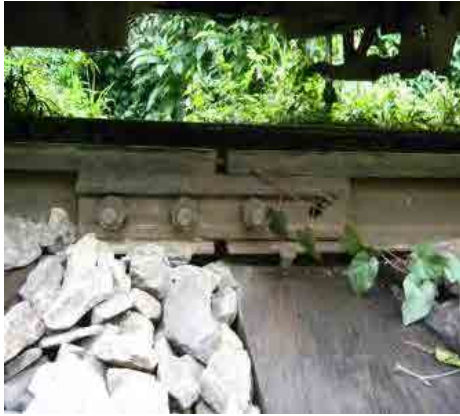
**Photo 2.3.19 Condition of Fastenings**

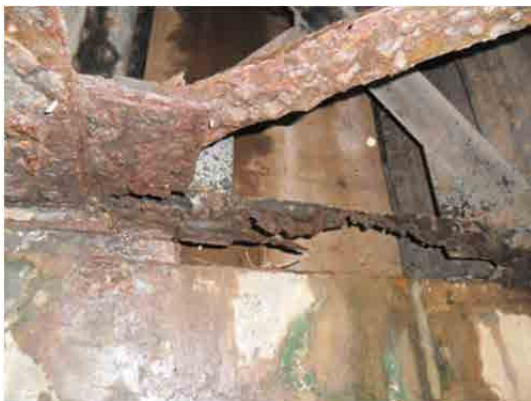
(Bridge No.1)

**Photo 2.3.23 Corrosion of Steel Girders**

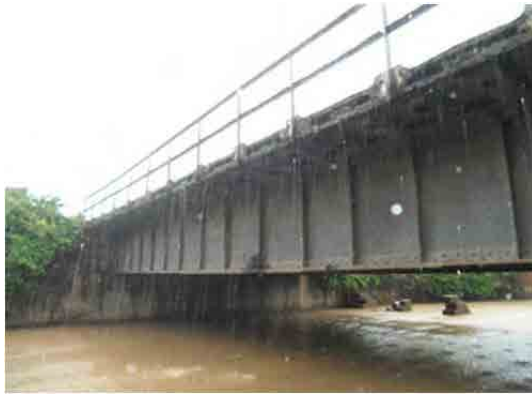
(Bridge No.1)

**Photo 2.3.24 Sectional Loss Observed in Stiffeners between Bridge Main Girders**

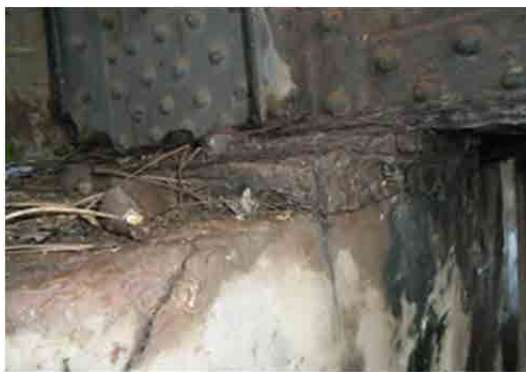
(a) Insufficient Edge Distance  
(Bridge No.1)

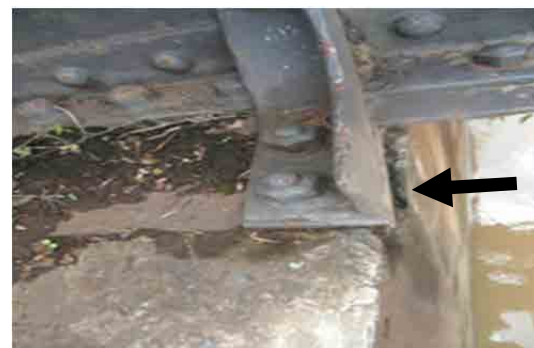
(d) Concrete Spalling at the Face of Bridge Seat  
(Bridge No.1)

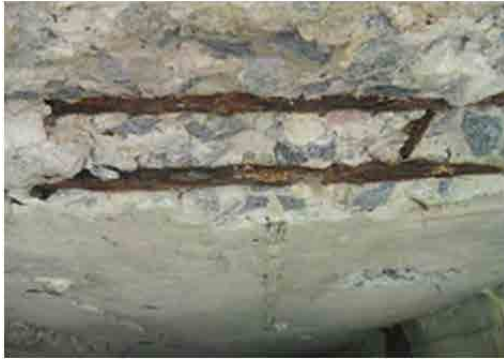
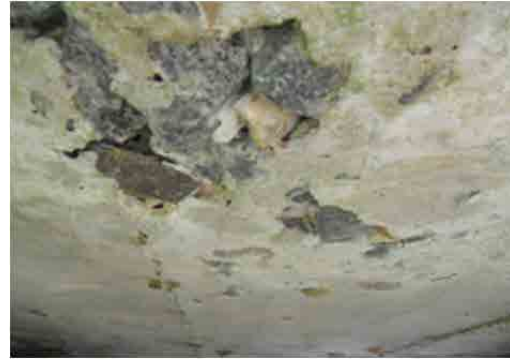
(a) Spalling of the Concrete

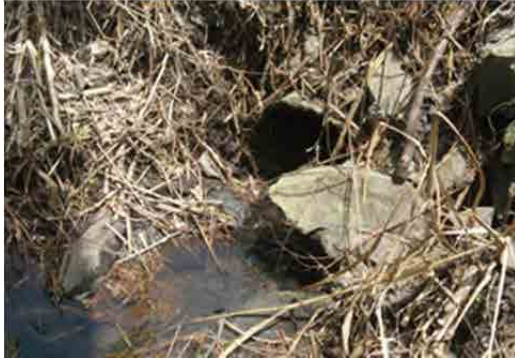
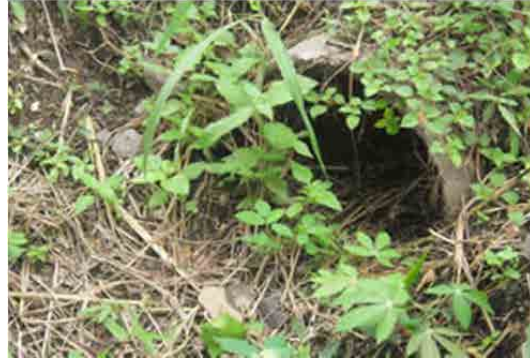
(b) Culvert Covered with the Sediment

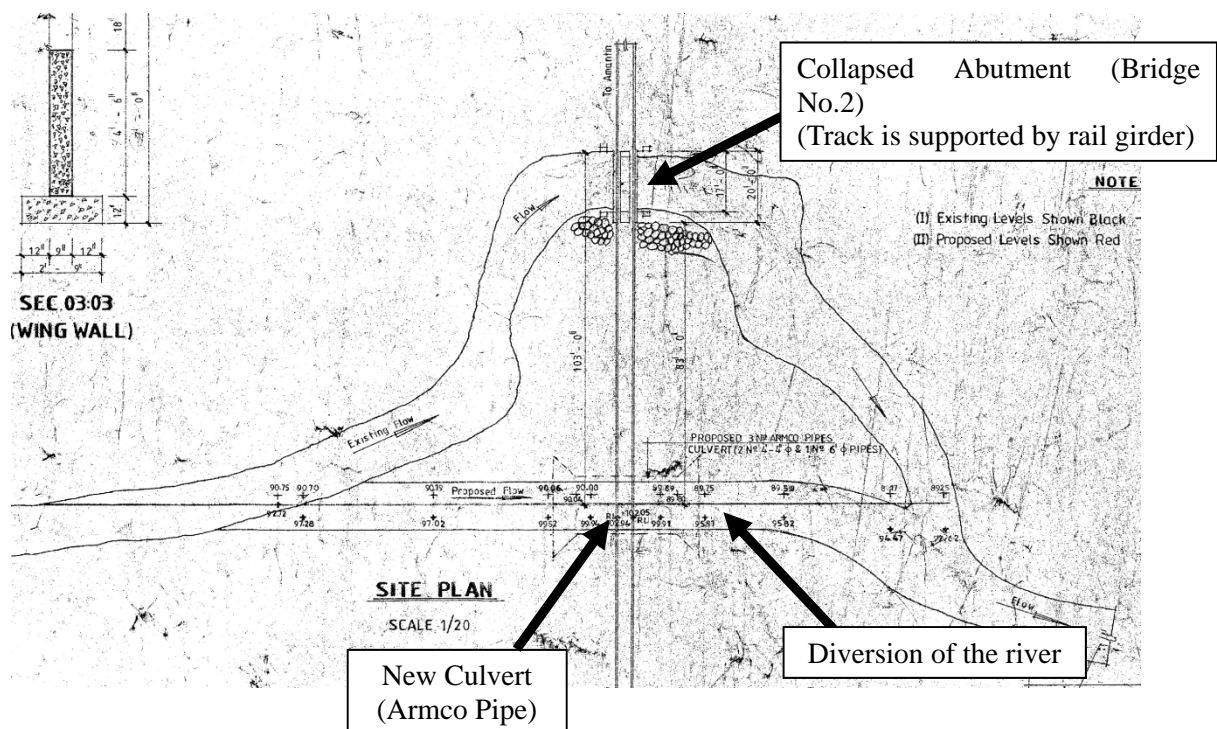
**Figure 2.3.1 Urgent Repair Works for Bridge No.2**

Figure 2.3.3 shows a drawing of track protection work used in the Western Line. And, this drawing describes the expiration date of the temporary bridge, “TEMPORARY BRIDGE STAY FOR 21 DAYS”. The use of these temporary bridges involves speed restriction, and a week limit for expiration date. The removal of this by urgent repair work is desirable as soon as possible.

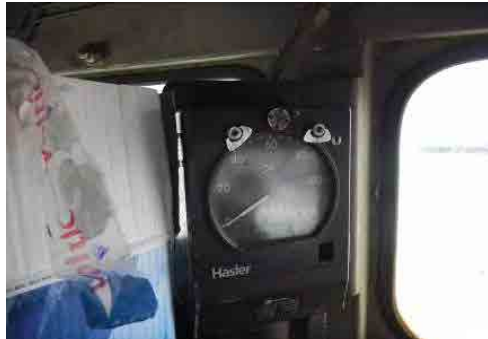
This matter is described in DE-CONSUL's report in 1993. The Drivers destroyed the speedometers to conceal their incriminating records of stopping to pick up illegal passengers. This is a matter that has been admitted. All speedometers of all locomotives are left without being fixed. The maintenance of speedometers is required.

**Photo 3.1.1 Broken Speedometer (1)**

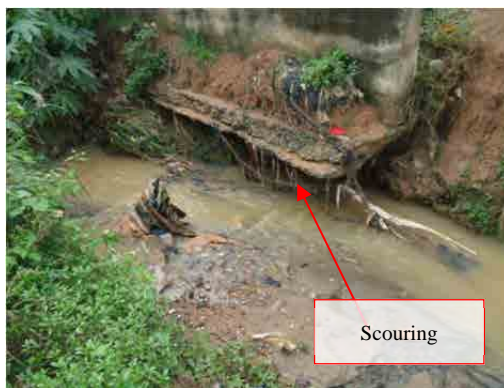
**Photo 4.2.37 Retaining Wall Foundation be Scoured in Ghana**

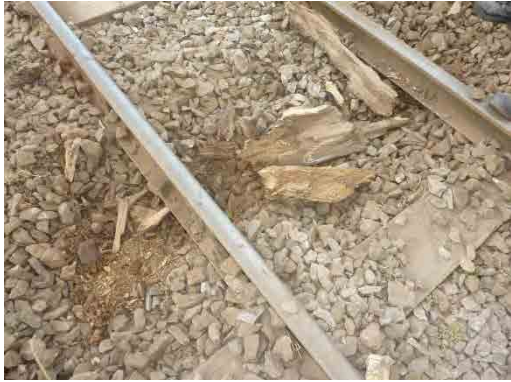
**Photo 4.2.62** The rotten sleepers are worn out (This fact means that these sleepers are left as they are rotten for a long time)

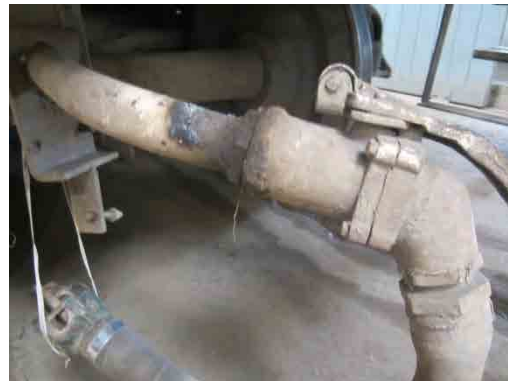
**Photo 4.2.94 Repair of Brake Pipe from Air Leakage**

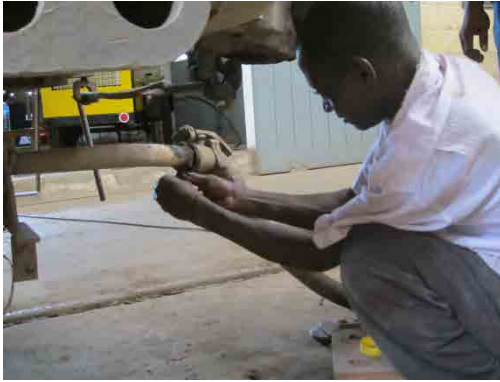
**Photo 4.2.95 Repair of the Brake Pipe from Air Leakage**

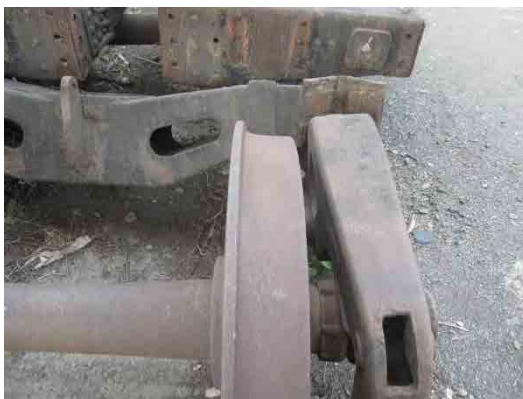
**Photo 4.2.131** Wheels with Vertical Wear at Tire Flange that can be Confirmed at a Glance
