APPENDIX 2

Bride Inspection Ledger

INVESTIGATION RECORD SHEET FOR BRIDGE

Study for Safety Operation and Management of Railway in the Republic of Ghana 2012 to 2013

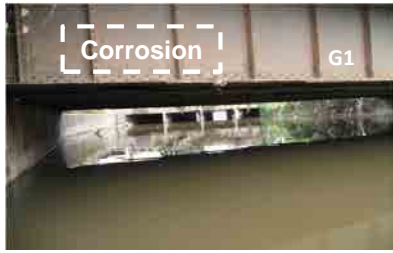
(Photo1)

| Comment | | <p>The whole bridge gets rusty.</p> <p>The corrosion of the lower flange is severe, and a section loss is seen because clearance under girder is</p> <p>No loss of rivet are seen.</p> <p>No rust fluid is not seen in the superstructures.</p> | | | | | | | |

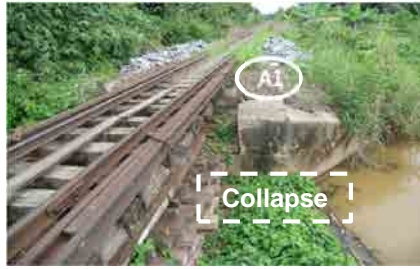
(Photo1)

| Comment | | <p>Abutment of Takoradi side (A1) is collapsed by scouring. Superstructure was modified by using wood sleepers as substructure. The whole bridge gets rusty. No loss of rivet are seen. No rust fluid is not seen in the superstructures. It is desirable to to remove the girder and to restore the roadbed as the embankment as soon as possible.</p> | | | | |

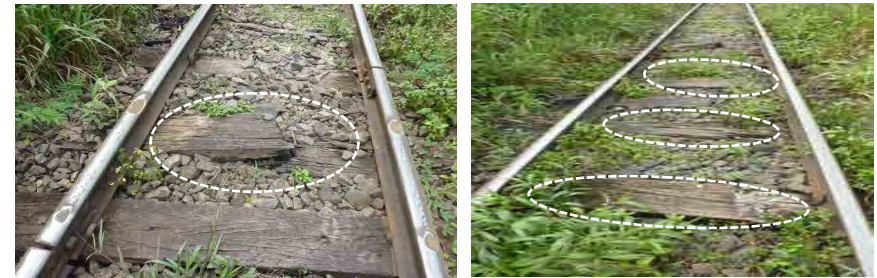
4

- Broken sleeper by the past derailment of vehicles.
- Rotten sleepers.

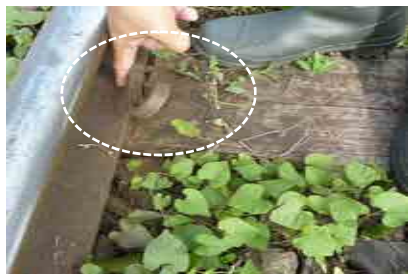
5

- Fastenings that rise up from the base of the rail

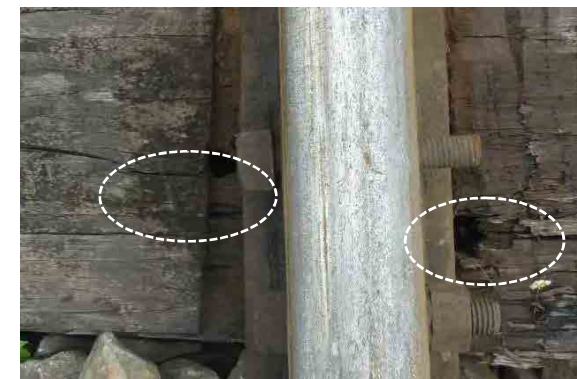
6

- Fastenings that is missing at the appointed place.

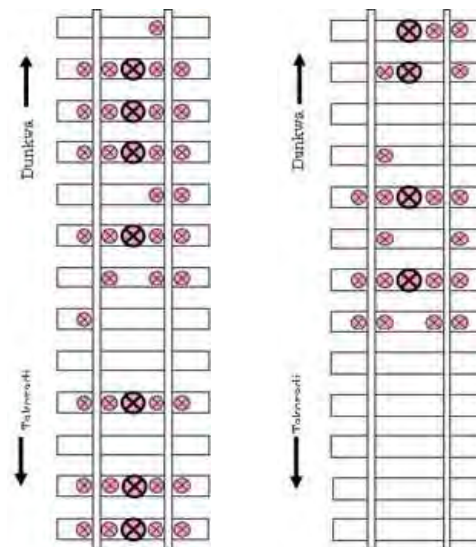
Ratio of defective sleepers=43%
(26/60)

Ratio of defective fastenings=59%
(141/(60 × 4))

Japanese standard
Defective sleeper : ≤7%
Defective fastening: ≤5%

- Establishment of standard for defective sleeper and fastening
- Periodical inspection (Once a year- Japanese Standard)
- Make drawings for controlling defective materials.
- This action should be carried out as soon as possible Between Takoradi and Nsuta .

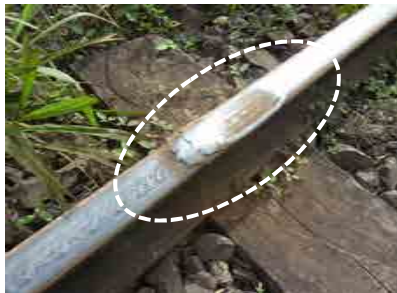
Wheel burn (Kojokrom ~ Angu section)

Wheel burns are found on the top of rail in several sections.

Wheel burns have to be eliminated as soon as possible by changing to new rail.

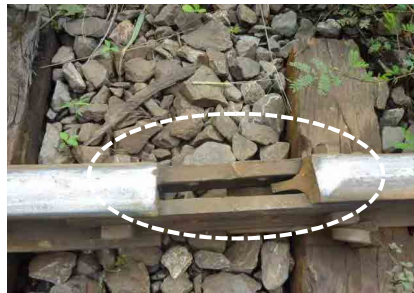
Joint gap is wider than 100mm, and end of right side rail is chipped(Kojokrom ~ Angu section)

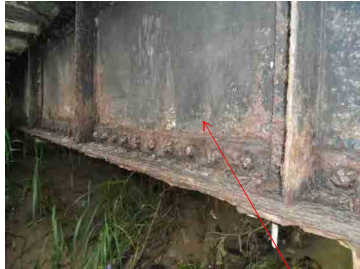
Corrosion

- Watch the progress of the rust and the situation of encrustation and deposits regularly.
- Remove the rust and repainting with durable materials.
- Remove the soil and garbage deposits in the shoes.
- Remove the loose rivets and replace them with high tensile bolts.

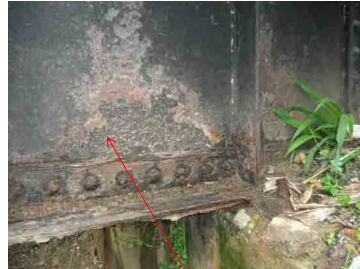
Corrosion

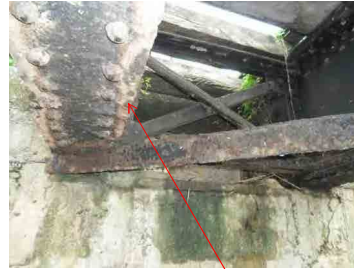
Corrosion

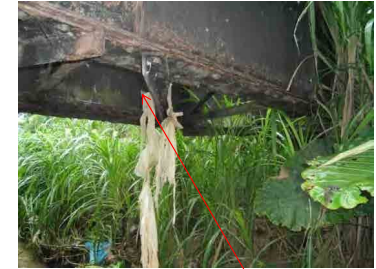
Corrosion

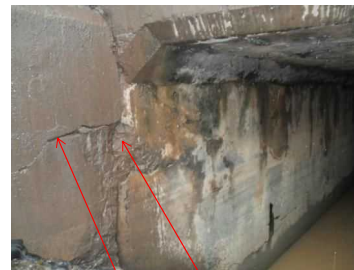
Crack

Flaking

- For the abutment of Manso, construct a temporary support and pile sand bags to prevents the inflow of water.
- For cracks and flaking of the concrete, carry out the injection method.

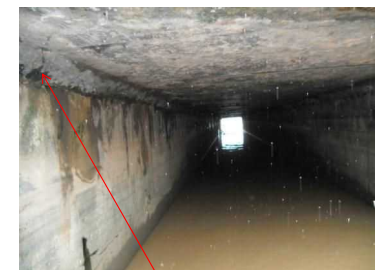
Crack

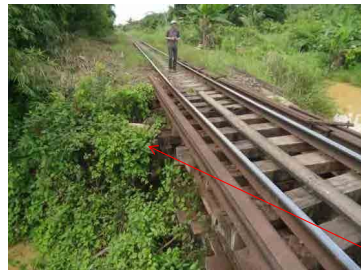
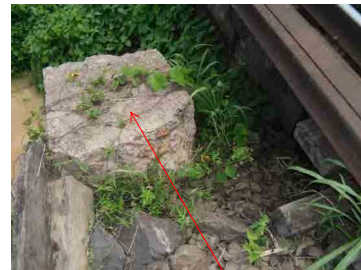
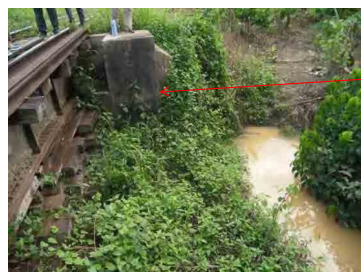
Collapse

- Watch flaking of concrete and progression of crack.
- Hit the surface of the concrete with a hammer and determine the degree of floating.
- Strengthen visual checks on the abutment (collapse) of Manso.

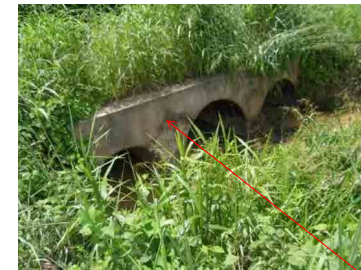
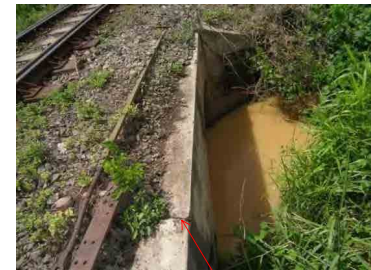
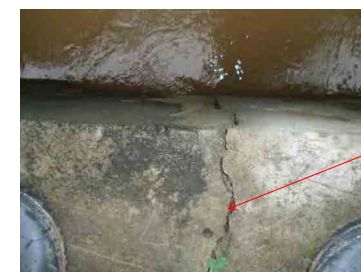
Flaking

Crack

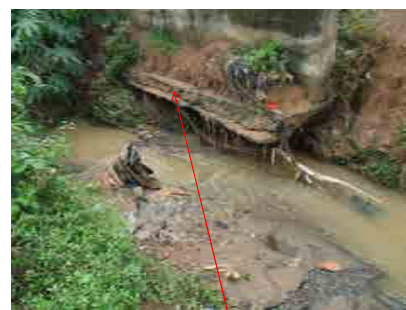
Scouring

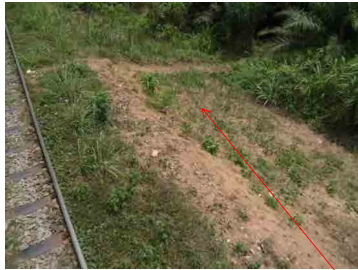
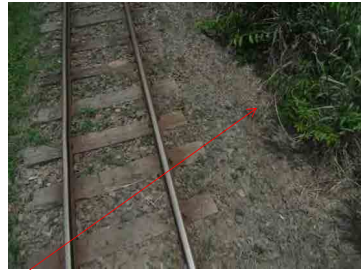
In the Banking Area, Cracking and Landslides

Cracking and landslide

- Watch for defects in the banking and cutting and signs of collapse regularly.
- Watch for defects in the banking and cutting immediately after heavy rain.
- When there is a risk of the collapse, the train service must be limited.

- In the banking area, infiltrated water must be prevented from entering the banking.
- In the cutting area, remove the risk of the collapse beforehand.
