**The Urgent Project
for
Rehabilitation of Yangon Port
and
Main Inland Water Transport
in
The Republic of The Union of Myanmar**

FINAL REPORT

SUMMARY

January 2015

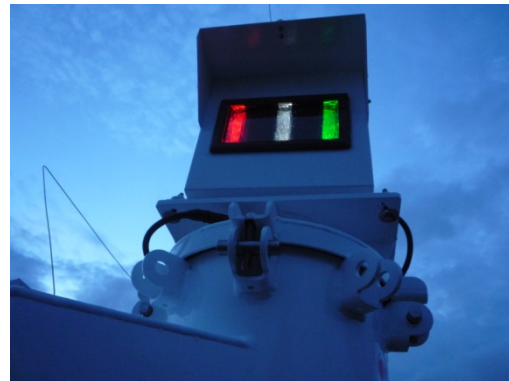
Monkey Point Sector Light Properly Working
at Night Time
