**The Urgent Project
for
Rehabilitation of Yangon Port
and
Main Inland Water Transport
in
The Republic of The Union of Myanmar**

FINAL REPORT

MAIN REPORT

January 2015

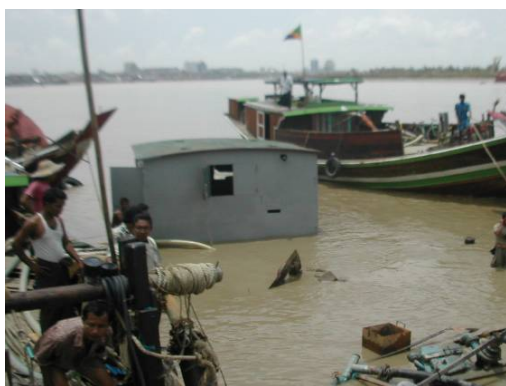
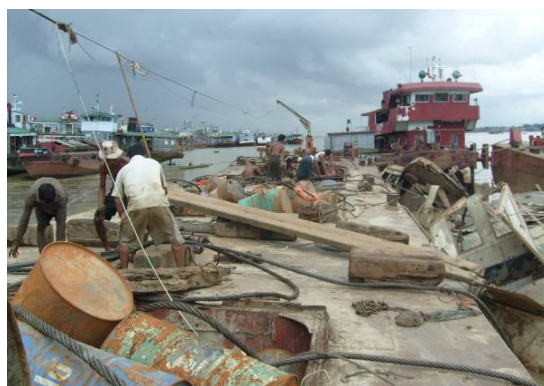
Photo 4.2.1 Salvage Work for Sunken Ship

1st step	Search and identify the precise position of ship.
2 nd step	3 to 4 wire slings are placed at the bottom of sunken ship.
3 rd step	Barges and/or floaters are set at both sides of sunken ship.
4 th step	Slings placed under the bottom are tied with barges and/or floaters
5 th step	During low tide, slings are tightened and ships float by buoyancy during flood tide.
6 th step	When a ship is afloat, move toward a shallower place.
7 th step	Repeat steps 5 and 6 until ships are moved out from navigation area.

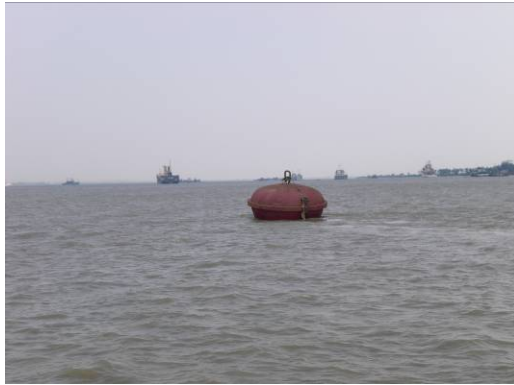
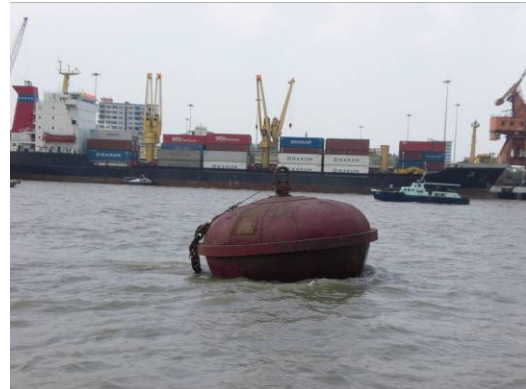
Photo 4.2.5 No.9 Mooring Buoy

There were 4 mooring buoys for ocean going ships and 10 mooring buoys for IWT ships at Yangon Port (see Photo 4.2.5). IWT leased 10 mooring buoys from MPA before Nargis hit but 7 of these buoys were damaged by the cyclone. Due to the shortage of mooring buoys, many ferries were waiting at the anchorage area in the port which was dangerous due to the strong current of the Yangon River.

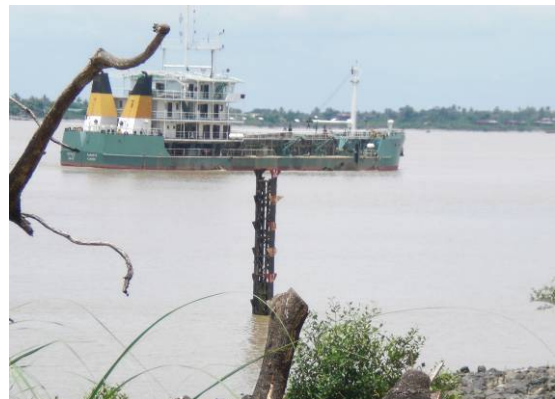
Photo 4.2.6 Dredger at Monkey Point

The Monkey Point Channel is located at the confluence point of the Yangon River and the Bago River. Consequently, the channel flow becomes very complicated due to the meeting of the two river flows and severe siltation is a serious problem.

In order to maintain the channel depth of 4.5 m at the Monkey Point, MPA dredges (trailing hopper suction dredgers shown in Table 4.2.6) dredge the channel 1 mile (1,850 m) in length and 100 m in width at the Monkey Point every day.

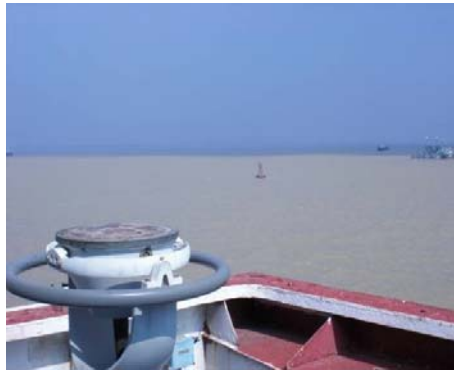
Photo 4.2.7 Passing UMP Buoy on her starboard side

There are 2 navigation buoys, i.e. UMP Buoy and LMP Buoy, in the Monkey Point Channel to indicate the southern limit of the narrow channel. These buoys are very important for identifying the channel and consequently preventing the grounding of ships. Both buoys seem to be in good condition but both are painted brown. It is recommended to use red paint to help identify the portside limit of the channel for entering ships. In addition, a red light signal should be installed on the buoy for safe navigation at night.

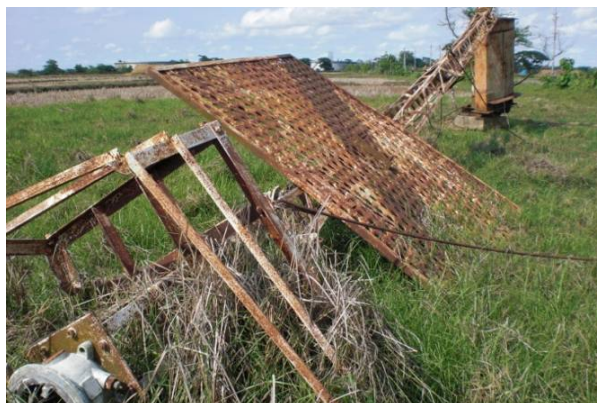
Photo 4.2.9 Damaged Back Leading Light at Thanlyin Point ④

Ships entering Yangon Port must pass the narrow Monkey Point Channel. In order to maintain safe navigation at the channel, MPA had installed leading lights at 6 places along a 35 mile stretch from the pilot station to the Monkey Point Channel as shown in Figure 4.2.2. However all leading lights were damaged by Nargis (See Photo 4.2.9), and this makes it difficult for ships to enter Yangon Port safely.

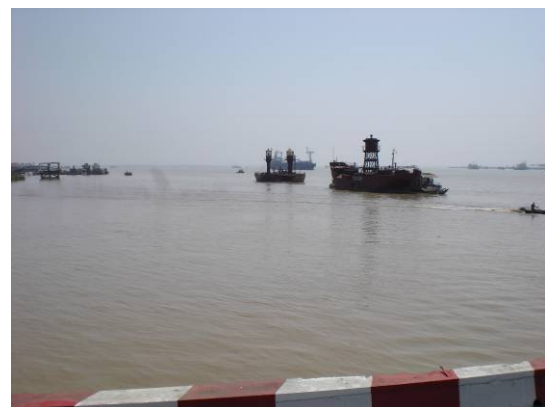
Photo 4.2.11 Lanthaya and Dagon Light Ship under repairing off a Dockyard

Both Lanthaya and Dagon Light Ship were damaged by Nargis and these were under repair at a dockyard in Yangon (see Photo 4.2.11).
