**The Urgent Project
for
Rehabilitation of Yangon Port
and
Main Inland Water Transport
in
The Republic of The Union of Myanmar**

FINAL REPORT

APPENDICES

YANGON PORT FACILITY

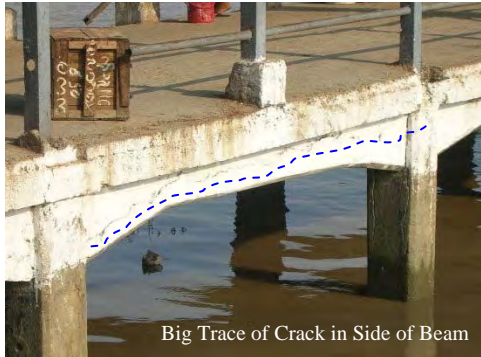
Photo 2

Big Trace of Crack in Side of Beam

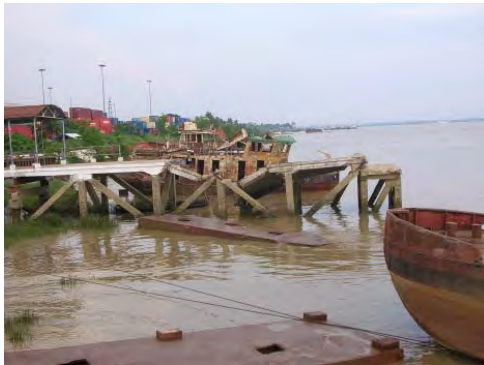
Photo 1

The concrete pier was Collapsed.
It should be taken away the concrete pier
and re-construct.

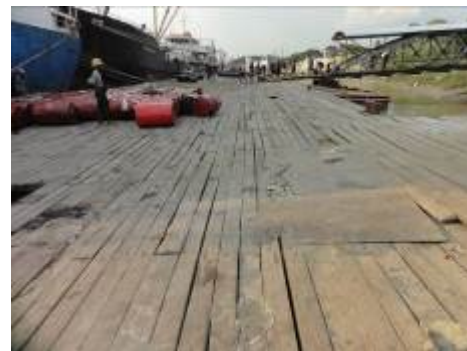
Photo 5 - Deck timber lost

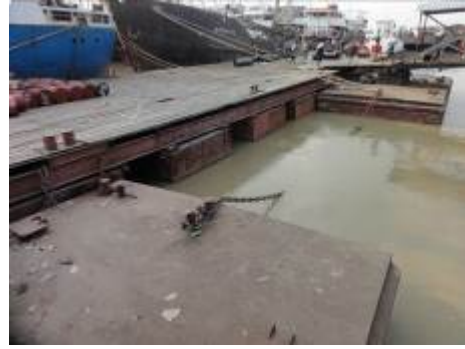
Photo 6 - Decking support beam rusted, need to replace

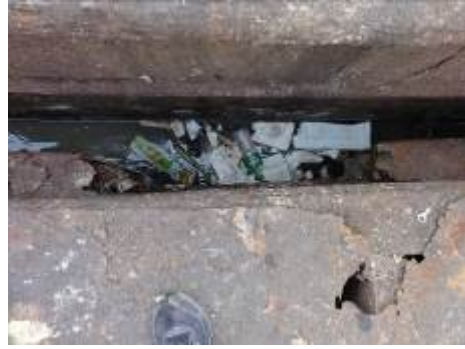
Photo 8 - Pontoon & sponson damage

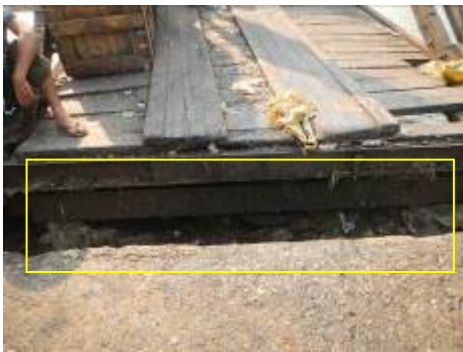
Photo 2 - Connection cover plate missing

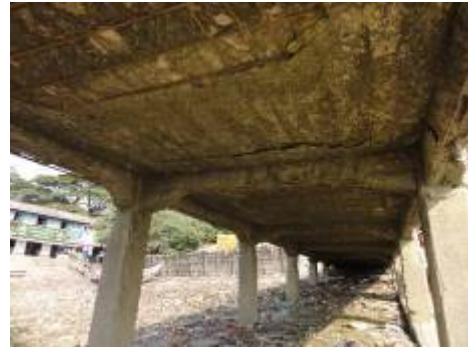
Photo 5 - Beam & slab damage

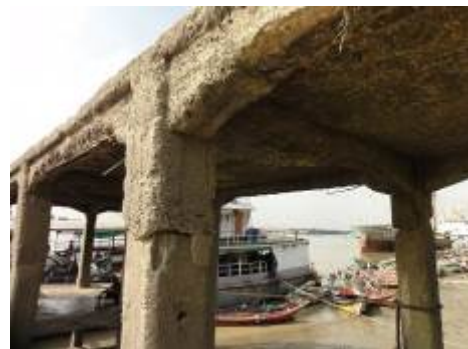
Photo 6 - Beam damage, Rebar is exposed

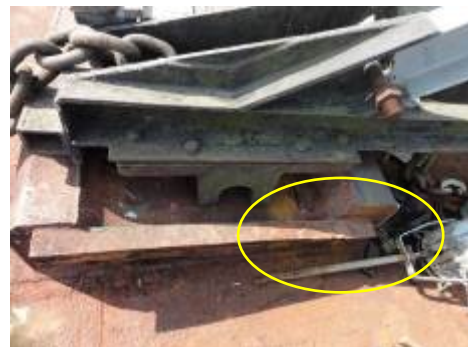
Photo 5 - Roller Wheel Missing

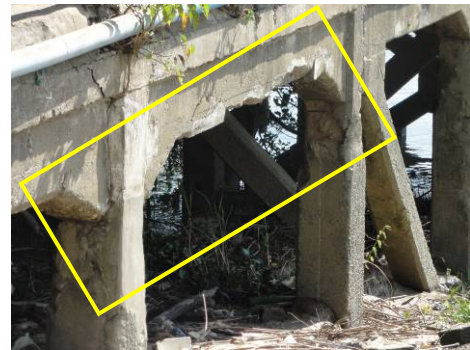
Photo 5 - Pier column & beam damage

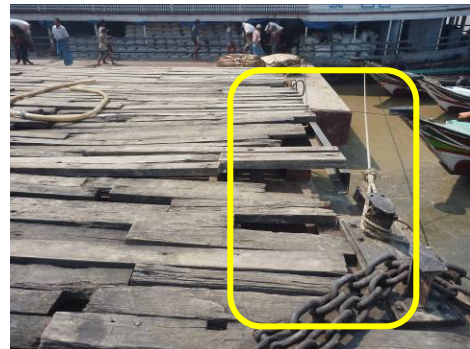
Photo 6 - Timber decking loss & damage

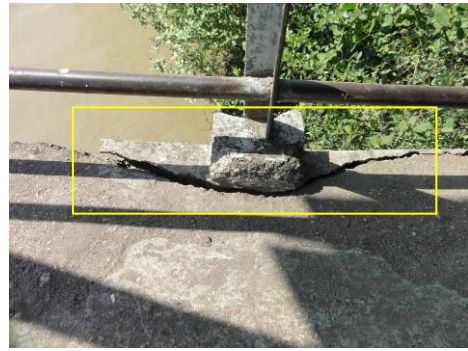
Photo 4 - Hand rail post damage

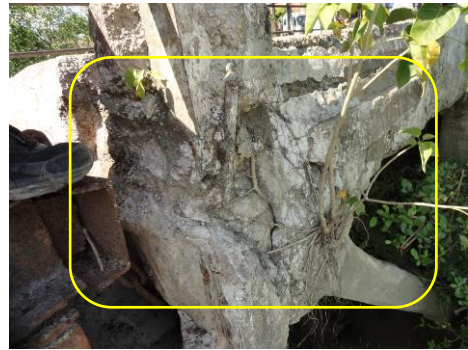
Photo 5 - Porter Way Damage, rebar export and rust

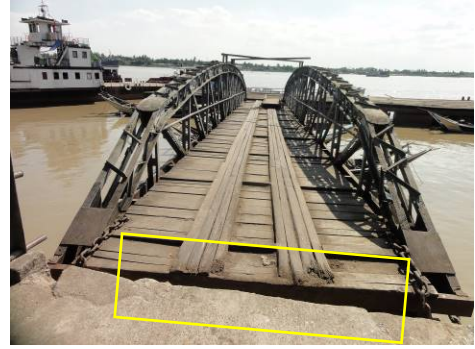
Photo 7 - Connection cover steel plate missing

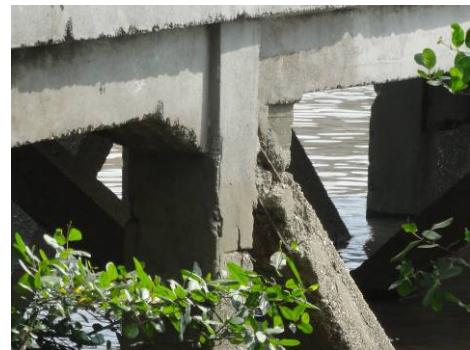
Photo 5 - Pier concrete damage

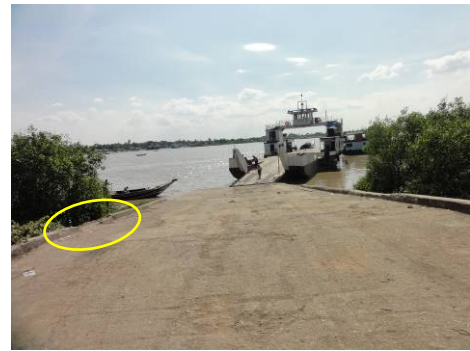
Photo 3 - Curb Stone Damage

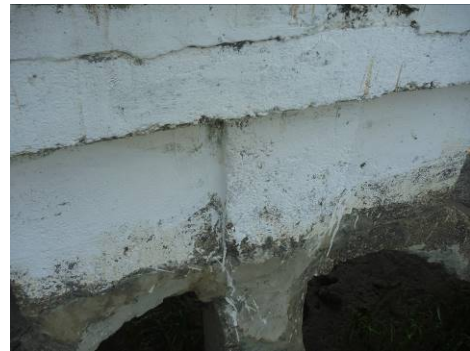
Photo 4 - Repaired beam and column

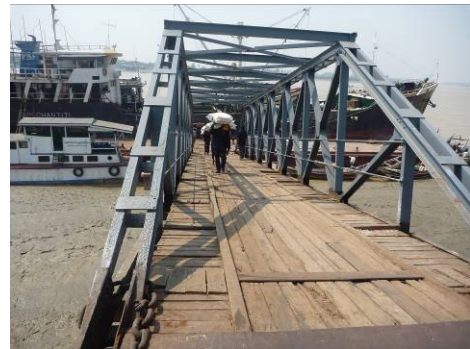
Photo 5 - New painted steel bridge with timber decking

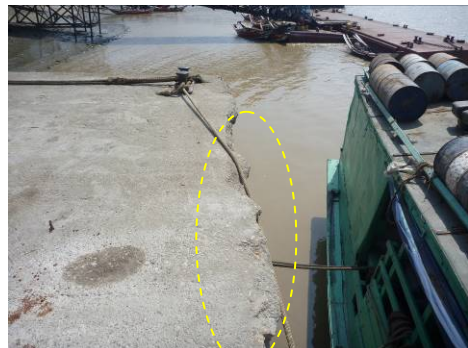
Photo 5 - Concrete slab damage

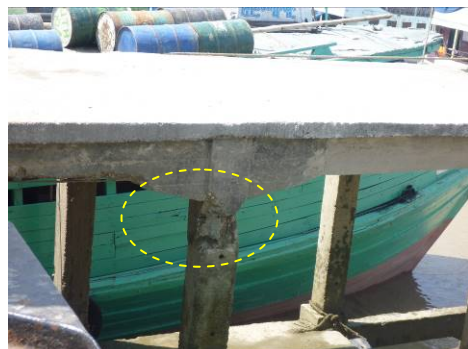
Photo 6 - Pier column damage
