Inspection and Evaluation of Port Facilities

<i>No.17</i>	<i>Name of Jetty</i>	Kaingdan No.1			
<i>Dimension</i>	Pontoon: Length 120' x Width 20' (before Nargis)		<i>Date of Inspection</i>	9 Dec,2014	
Result of Inspection and Evaluation of Port Facilities					
<i>Facility</i>	<i>General Evaluation</i>	<i>Condition of Damage And/or Deterioration</i>	<i>Measures to be taken</i>	<i>Change from Last survey in 2011</i>	<i>Reference Photo</i>
Pontoon	Good	No damage		No	Photo 2
Bridge	Fair	Timber deck is broken	Need to be repair bridge decking timber lost	No	Photo 1,4
Pier	Fair	N	N	No	Photo 1,6
Sponson	Good	No damage		No	Photo 2

APPENDIX B NAVIGATION SAFETY	B-3
B.1 On board Inspection Report of Navigation Safety of Yangon Port and Channels	B-3
B.1.1 Outline of the On Board Survey	B-3
B.1.2 Result of Inspection	B-3
B.1.3 Natural Condition	B-4
B.1.4 Current Condition of the Yangon Port and Channel.....	B-5
B.2 Evaluation for Navigation Aids	B-22
B.3 Comment for the Rating	B-23
B.4 Interview of Captain of M.S.T. Mhan Aung and Harbor Master	B-24
B.5 The Obstructions in Fairways Act Amending Law 1963	B-26

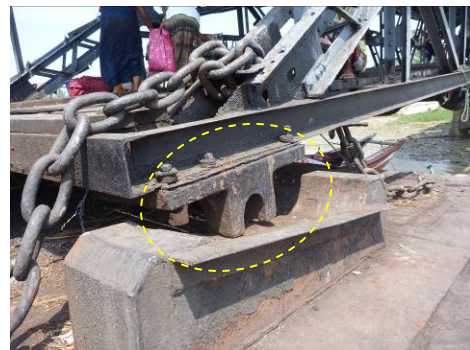
Photo 5 - Roller wheel is missing

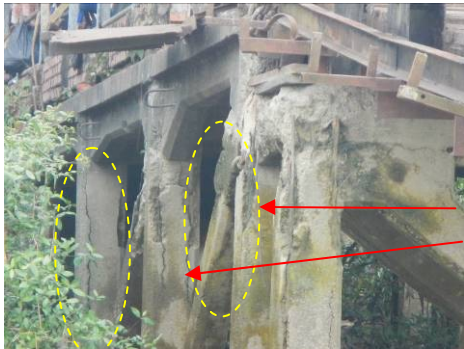
Photo 2

Bracing & Column damage

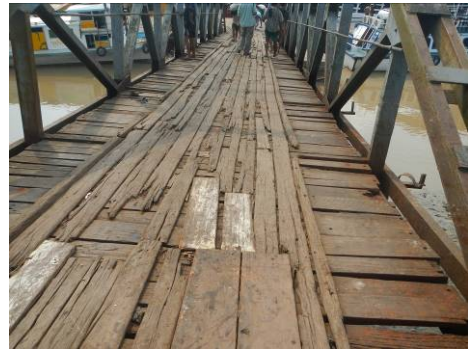
Photo 5 - Timber loose & damage

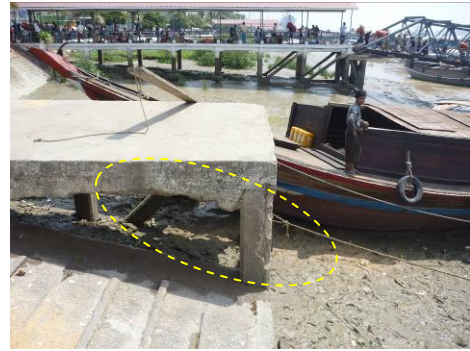
Photo 4 - concrete damage

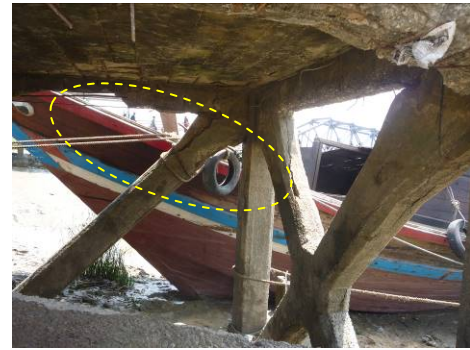
Photo 5 - Bracing & Column damage

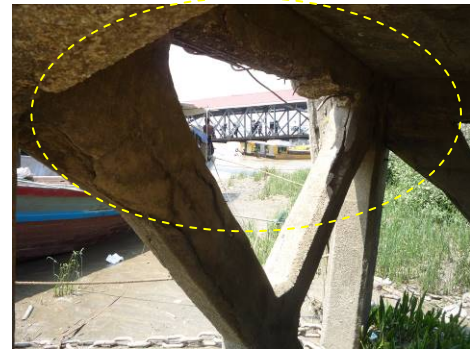
Photo 6 - Seriously damage the beams and bracing

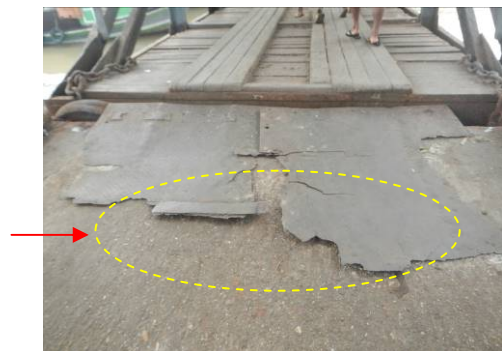
Photo 6 - Bridge facility damage

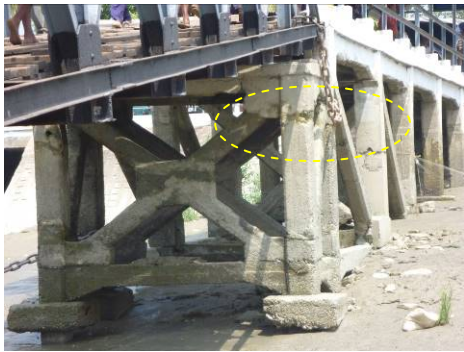
Photo 2 - Abutment column damage

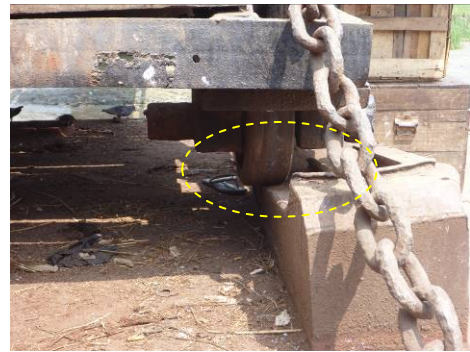
Photo 5 - Roller wheel is shifted

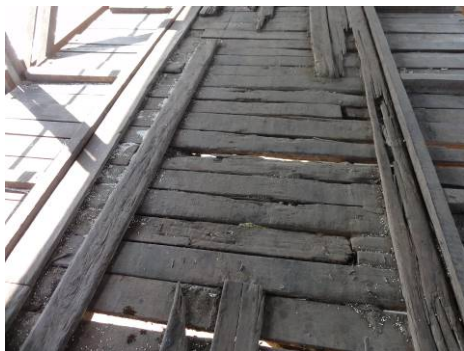
Photo 3 - Timber decking loss & damage

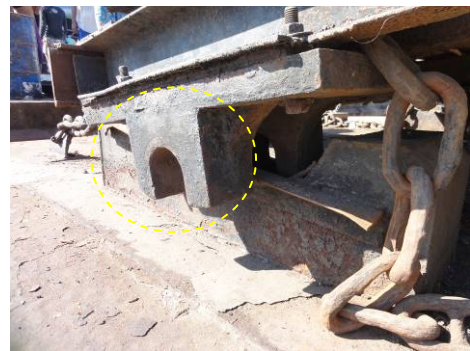
Photo 9 - Roller wheel is missing

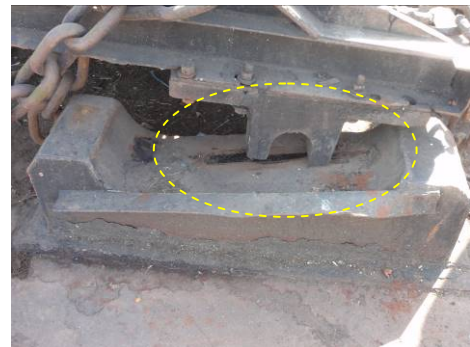
Photo 6 - Roller wheel is missing

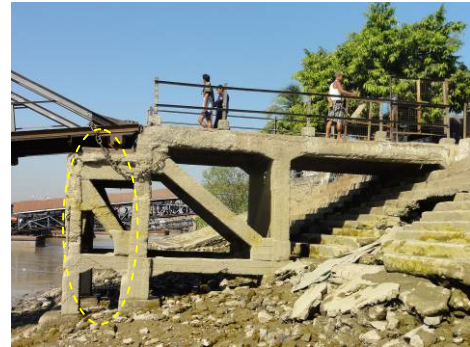
Photo 4 - Abutment damage

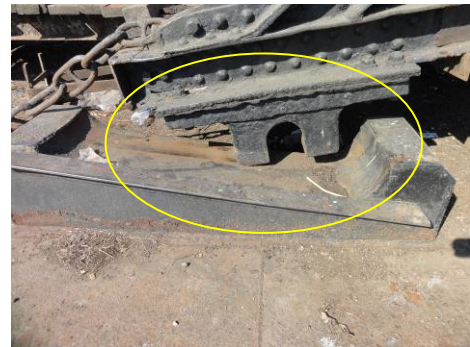
Photo 5 - Roller wheel is missing

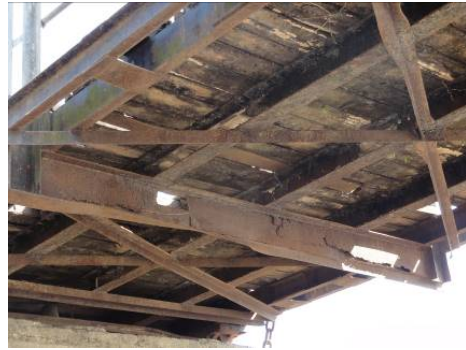
Photo 4 - Porter way girder rust and damage

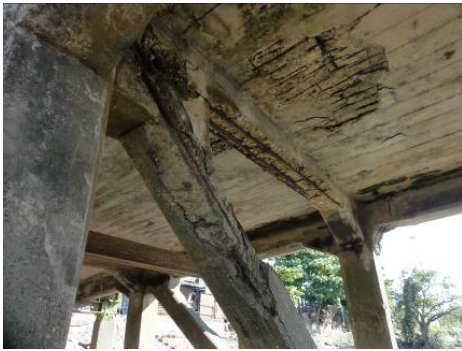
Photo 2 - Beam , slab rebar exposed and rusted

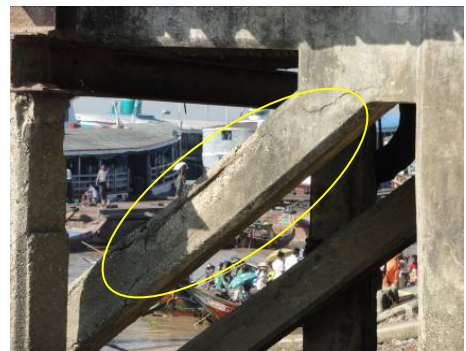
Photo 7 - Pier bracing defected

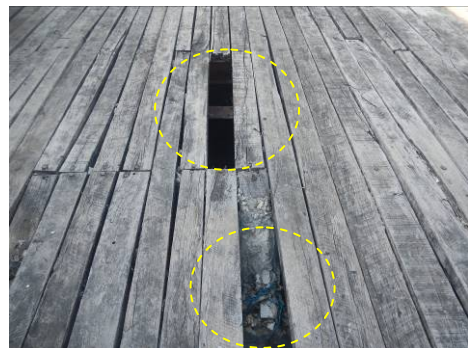
Photo 6 - Timber Decking damage

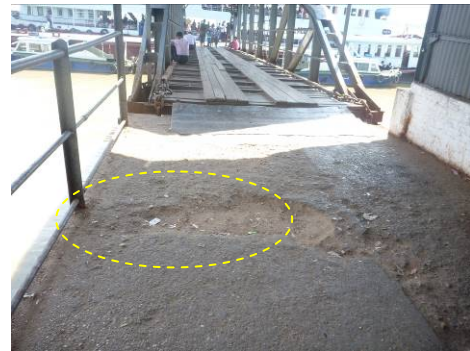
Photo 4 - Passenger way is damage

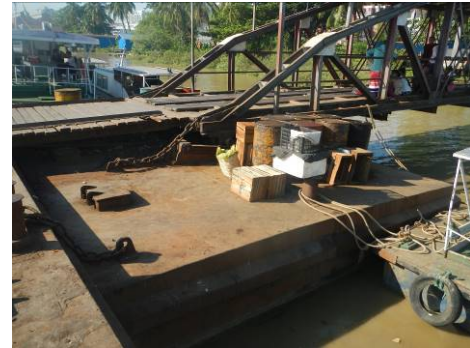
Photo 2 - Support is rusted & broken

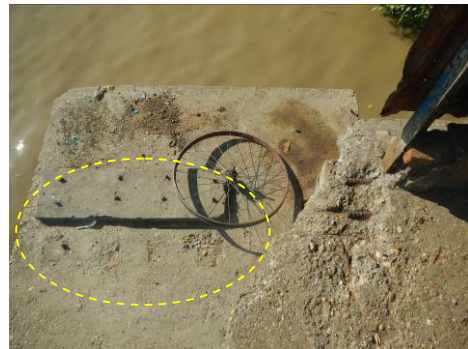
Photo 4 - Abutment slab corner damage

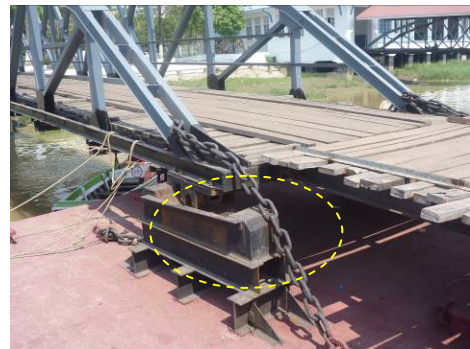
Photo 5 - Roller wheel missing

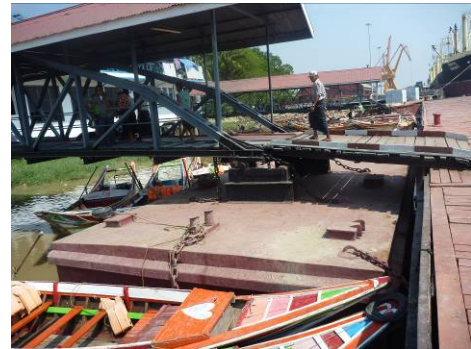
Photo 2 - Abutment column damage

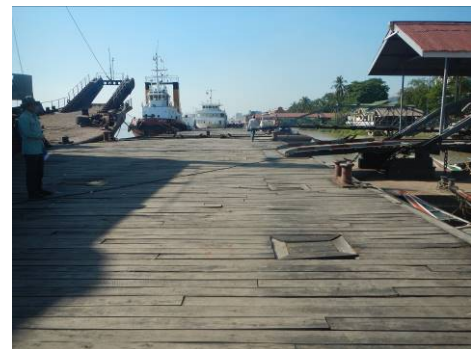
Photo 3 - Decking Damage

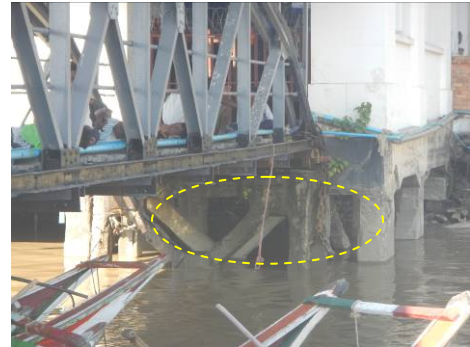
Photo 4 - Abutment Column Damage

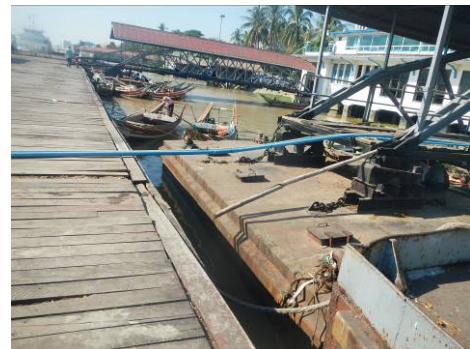
Photo 2 - Roller wheel is missing

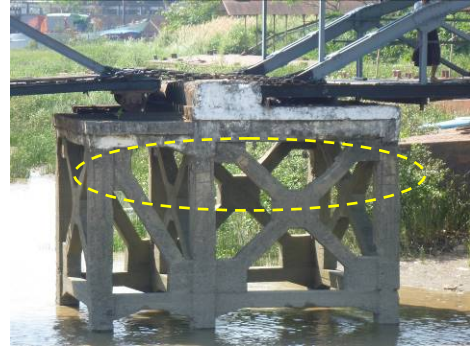
Photo 4 - Abutment column and bracing damage

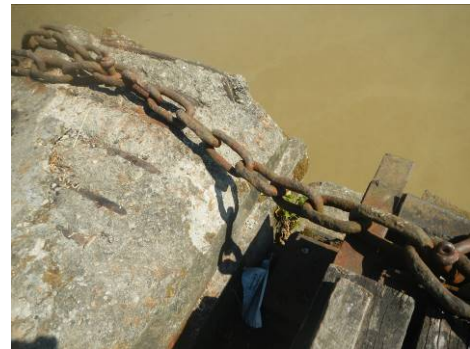
Photo 2 - Abutment Slab concrete damage

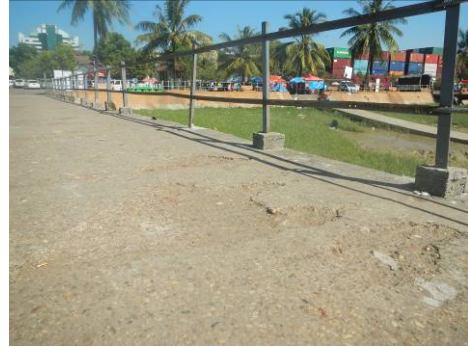
Photo 4 - Hand rail post damage

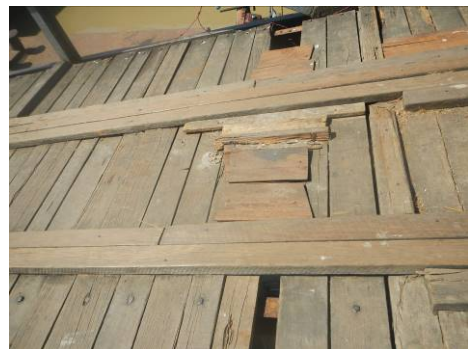
Photo 6 - Timber Decking damage

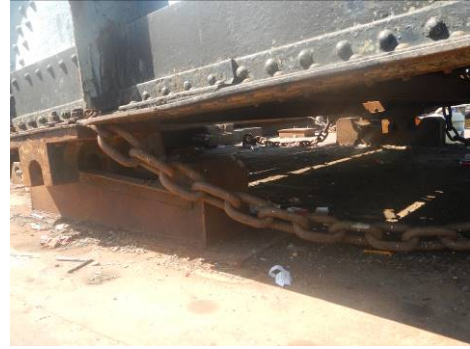
Photo 8 - Roller Wheel missing

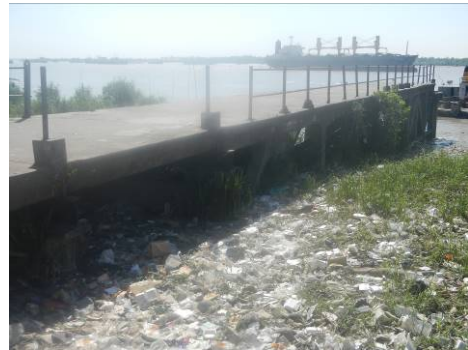
Photo 3 - Hand rail missing

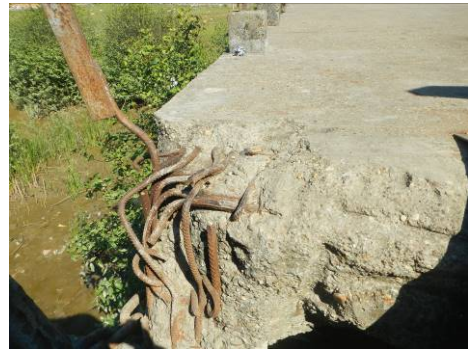
Photo 5 - Damage corner of Abutment

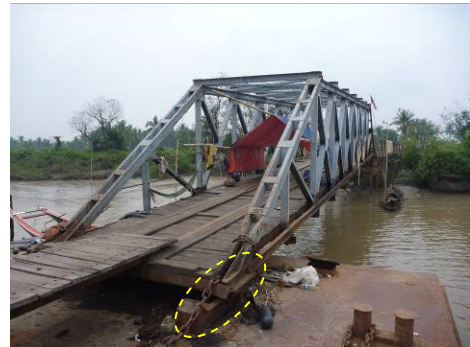
Photo 4 - Roller wheel is missing

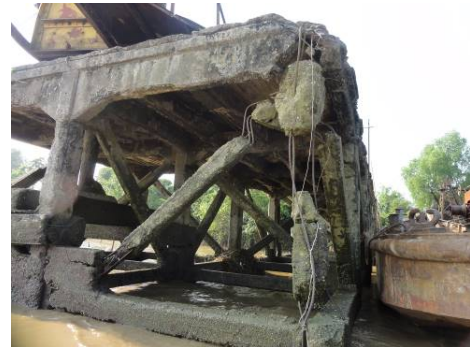
Photo 5 - Column and bracing are totally damage

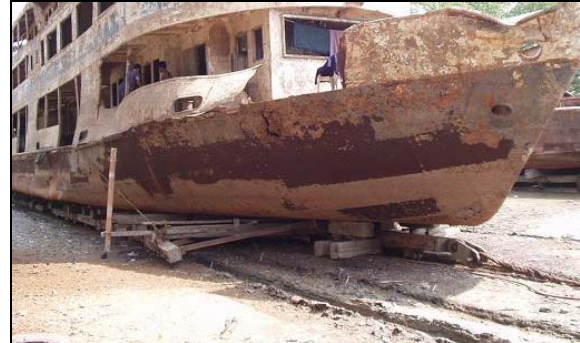
Photo C.2.2
Damaged Wooden Cradle
