**Ex-Post Situation Survey
for the Project for the Improvement of
Dusty-Nizhniy Pyandzh Road**

Ex-Post Situation Survey Report

March 2015

CTI Engineering International Co., Ltd.

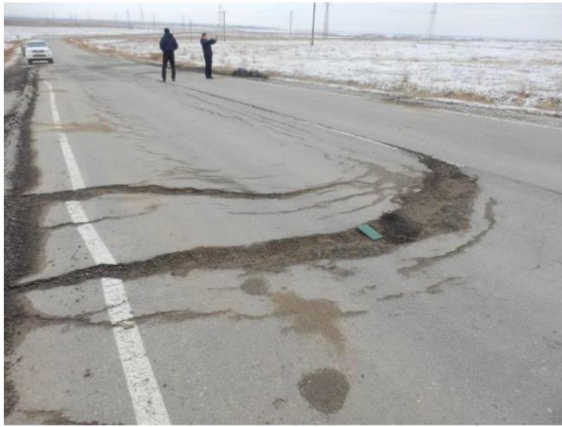
Sliding of AC Pavement

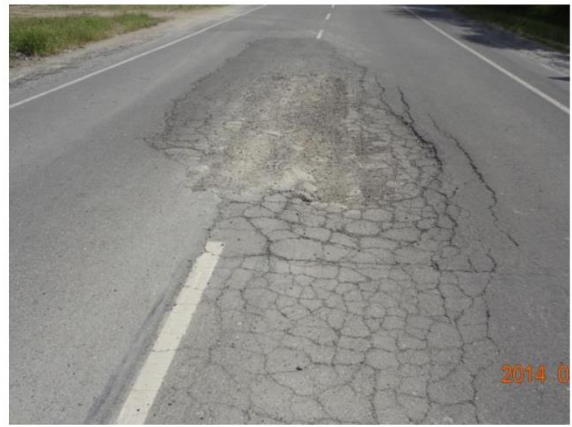
Alligator Crack on AC Pavement/
Exposure of AS Stabilized Base Course

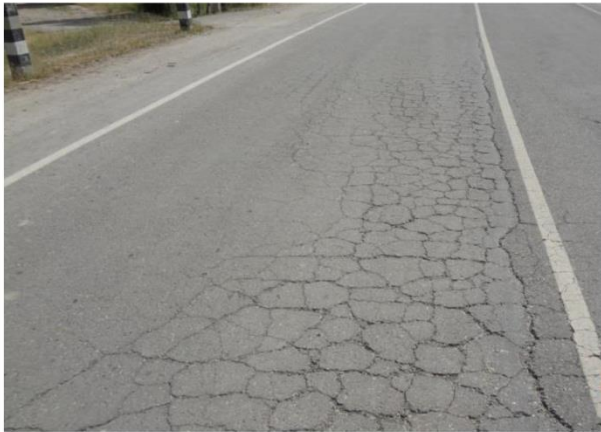
Alligator Crack on AC Pavement

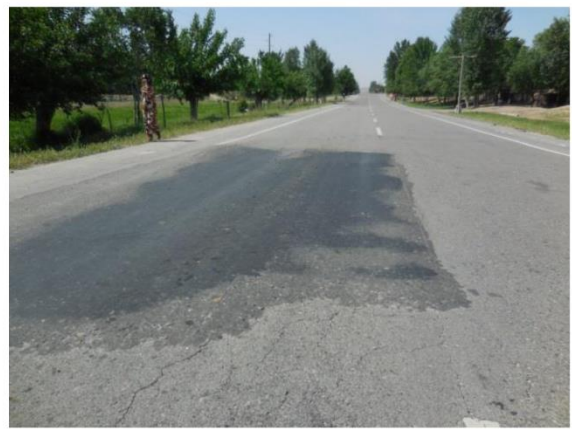
Repair by Cold Mixture at AC Pavement
Defect Location

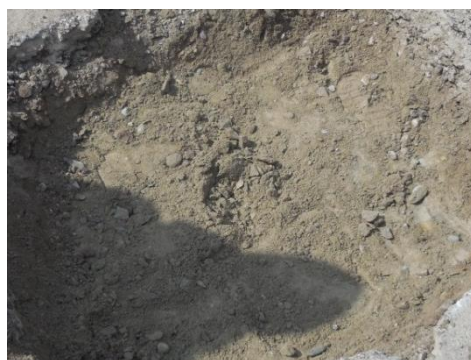
- The design strength of cement stabilized sub-base course at the defect section was not secured. The loose condition of the sub-base/base course was confirmed.
- The moisture content of cement stabilized sub-base course mixed with clayey material is high and has only strength same as base material. The cement stabilized base course at defect sections of flat area have two layers, which are sandy gravel layer and clayey layer.

Cement Stabilized Base course of Sand + Gravel

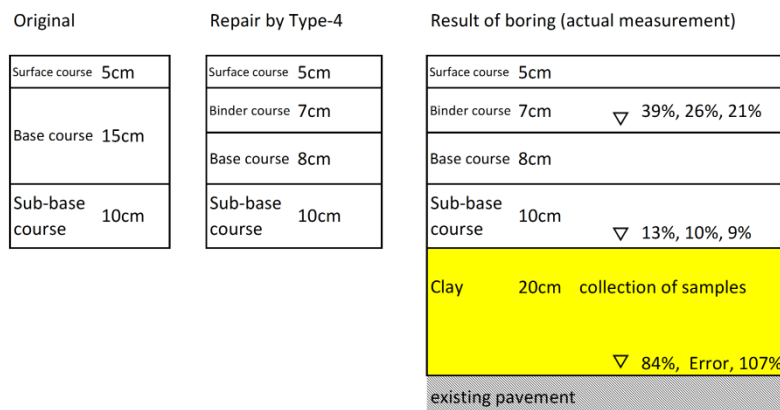
Figure 2.19-1 Excavation Cross Section (Sta.6+904)

Pavement Structure			Strength Test		Remark
Structure	Design	Actual measurement	Design	Actual measurement	
AS pavement thickness	Surface course 5cm	5cm	-	-	
	Binder course 7cm	7cm	-	-	
Base course	8cm	Total 18cm	30	Cement stabilized base course surface Base course surface CBR(39,26,21) Could not confirm the boundary of base/sub-base course	Main material: sand + round rock
Sub-base course	10cm		30		
Subgrade	-	20cm	15	Subgrade(fill) Subgrade surface CBR(13,10,9)	Main material : Clay(yellow) Collection of samples
Existing AS pavement				Pavement surface CBR (84,107)

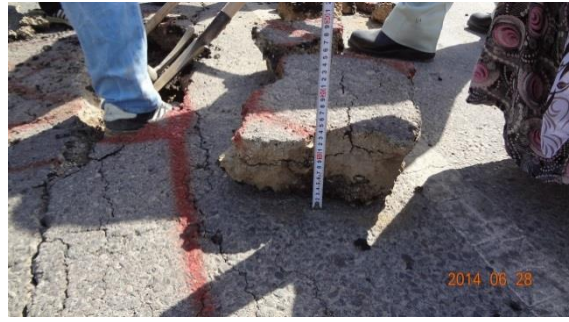
② Pavement Thickness 12cm (5cm+7cm)

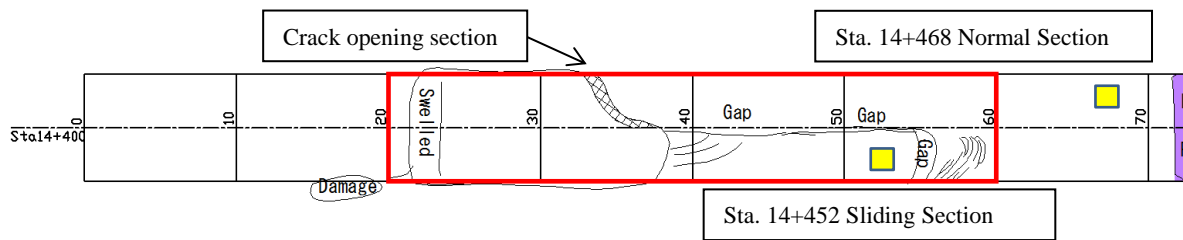
Figure 2.19-4 Measurement of Sliding Surface at Steep Section

The sliding of AC pavement near the Sta. 14+400 is remarkably high. By checking the adhesive condition of the cement-stabilized base course and AC pavement at normal section and the sliding section near the station above, the causes of sliding shall be clarified. The surface conditions of target locations are shown in Figure 2.19-4 and Figure 2.19-5.

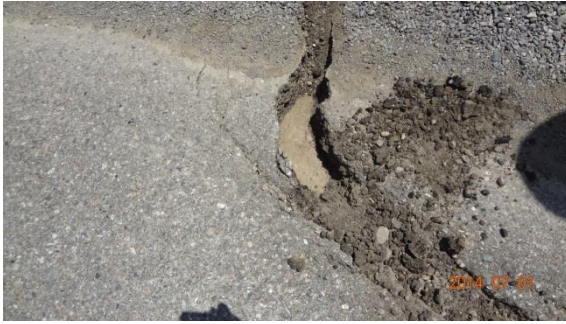
Crack Opening Section

It was confirmed the surface of the cement-stabilized base course was sliding. The prime coat looks peeling and adhered on the AC pavement.

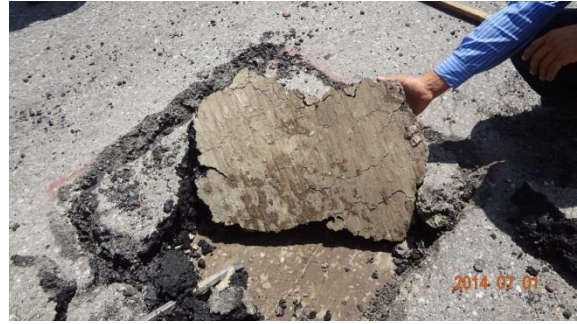
Sliding Section

The prime coat on the cement-stabilized base course surface was completely adhered on AC pavement. It was confirmed the aggregate of the cement-stabilized base course was sliding under the AC pavement.

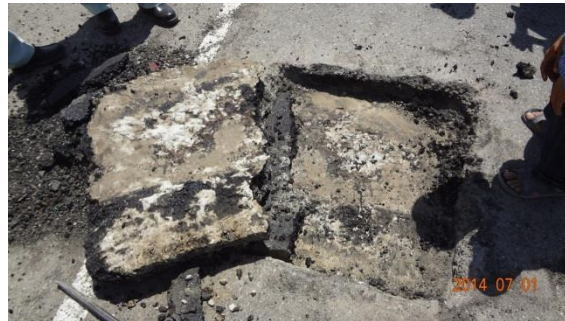
Normal Section

It was confirmed that the AC pavement and cement-stabilized base course were adhered together completely. The aggregate of the cement-stabilized base course is completely adhered at the AC pavement side.

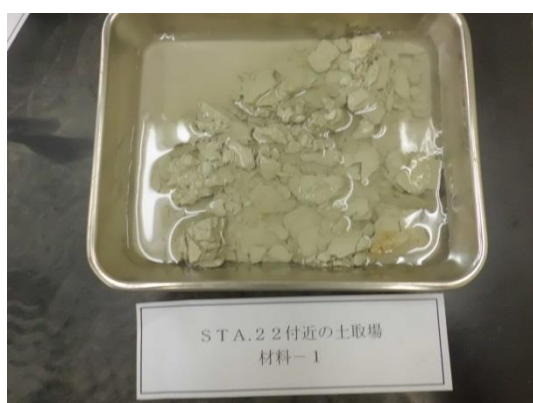
Grain micronizing of material-① after 18 hours of absorbing of water and swelling

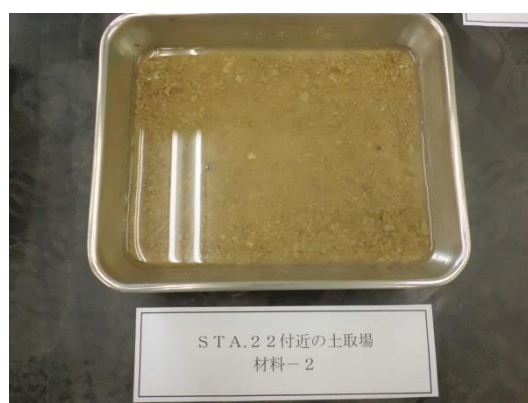
Grain micronizing of material-② after 18 hours of absorbing of water and swelling
