Result of Pavement Inventory Survey

Survey Data Sheet for Dusty-Nijny Pyandzh Road Date

1.1 Confirmation of Damage Condition

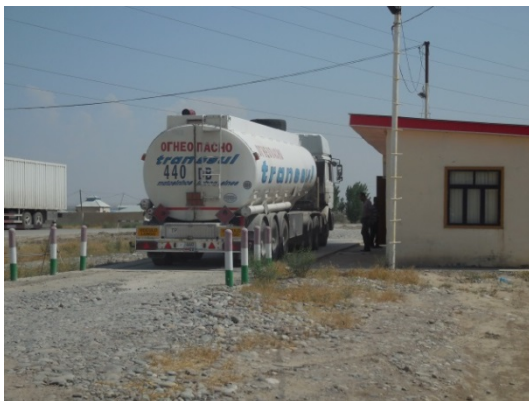
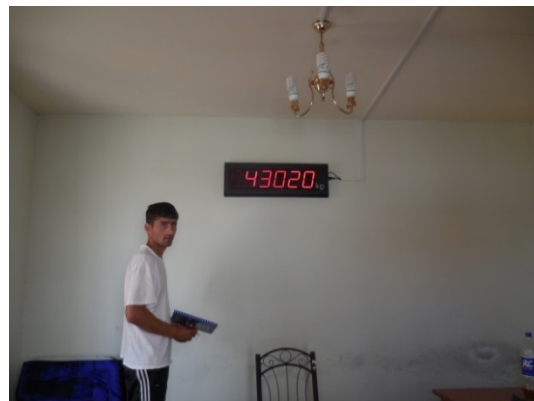
Installation of the easy Vehicle Weight Measure Device since 2011 in front of the gate at the border with Afghanistan to measure the over load of large vehicles. The truck scale had been placed since 2014 and the measurement is conducting 24 hours. Nevertheless, the measurement of the vehicle weight was started in 2006.

Truck Scale Placed in front of the Border Gate

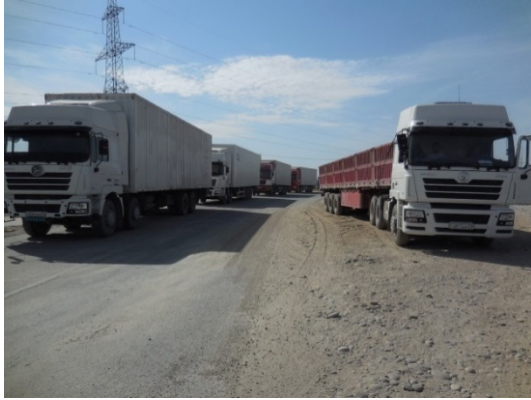
Vehicles Waiting for the Night Passing

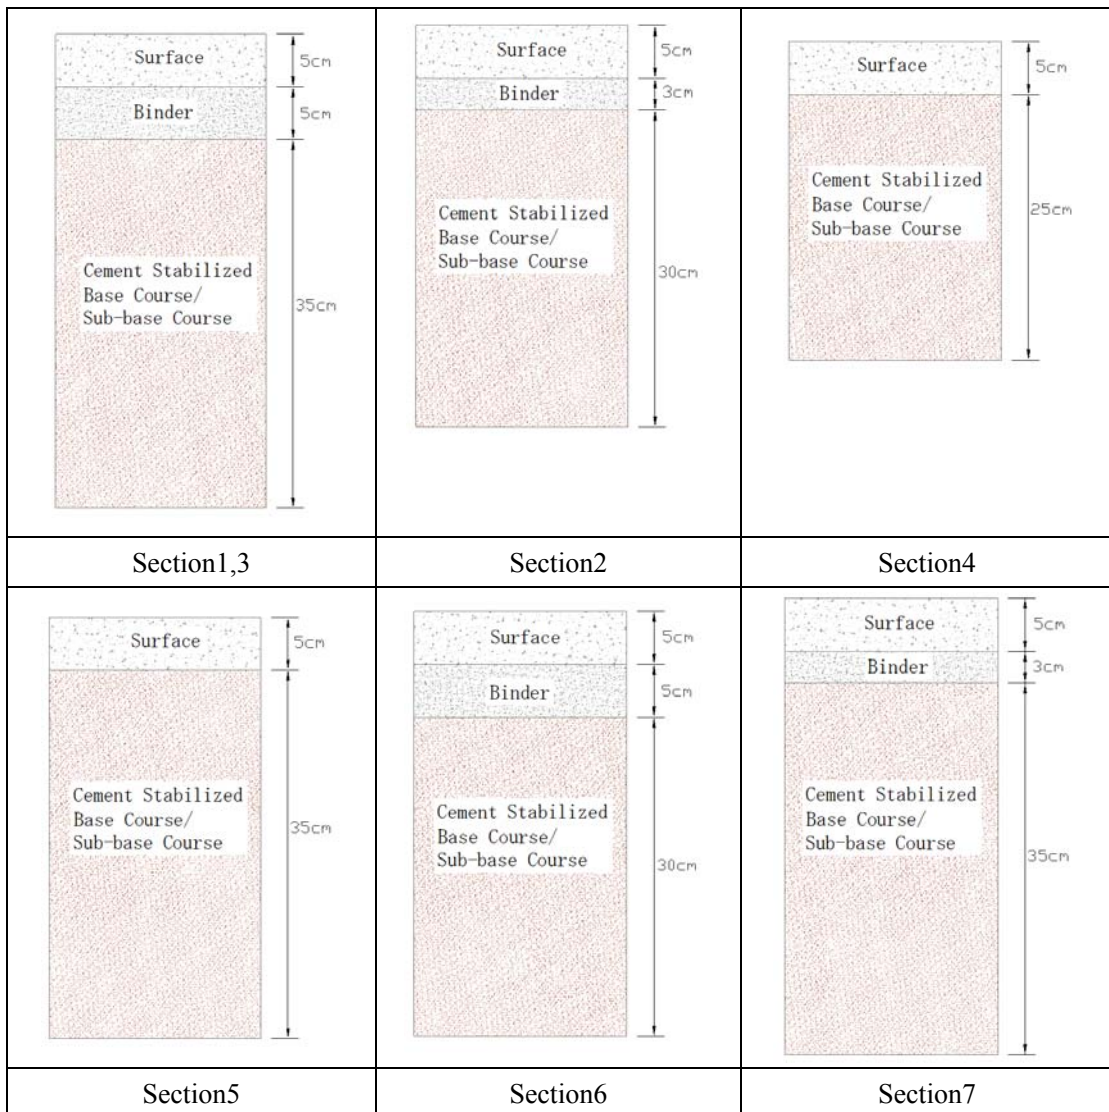
Pavement Structures

1,3	2	4	5	6	7
Accumulated 18kip Equivalent Single Axle Load loading number(W18)	118,940					
Standard Deviation (Z0)	-0.841					
Standard Error	0.45					
Performance Service Index ΔPSI	1.7					
Mp	4,500	7,800	13,050	8,850	5,700	6,150
CBR	3.0	5.2	8.7	5.9	3.8	4.1
Required Structural Number(SN)	2.755	2.288	1.819	2.121	2.515	2.442

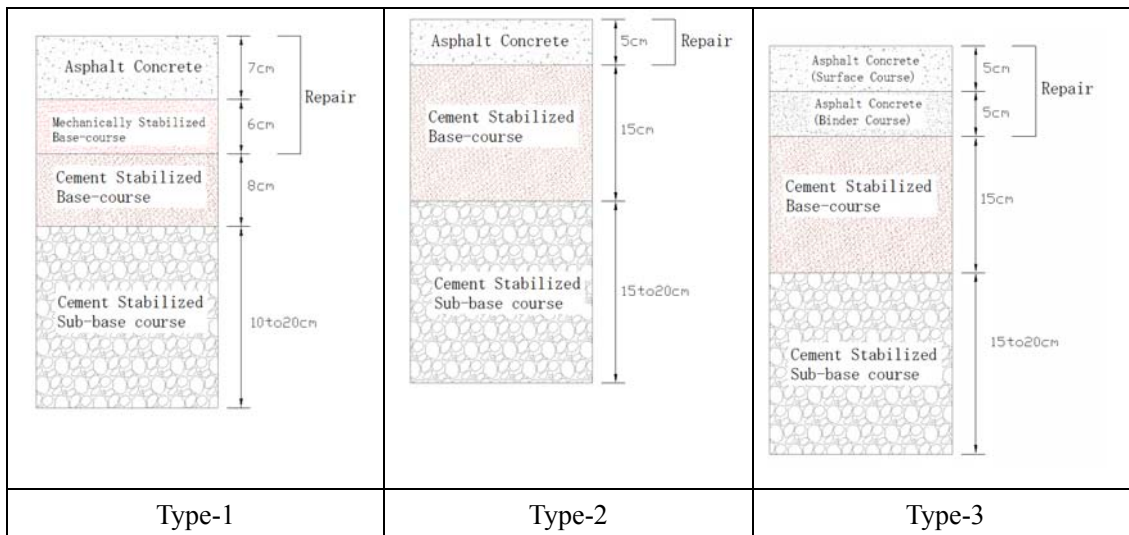
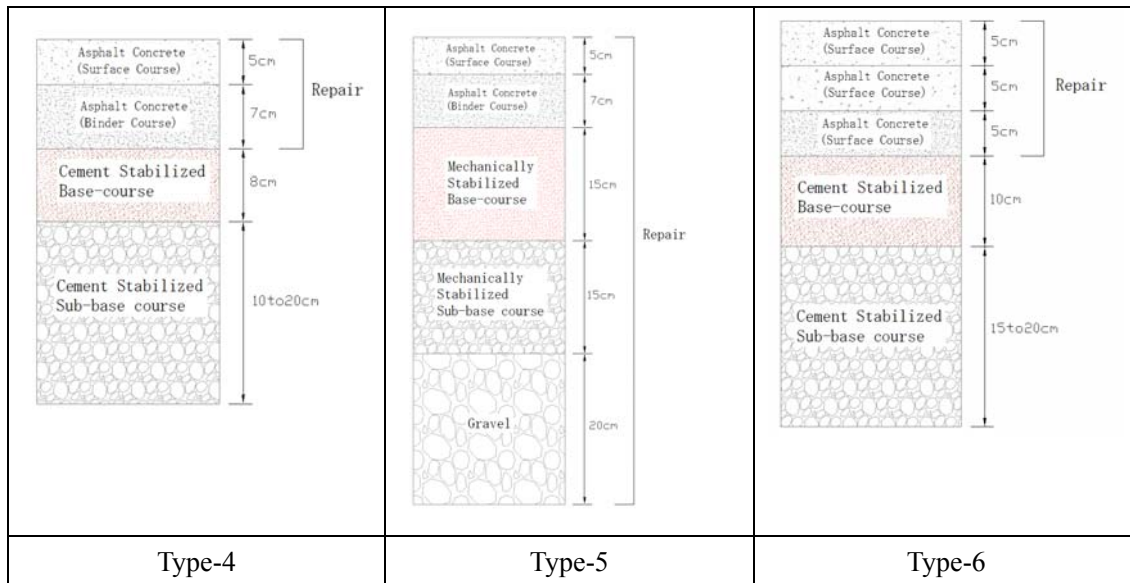
Repair Types during the Defect Liability Period

After the construction completed based on the initial design, the defects had been found during the defect liability period. The repair was done based on the following types.

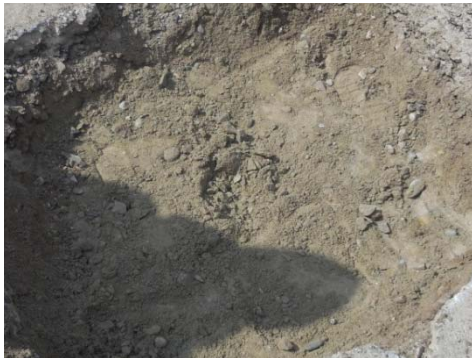
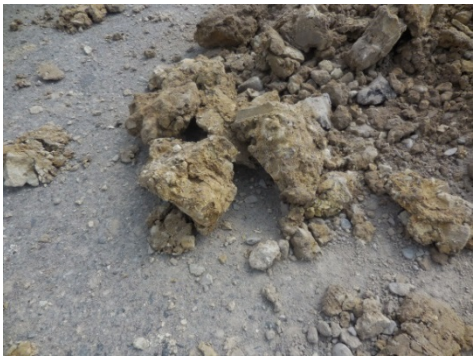
Based on the trial digging of the cement stabilized sub-base at two locations Sta.4+480 and Sta.5+029 of the first survey, the followings are confirmed:

- The design strength of the cement stabilized sand + boulder at the damage section is not secured. The condition of loosen due to the pavement damage has been confirmed
- The moisture content of cement stabilized lower sub-base layer is high and clayey. The cement stabilized sub-base course is divided into 2 layers which are sandy and gravel base course and clayey sub-base course. The strength of the entire base course seems to be not enough.

Cement Stabilized Base course of Sand + Gravel Cement Stabilized Sub-base of Clay

The base course is of sandy soil, where the sub base-course is having highly PL 32.7% and classified as silt. The moisture content is high and the fine grain is more than 20%.

The subgrade is extremely firm at the existing AS pavement. The average 3 times of clegg hammer is over 100%. Thus, the damage at these two locations seemed to be caused by the heavy traffic load and the stagnated water on the existing AS pavement penetrated from the damaged surface.
