**THE PROJECT OF LANDSLIDE
MANAGEMENT IN THE REPUBLIC OF
MAURITIUS**

FINAL REPORT

SUMMARY REPORT

March 2015

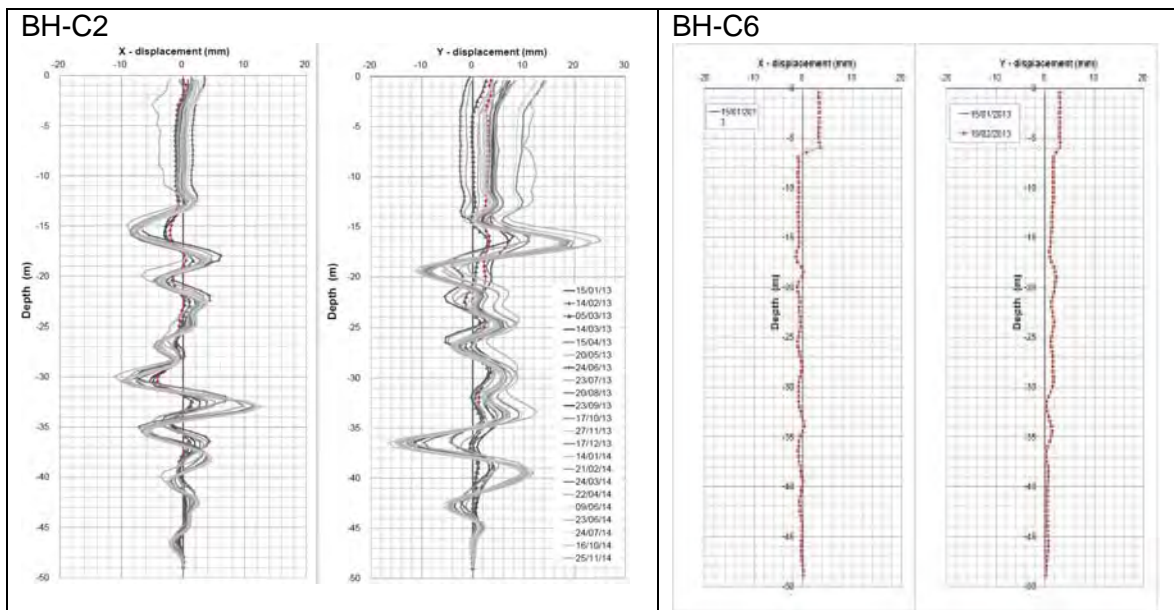
Figure 3.4.6 Results of Inclinator (source: JET)

BH-C6 is installed near Chittrakoot Government School. The monitoring could be done only 2 times (January and February 2014), since the bend of the pipe at the depth of 6 m is in excess of permissive range for the sensor to pass through. This shows that the landslide with a 7m deep slip surface is very active.

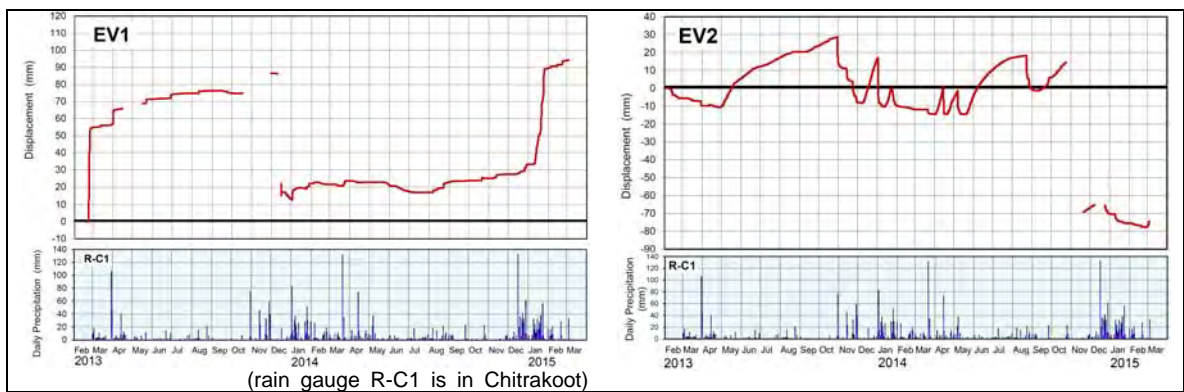
Figure 3.4.15 Results of Extensometer (source: JET)

EV2 which is installed at the toe of the landslide area shows compression movement immediately after the installation. However, it changes to tension movement in May and the tension movement continues all the time until September. The tension movement may be caused by partial deformation of the canal which EV2 straddles as shown in Figure 3.4.19. Even a big deformation was recorded at EV1 in January 2015, EV2 did not record big deformation.

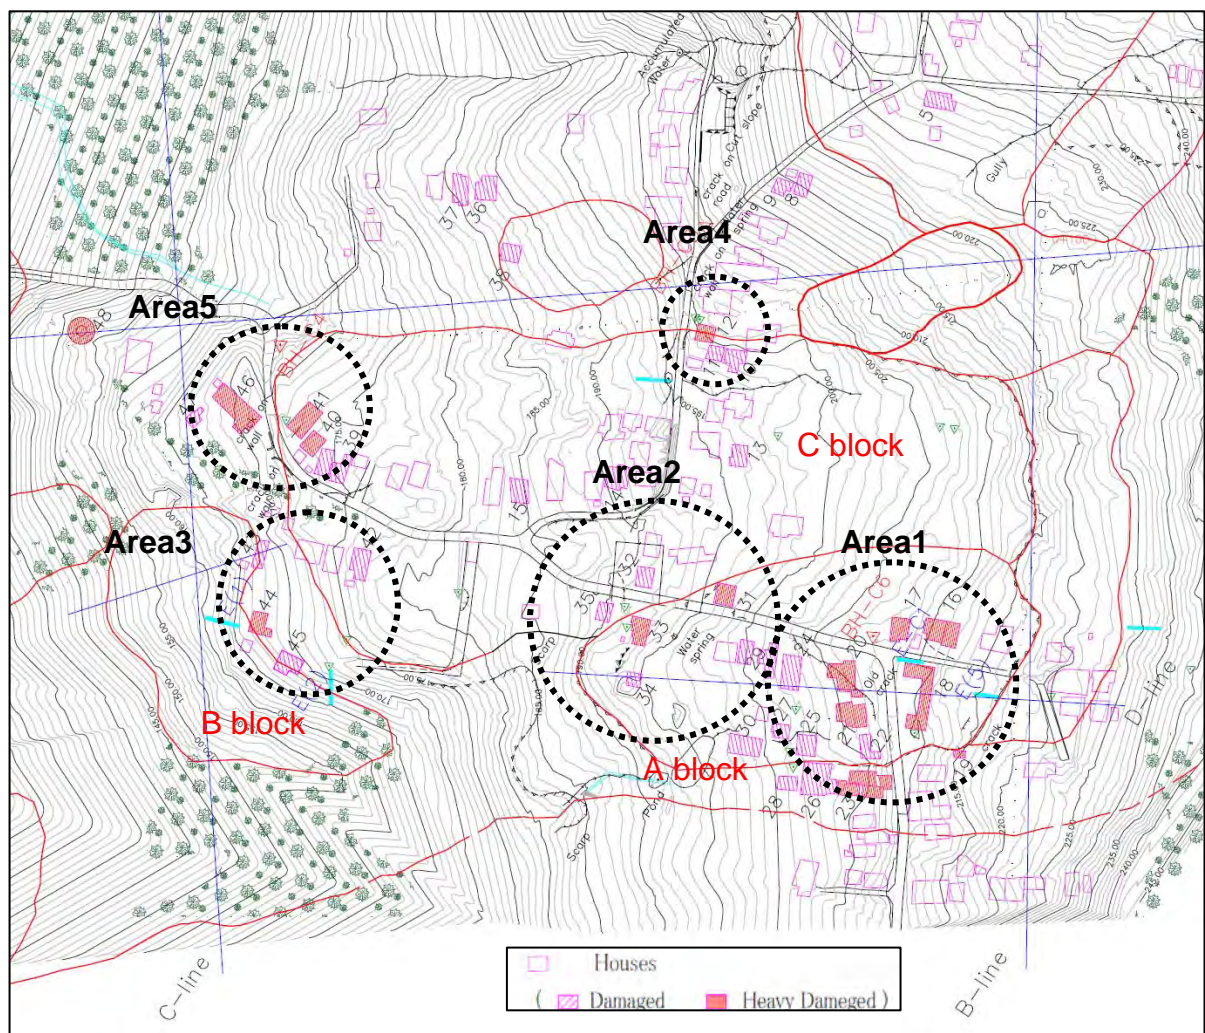
Figure 3.7.1 Results of Survey on Damage to Houses, Chittrakoot (source: JET)

A survey on damage to houses was conducted in conjunction with MPI, with the aim of understanding the extent of landslide damage in the relevant areas. The houses determined to have suffered damage are shaded in pink, with heavily damaged houses shaded in red. The locations of damaged houses generally correspond to the locations that suffered deformation in the 2005 landslide.

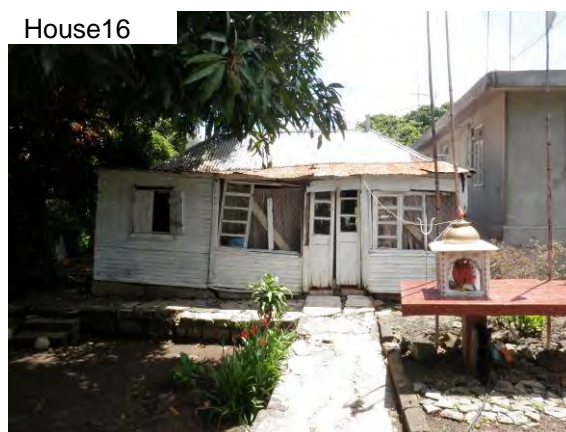
Photo 3.7.2 Heavily Damaged House

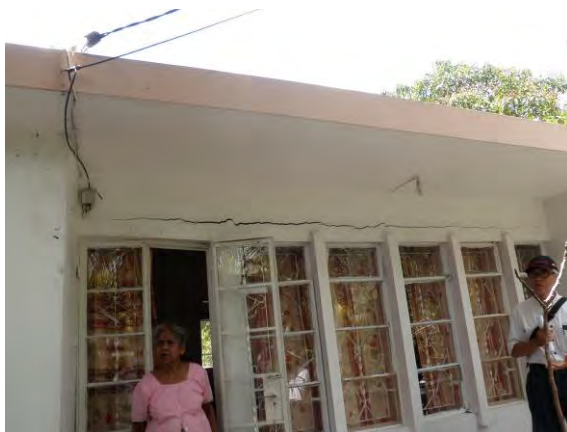
Lower Slope	15~17°	Spanning from the road above the houses to the main road on the coast, it is a steep slope crowded with houses. Because there are houses and a main road along the coast subject to preservation, whenever a landslide or slope failure occurs the damage is extensive and it is an area with an urgent need for countermeasure works.
-------------	--------	--

Photo 3.7.3 Horizontal Open Cracks in the Wall

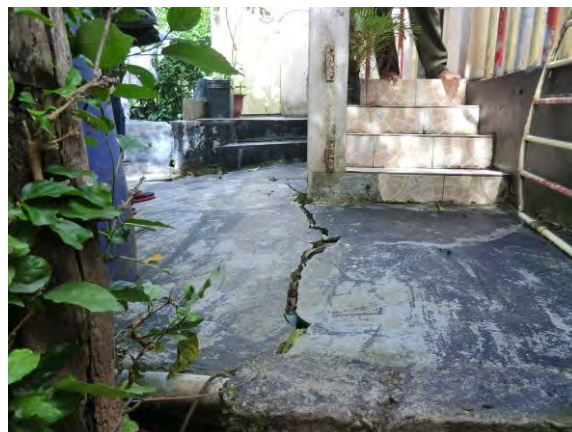
Photo 3.7.4 Open Cracks in the Foundation

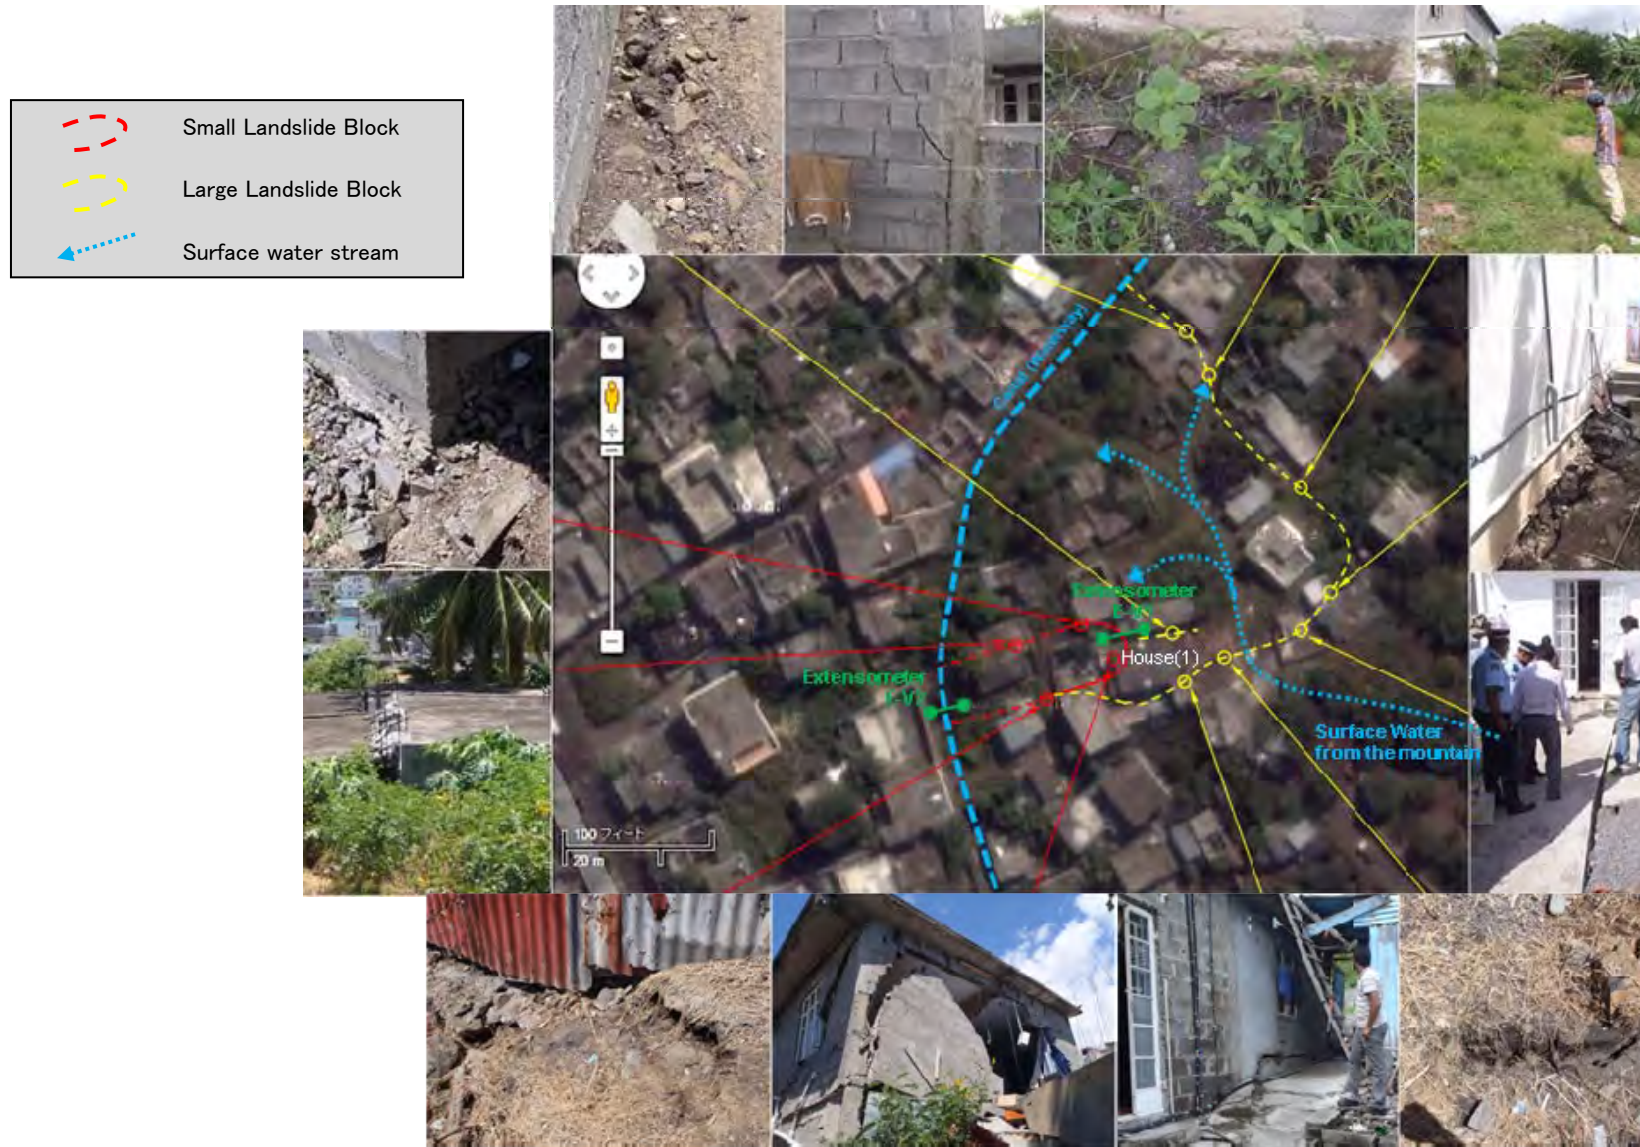
Figure 3.7.4 Landslide Plan Map (3rd Reconnaissance on 26th February 2013) (source: JET)

News that a part of House (1) had broken reached MPI on 25th February 2013. MPI and JET went to the site on 26th February, and 3rd reconnaissance was carried out. The outside wall of house (1) was completely broken, and the main scalp had increased in size since the 2nd reconnaissance. In addition, new open cracks were found in the upper part of this house. The 3rd reconnaissance confirmed that the landslide area of Vallee Pitot was much larger than previously thought (indicated by the yellow dotted line in the figure below).
