7. Landslide Recording Sheet

# General Information Sheet (Other)

Management number	000000001	Reporter's name:	Tomoharu IWASAKI	Date of report :	June 14, 2012
Address	Temple Road, Creve Coeur	Type*	Damage of wall	latitude	-20.149417
			longitude	57.582472

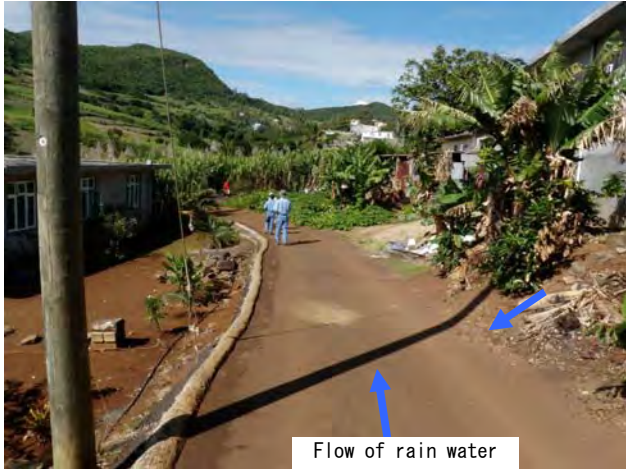
The 1m high retaining wall along the road was found to have collapsed due to erosion by surface water flow during rainy season.

Ph-1 Full view of damage of retaining wall

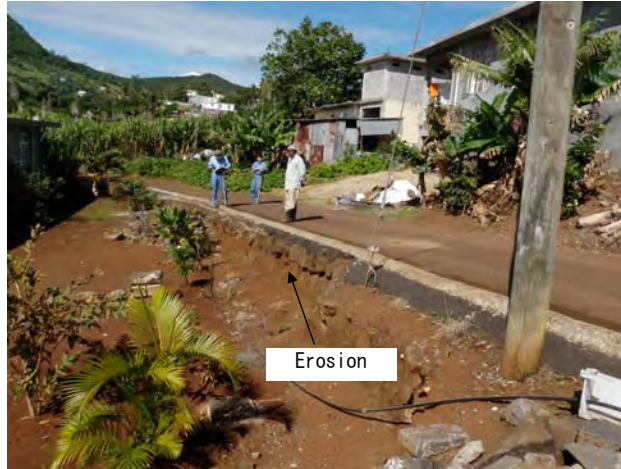
Ph-2 damage in retaining wall by erosion

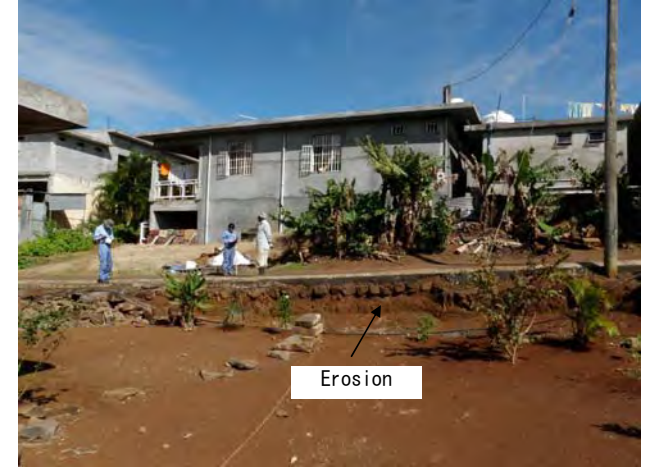
Ph-3 damage in retaining wall by erosion

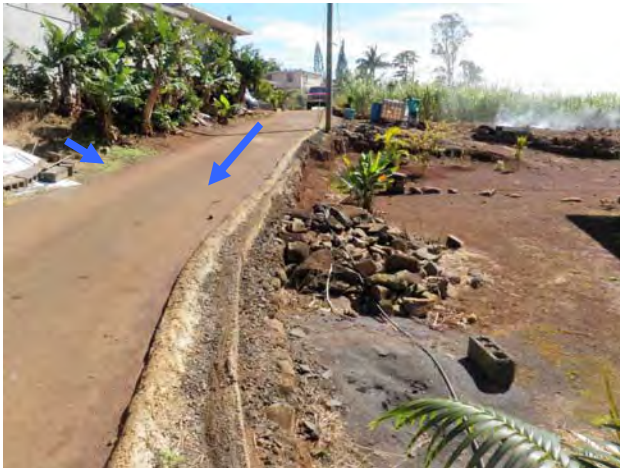
Ph-4 Retaining wall that comes off

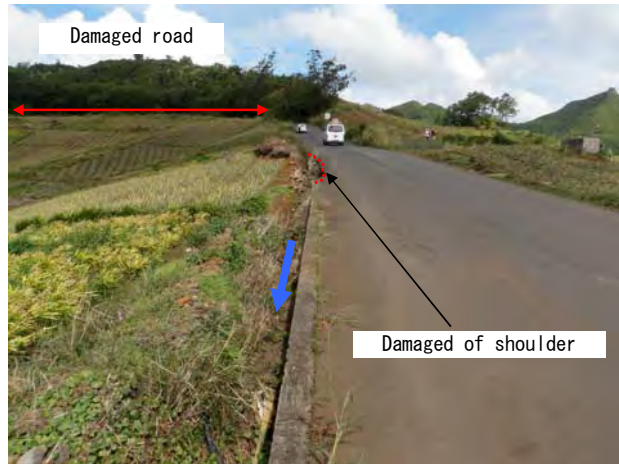
The cracks have been spotted on the road surface due to the deterioration of bearing capacity of the roadbed. The cracks have been repaired although the soil compaction on the roadbed and the strength confirmation of the road body will be necessary.

Ph-1 Full view of of damaged road

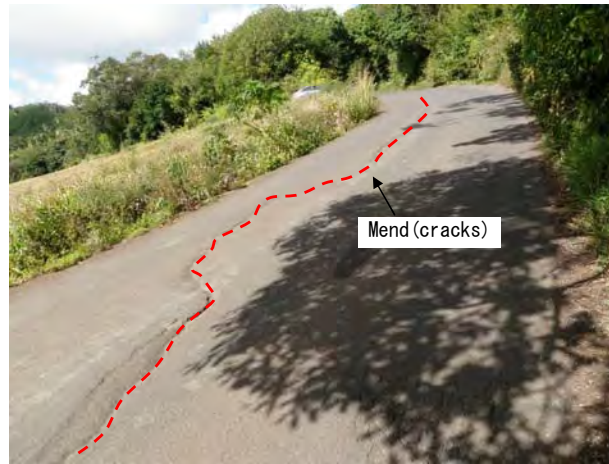
Ph-2 Repair mark on road

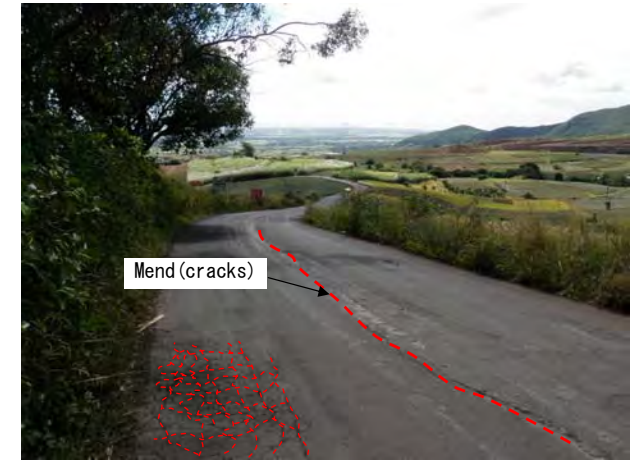
Ph-3 Repair mark on road

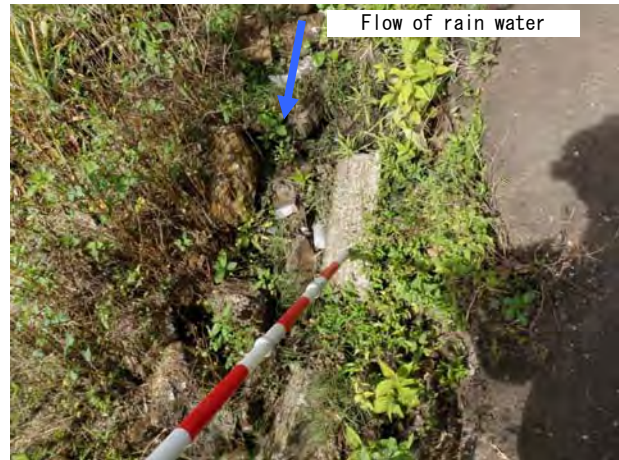
Ph-4 Damage of shoulder

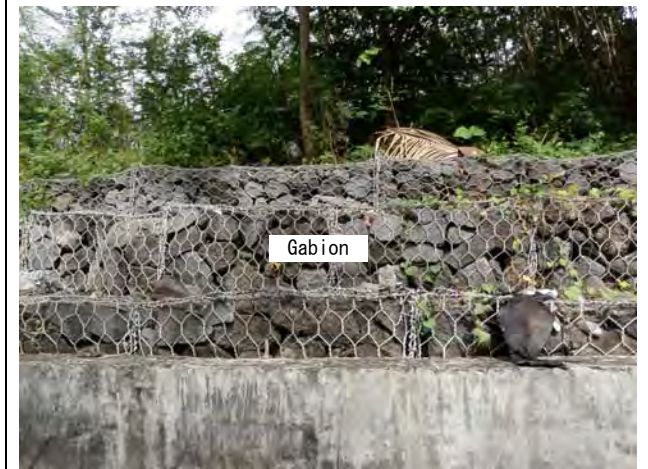
Ph-4 There is no damage

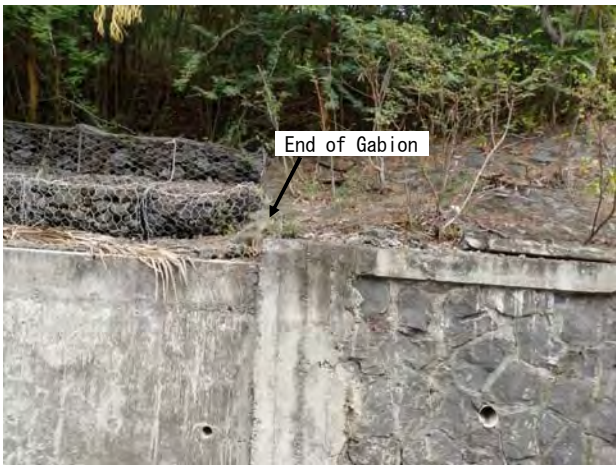
Ph-5 End of the gabion

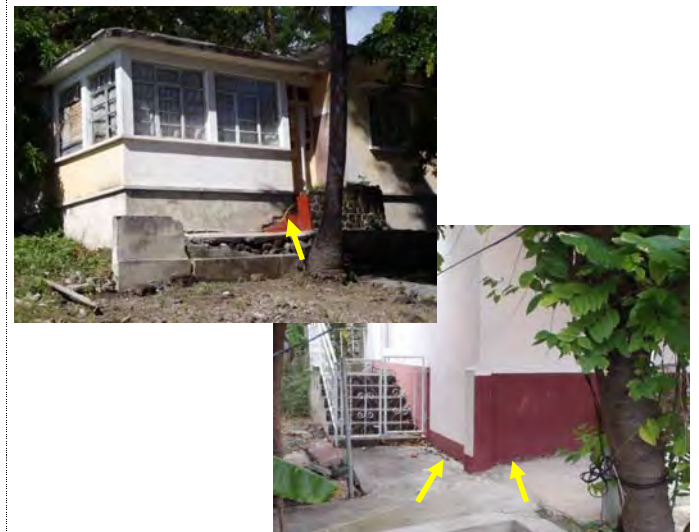
Ph-3 Damage on house

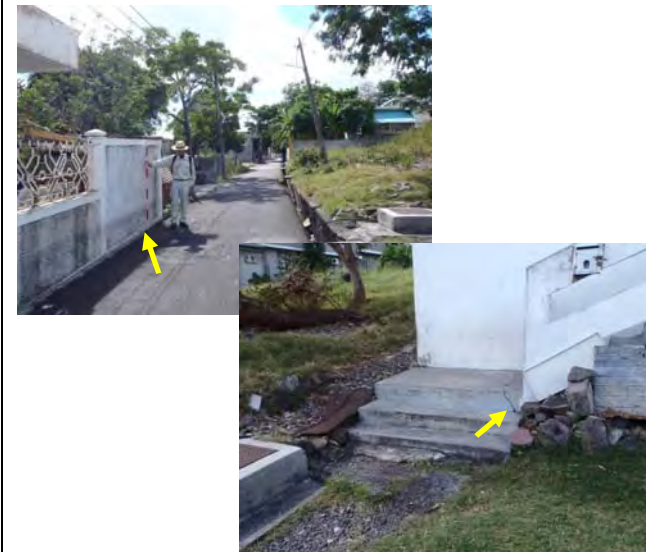
Ph-4 Damage on house

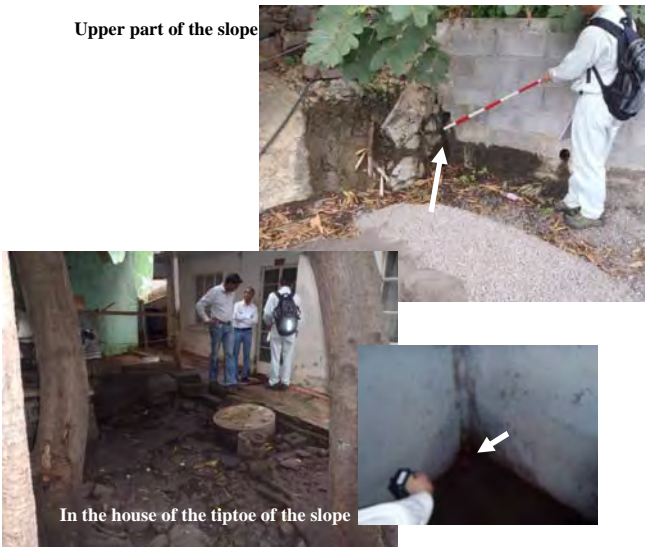
Ph-5 Spring waters

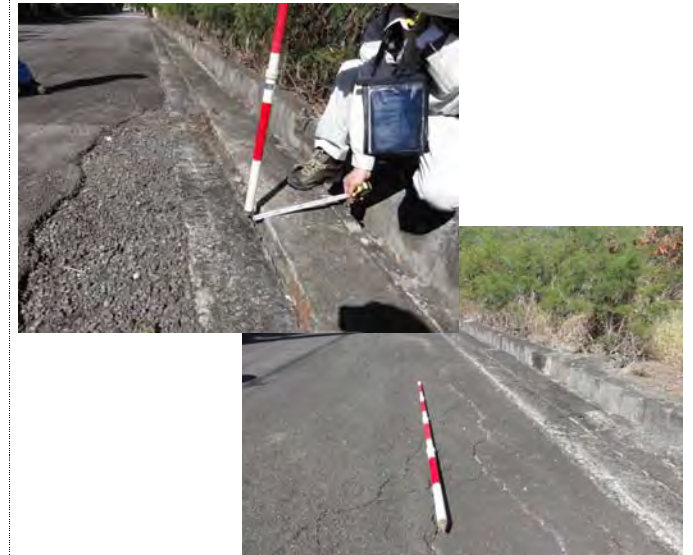
Ph-3 Cracks on the road (Upper road)

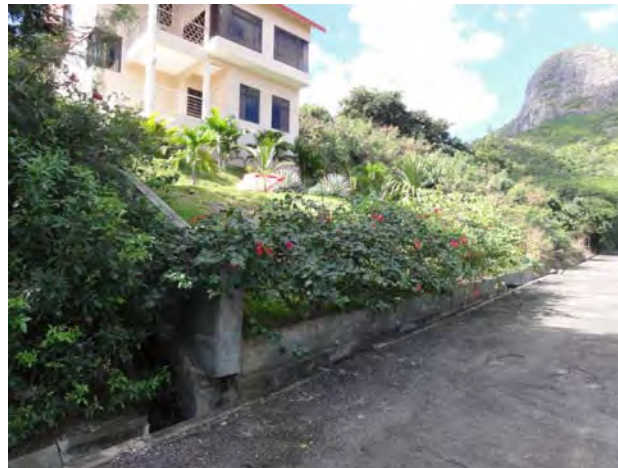
Ph-5 Toe of the slope

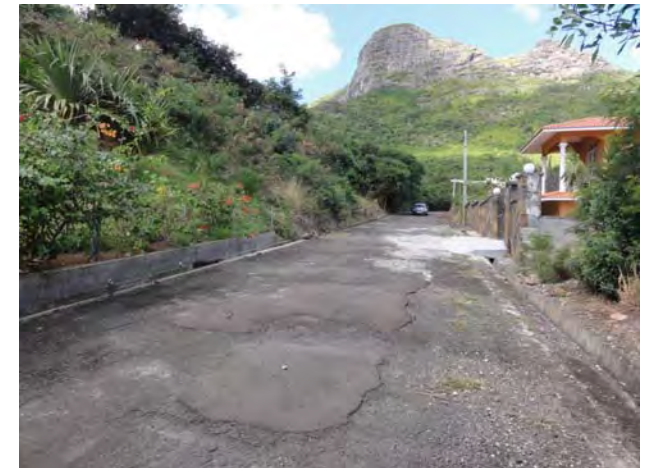
Ph-6 Cracks on the road (Lower road)

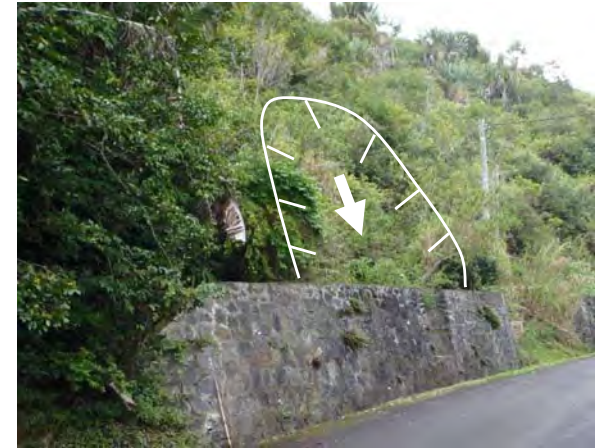
Ph-3 Trace of past slope failure

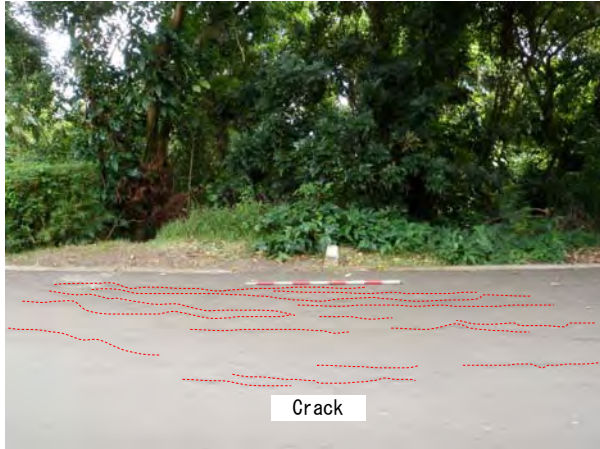
Cracks in the road shoulder have occurred due to a lack of bearing capacity .  
 The crack is located in the vicinity of the boundary of the cutting ground and the fill.  
 The subsidence of the road is 10-15cm.  
 The soil compaction is insufficient.  
 The fill material is soft.

It is caused by insufficient soil compaction.

Ph-1 Crack on road side

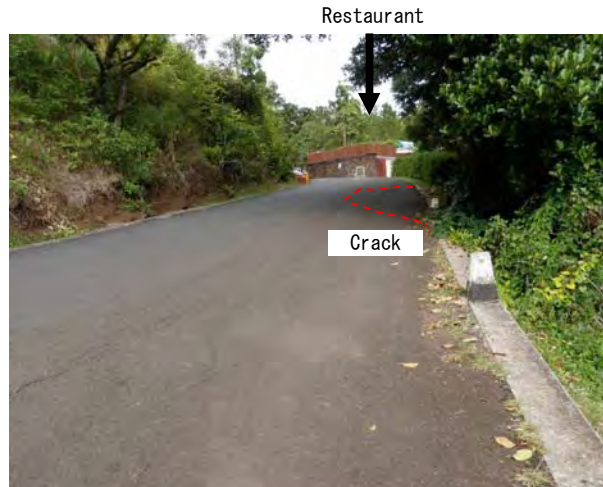
Ph-2 Crack on road side

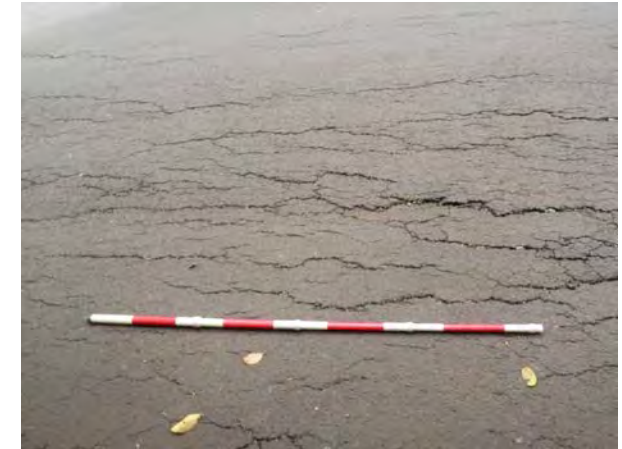
Ph-3 The crack occurred in the road sea side shoulder. (By the damage of differential settlement)

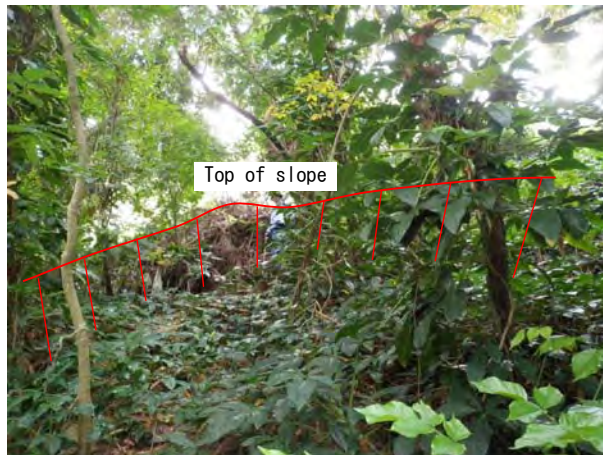
Ph-4 Slope under shoulder

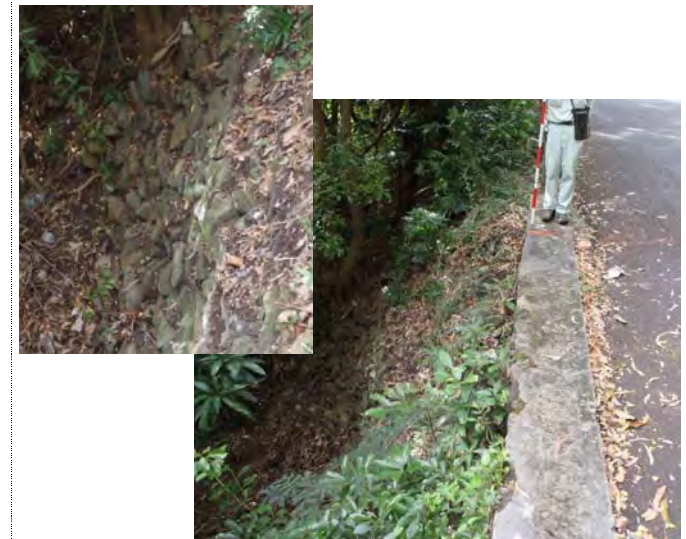
Ph-3 Stone masonry wall of the road shoulder (B-B' cross section)

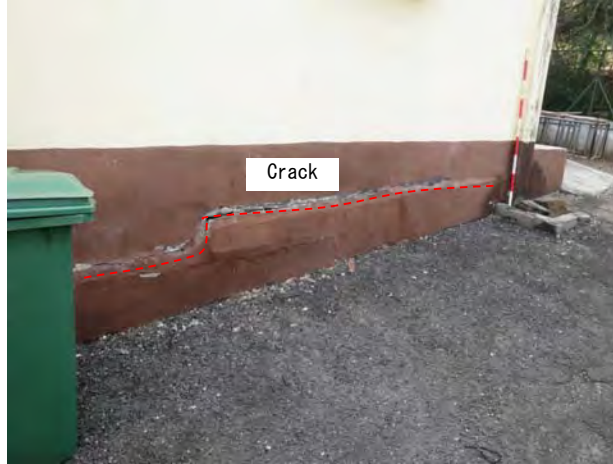
The crack at the base of village hall area and edge of concrete basketball court has been confirmed. However, the surrounding structures are not affected, therefore it is considered unlikely this damaged was caused by landslides. Rather it is likely to be caused by lack of bearing capacity of the ground or a problem with the structure itself.

Ph-2 Cracks of wall (by differential settlement)

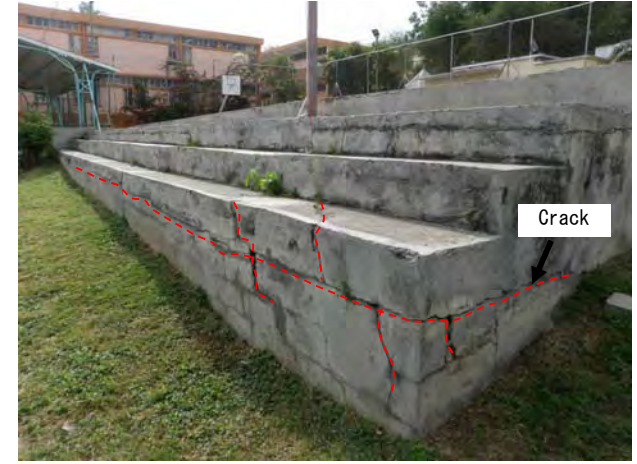
Ph-3 Horizontal crack of the Concrete step

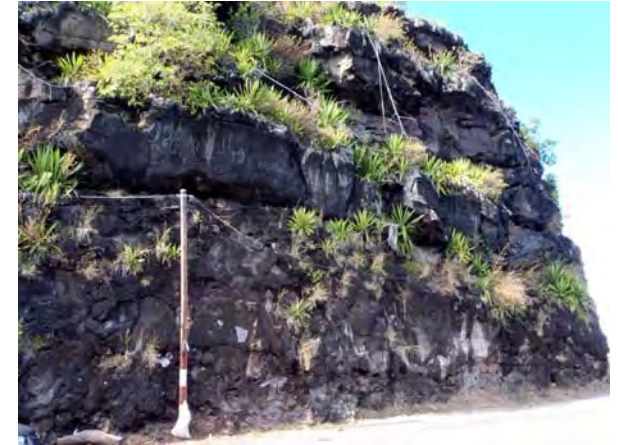
Ph-2 The rock constituting a cliff (many cracks and weathering intensely)

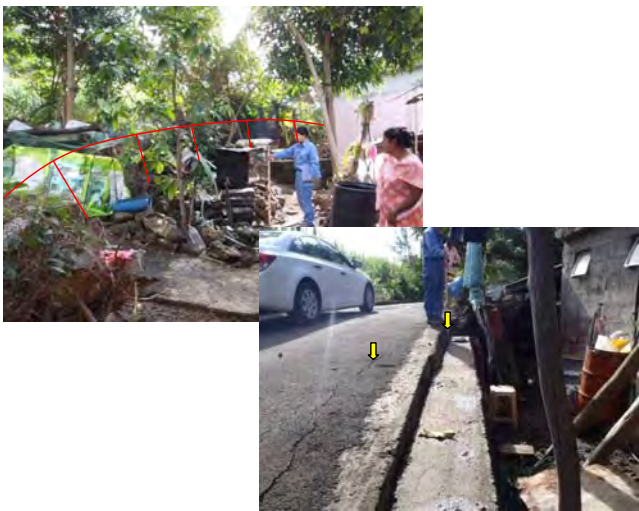
Ph-4 Head crack of a small landslide of the lower part

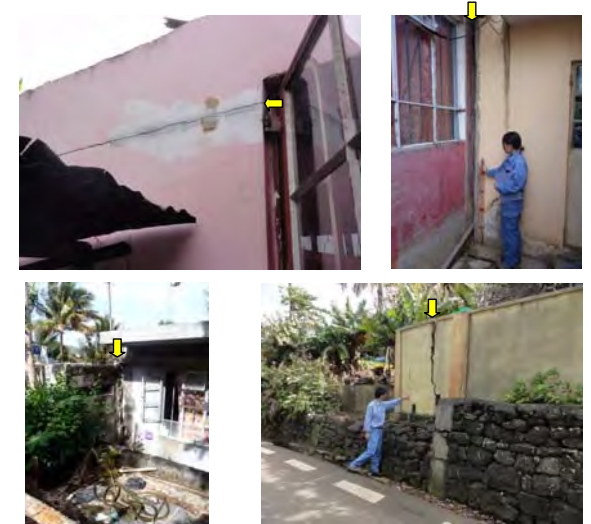
Ph-6 Heavy damage on house

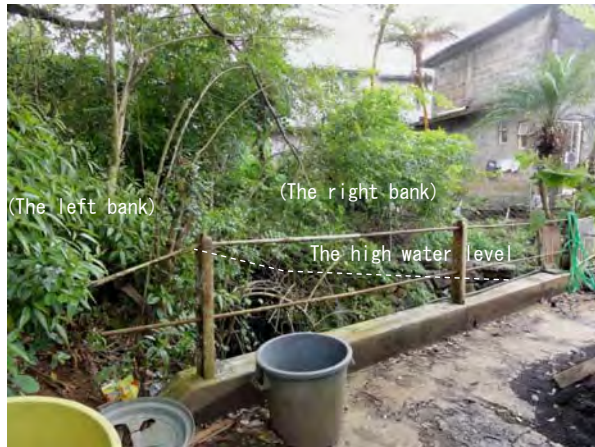
Ph-1 Full view of the river

The left river bank which a flow of the water crashes. It is eroded area. The past damage is restored now.

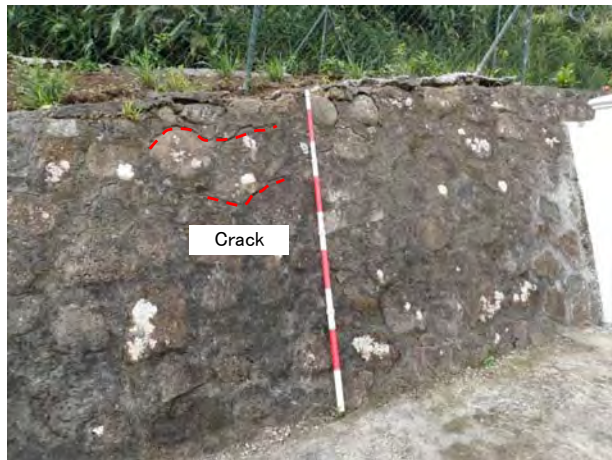
Ph-4 Crack of retaining wall

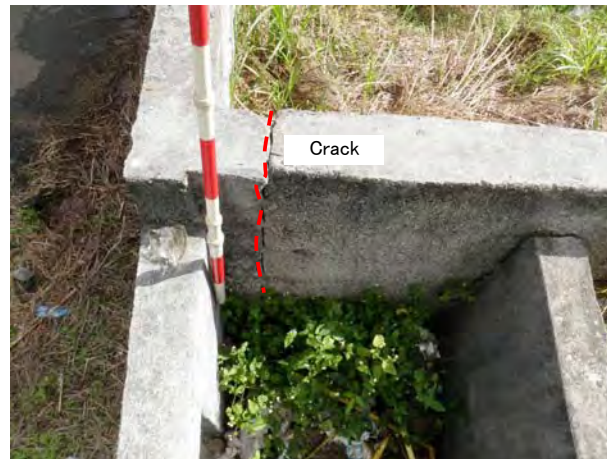
Ph-5 Crack of concrete wall

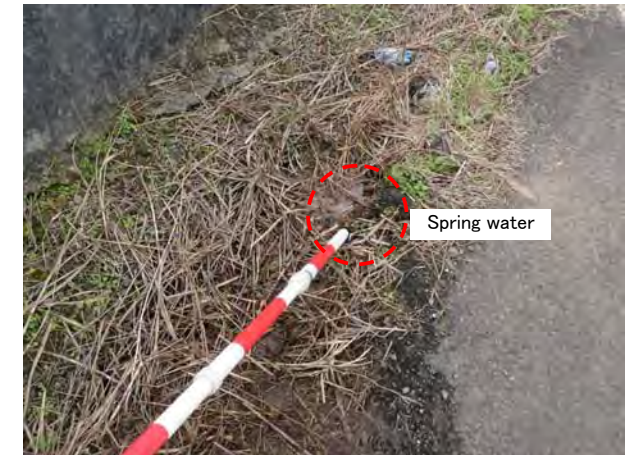
Ph-6 Spring water

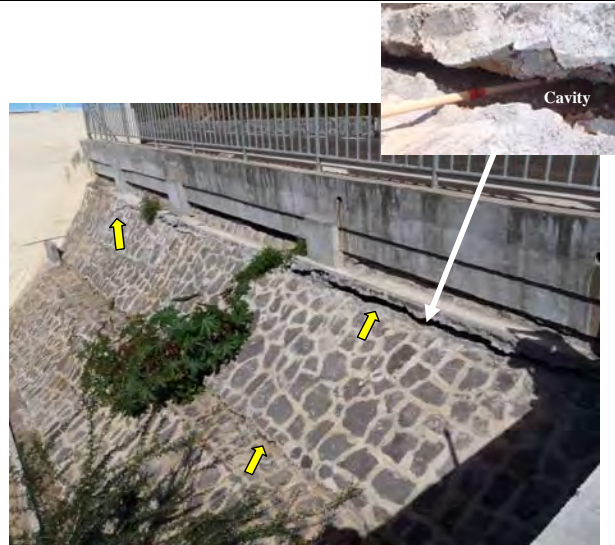
Ph-2 Cracks on Stone block

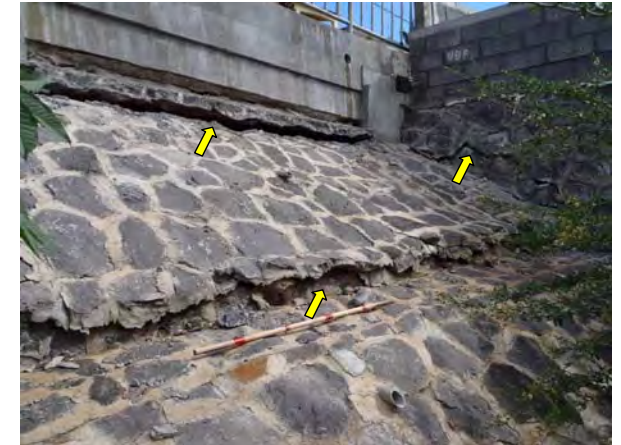
Ph-3 Cracks on Stone block

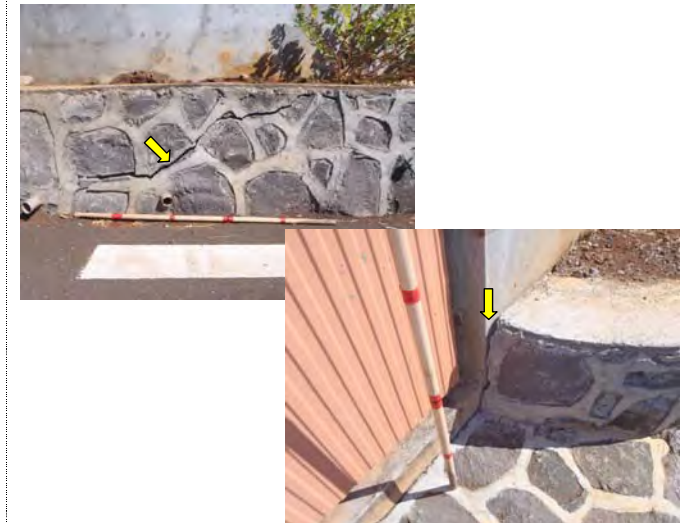
Ph-6 Cracks around the house
