## 8. Result of Aerial Photograph Interpretation

## Regular Check Sheet

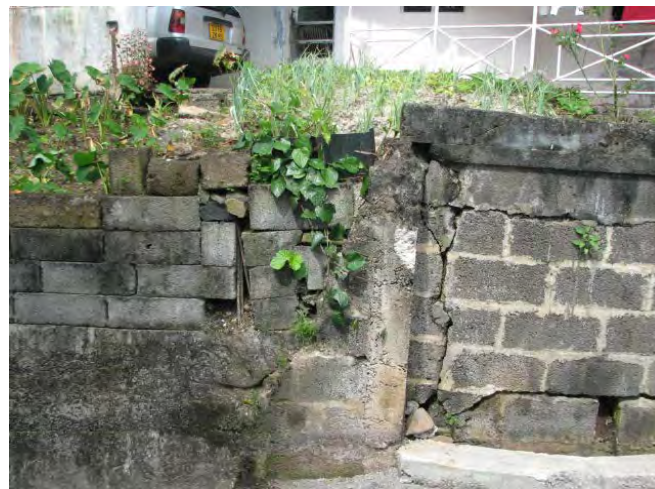
The damage of the concrete block wall

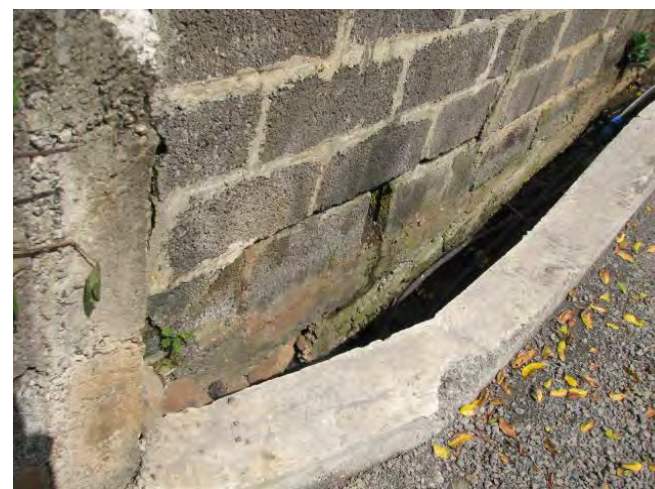
Damage of the drainage of the roadside

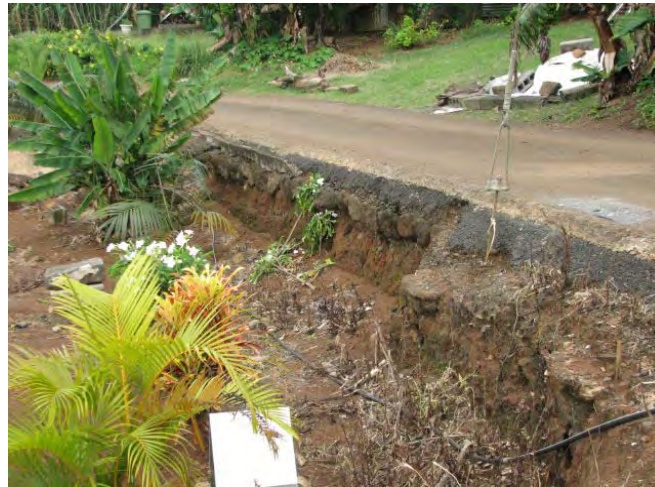
Damage in retaining wall by erosion

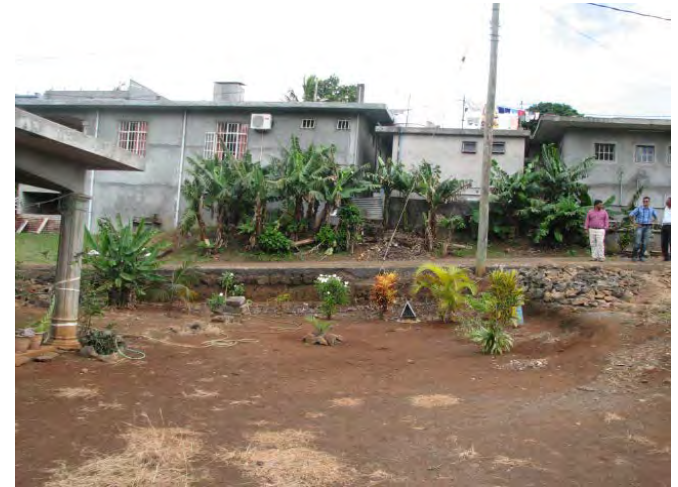
Damage in retaining wall by erosion

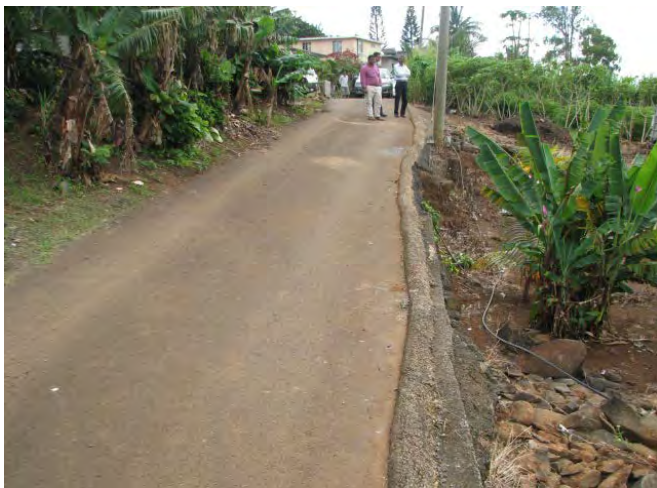
Retaining wall that comes off

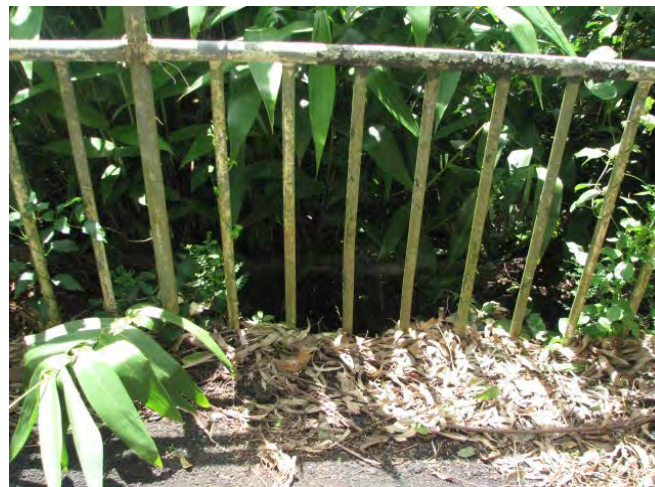
Slope failure

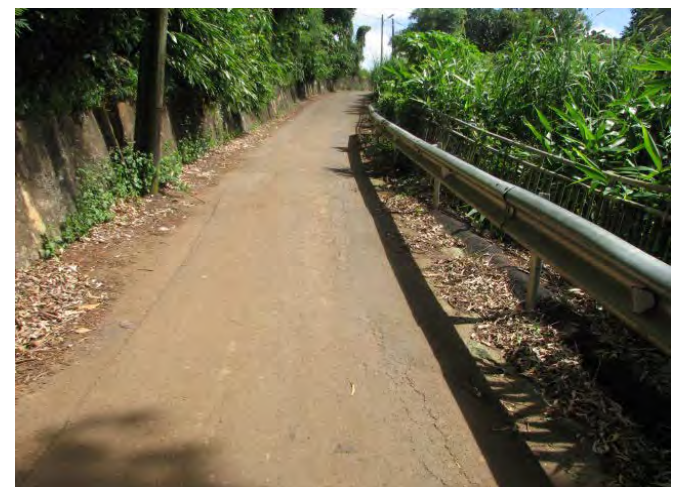
Transverse cracks

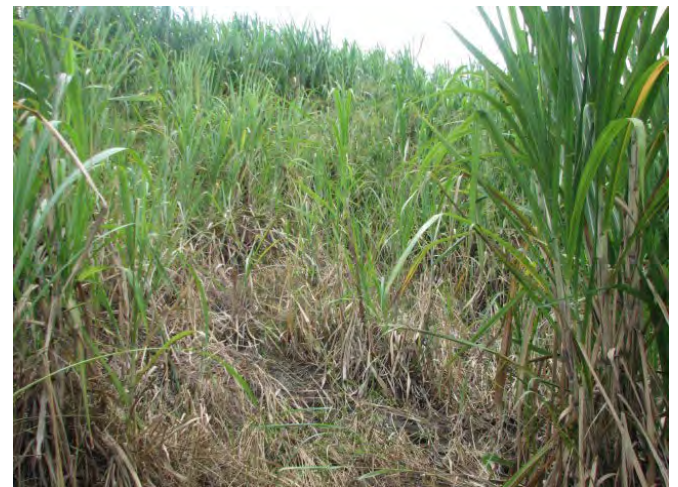
Trace of slope failure

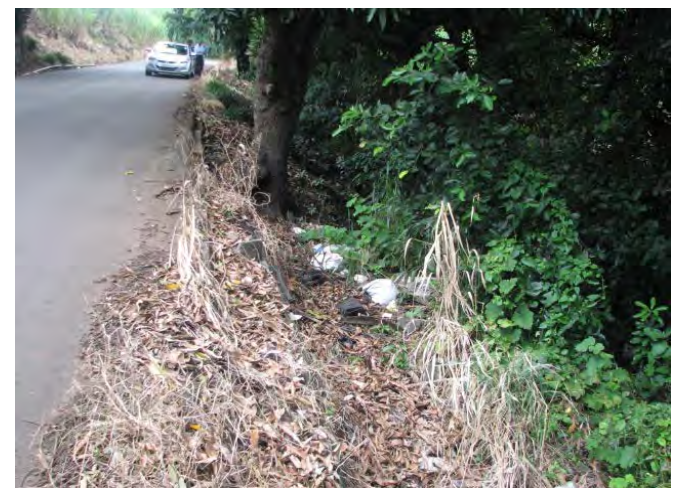
Rocks and gravel by slope failure

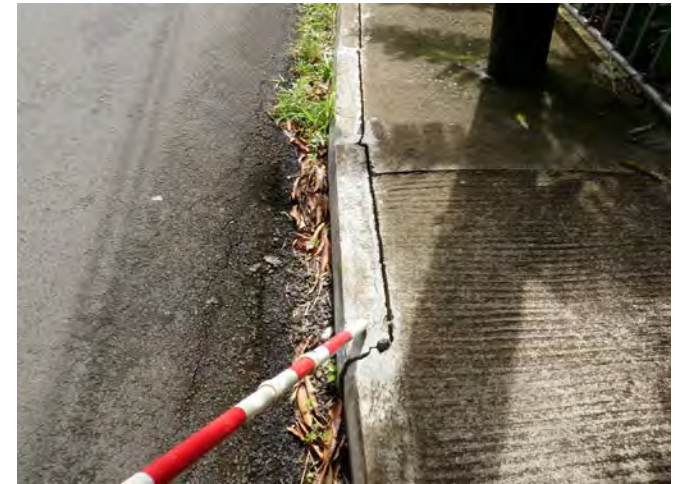
New crack along the road

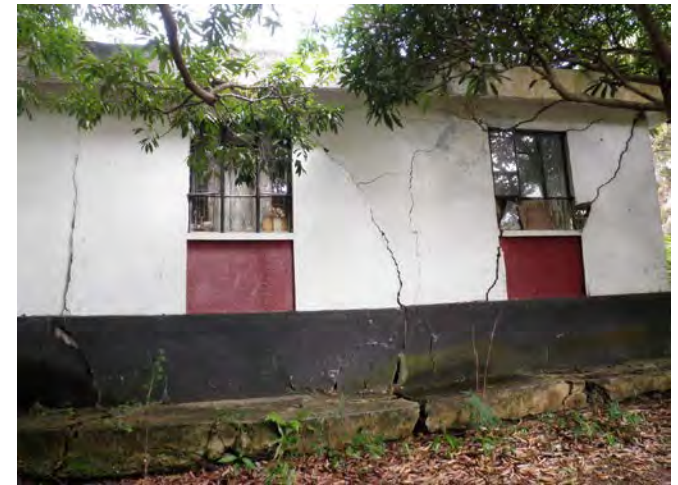
Heavy damage at houses

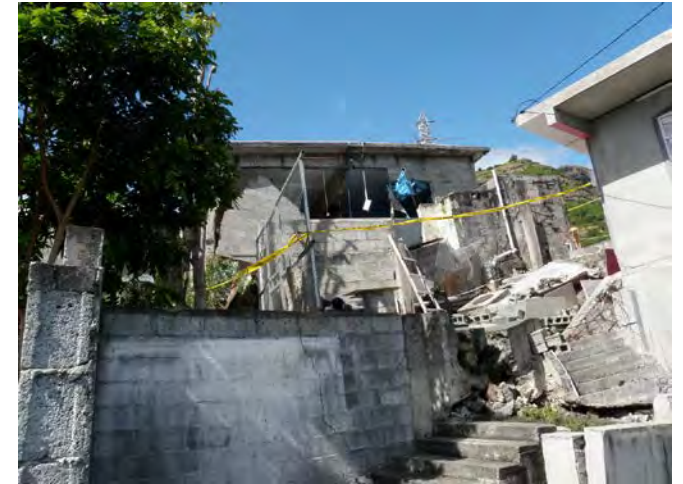
The broken house

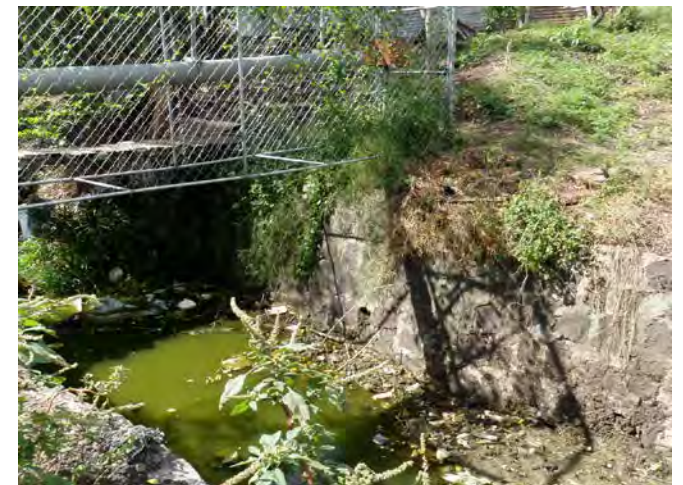
Cracks at bank protection

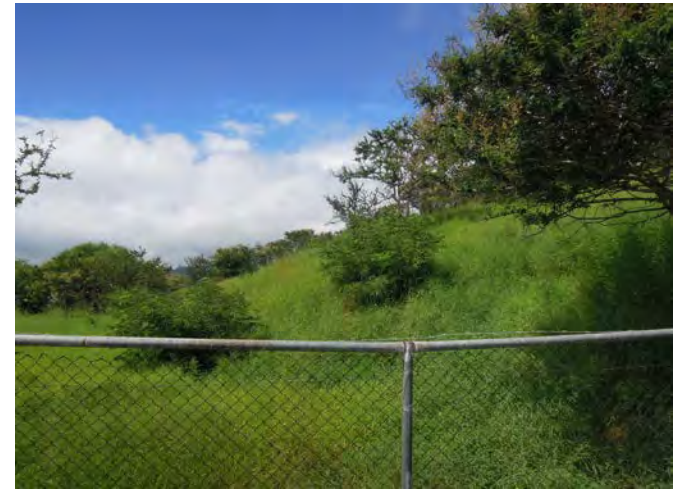
Middle slope of the landslide area.  
The slope is straight (along red line). No swelling and bending on the slope.

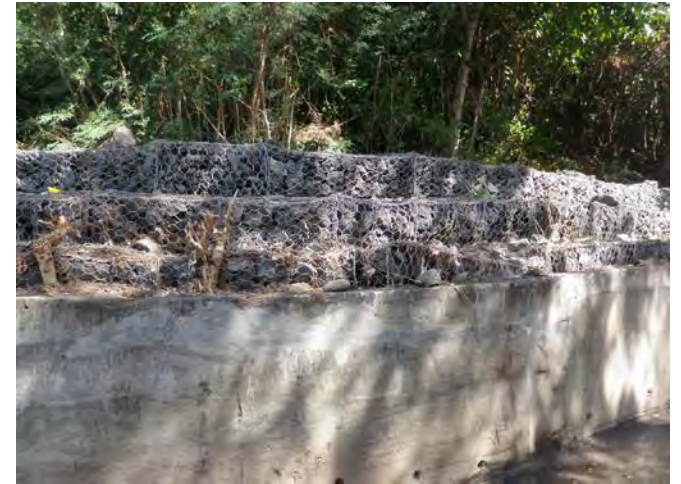
Some gabions have been damaged a little.

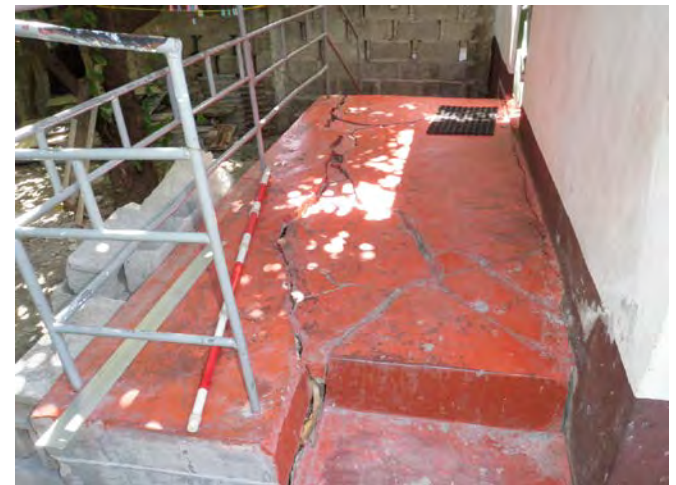
Open cracks of veranda

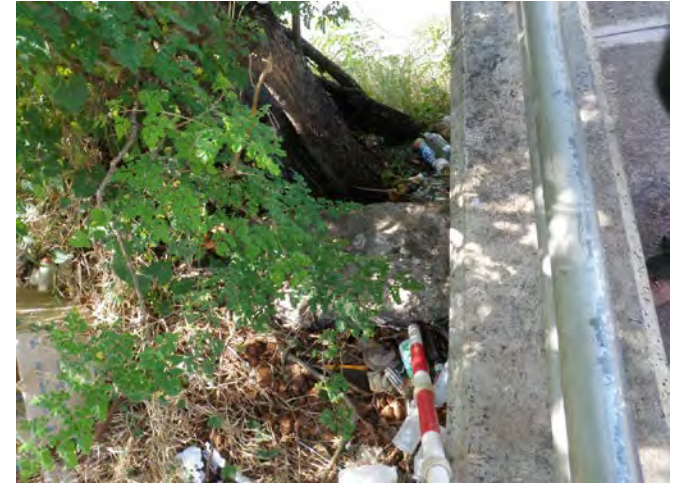
Other problem							
Condition	The slope around the bridge has small collapsed and sediment discharge was confirmed in the ditch.						
Proposed action	Artificial structures (drainage, ditch, etc.) should be constructed on the slope. It is necessary to green the slope .						
Purpose of action	To prevent further erosion of the slope.

Crack of concrete

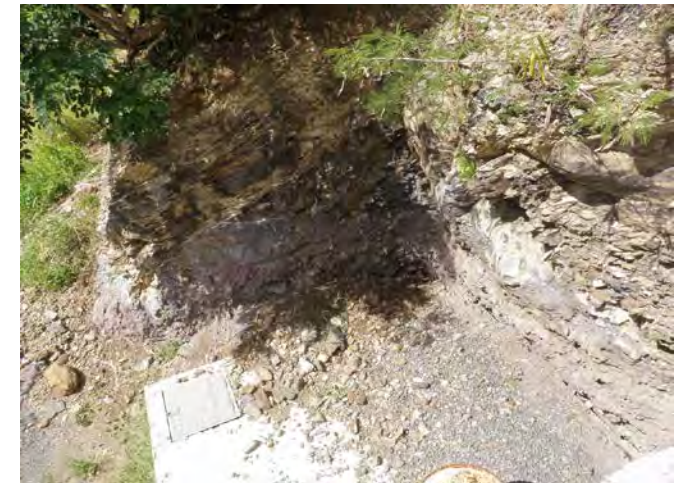
Falling rocks from the outcrop

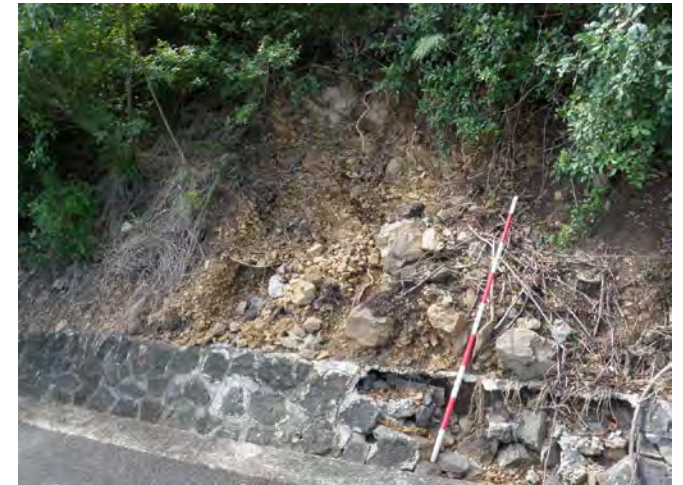
Condition	A lot of damages of the ditch are confirmed. The rockfall and the small collapse are confirmed.						
Proposed action	It is necessary to repair the ditch. In the future rockfall countermeasures should be constructed along the road.						
Purpose of action	To prevent rockfall and slope failure.

Slope failure along the road

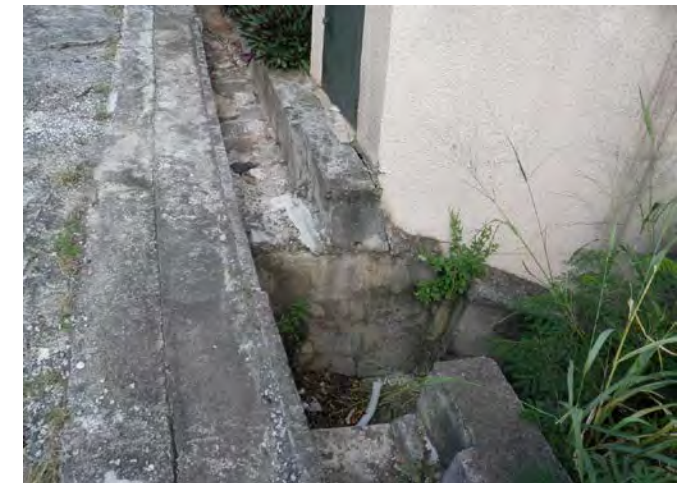
Damage on house

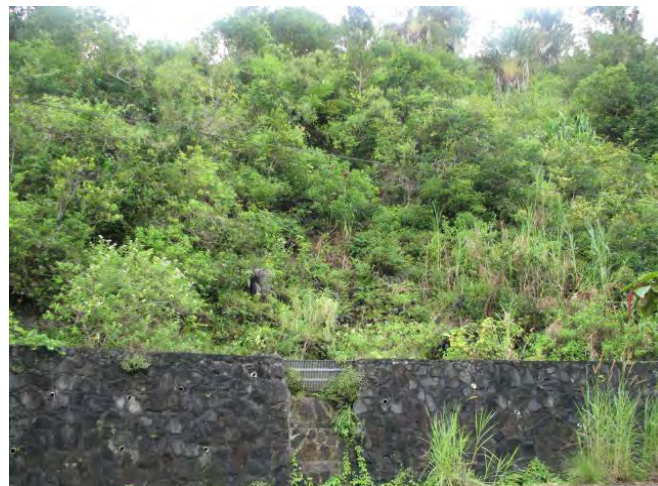
Trace of past slope failure

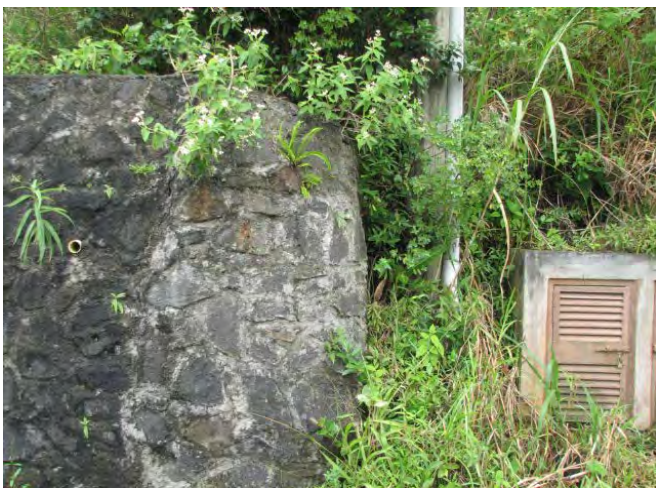
Cracks on retaining wall

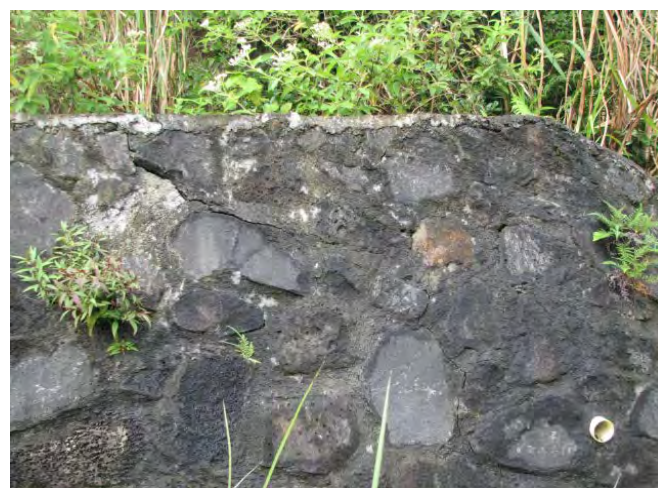
Cracks on retaining wall

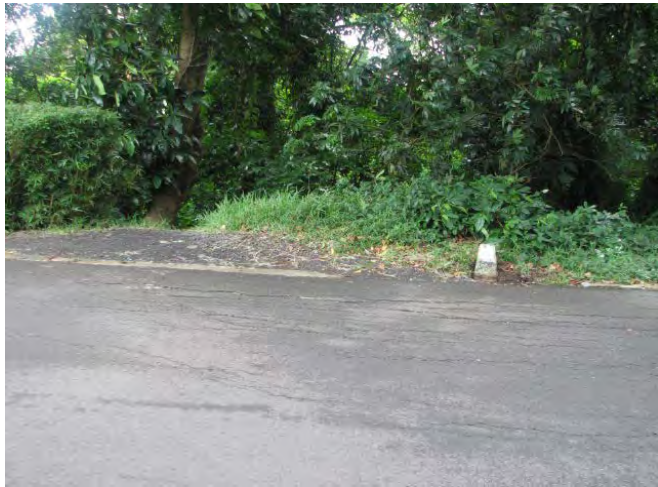
Crack on the road side

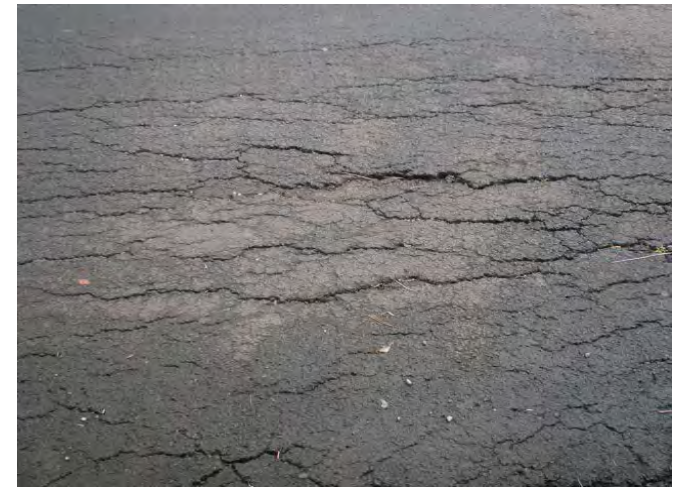
The crack occurred in the road shoulder (by damage of differential settlement)

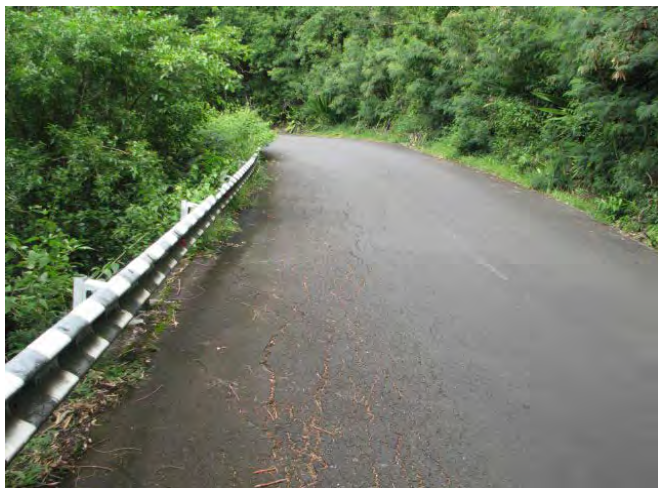
Cracks and subsidence along A-A' line

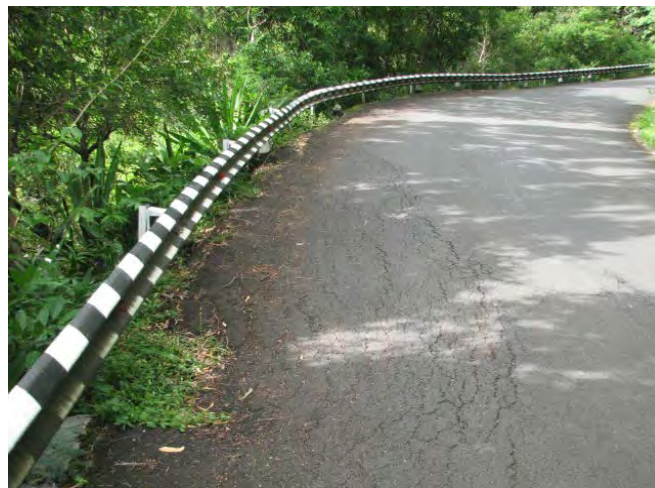
Cracks and subsidence on upper part

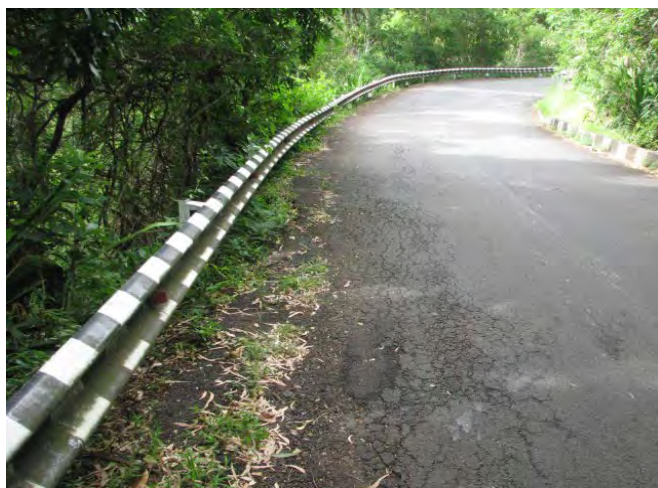
Cracks and subsidence on lower part

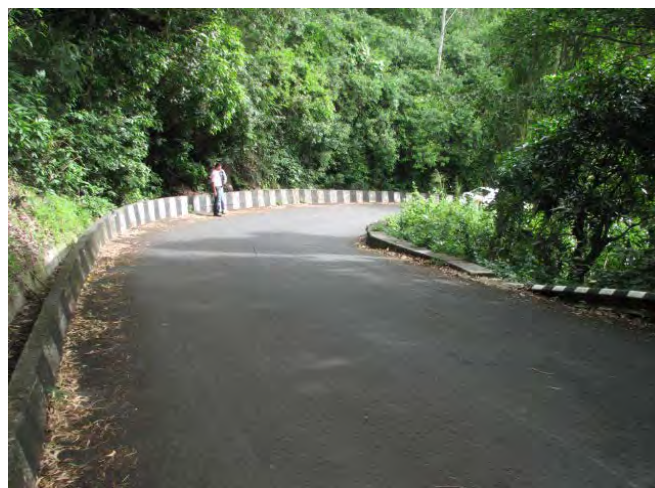
Cracks and subsidence along B-B' line

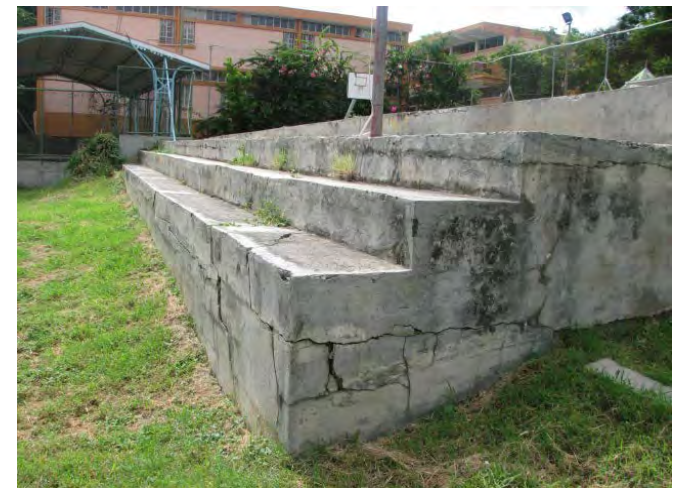
Management number	01010101010123	Disaster	Damage of house	Area name	Gremde Riviere Noire Village Hall		
Date	April 10, 2013						
Reporter's name	Takeshi KUWANO						
Landslide /Slope failure	New failure						
	Swell slope						
	New/enlarged step/cliff						
	New/enlarged crack on slope						
Rockfall	New rockfall						
	Enlarged crack on rock slope						
	Erosion of unstable rock						
Debris flow	Filling up of debris sediment						
	Overflow of debris on road						
	Clogged culvert						
	New failure on river slope						
Spring water	Depleted/decreased spring water						
	Increased spring water						
	New spring water						
	Turbid spring water						
House/road	New/enlarged step/settlement						
	New/enlarged crack						
Counter-measure	Damage/deformation						
	Clogged drainage						
	Overflowed drainage						
Other problem							
Condition	No significant progress. The cracks are caused by not landslide but lack of bearing capacity of the ground.

Horizontal cracks of the concrete step

Proposed action	This area can be removed from the inspection sites after the discussion by related organization.						
Purpose of action

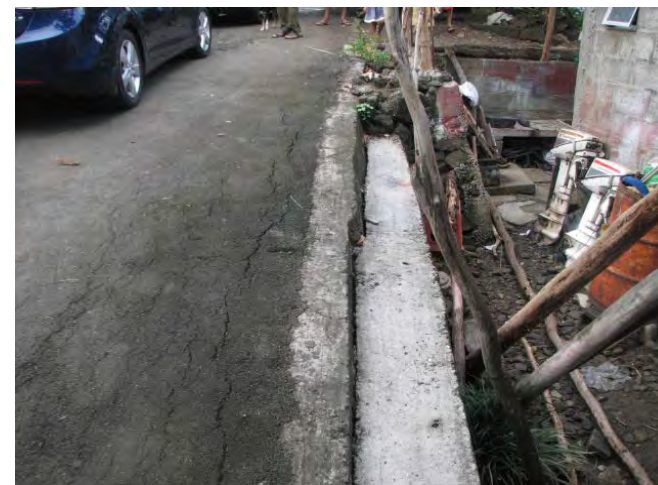
Head cracks of the lower landslide

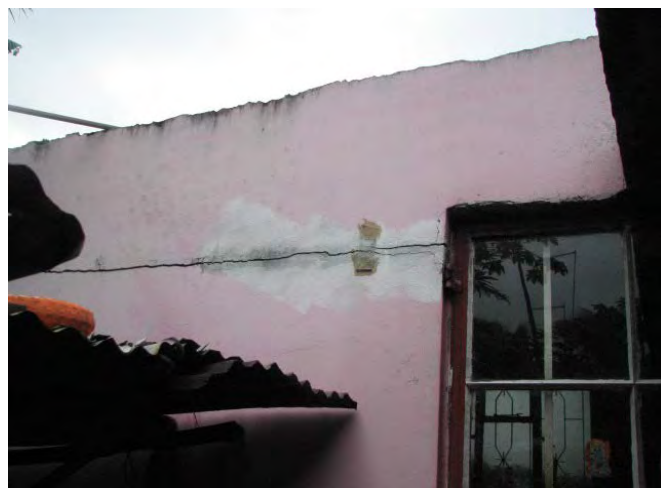
Heavy damages at houses

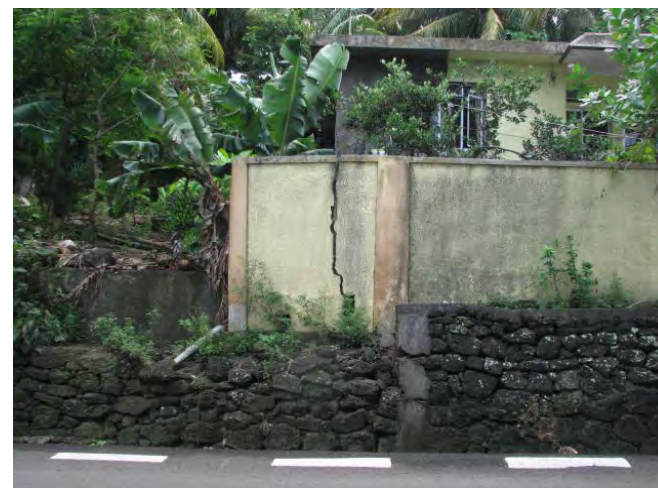
Heavy damages at houses

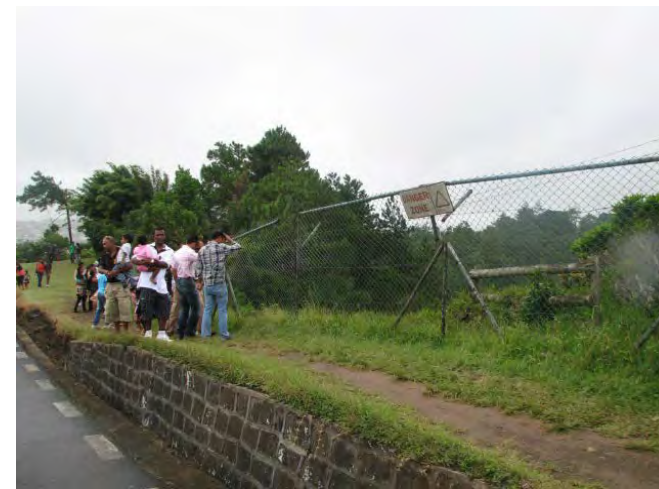
The fence in the back of the slope failure  
It is damaged by the slope failure

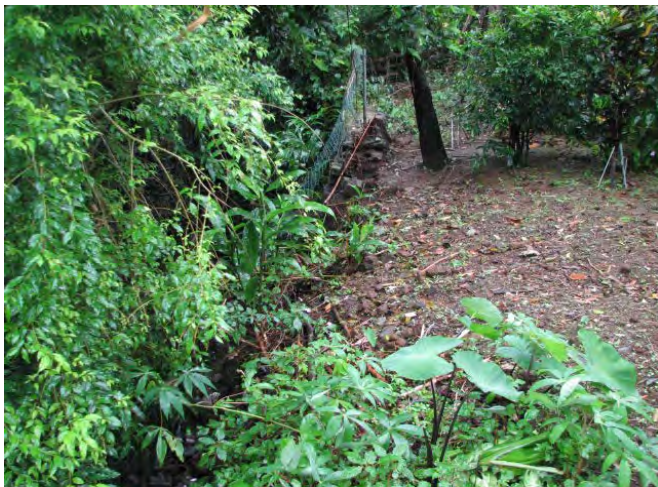
Management number	01010101010133	Disaster	Stream erosion	Area name	Piper Morcellement Piat		
Date	April 10, 2013						
Reporter's name	Takeshi KUWANO						
Landslide /Slope failure	New failure	Erosion by river					
	Swell slope						
	New/enlarged step/cliff						
	New/enlarged crack on slope						
Rockfall	New rockfall						
	Enlarged crack on rock slope						
	Erosion of unstable rock						
Debris flow	Filling up of debris sediment						
	Overflow of debris on road						
	Clogged culvert						
	New failure on river slope						
Spring water	Depleted/decreased spring water						
	Increased spring water						
	New spring water						
	Turbid spring water						
House/road	New/enlarged step/settlement						
	New/enlarged crack						
Counter-measure	Damage/deformation	Collapse					
	Clogged drainage						
	Overflowed drainage						
Other problem							
Condition	Stone masonry wall was collapsed due to the heavy rain in Middle February. The collapse cause further erosion on house side.

Broken wall on house side

Proposed action	The retaining wall should be repaired.						
Purpose of action	To avoid further collapse on house side.

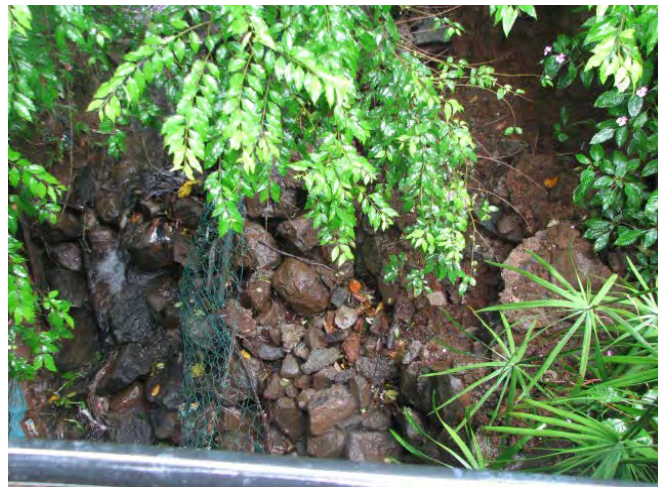
Close view of collapsed rocks

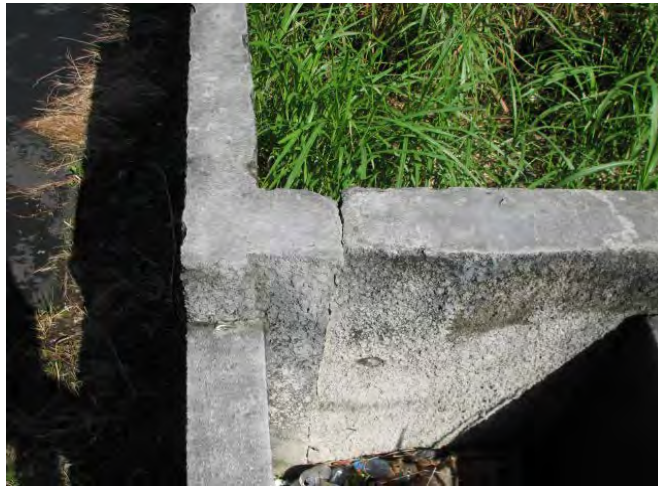
Crack of concrete wall

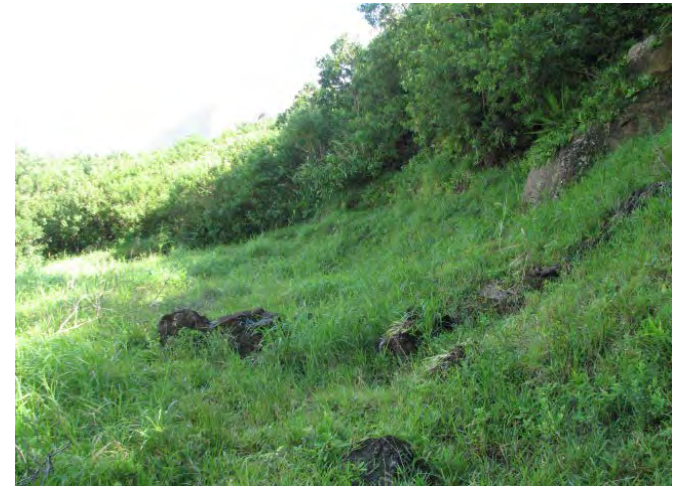
Falling rocks

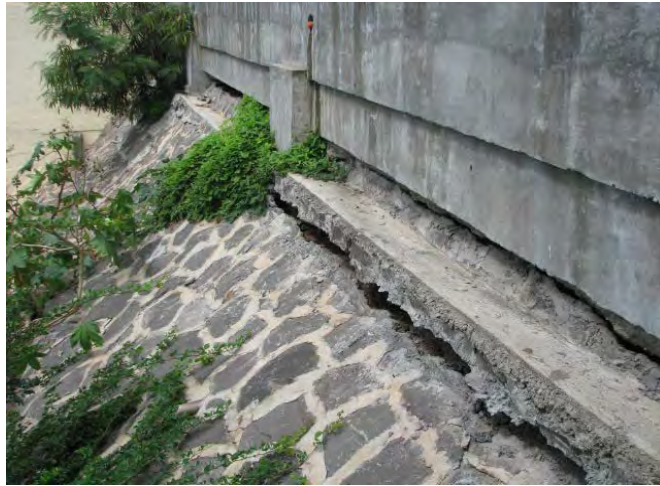
Cracks on stone block

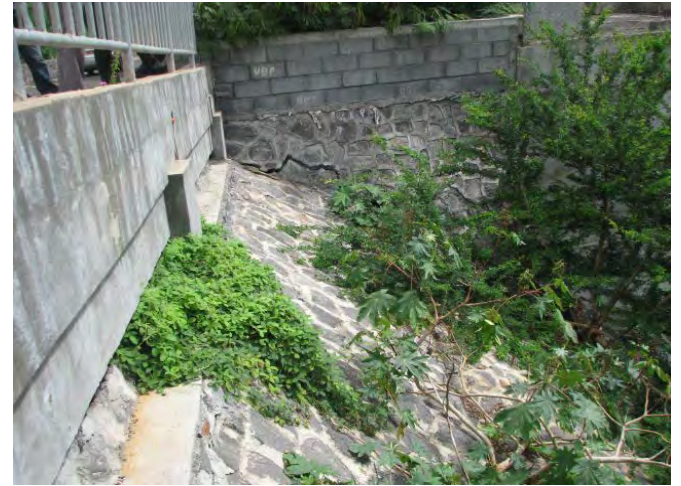
Cracks on stone wall
