FOLLOW-UP COOPERATION STUDY REPORT
ON
THE PROJECT FOR IMPROVEMENT OF ROAD
MAINTENANCE EQUIPMENT
IN
THE FORMER YUGOSLAV REPUBLIC OF
MACEDONIA

JANUARY 2015

JAPAN INTERNATIONAL CORPORATION AGENCY

INGEROSEC CORPORATION

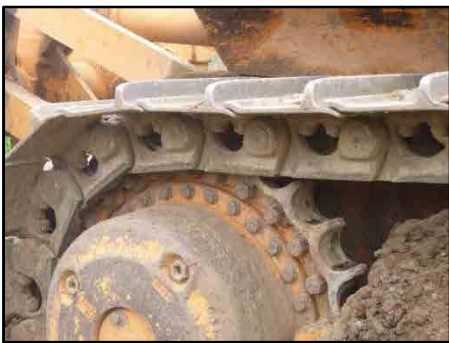
Wear condition of undercarriage
(Bulldozer)

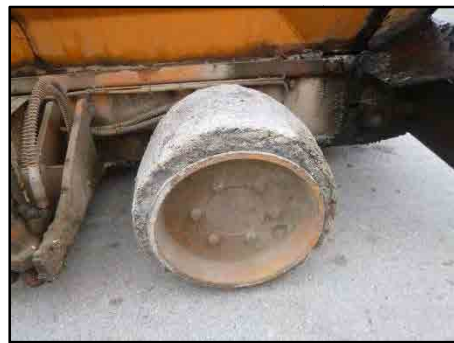
Wear condition of front tire
(Asphalt finisher)

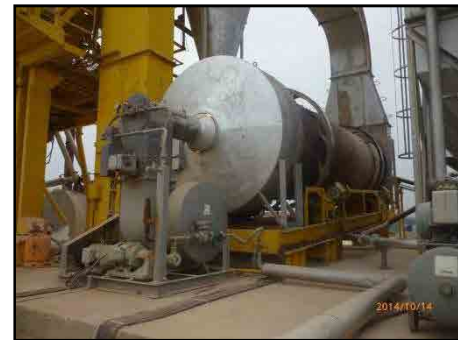
Dryer and dryer burner

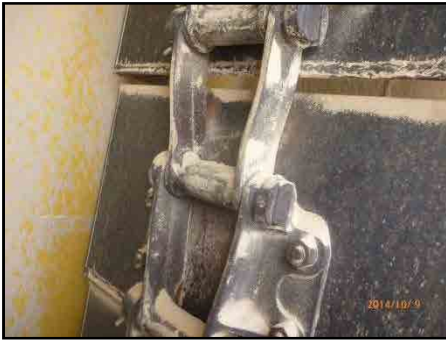
Quite few wear at the chains of hot elevator

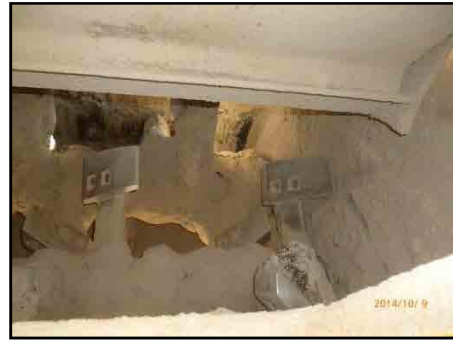
Almost no wear in the mixer chip

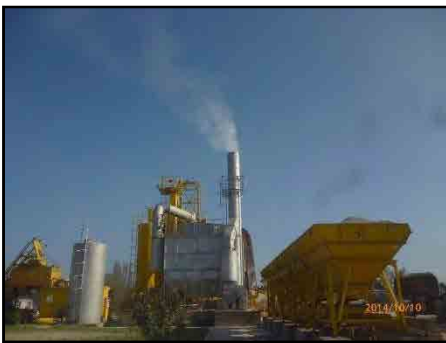
Dust from the chimney due to damaged cloths of bag filter

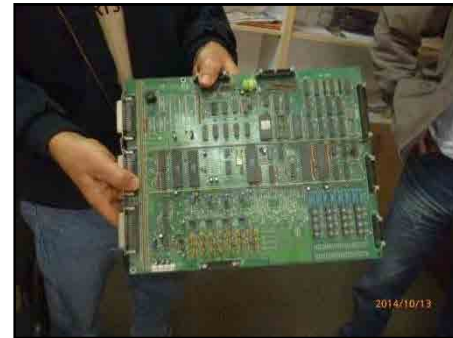
Damaged control panel board by lightning

Table 3-8 shows the production record of asphalt mixture by the asphalt plant used at Skopje branch that was procured in the Grant Aid Project. Production levels dropped in 2008 and 2009 due to the stoppage of plant operation when the control panel, etc. were damaged by lightning strike.

1) Makedonijapat has independently repaired damage to electrical systems caused by lightning strikes. It has replaced control panel circuit boards and weighing device load cells with spare parts supplied by Japan, and it has procured equivalent parts for parts not in stock such as load cell amplifiers (transmitters) and aggregate feeder inverters.

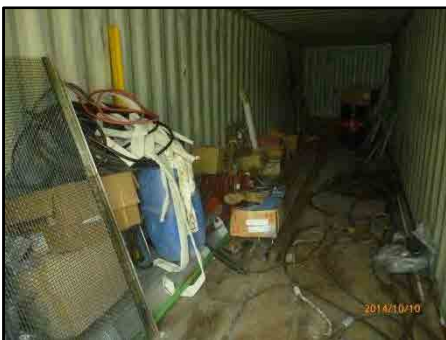
Messy part warehouse

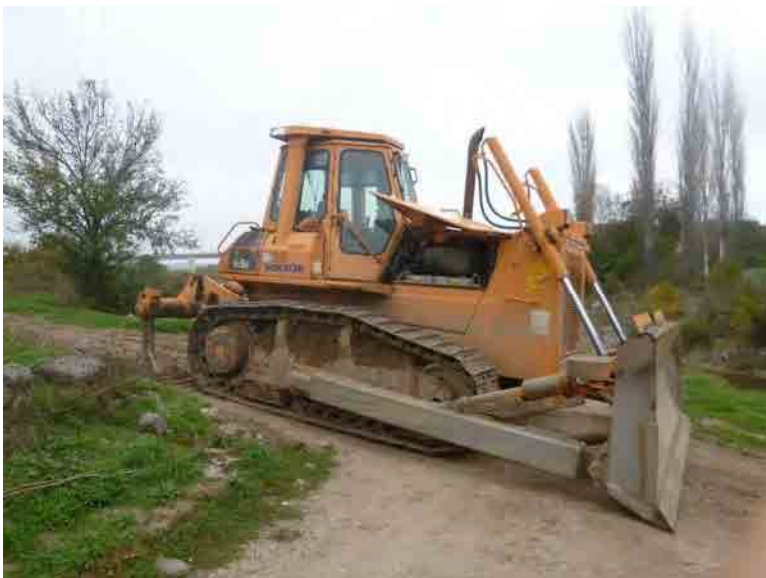
Type	: Bulldozer	Manufacturer	: Komatsu
Model	: D65E-12	Serial number	: 65105
Branch	: Skopje branch		
Check point	: Beljakovci job site, 20km from Kumanovo Land clearing job		
Service meter/odd meter	:	Out of order (stopped at 937Hr)	
Overall conditions	:	Good	
1. Coolant leakage occurred one month ago. Radiator sealant (SONAX) was procured from Tovi , Skopje and put in. The operator is wondering until when this sealant works.			
2. Alternator could not charge 5 – 6 years ago and was replaced with genuine one.			
3. Service meter stopped. Mr. Nikola will fix it.

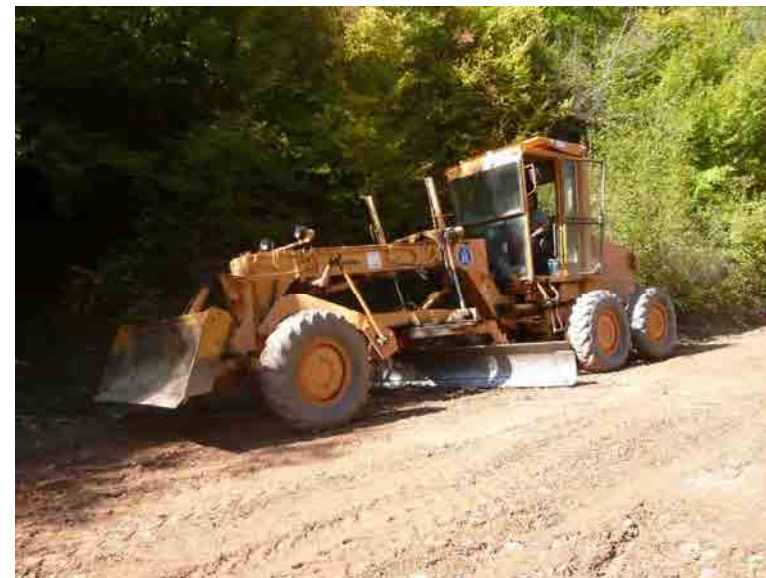
Type	: Motor grader	Manufacturer	: Komatsu
Model	: GD511A-1	Serial number	: 11224
Branch	: Skopje branch		
Check point	: Mogorche job site near Debal Spreading roadbed material for improving the unpaved road		
Service meter/odd meter	:	Out of order (stopped at 1,780Hr 2 years ago)	
Overall conditions	:	Good	
1. Starting switch sometimes fails. Engine stop relay has a problem. At present the operator directly connects the starting motor with a wrench.			
2. In 2012 the rear tires were replaced. The shop was TDA Trade , Skopje city.			
3. Twice a year the engine oil was changed before and after the winter season.			
4. Cutting edges of front dozer were replaced with local-make ones in 2012.

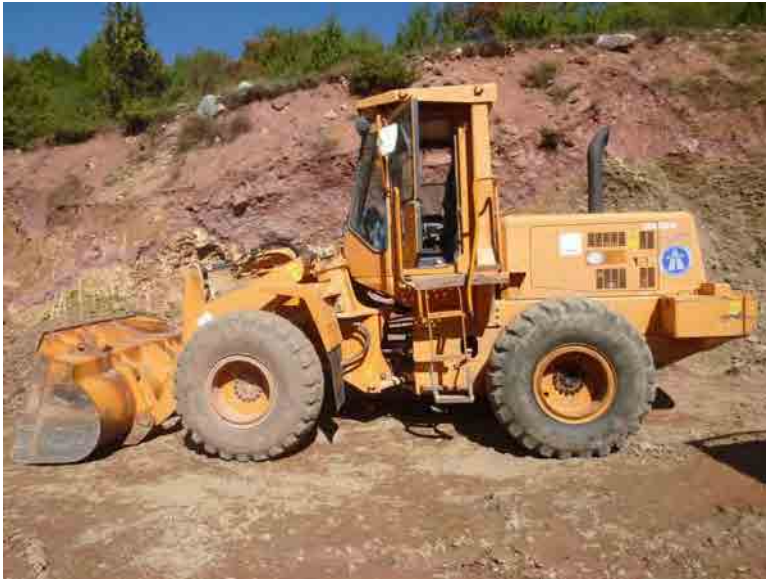
Type	: Wheel loader	Manufacturer	: Komatsu
Model	: WA320-3	Serial number	: 54150
Branch	: Skopje branch		
Check point	: Lazaropole borrowing area of roadbed material The materials were loaded onto dumpers and carried to Mogorche job site where grader and roller were working.		
Service meter/odd meter	: 5,824Hr		
Overall conditions	: Good		
1. This machine was moved from the asphalt base in Skopje on 06 of October but would be returned in the week of 13th.			
2. Fuel gauge was broken.			
3. The operator said after 2 to 3 hour working, sound comes from inside of the work equipment lever, which could not be confirmed by the checker.			
4. Hydraulic filter was replaced around 5months ago, until then noise came from the Hydraulic tank.

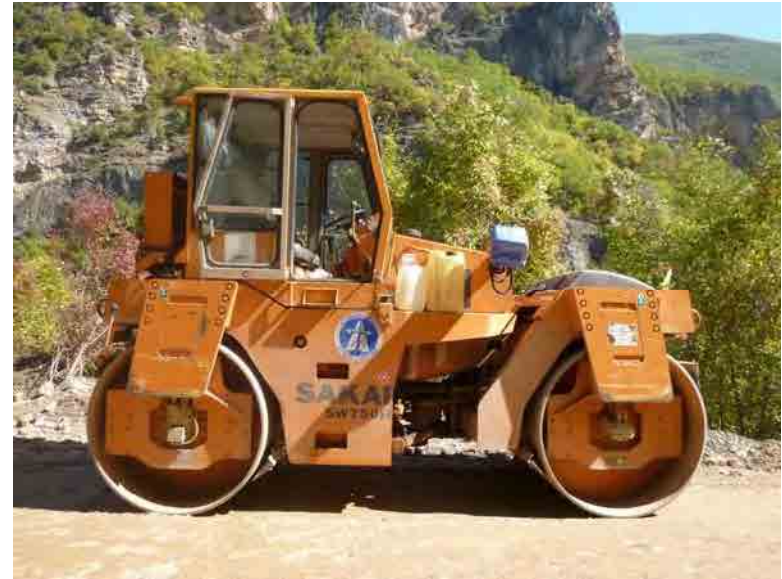
Type	: 10ton Vibratory roller	Manufacturer	: Sakai H. I. (Heavy Industry)
Model	: SW750H	Serial number	: SW13-20209
Branch	: Skopje branch		
Check point	: Mongorche job site near Debal Compaction of spreaded roadbed materials		
Service meter/odd meter	: 2,666Hr		
Overall conditions	: Good		
1. Caution lamps of battery charging and oil pressure were kept on lighting.			
2. Forward side rubber isolator of right-hand rear were replaced with local make ones which were found at Veles branch in May, 2013. Rear side rubber absorbers were original ones, but without any problems.

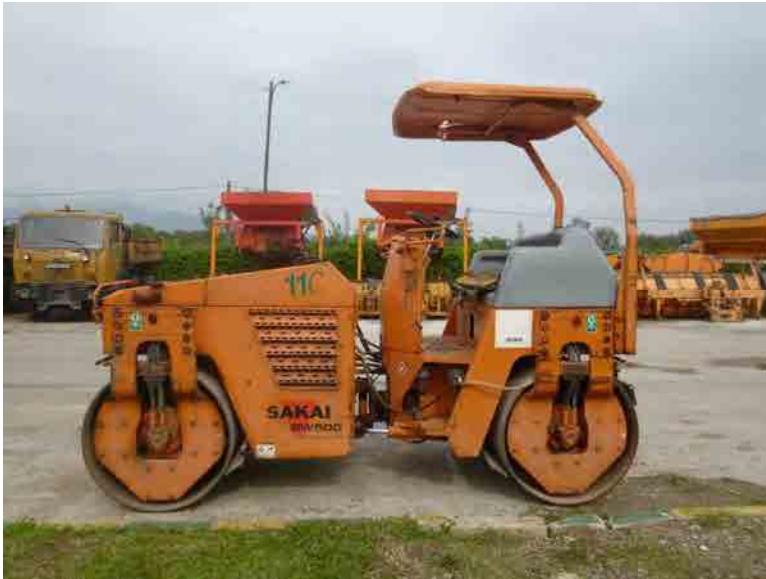
Type	: 4ton Vibratory roller	Manufacturer	: Sakai H. I.
Model	: SW500-1E	Serial number	: VSW18-10111
Branch	: Skopje branch		
Check point	: Skopje branch		
Service meter/odd meter	:	1,541Hr	
Overall conditions	:	Good	
1. A sprinkler pump is out of order.

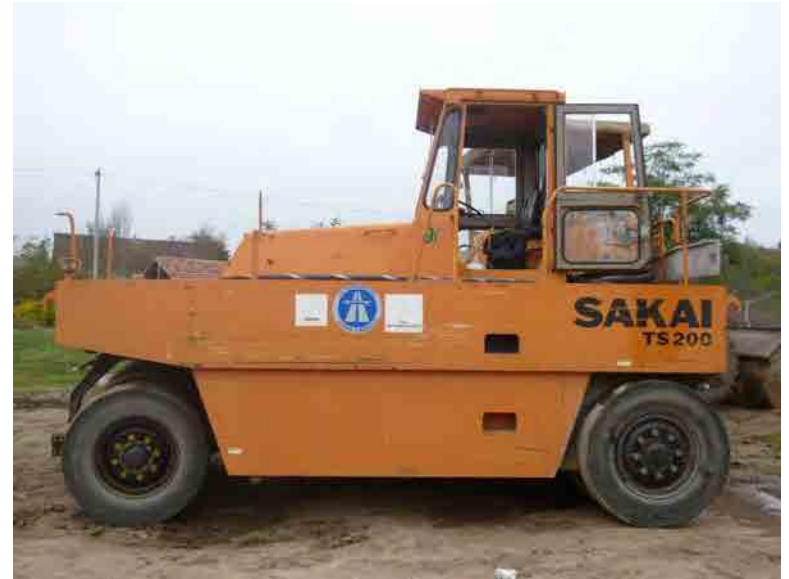
Type	: Tire roller	Manufacturer	: Sakai H. I.
Model	: TS200	Serial number	: TTS6-23236
Branch	: Skopje branch		
Check point	: Beljakovci job site, where D65E-12 #65105 of Skopje branch was also working.		
Service meter/odd meter	:	2,572Hr / 12,890m	
Overall conditions	:	Good	
1. Left-side rear tire was side-cut. An order of new tire was placed 6months ago, and arrived at Skopje in the beginning of October. That's a BKT tire from India with price of 1300-1400 Euro. That tire is to be installed after bringing back to Skopje once this job is finished.			
2. The water pump for spraying was repaired 3 years ago.

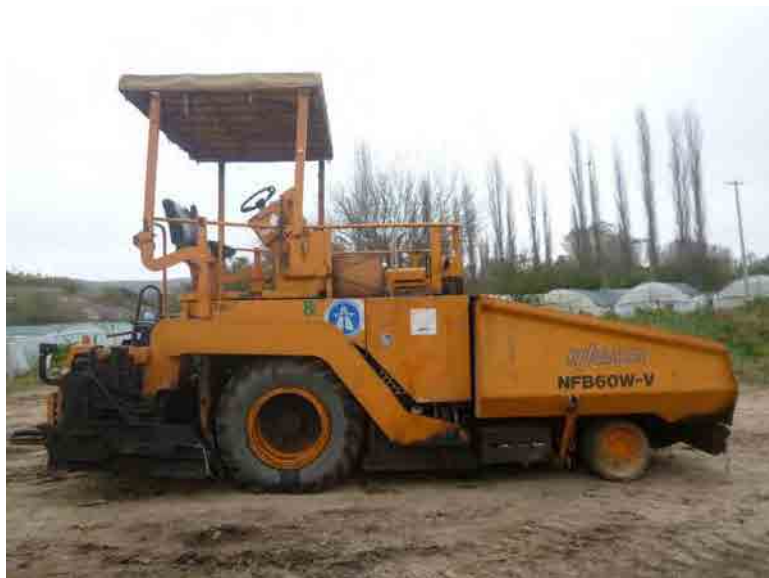
Type	: Asphalt finisher	Manufacturer	: Niigata (Sumitomo)
Model	: NFB60W-V	Serial number	: NFB6W-20138
Branch	: Skopje branch		
Check point	: Beljakovci job site, where D65E-12 #65105 of Skopje branch was also working.		
Service meter/odd meter	:	3,198Hr	
Overall conditions	:	Good	
1. Mr. Nikola , an engineer of Makedonijapat, repaired the starting circuit around 2years ago.			
2. The shafts of sprocket driving chains were replaced, twice at left, once at right.			
3. The starting motor and the alternator were replaced at the service point in Skopje of ISKRA, a Slovenian Company .			
4. Oil consumption rate is high, 1.5liters per 50 liters of fuel. Even 2 years ago, the engine was repaired at Skopje by the mechanics of TOTI PROM – Kavadarci , the piston rings have to be changed.

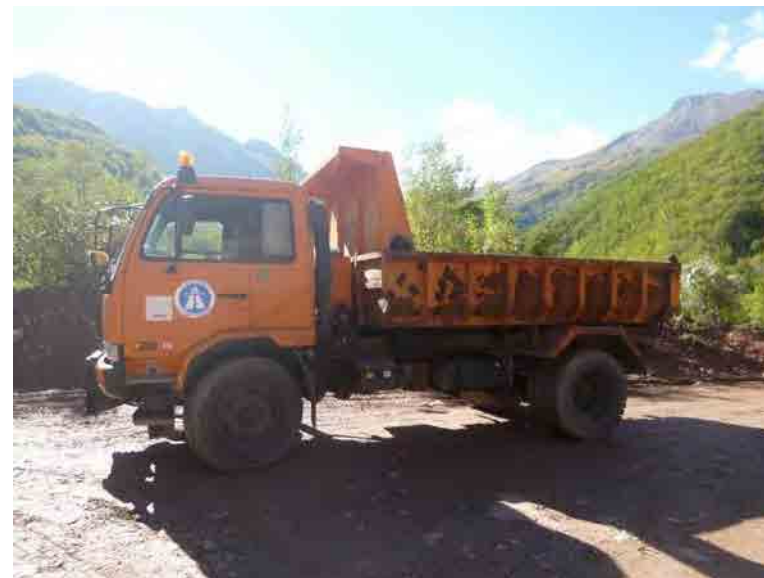
Type	: Dump truck	Manufacturer	: Nissan Diesel (UD trucks)
Model	: PKC212EHLB	Serial number	: PKC212E-00346
Branch	: Skopje branch	E/G serial number:	FE6-001362H
Check point	: Lazaropole job site (Debal) where WA320 was working Hauling roadbed materials to Mogorche		
Service meter/odd meter	:	404,590km	
Overall conditions	:	Fair	
1. One week ago the starting switch was broken, so additional circuit was set near the steering wheel to start-up.			
2. In June the starting motor was replaced by ISKRA , a Slovene company but without genuine parts. So the seal cannot be fitted completely, resulting in water invasion.			
3. According Mr. Saso, Skopje branch mechanization manager, there are cracking at the flywheel and the pressure plate with highest priority for repairing together with the starting motor as secondary priority.

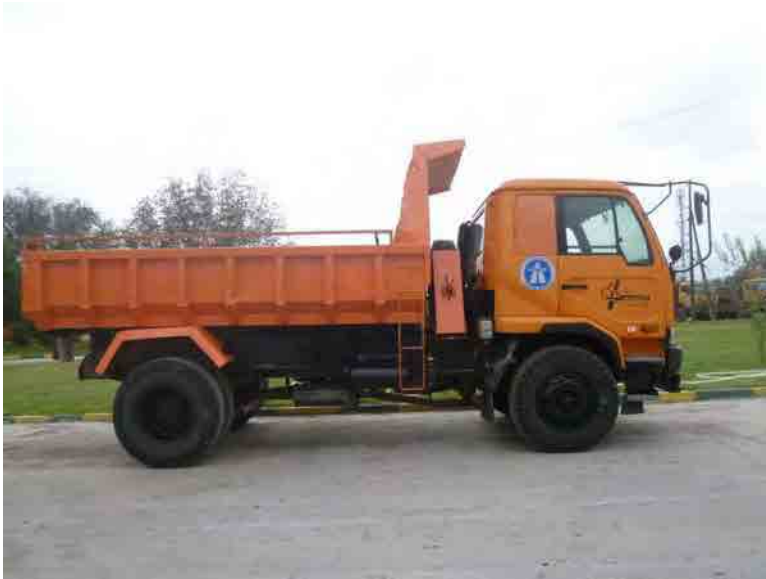
Type	: Dump truck	Manufacturer	: Nissan Diesel (UD trucks)
Model	: PKC212EHLB	Serial number	: PKC212E-00348
Branch	: Skopje branch	E/G serial number	: FE6-001368H
Check point	: Skopje branch		
Service meter/odd meter	:	792,868km	
Overall conditions	:	Fair	
1. Engine did not start when checking was done, but the next day could be started. (On 13th also did not start.)			
2. The pressure plate was worn-out.

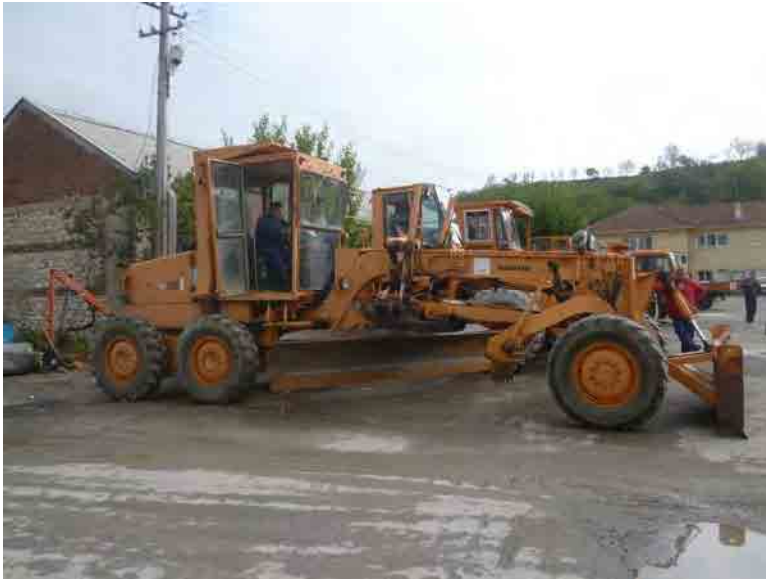
Type	: Motor grader	Manufacturer	: Komatsu
Model	: GD511A-1	Serial number	: 11222
Branch	: Veles branch		
Check point	: Veles branch		
Service meter/odd meter	:	3,789Hr	
Overall conditions	:	Good	
1. Rotation direction of front tires is incorrect, so exchange was requested.			
2. Left-side cutting edge was split partially, but still there are 5cm wear allowance at right side.

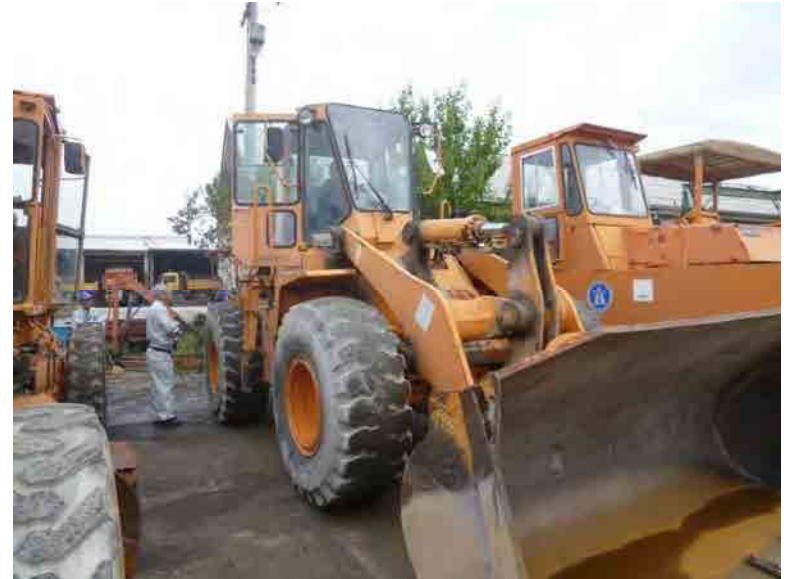
Type	: Wheel loader	Manufacturer	: Komatsu
Model	: WA320-3	Serial number	: 54151
Branch	: Veles branch		
Check point	: Veles branch		
Service meter/odd meter	:	4,401Hr	
Overall conditions	:	Good	
1. The starting motor was replaced.			
2. The alternator was repaired partially in Veles.			
3. Water pump of the engine was replaced with imported one from Greece.			
4. The Front glass was cracked.

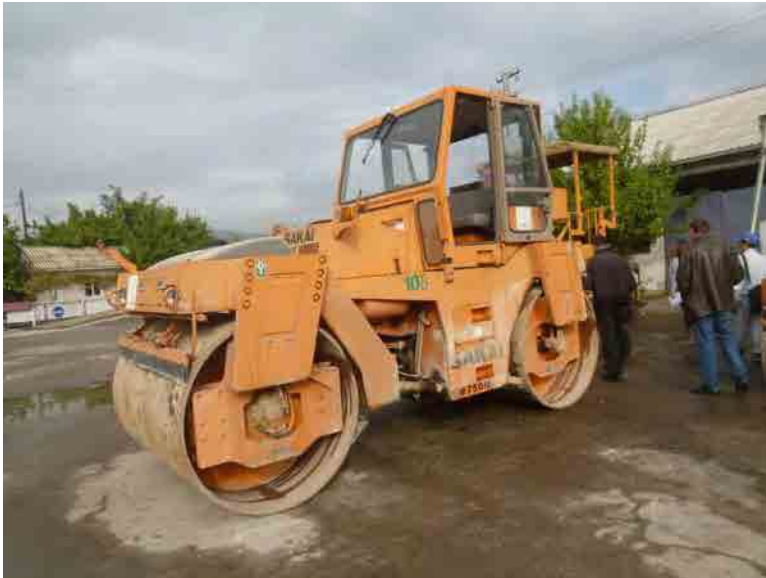
Type	: 10ton Vibratory roller	Manufacturer	: Sakai H. I. (Heavy Industry)
Model	: SW750H	Serial number	: VSW13-20210
Branch	: Veles branch		
Check point	: Veles branch		
Service meter/odd meter	:	2,622Hr	
Overall conditions	:	Good	
1. Very good conditions except 16 (4 x 4) rubber isolators.			
2. Blades of rollers are self-make.

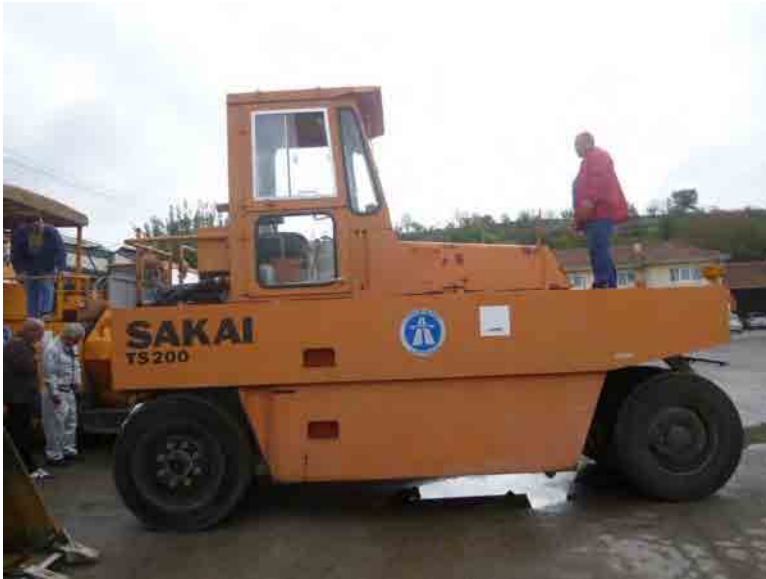
Type	: Tire roller	Manufacturer	: Sakai H. I.
Model	: TS200	Serial number	: TTS6-23233
Branch	: Veles branch		
Check point	: Veles branch		
Service meter/odd meter	:	11,661Hr	
Overall conditions	:	Good	
1. Water pump for spraying was changed.			
2. Water separator was contaminated much.

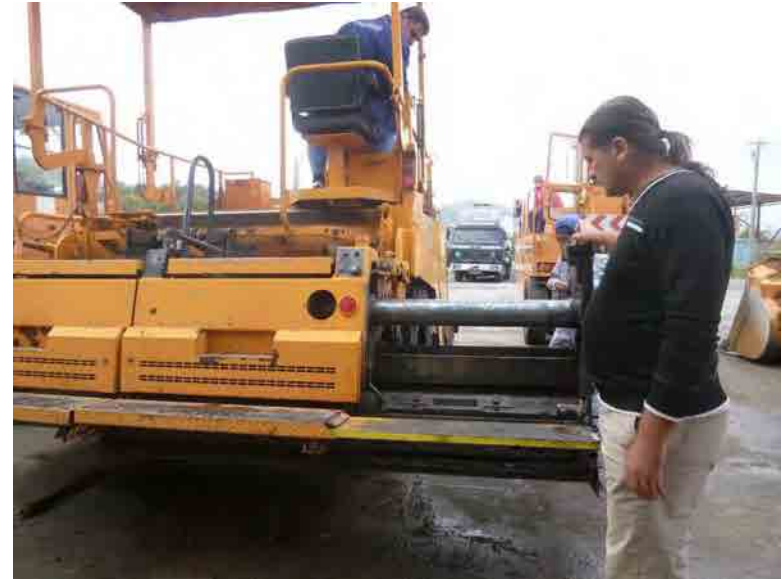
Type	: Asphalt finisher	Manufacturer	: Niigata (Sumitomo)
Model	: NFB60W-V	Serial number	: NFB6W-20139
Branch	: Veles branch		
Check point	: Veles branch		
Service meter/odd meter	:	3,415Hr	
Overall conditions	:	Good	
1. Control of travelling speed was mal-functioning sometimes. The board of speed control is out of order. This trouble happened on the all finishers.			
2. Front tires were worn out

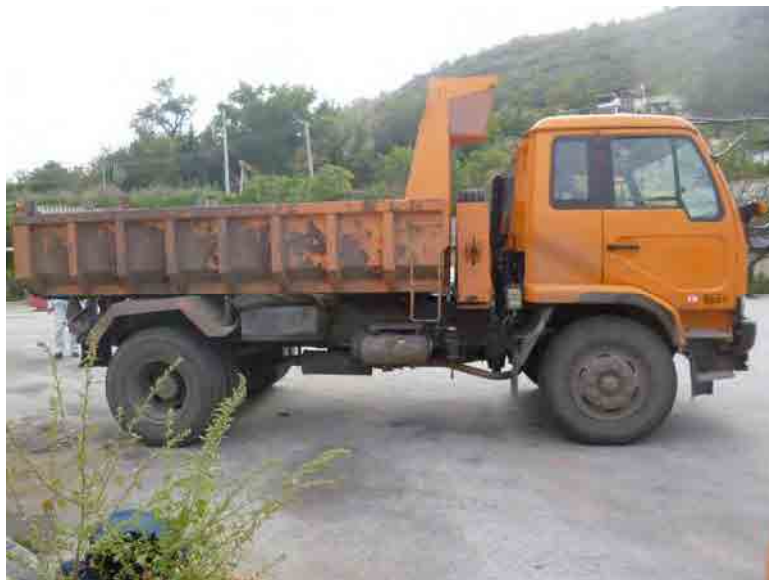
Type	: Dump truck	Manufacturer	: Nissan Diesel (UD trucks)
Model	: PKC212EHLB	Serial number	: PKC212E-00347
Branch	: Veles branch	E/G serial number	: FE6-001363H
Check point	: Veles branch		
Service meter/odd meter	:	186,260km	
Overall conditions	:	Good	
1. Engine control unit was out of order.

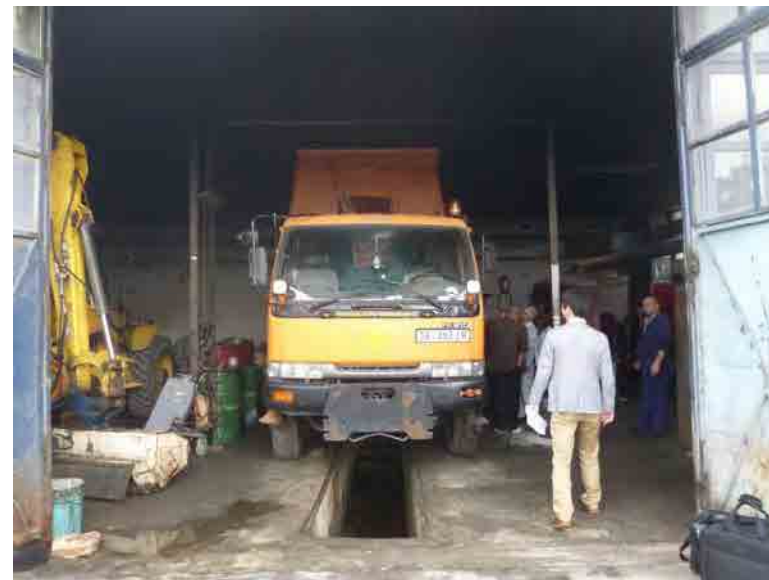
Type	: Dump truck	Manufacturer	: Nissan Diesel (UD trucks)
Model	: Veles branch	Serial number	: PKC212E-00348
Branch	: Veles branch	E/G serial number	: FE6-001368H
Check point	: Veles branch		
Service meter/odd meter	:	221,678km	
Overall conditions	:	Good, but under repairing	
1. Hydraulic motor was detached and sent to Skopje for repairing.			
2. Pre-fuel filter (16403—99011) has not been changed, because they did not receive them. However delivery record shows each 2 sets were delivered per unit, and 1 set is still stocked based on the part stock log.			
3. ALCO make SP-848, a locally procured fuel filter, was attached.

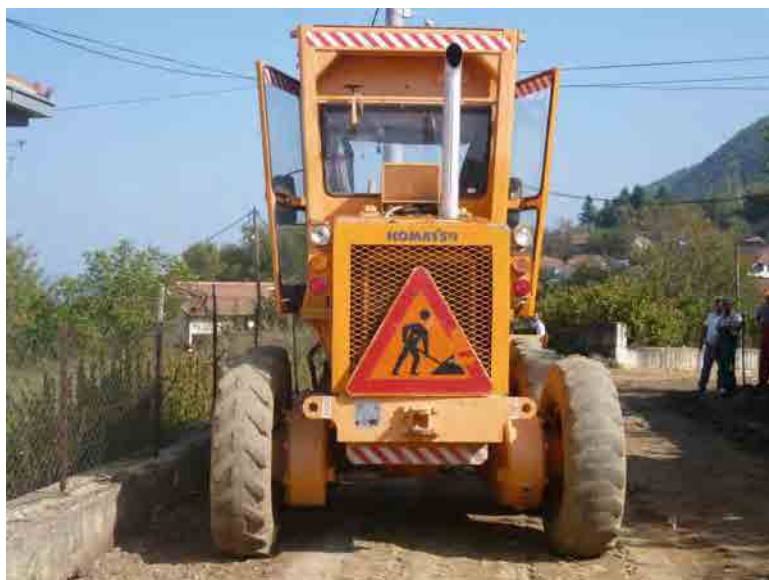
Type	: Motor grader	Manufacturer	: Komatsu
Model	: GD511A-1	Serial number	: 11223
Branch	: Stip branch		
Check point	: Mokrino village, Municipality of Novo Selo (near the border with Bulgaria). Grading work at village road		
Service meter/odd meter	:	Out of order	(stopped at 2,175Hr)
Overall conditions	:	Good	
1. Worn-out tires which were attached a few years ago. Their brand is Taishan, Chinese.			
2. Cutting edges of front dozer are original ones.			
3. Cutting edges of blade are changed every year. Trakparts are importing from Greece.

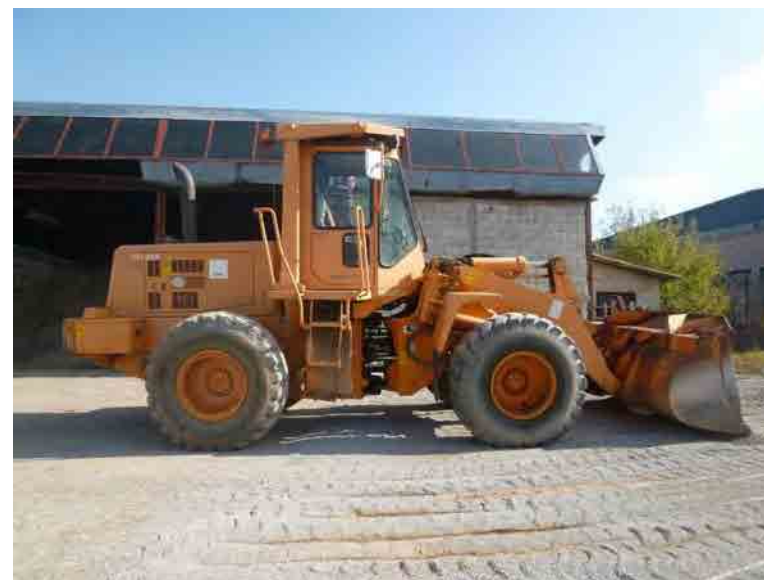
Type	: Wheel loader	Manufacturer	: Komatsu
Model	: WA320-3	Serial number	: 54152
Branch	: Stip branch		
Check point	: Delchevo office of Stip branch		
Service meter/odd meter	:	4,278Hr	
Overall conditions	:	Good	
1. This machine was moved from asphalt base.			
2. 90% of works are for gravel loading, remained 10% for road clearing after landslide.			
3. Front tires were changed with East-up, Chinese ones, on the other hand front tires have not been changed.			
4. Locally procured fuel filter is used; Luber-finer LFF4294 or Baldwin BT339.			
5. Engine oil and filter are replaced before winter.

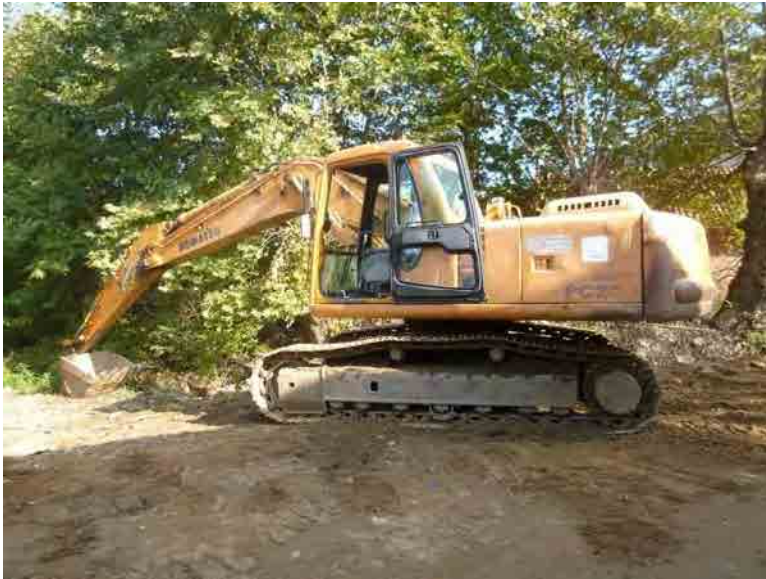
Type	: Hydraulic excavator	Manufacturer	: Komatsu
Model	: PC200-6	Serial number	: 110551
Branch	: Stip branch		
Check point	: Mokrino village, Municipality of Novo Selo (near the border with Bulgaria).		
Service meter/odd meter	:	5,851Hr	
Overall conditions	:	Fair	
1. Pins at bucket linkage are worn-out, making noise and difficult to fine jobs			
2. 5 years ago, the machine fell down and the top of boom were bended, so the arm is attached incorrectly.			
3. Bucket has a large crack necessary to weld and side cutters are worn-out.			
4. Left-side track frame parts are broken, so the front idler cannot be adjusted. They also repaired the same of right-side 3months ago. Metalomekanica in Skopje Repaired by 1,500Euro.			
4. Control valve of breaker JKHB1500 became out of order 1 month ago.

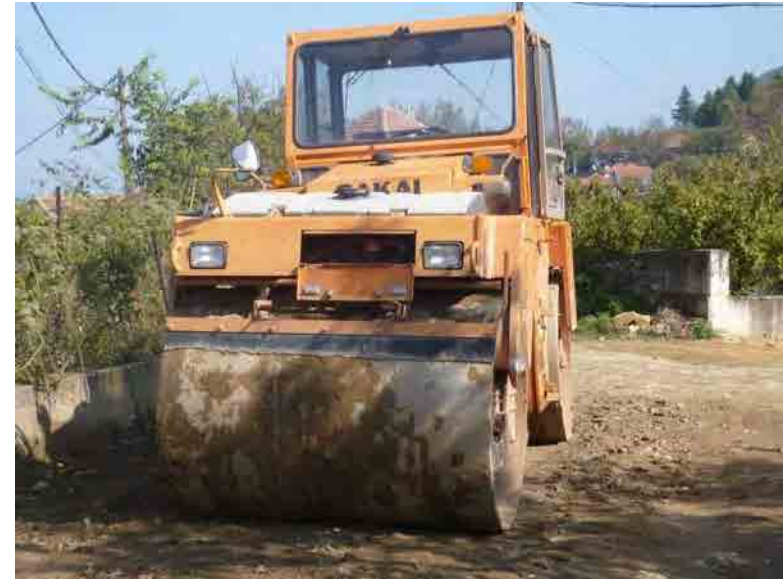
Type	: 10ton Vibratory roller	Manufacturer	: Sakai H. I. (Heavy Industry)
Model	: SW750H	Serial number	: VSW13-20208
Branch	: Stip branch		
Check point	: Mokrino village, Municipality of Novo Selo (near the border with Bulgaria).		
Service meter/odd meter	:	4002Hr	
Overall conditions	:	Fair	
1. All the caution lamps keep turning on even when the engine is running.			
2. Near the cab a polyester tank is attached as a fuel tank. This is because the air enters the fuel line when the ordinal tank is used, and every 15minutes the operator must take out air from the fuel line.			
3. Sprinkler pump is out of order.

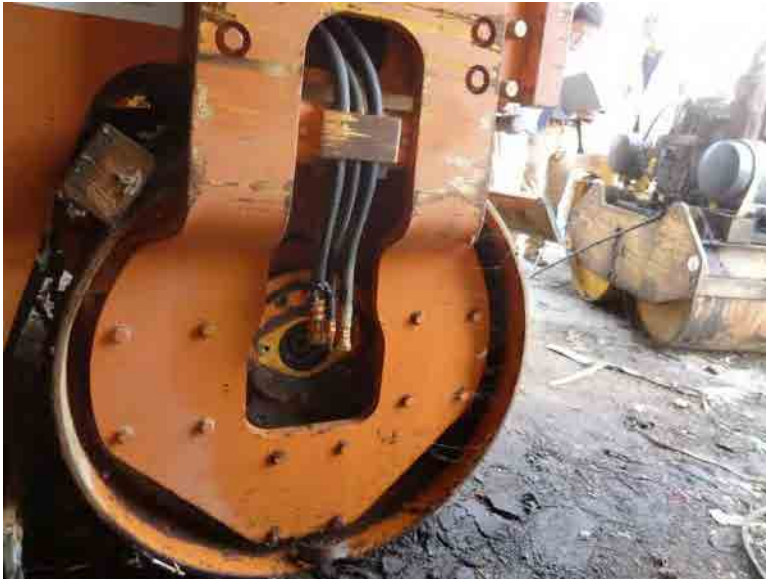
Type	: 4ton Vibratory roller	Manufacturer	: Sakai H. I.
Model	: SW500-1E	Serial number	: VSW18-10108
Branch	: Stip branch		
Check point	: Stip branch workshop		
Service meter/odd meter	:	1,252Hr	
Overall conditions	:	Out of service	
1. This machine was stopped working for 4 – 5 years. Both rear hydraulic motors were broken. Makedonija PAT sought the motors in Greece, but failed.			
2. This machine is said to be used as cannibalization.

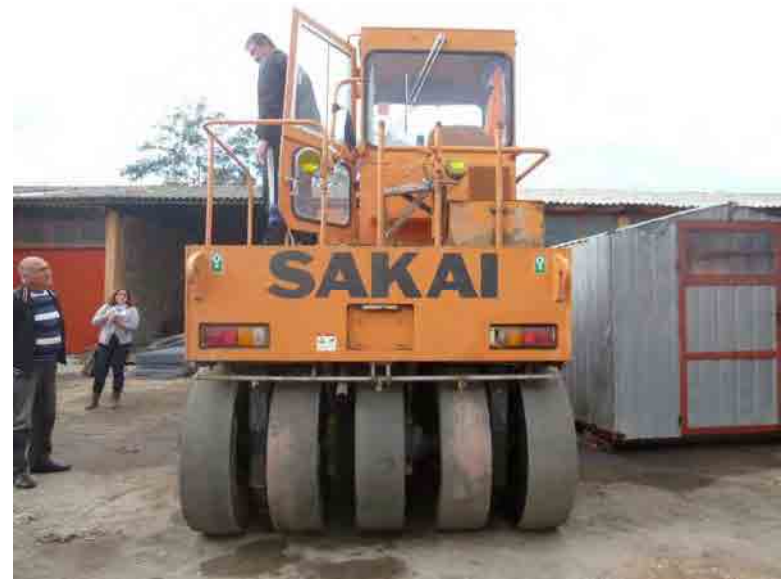
Type	: Tire roller	Manufacturer	: Sakai H. I.
Model	: TS200	Serial number	: TTS6-23234
Branch	: Stip branch		
Check point	: Stip branch workshop		
Service meter/odd meter	:	3,126Hr / 11,856km	
Overall conditions	:	Good	
1. In May 2014 the filters were changed as follows;			
Fuel filter	Baldwin BF76		
E/G oil filter	Baldwin B-205		
2. Water separator was contaminated.

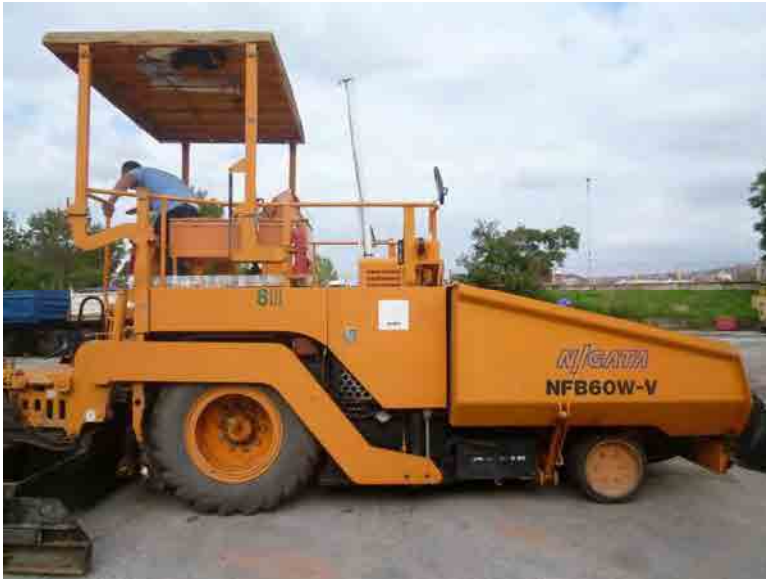
Type	: Asphalt finisher	Manufacturer	: Niigata (Sumitomo)
Model	: NFB60W-V	Serial number	: NFB6W20140
Branch	: Stip branch		
Check point	: Stip branch		
Service meter/odd meter	:	3,247Hr	
Overall conditions	:	Good	
1. The machine just returned from work.			
2. The operator complained when dials of both side conveyors are set to the same position, each conveyors runs with different speed. However this difference of speed can be adjusted by setting the dials properly.			
3. The front wheels are worn-out.

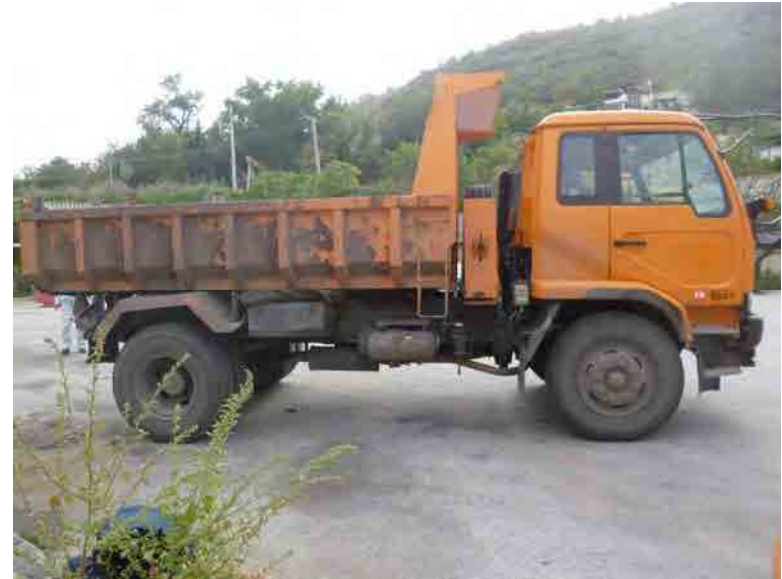
Type	: Dump truck	Manufacturer	: Nissan diesel (UD trucks)
Model	: PKC212EHLB	Serial number	: PKC212E-00349
Branch	: Stip branch	E/G serial number	: FE6-001369H
Check point	: Stip branch		
Service meter/odd meter	:	297,758km	
Overall conditions	:	Good	
1. The operator complained that the locally procured V-belt for alternator with 13mm width could not be fixed with tension because width of the original V-belt was 15mm width. We suggested the tension lever to fix properly.			
2. There was oil leakage from hydraulic hose to the dump cylinder.

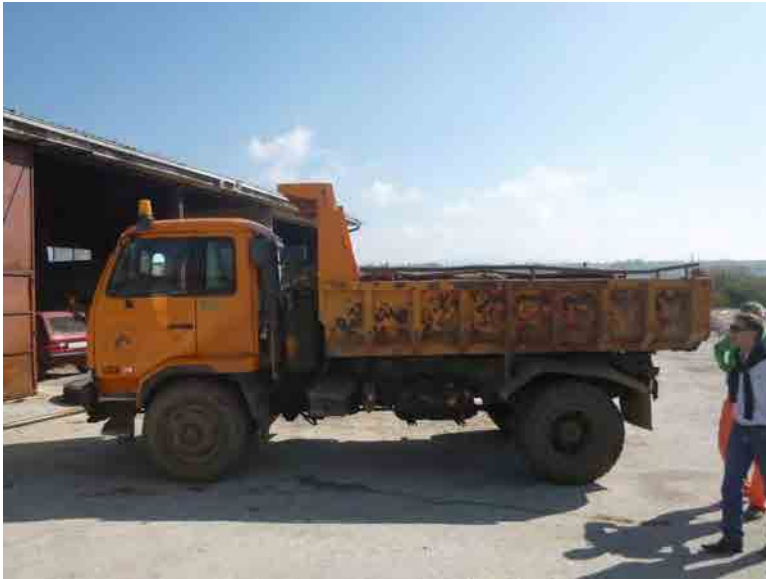
Type	: Dump truck	Manufacturer	: Nissan Diesel (UD trucks)
Model	: PKC212EHLB	Serial number	: PKC212E-00345
Branch	: Stip branch	E/G serial number	: FE6-001355H
Check point	: Stip branch Smojmirovo office (south-east of Delcevo)		
Service meter/odd meter	:	337,117km	
Overall conditions	:	Good	
1. The driver told there was no problem, but Mr. Petko explained sometimes the starting motor sometimes failed to start.			
2. Vessel was so rusty because of hot hauled asphalt with 170 degrees Celcius.			
.

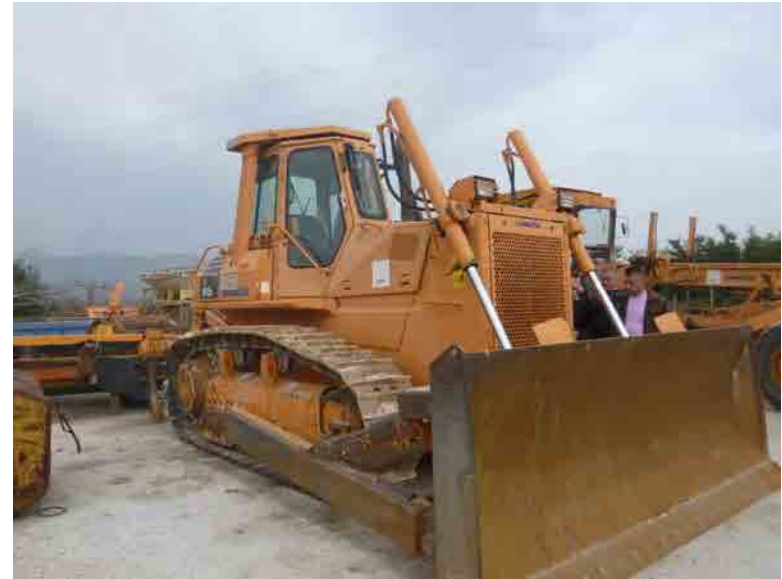
Type	: Bulldozer	Manufacturer	: Komatsu
Model	: D65E-12	Serial number	: 65104
Branch	: Bitola branch		
Check point	: Bitola branch, Asphalt base		
Service meter/odd meter	:	1,564Hr	
Overall conditions	:	Good	
1. There was water leakage from radiator, and brazing works were done at their workshop 3 to 4 years ago.			
2. One year ago a hydraulic hose was replaced.

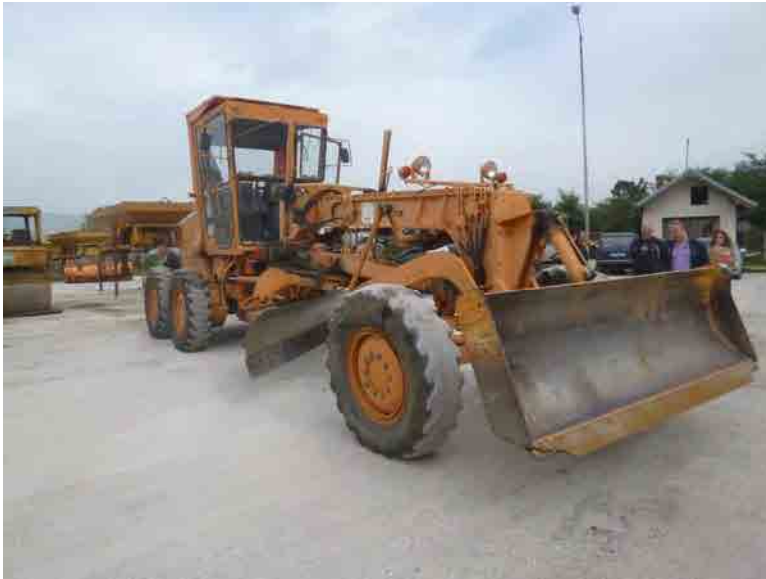
Type	: Motor grader	Manufacturer	: Komatsu
Model	: GD511A-1	Serial number	: 11225
Branch	: Bitola branch		
Check point	: Bitola branch, asphalt base		
Service meter/odd meter	:	Out of order (stopped at 573Hr)	
Overall conditions	:	Good	
1. Cutting edges of front dozer and blade, teeth of scarifier are not so good. Edges of blade are locally-make, edges of front dozer are split, and 2 of 9 scarifier teeth are not attached.			
2. Rear tires were changed with Mitas, Czech.			
3. 2 – 3 years ago, the center of radiator fan was broken partially, but repaired.			
4. There is no trace of engine oil and filter change.

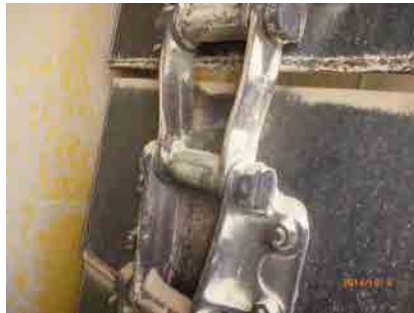
Bucket chain of hot elevator (quite few wear)

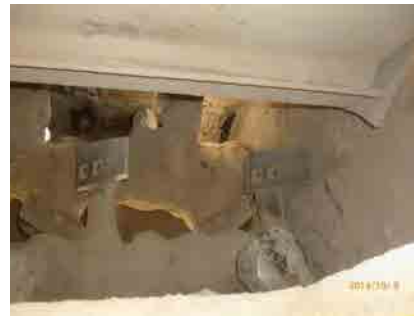
Inside Mixer (No wear at rotating wings and so on)

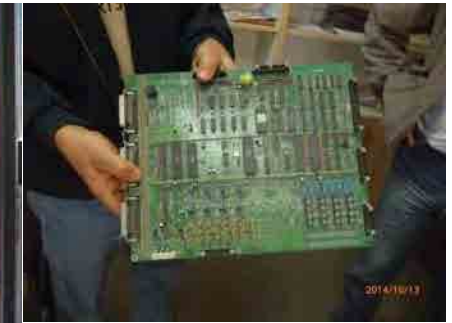
Replaced base board because of being damaged

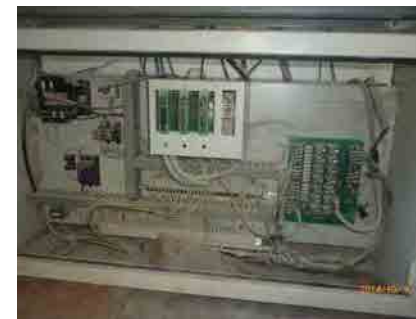
Newly replaced load cell amplifier

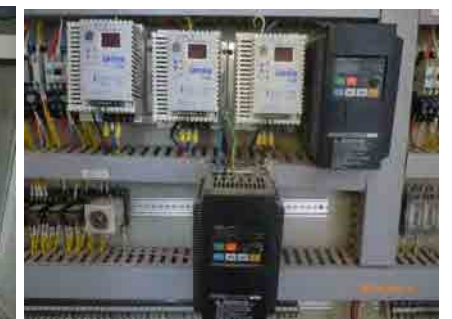
Newly replaced inverter
