# The Preparatory Survey for the Project for Enhancement of Safety in Apia Port

## Tug Boat Inspection Report T/B ATAFA

Augsut 2014

Oriental Consultants Co., Ltd.

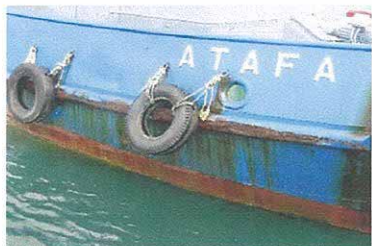
| Nº | LOCATION | NAME | SPECIFICATION | CONDITION | REMARK |
|---|---|---|---|---|---|
| 1 | Outside shell<br>Starboard side | | | No good | Repair |

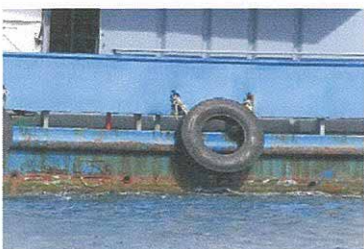
| Nº | LOCATION | NAME | SPECIFICATION | CONDITION | REMARK |
|---|---|---|---|---|---|
| 2 | Outside shell<br>Port Side | | | Nn good | Repair |

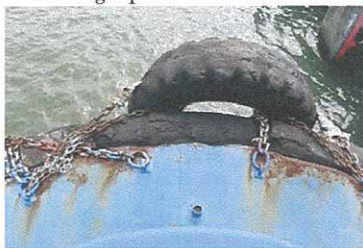
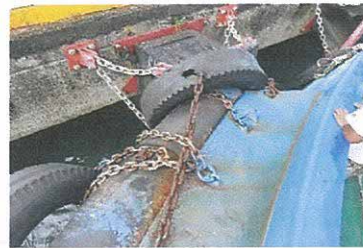
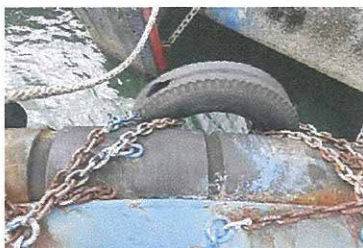
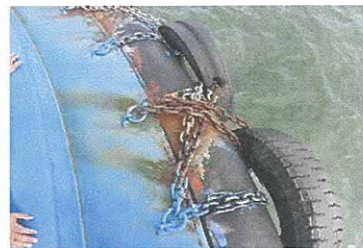
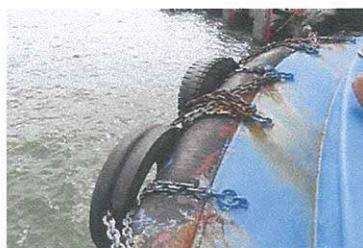
| No | LOCATION | NAME | SPECIFICATION | CONDITION | REMARK |
|---|---|---|---|---|---|
| 3 | Outside shell | Rubber fender<br>Fore | SHIBATA<br>L=9000 11x780<br>OD : $\phi$ 500<br>ID : $\phi$ 250/90 | No good | Repair<br>(60x30) |

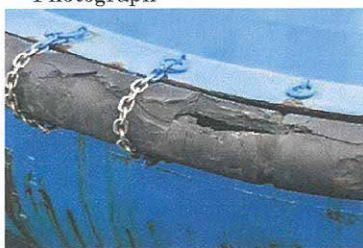
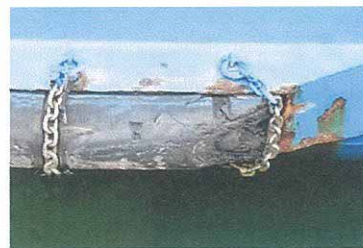
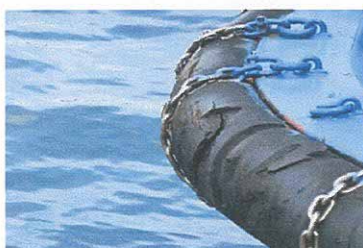
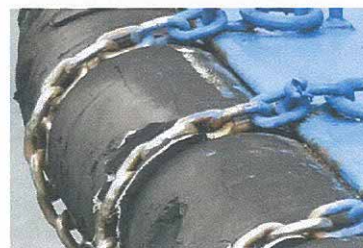
| No | LOCATION | NAME | SPECIFICATION | CONDITION | REMARK |
|---|---|---|---|---|---|
| 4 | Outside shell | Rubber fender<br>Aft | SHIBATA<br>L=11000 17x630<br>OD : $\phi$ 300<br>ID : $\phi$ 150/75 | No good | Repair<br>(60x30) |

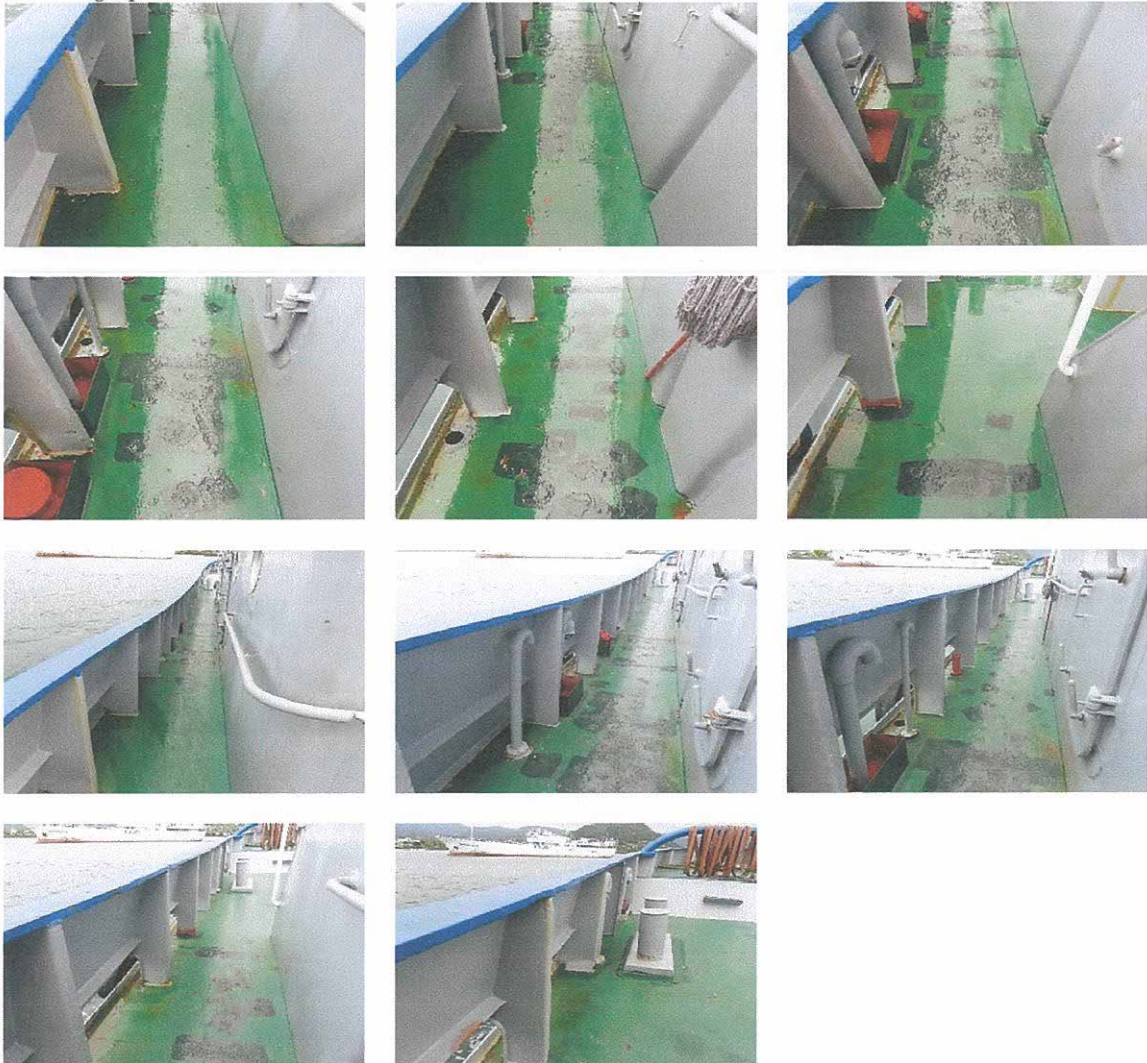
| No | LOCATION | NAME | SPECIFICATION | CONDITION | REMARK |
|---|---|---|---|---|---|
| 7 | Upper deck<br>midship area<br>(Starbord side) | Bulwark & Bulwark<br>stay<br>Deck plate | Deck : 7.0t<br>B. Top : 9.5t<br>B. Stay : 6.0t | Curve damage &<br>Corrosive<br>Corrosive damage | Repair |

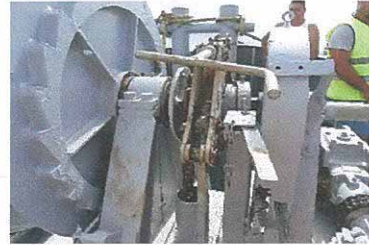
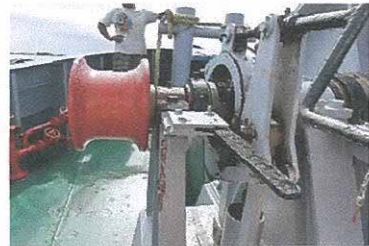
| No | LOCATION | NAME | SPECIFICATION | CONDITION | REMARK |
|---|---|---|---|---|---|
| 13 | Upper deck<br>Fore | Windlass | MASADA IRON<br>WORKS CO.,LTD<br>Type : MSW-1<br>1.5T x 9m/min<br>Motor : 5.5kw<br>x 935rpm | Good | Maintenance<br>Gear cover repair |

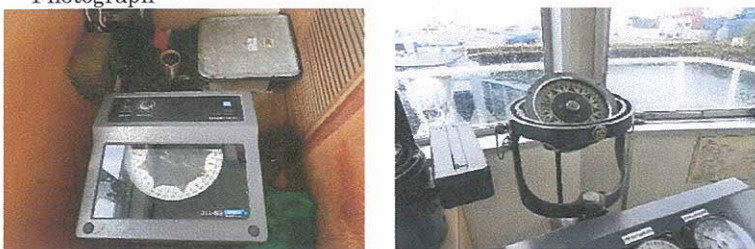
| No | LOCATION | NAME | SPECIFICATION | CONDITION | REMARK |
|---|---|---|---|---|---|
| 19 | Navigation bridge deck<br>Wheel house | Gyro compass & Repeater | TOKIMEC<br>Type : ES110<br>Repeater S. No. : 4745 | No good | Repair or Renew |

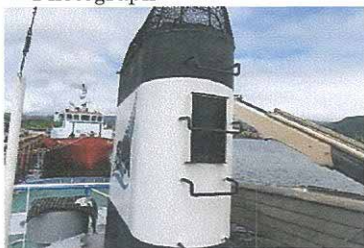
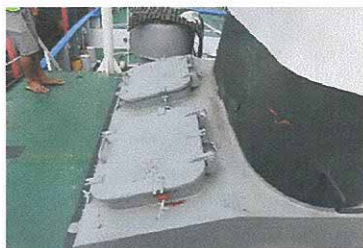
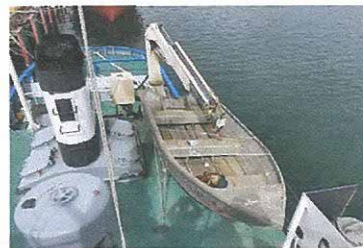
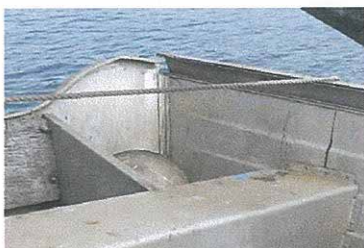
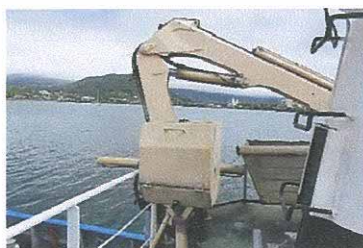
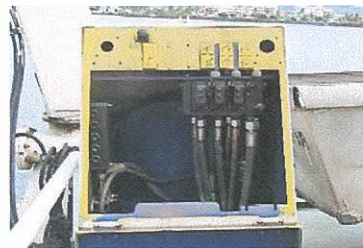
| No | LOCATION | NAME | SPECIFICATION | CONDITION | REMARK |
|---|---|---|---|---|---|
| 29 | Navigation bridge deck | Funnel & sky light<br>Deck crane | Steel<br>NIPPON ICAN<br>M. No. 40702089<br>Capacity : 1.0Tx3.0M | Good<br>No good | Maintenance<br>Hydraulic oil leak<br>out(Cylinder) |

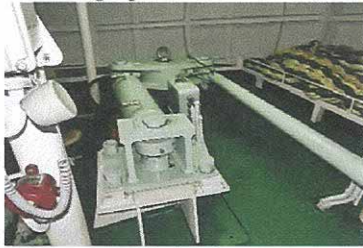
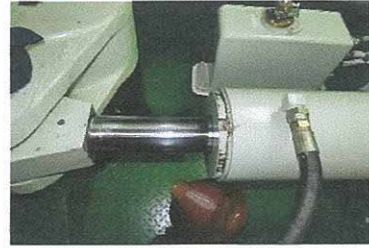
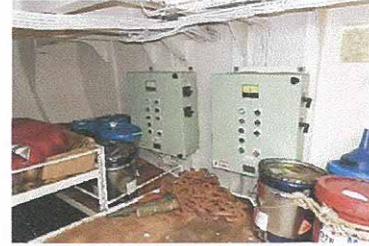
| No | LOCATION | NAME | SPECIFICATION | CONDITION | REMARK |
|---|---|---|---|---|---|
| 31 | Steering gear room | Steering gear unit & Hydraulic oil pump unit | | Good | Hydraulic oil cylinder(Starboard Side) leak out |

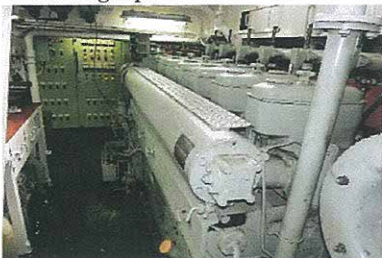
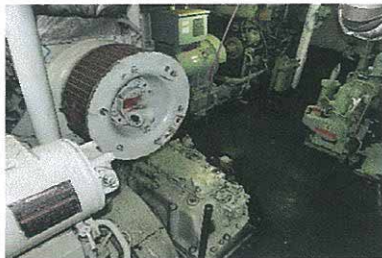
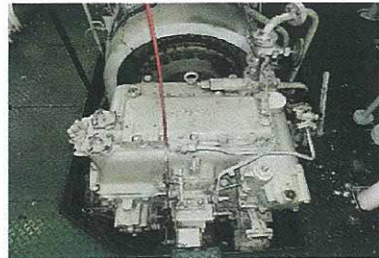
| N <sup>o</sup> | LOCATION | NAME | SPECIFICATION | CONDITION | REMARK |
|---|---|---|---|---|---|
| 40 | Engine room | Main engine & Reduction gear (Starboard side) | YANMER M200-SN<br>800PSx900min-1<br>S. No. : FN30405<br>R/G:Y50U 2N 3420<br>S/C:IHI-BBC | Good | Maintenance (Parts) |

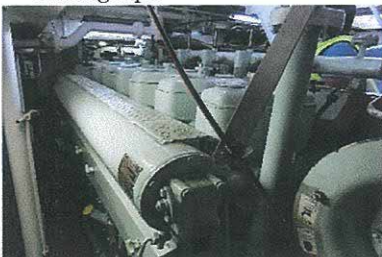
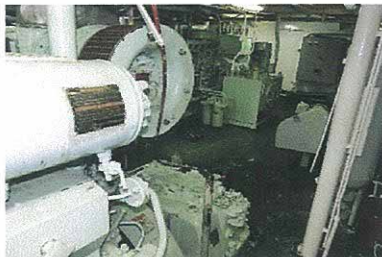
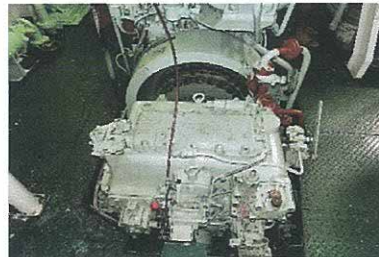
| N <sup>o</sup> | LOCATION | NAME | SPECIFICATION | CONDITION | REMARK |
|---|---|---|---|---|---|
| 41 | Engine room | Main engine & Reduction gear (Port side) | YANMER M200-SN<br>800PSx900min-1<br>S. No. : FN30404<br>R/G:Y50UN 2N 8402<br>S/C:IHI-BBC | Good | Maintenance (Parts)<br>Supercharger noise & Reduction gear noise check (Shaft & Ball bearing) |

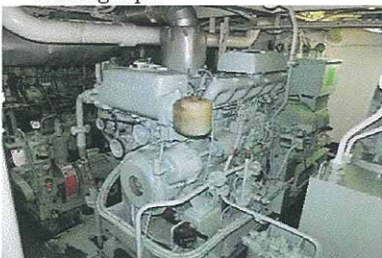
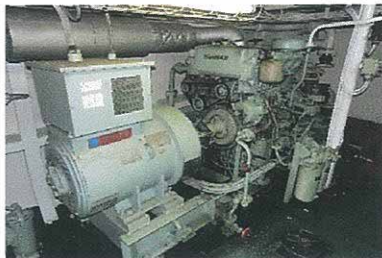
| N <sup>o</sup> | LOCATION | NAME | SPECIFICATION | CONDITION | REMARK |
|---|---|---|---|---|---|
| 42 | Engine room | Generator engine & Generator (Center) | YANMAR 6CHL-N<br>62ps 1500rpm<br>E No. : 0757<br>TAIYO FB-25B<br>50kVA | Good | Maintenance (Parts) |

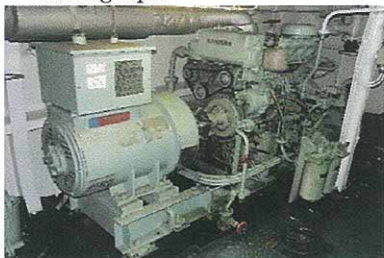
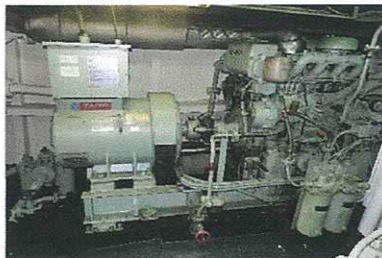
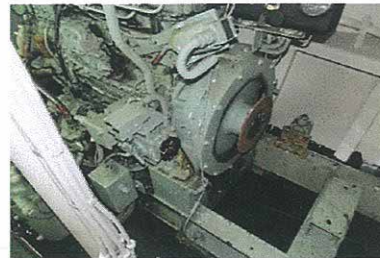
| N <sup>o</sup> | LOCATION | NAME | SPECIFICATION | CONDITION | REMARK |
|---|---|---|---|---|---|
| 43 | Engine room | Generator engine & H. Generator<br>(Starboard side) | YANMAR 4CHL-N<br>38ps 1500rpm<br>E. No. : 00966<br>TAIYO FB-22D<br>30kVA | Good | Maintenance<br>(Parts)<br>Renew punp crutch |

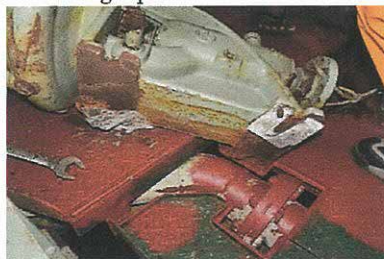
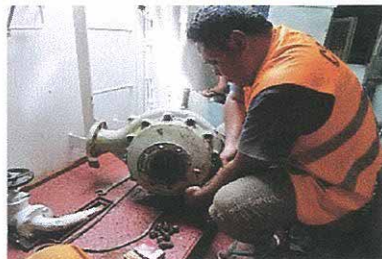
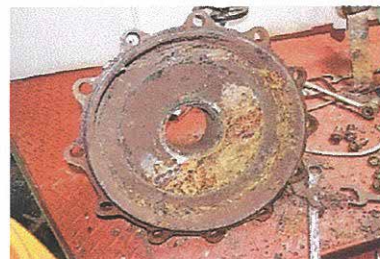
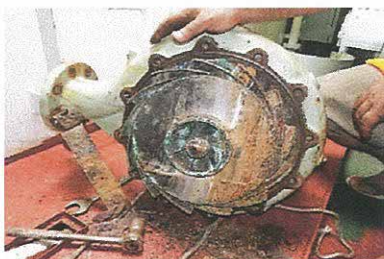
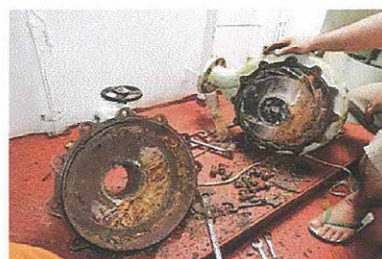
| N <sup>o</sup> | LOCATION | NAME | SPECIFICATION | CONDITION | REMARK |
|---|---|---|---|---|---|
| 44 | Engine room<br>(Starboard Side) | Fire pump | DAIICHI<br>Type : TA40/2<br>Capacity : 30m <sup>3</sup> /h<br>Head : 50m | No good | Renew<br>Maintenance training |

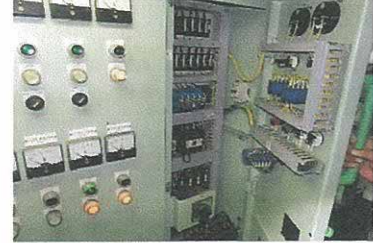
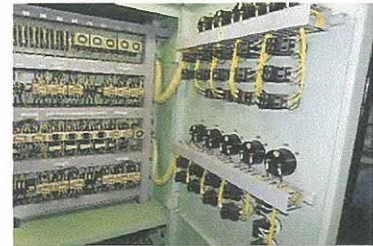
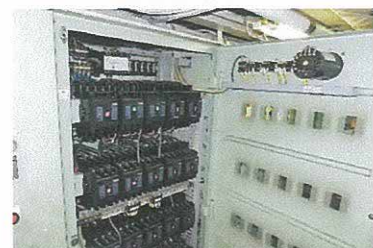
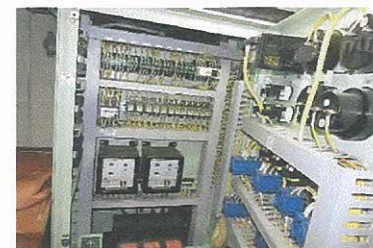
| No | LOCATION | NAME | SPECIFICATION | CONDITION | REMARK |
|---|---|---|---|---|---|
| 57 | Engine room | Electric switch panel | | Good | Maintenance<br>Insulation resistance<br>test |
