5.2.2.Detail Survey in Model Area  
a. Maps of Pilot Model District

## b. District Model Tanah Abvang Kec. Tanah Abang

REPORT OF EXISTING DRAINAGE SYSTEM

## 6. THE CONDITION OF DRAINAGE CHANNEL IN SURVEY AREA

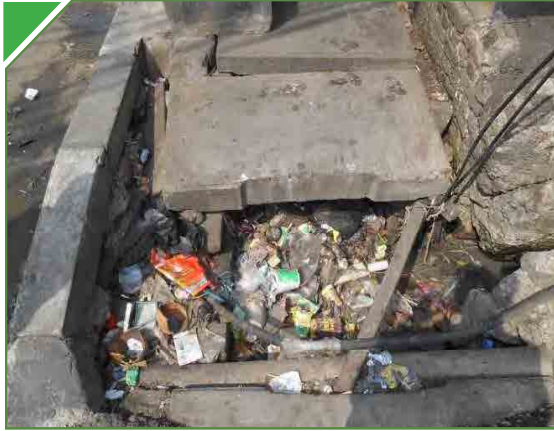
Clogging KS Tubun (Mas Mansyur)

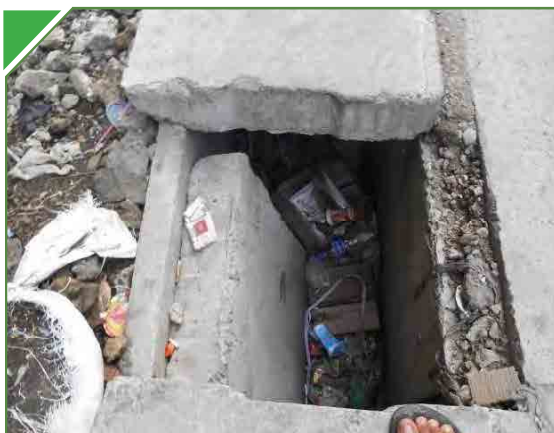
Failed Cover at Kebonpala 1

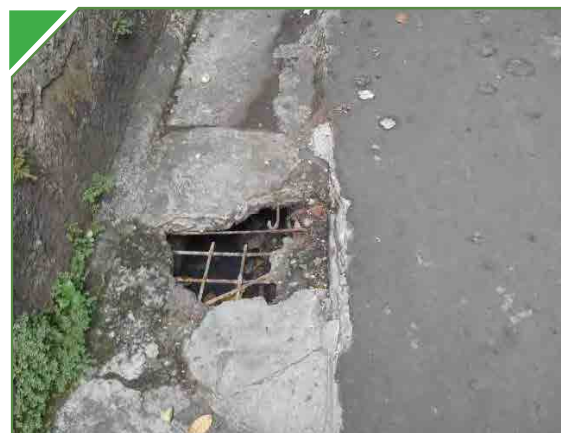
Failed Cover KS Tubun
