**The Project for
Improvement of Road Technology
in Disaster Affected Area in Myanmar**

**Technical Note on National Highway
& Expressway**

(Geometric Structure & Traffic Safety Facility)

June 2015

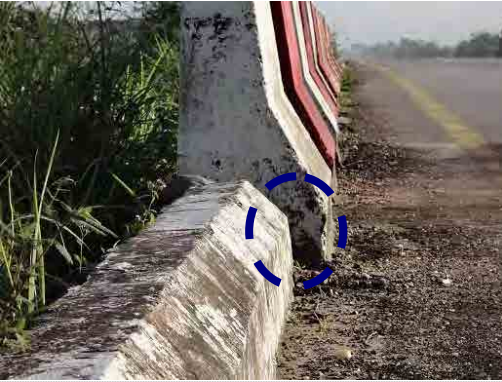
No.	Observation & Effect (If Neglect)	Photo	
1	<p>(Observation) - The furniture is not located in a straight line each other.</p> <p>(Effect) - Damage will be severer if vehicle hits gap between the objects.</p>

<p data-bbox="853 703 1368 735">Parapet wall is located ahead of the curb stone.</p>

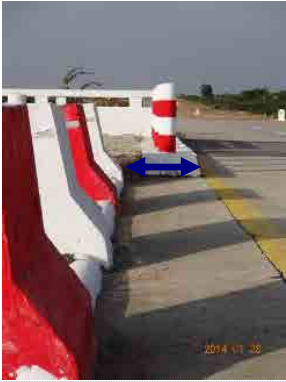
<p data-bbox="1406 703 1946 762">Foundation of post is located ahead of the parapet walls.</p>
2	<p>(Observation) - The furniture is located ahead of protective facility (e.g. guardrail).</p> <p>(Effect) - Damage will be severer if vehicle hits the object.</p>

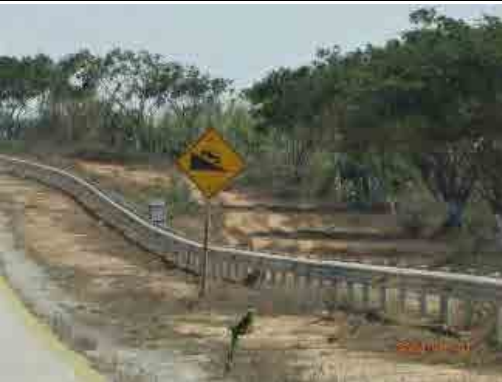
<p data-bbox="853 1155 1368 1187">Traffic sign is located ahead of guardrail.</p>

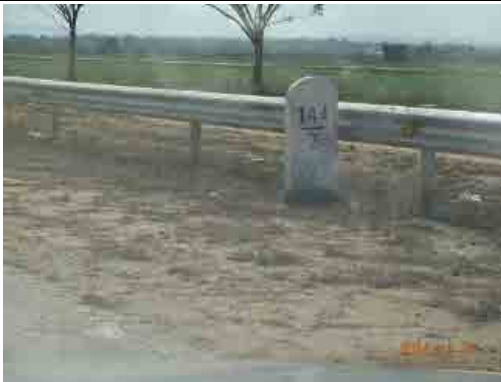
<p data-bbox="1406 1155 1946 1187">Milestone post is located ahead of guardrail.</p>

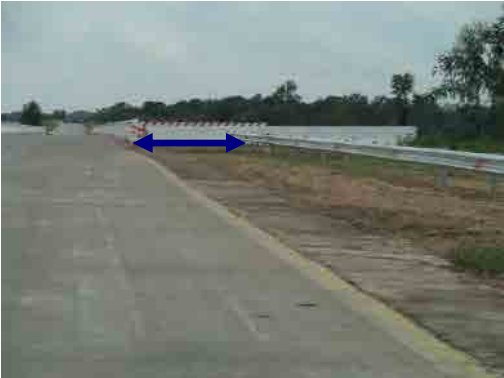
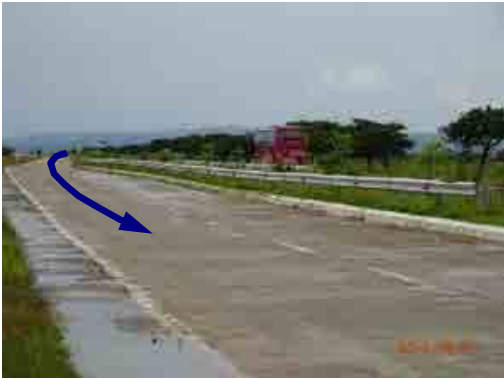
No.	Observation & Effect (If Neglect)	Photo	
3	<p>(Observation) - Inappropriate alignment/location of guardrail.</p> <p>(Effect) - Damage will be severer due to inappropriate alignment/location as stated in right columns.</p>

<p>Gap between guardrail and handrail on bridge. Overrun vehicle may hit concrete block.</p>	<p>Guardrail is installed inside of the curve instead of outside. Over speeded vehicle may overrun from carriageway.</p>
4	<p>(Observation) - Absence of the furniture.</p> <p>(Effect) - Risk of accident will increase due to the absence as stated in right columns.</p>

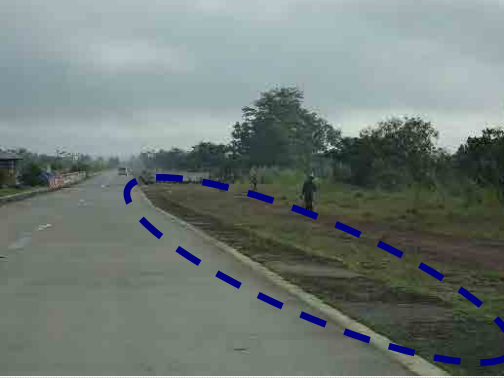
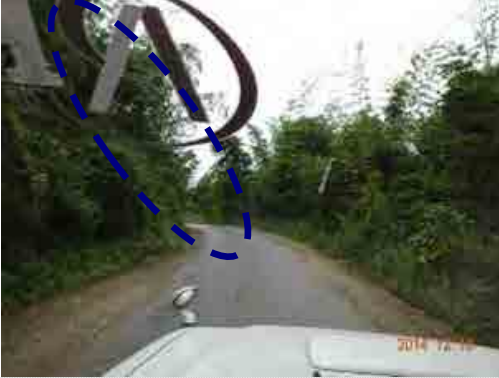
No.	Observation & Effect (If Neglect)	Photo	
1	<p>(Observation) - Insufficient maintenance work.</p> <p>(Effect) - Risk of accident will increase as stated in right columns.</p>

<p>Debris composed of soil and grass covers on shoulder due to lack of cleaning work. Vehicle will loose control once it runs on the shoulder.</p>	<p>Driver's visibility is hindered due to insufficient vegetation control.</p>
2	<p>(Observation) - Work group does not comply with authorized method.</p> <p>(Effect) - Risk of accident will increase as stated in right columns.</p>

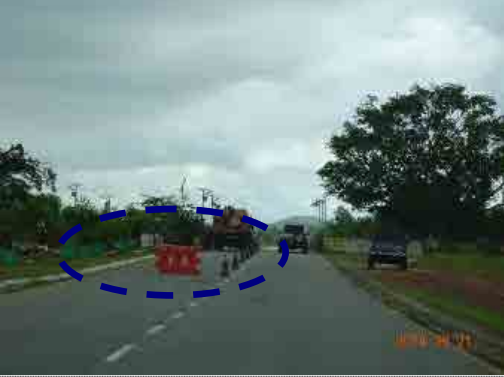
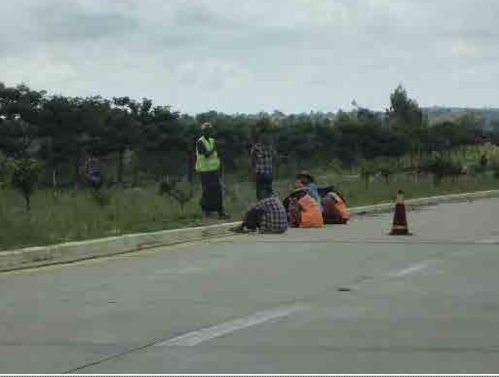
<p>Inappropriate arrangement of traffic control items (Barrier). Abrupt steering may be required in front of the barrier.</p>	<p>Workers took a rest within carriageway. Firstly, risk of accident against human. Vehicle also will be suffered secondary accident due to action to avoid human.</p>

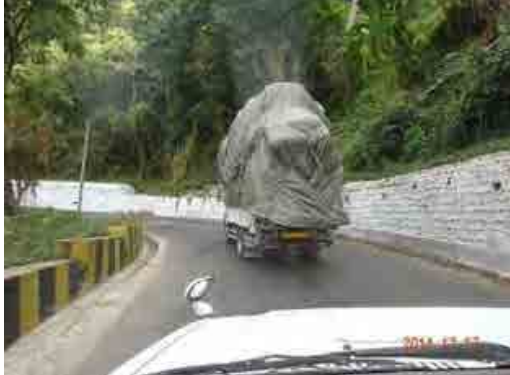
<p>Height of cargo is too high. Firstly, risk of overturning accident and/or collapse of cargo. Following vehicle also will be suffered secondary accident due to initial accident.</p>

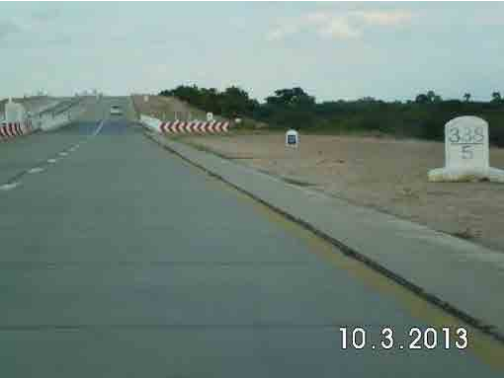
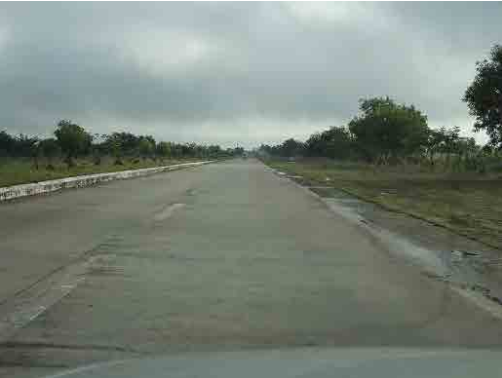
<p>Gap between carriageway and shoulder. Possible cause is failure of dimension control during construction period (?)</p>	<p>Water remains in the gap area.</p>
3	<p>(Observation) - Destruction of the structure.</p> <p>(Effect) - Traffic safety will be threatened if it becomes severer. - Risk of road closure if destructed completely. - Cost of repair/rehabilitation will significantly increase.</p>

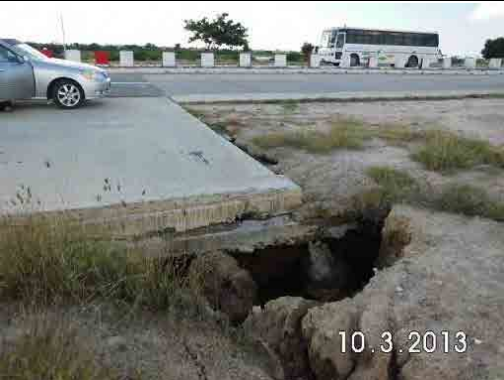
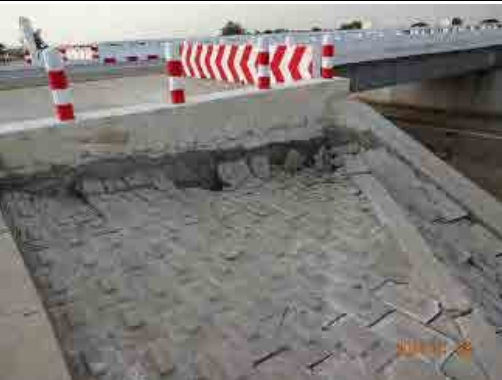
<p>Large cavity under concrete slab. Possible cause is erosion due to inadequate treatment of groundwater.</p>	<p>Collapse of slope protection (concrete block). Possible cause is circular slip on the slope or settlement on foundation ground.</p>

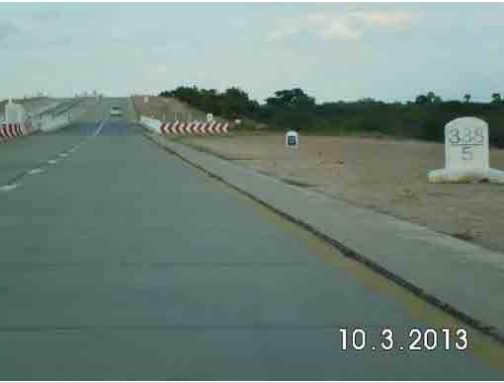
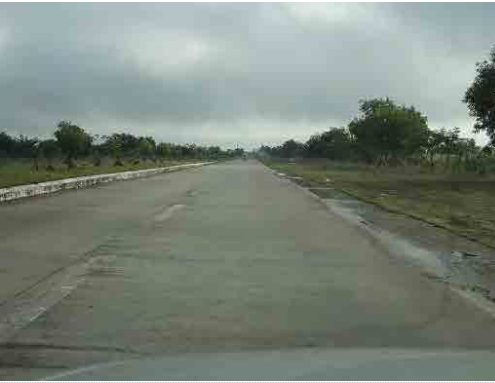
No.	Proposal	Photo	
2	<p>(Continued)</p> <p>Practicability: C for desirable and A for secondary</p>

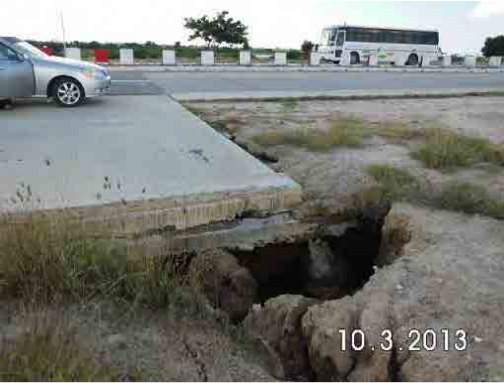
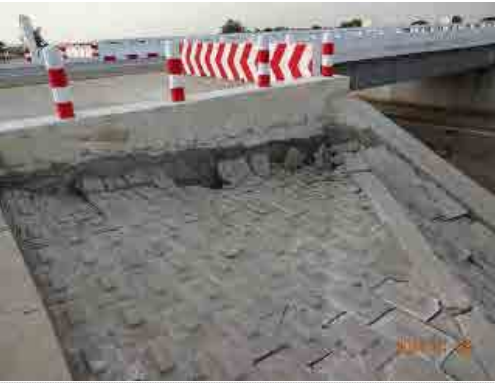
3	<p>(Observation) - Destruction of the structure.</p> <p>(Proposal) - Countermeasure work based on investigation, analysis and design. (desirable) - Destroyed part will be replaced with gabion box. (secondary)</p> <p>Practicability: C for desirable and B for secondary</p>

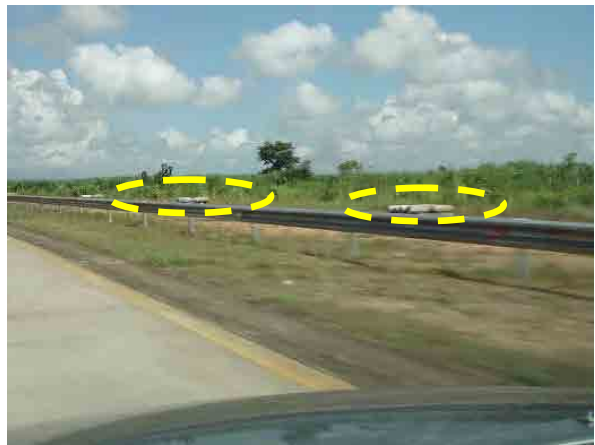
Ph.20 Posts were replaced with guardrail (good example).

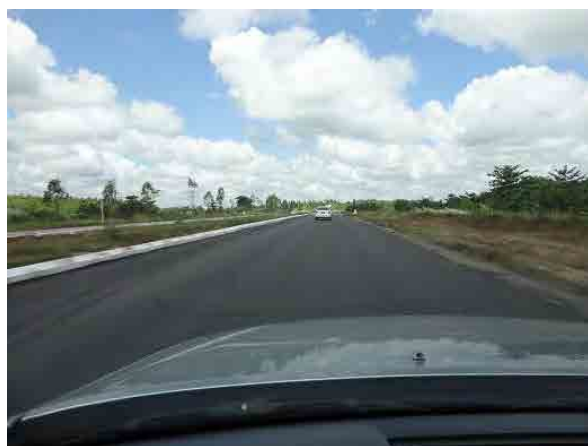
Ph.21 Lane mark should be painted to divide traffic flow clearly.

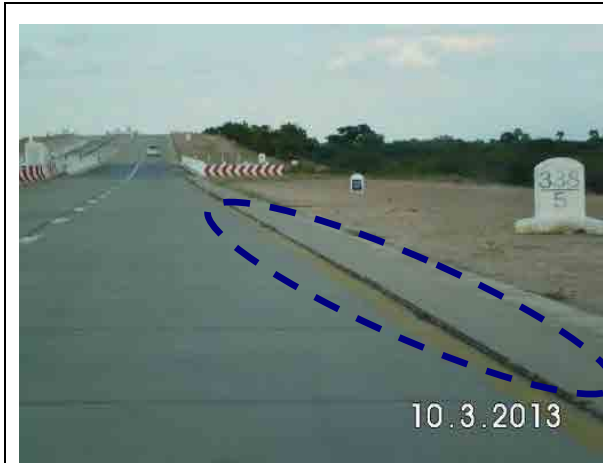
Ph.23 Gap occurred between carriageway and shoulder.

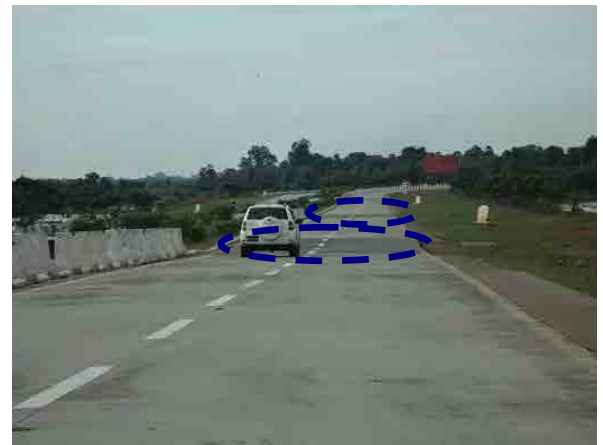
Ph.26 Repair works (asphalt overlaying) on settled parts occurred behind and/or beyond the box culverts.

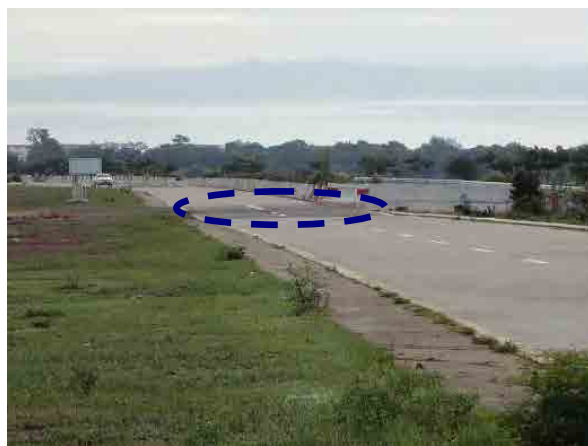
Ph.27 Repair works (asphalt overlaying) on settled parts occurred behind and/or beyond the box culverts.

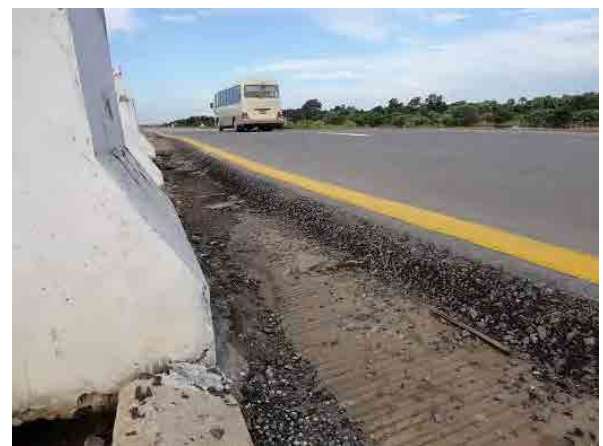
Ph.28 Asphalt overlaying work. Insufficient treatment on the edge. Vibration occurred during even non-heavy vehicle was passing.

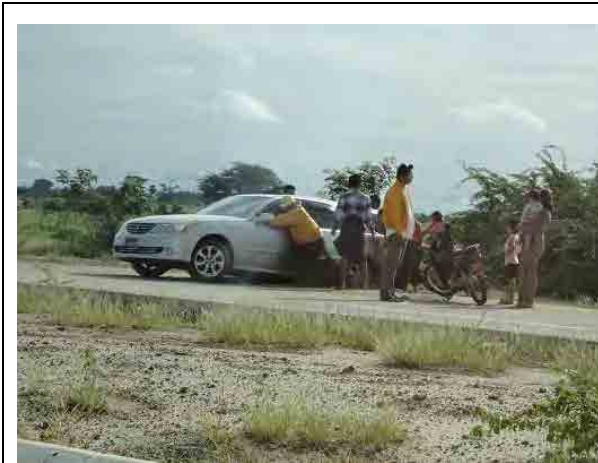
Ph.35 Car could not return to the carriageway by itself due to big gap with the shoulder.

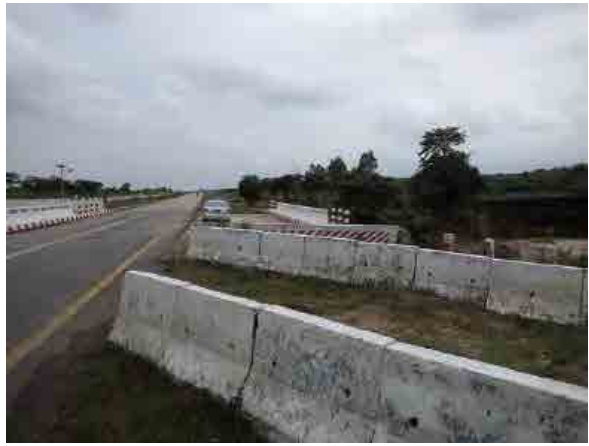
<p>Ph.79 Unnecessary blockage (concrete wall) in front of widened bridge. It may cause severe damage in case of the collision.</p>	<p>Ph.80 Unnecessary blockage (concrete wall) in front of widened bridge.</p>

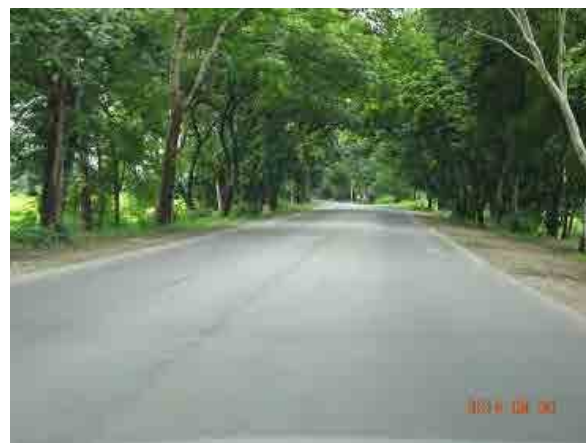
Ph.82 Road condition was good in general. But lane mark should be painted to divide traffic flow clearly.

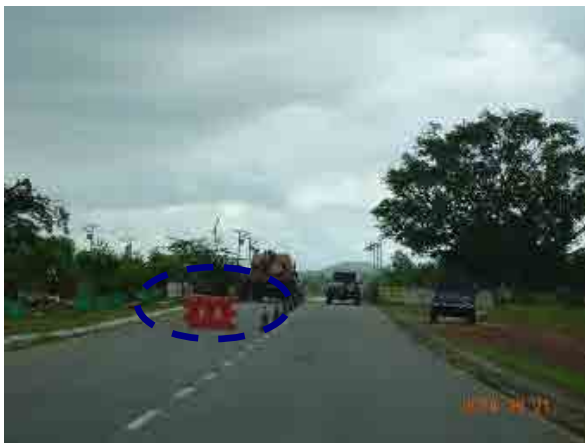
Ph.107 Traffic controlled area should be gradually guided by taper shape.

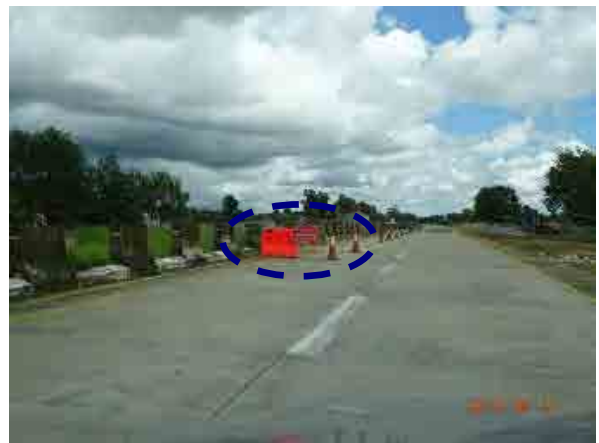
Ph.108 Repair work on median strip. Traffic controlled area should be gradually guided by taper shape.
