**PROJECT
FOR
IMPROVEMENT OF OPERATION AND
MAINTENANCE OF WATER SUPPLY AND
SEWERAGE SYSTEMS
IN
PARANA STATE, BRAZIL**

PROJECT COMPLETION REPORT

VOLUME II

Japan International Cooperation Agency (JICA)

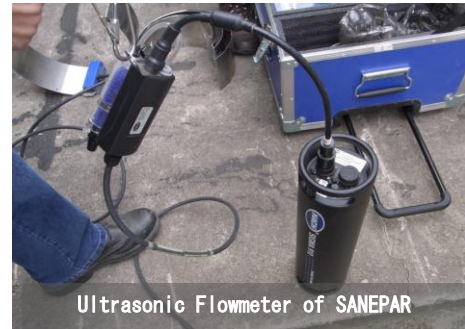
Ultrasonic Flowmeter of SANEPAR

It should be noted that SANEPAR purchased 10 insert formula TV cameras in February 2013. And 3 of them were deployed at CMA and 1 at coastal area. For inspection and diagnosis of sewage pipe network these insert formula TV cameras should be taken advantage of in addition to simple TV cameras and self-propelled TV camera.

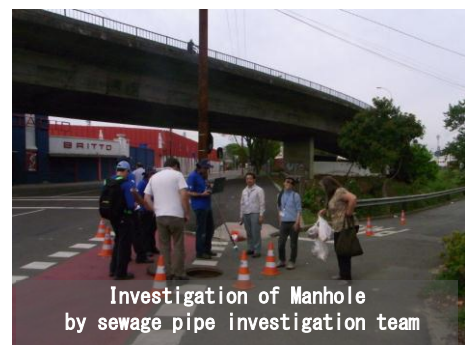
Investigation of Manhole by sewage pipe investigation team

Team of sewage pipe investigation was established in USEG of GGML in fiscal year of 2012 and began operation in August 2012. This team investigates manhole with more than 300mm of diameter visually records the result to unified table. In October 2012 investigation of 16.5 km was finished resulting about 18% of total manholes could not found because of covering by pavement that will make future inspection and diagnosis difficult. And also some pipes are exposed to air and broken by erosion of land. This team is in charge of the flow investigation of sewage pipe and of C/P of the project and plays a central role of it.

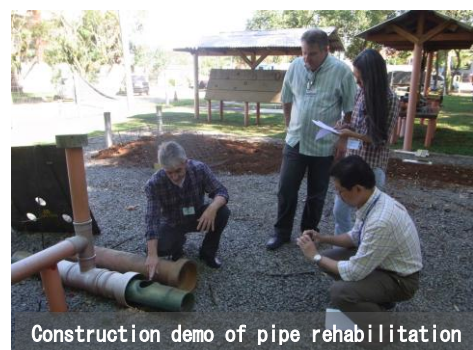
Construction demo of pipe rehabilitation

A couple years ago SANEPAR implemented rehabilitation of sewage pipe by lining experimentally. About 30km of rehabilitation by lining was conducted but in a lot of interval the lining was deformed, sewage flow was obstructed and remarkably deformed pipes were reconstructed. A contractor in Sao Paulo that constructed them is not currently serves. It is estimated that thermosetting resin was utilized and reason of deform was deficiencies in construction management such as lack of temperature control when cured because in the construction of a demonstration on the ground had been properly cured.

On the other hand because the thickness of the material is about 7mm by survey of demonstration in case of minimum diameter in Brazil (150mm), cross-sectional area after lining will reduce to about 80% of that before lining. The capacity after lining will be very small compared with 200mm (minimum diameter in Brazil). So that the lining of pipes makes rehabilitation of them but will cause issues on O/M because they will be blocked easily and overflowed easily by infiltration of rainwater. From these facts with regard to the application of the method to the rehabilitation of sewer pipe of 150 mm by lining method, it is necessary to perform a careful consideration, including whether it is good or bad.

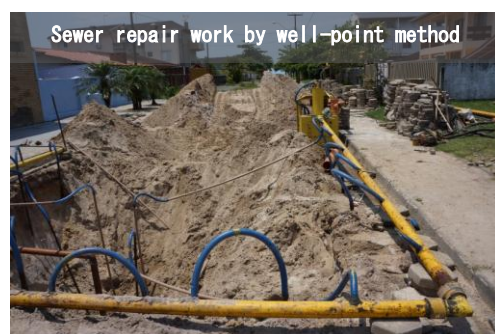
Especially in the place near the seashore where there is highly liquid sand high groundwater level, in case of small repair work normal open cut method cannot be applied and well-point method (method of lowering the groundwater level by pumping groundwater by a number of underground pipe) is applied

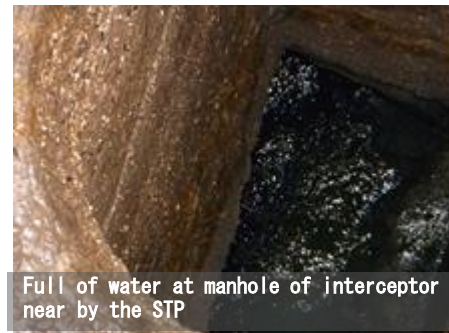
a manhole of interceptor at most downstream, which shows full of water due to the back water of high water level of grit chamber of STP of Belem. Judging from the figure pointing the site of occurrence of back flow, it occurs near by the trunk sewer. It is presumed that the trunk sewer, which is lack of capacity in dry weather, may be in a pressured state in wet weather by increase of flow by infiltration and back flow will be occur in the collector of tributary of it.

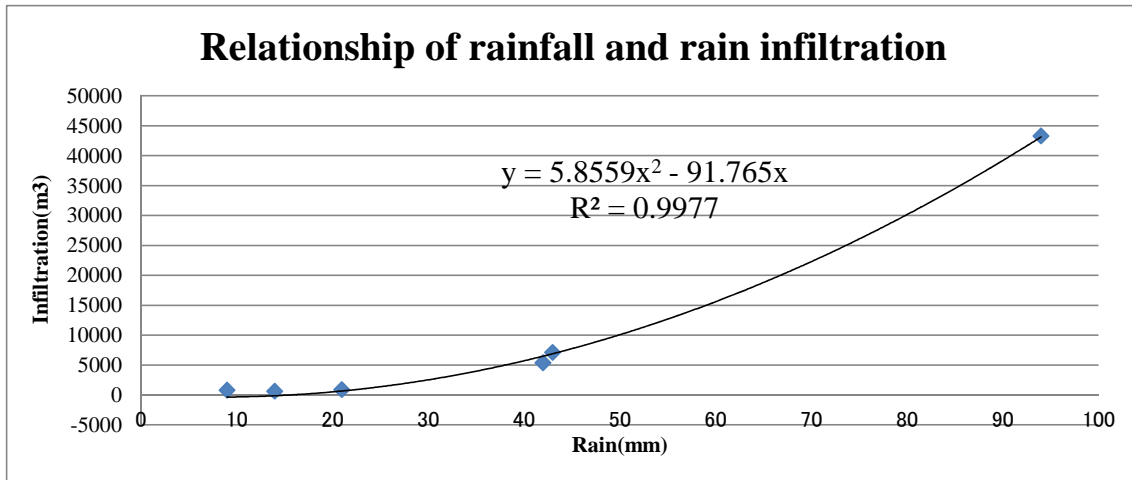
Figure 1.3.3 The relation between rainfall amount and infiltration volume

Relation in Figure 1.3.3 was drawn by plotting precipitation volume vs infiltration volume in Table 1.3.3.

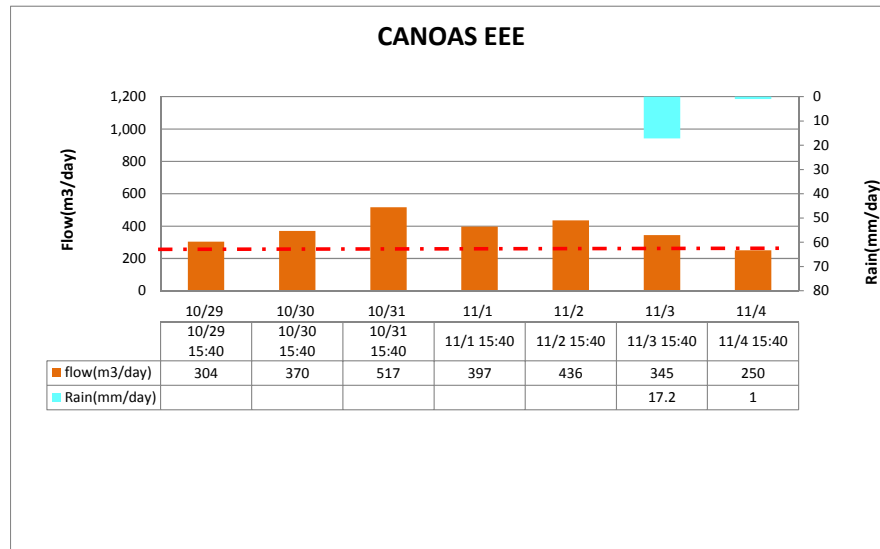
Figure 1.3.6 Result of the measurement at Canoas EEE

The result of the measurement is shown in Figure 1.3.6. Flow volume of dry weather is about 400m³/day.

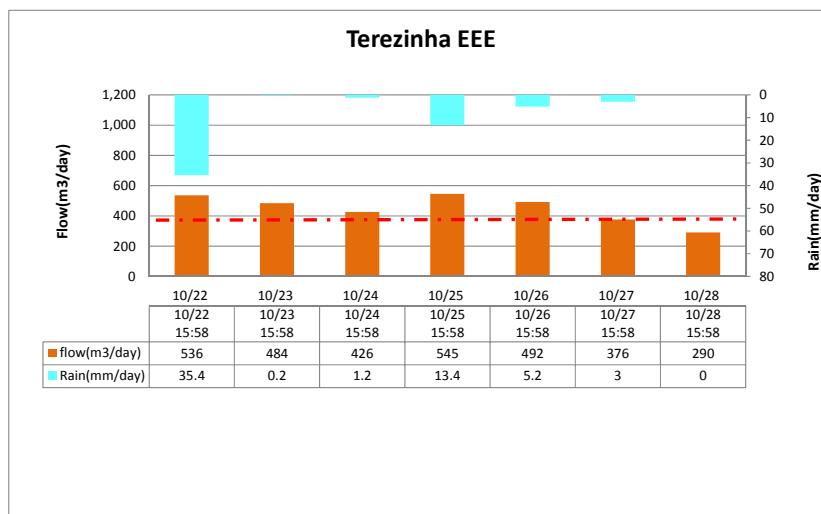
Figure 1.3.7 Result of the measurement at Terezinha EEE

The result of the measurement is shown in Figure 1.3.7. Flow volume of dry weather is about 500m³/day.

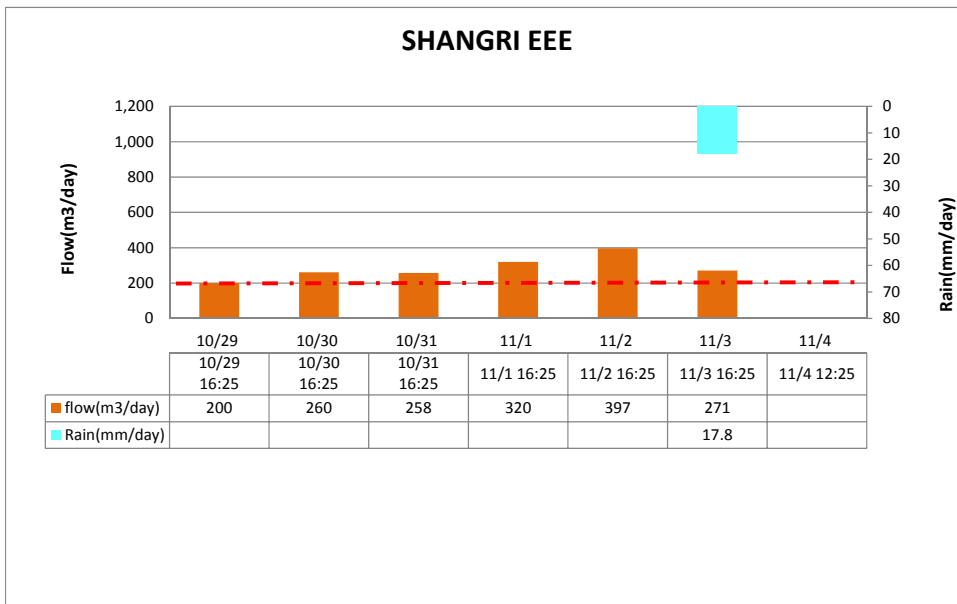
Figure 1.3.9 Result of the measurement at Shangri-La EEE

The result of the measurement is shown in Figure 1.3.9. Flow volume of dry weather is about 300m³/day. It is difficult to estimate the infiltration volume of rain water at Nov/3rd.

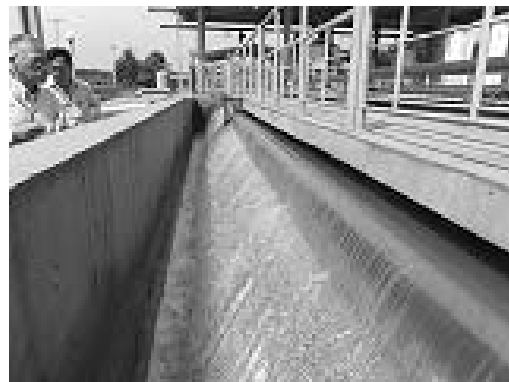
DAF: Scum rise is already seen in open conduits before entering floatation unit. Operational period is 5min operation, 10min of suspension. Frequent faults occur. The cause of derailment is thought to be too long span of sludge collector.

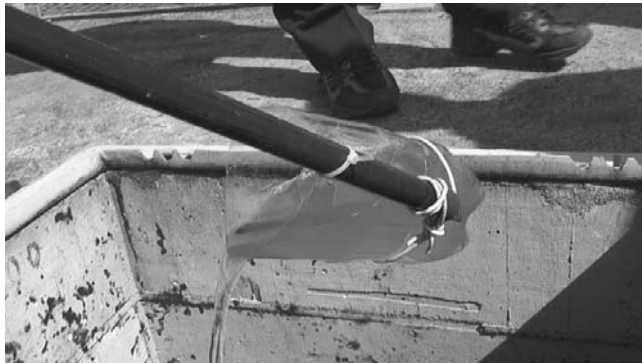
Also no foams build-up was discovered on the lagoon surface. On the other hand, tendency of greenish of lagoon effluent is remarkable. This is due to the algae build-up as the poor removal of nitrogen and phosphorus effluent has been kept longer period with sufficient light under warm temperature. The countermeasure should only be existed to eliminate those causes.

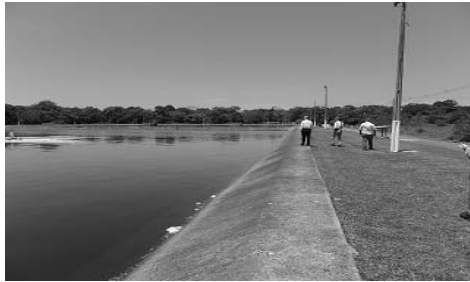
Foam is building up on the surface of lagoon. Algae are apt to grow after rain season and effluent becomes greenish.
