フィリッピン共和国ビンガダム修復計画

事前調査報告書

1987年3月

国際協力事業団

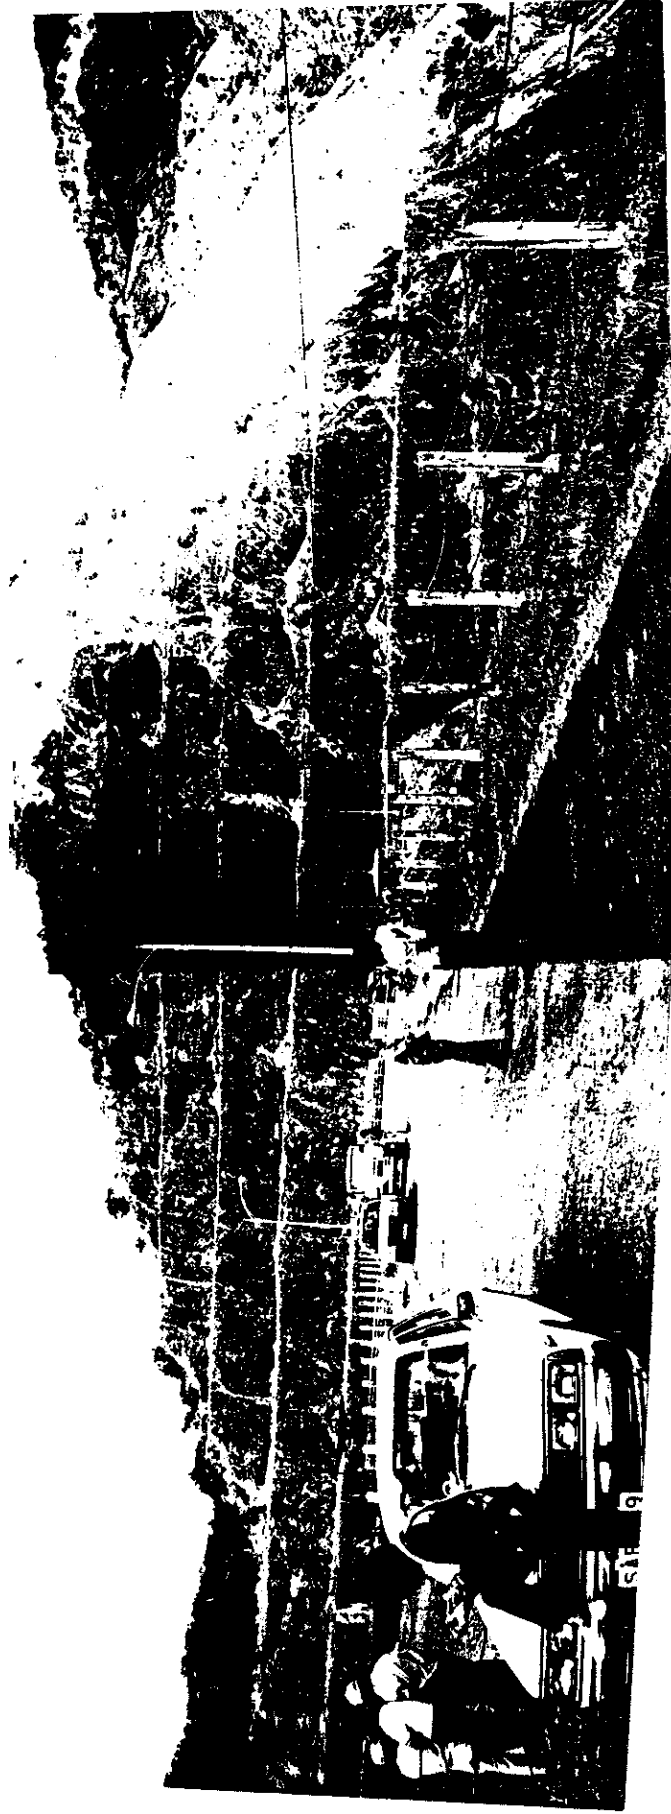
ダム左岸掘削法面状況

ダム軸より上流側の掘削法面は整然としているが、下流側はシームや小断層沿いに浸食及び岩塊の落石が認められる。洪水吐ゲートまでは若干のスペースはあるものの浸食と落石防止のためのなんらかの保護工が必要と思われる。

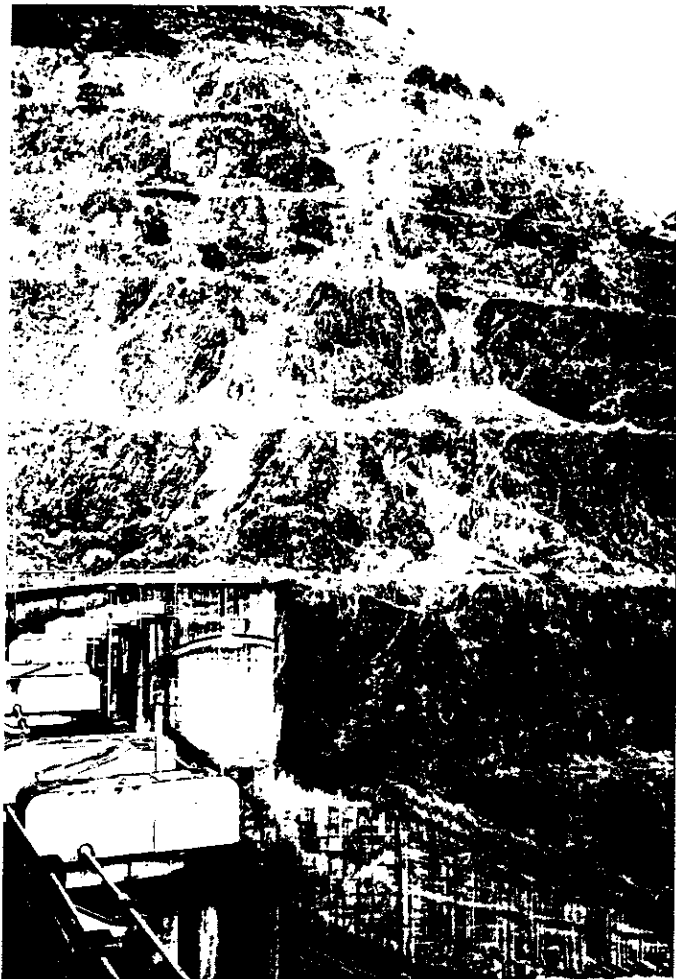
掘削法面の浸食状況

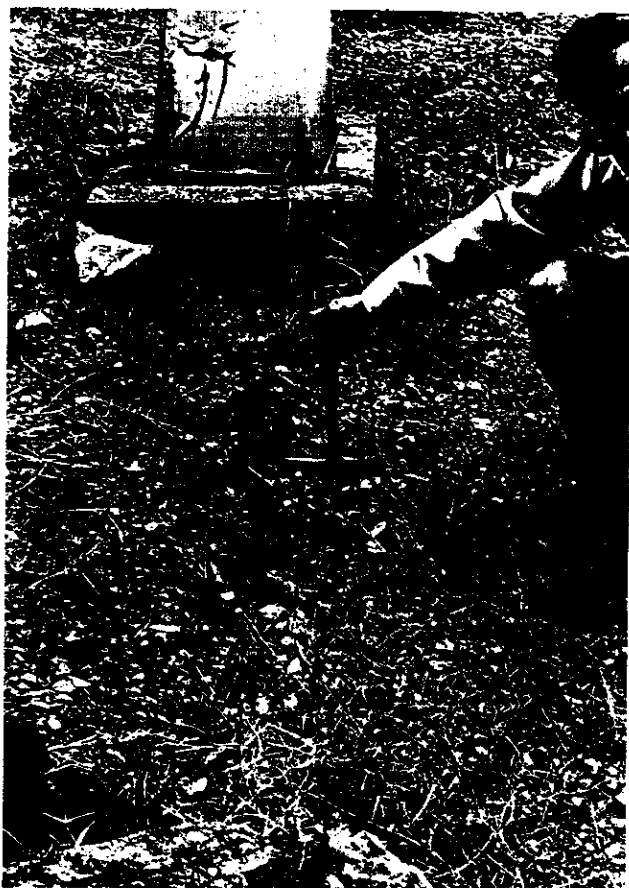
ダム堤体上流側のフラッグ

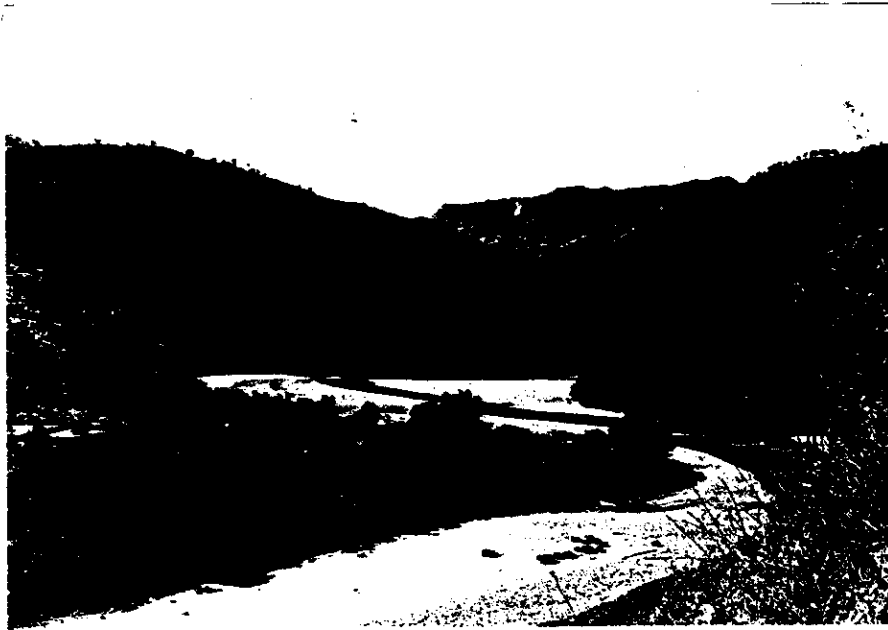
ビンガ野水池直上流の堆砂状況
