**PREPARATORY SURVEY REPORT  
ON THE PROJECT FOR  
ASMALA WATER SUPPLY DEVELOPMENT  
IN THE STATE OF ERITREA**

July 2015

**JAPAN INTERNATIONAL COOPERATION AGENCY**

GE
JR
15-127

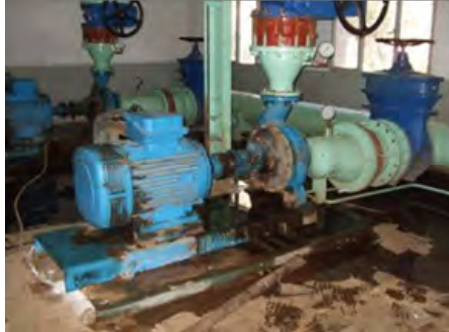
Adi Sheka dam	Adi Sheka PS

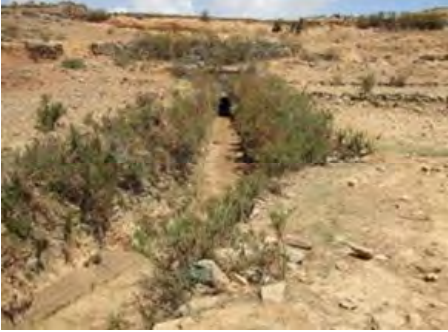
Raw water transmission channel from Adi Sheka dam	Mai Serwa dam

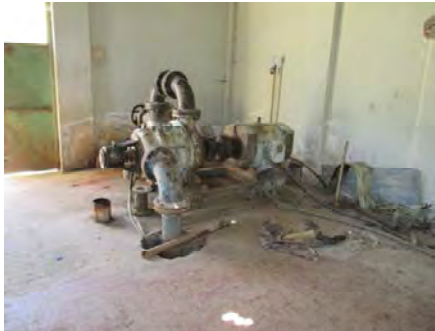
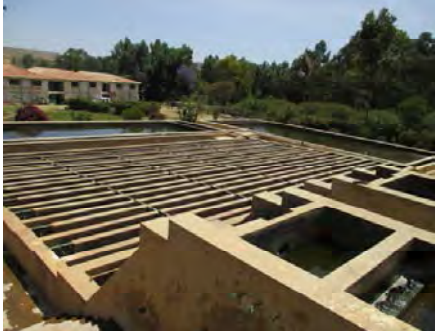
Mai Serwa PS	Stretta Vaudetto WTP

Stretta Vaudetto WTP	Treated water transmission pump in Stretta Vaudetto WTP

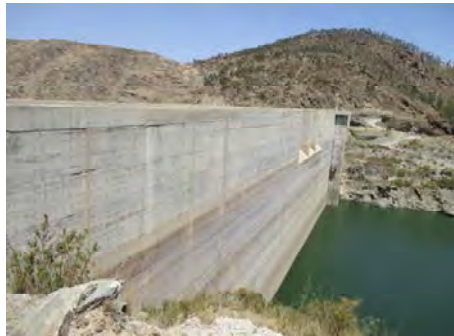
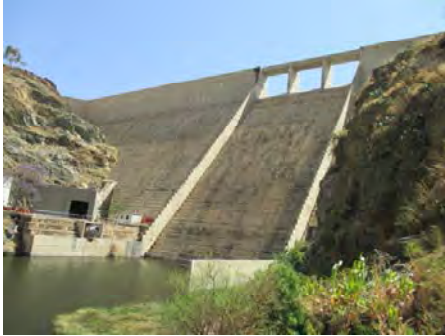
Toker dam	Toker dam

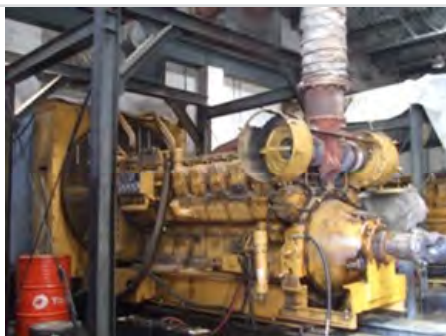
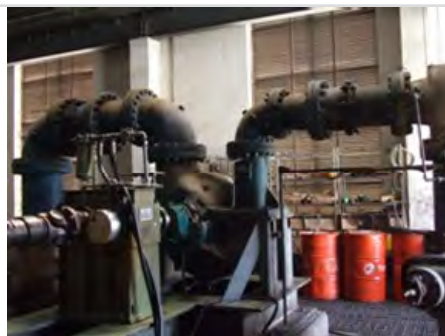
Toker PS Diesel engine	Toker PS Raw water transmission pumpポンプ

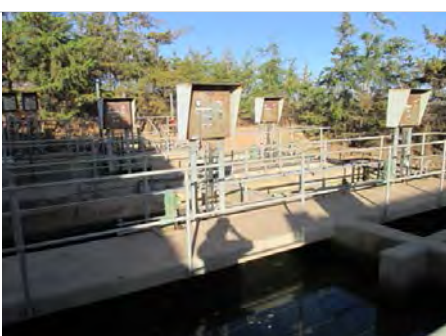
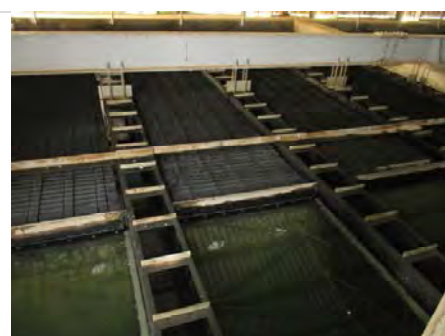
Toker WTP Flocculation facility	Toker WTP Sedimentation facility

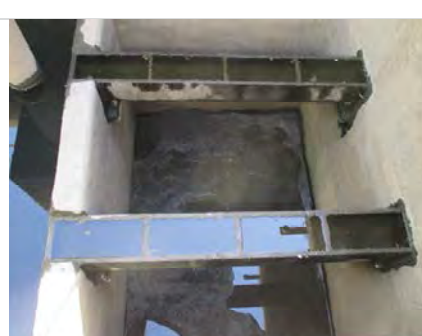
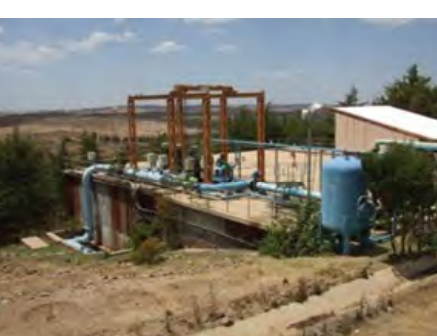
Toker WTP Rapid sand filter	Treated water transmission pump in Toker WTP

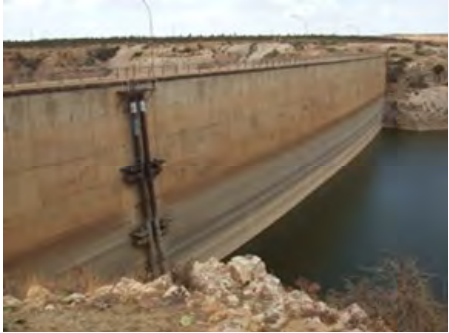
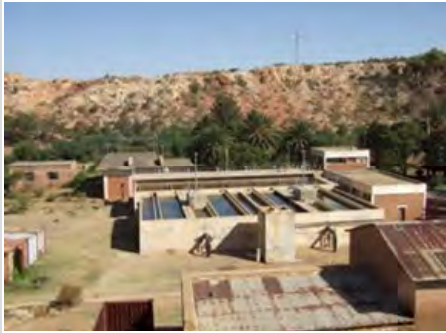
Mai Nefhi dam	Mai Nefhi WTP

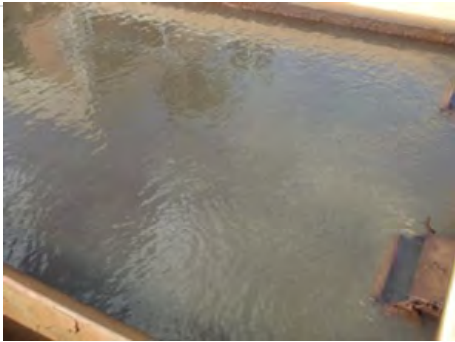
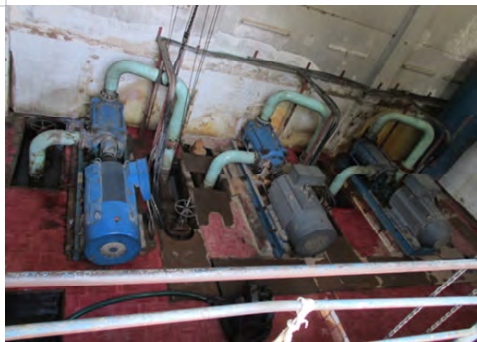
Mai Nefhi WTP Rapid sand filter	Treated water transmission pump in Mai Nefhi WTP

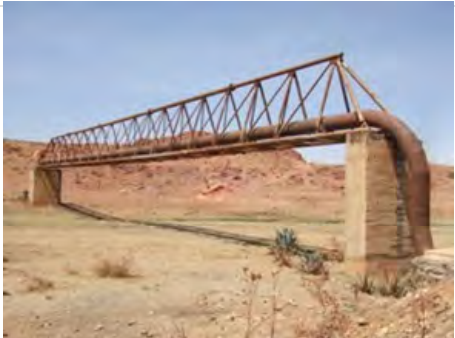
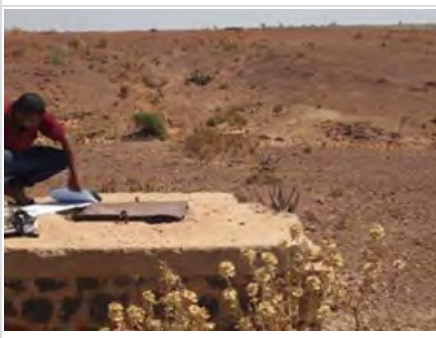
Treated water transmission pipeline Pipe bridge	Treated water transmission pipeline Valve pit

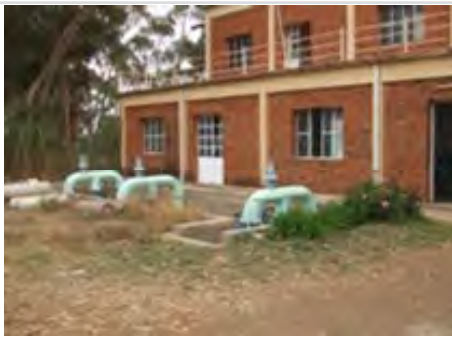
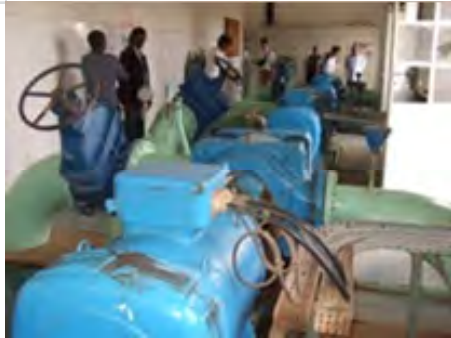
Sembel PS	Distribution pump in Sembel PS

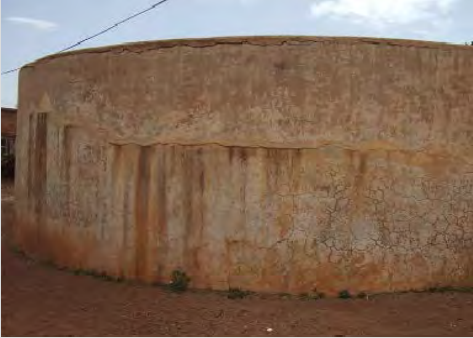
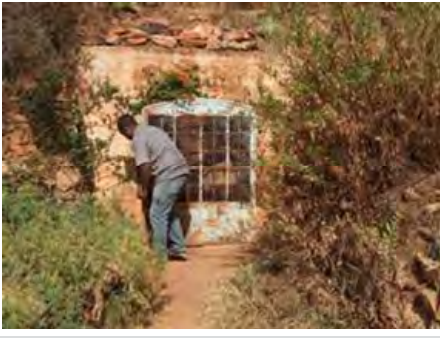
Hazhaz reservoir	Tsetserat reservoir

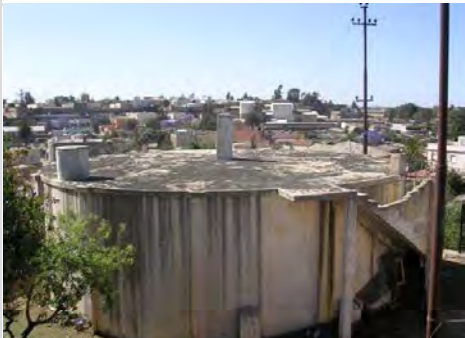
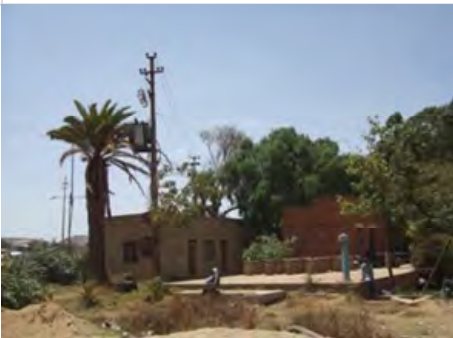
Monopolio reservoir	Mai Chehot PS Exterior

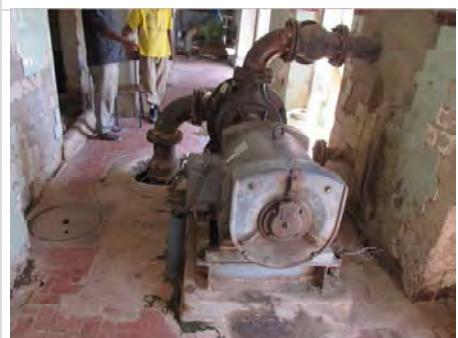
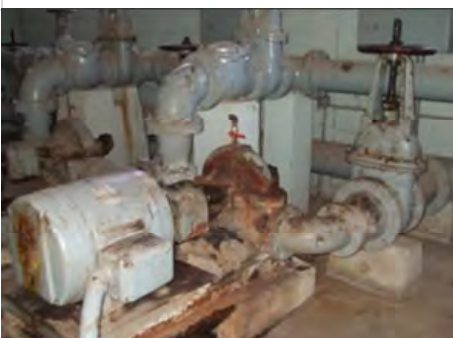
Distribution pump in Godaif PS	Distribution pump in Denden PS

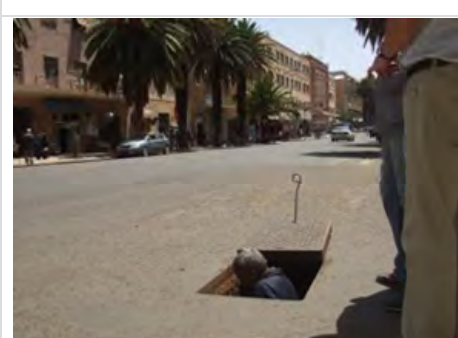
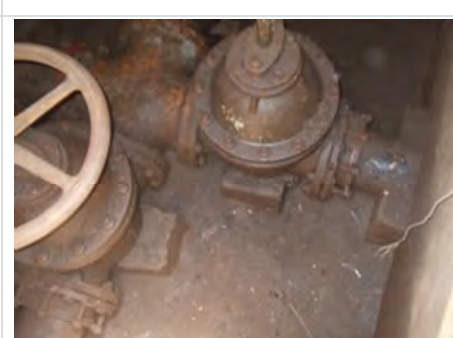
Valve pit on the primary distribution pipeline	Gate valve on the primary distribution pipeline
