連邦公共事業省

**ナイジェリア国  
コンクリートテスター（CTS）を  
用いた道路付帯コンクリート構造物の  
点検技術の普及・実証事業  
業務完了報告書**

平成 27 年 10 月

日東建設株式会社

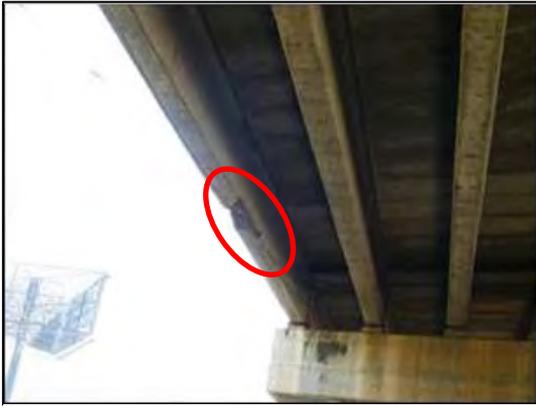
また、各橋梁の状態確認時に大規模な損傷を受けている橋梁 (Karu Flyover Bridge) を発見した。損傷の状況は橋桁のコンクリートの剥落、鉄筋露出と大変危険な状況にあり、公共事業省へ報告した。第2回渡航時に現場確認したが補修は行われていなかった。そのため他の橋梁とあわせ補修工事の工法などを第3回渡航時に提案した。

図 3-1 重大な損傷（桁コンクリートの剥離 赤枠 Karu Flyover Bridge）

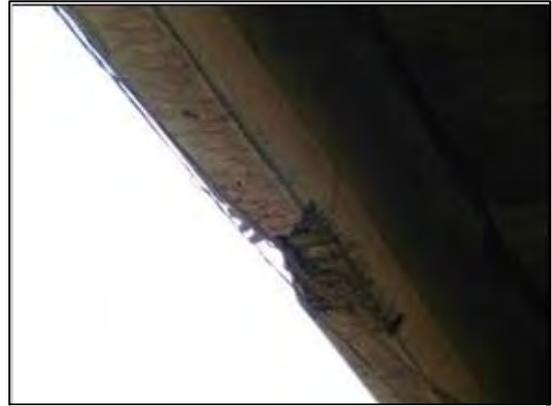
図 3-2 重大な損傷（桁コンクリートの剥離：拡大写真 Karu Flyover Bridge）

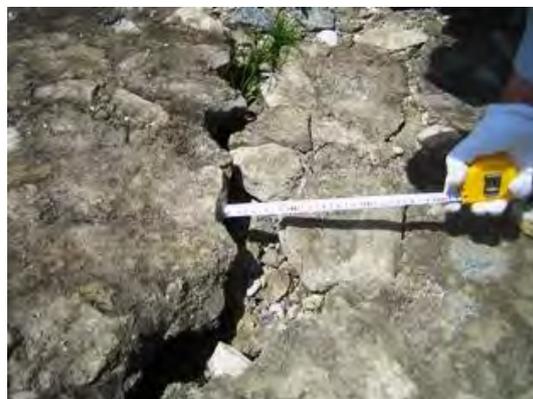
Giri Interchange Bridge では、橋台盛土に大きなクラックが発生していた。アブジャ周辺の気候はサバンナ気候に分類されており、雨量が多い地域ではないため、今すぐのり面崩壊が発生する可能性は低い、修復しないまま放置しておくともクラックが進行し、のり面の大きな損傷に至る可能性がある。

図 3-8 橋台盛土のひび割れ（Giri Interchange Bridge）

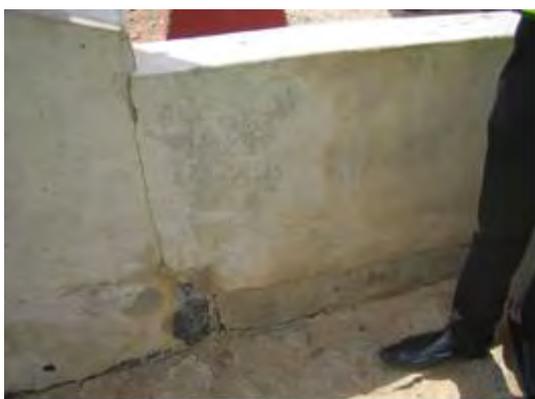
図 3-9 壁高欄の剥離（Gwagwalada Lokaja Flyover Bridge）

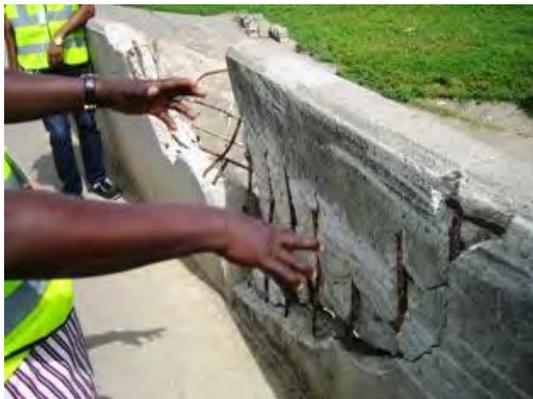
特に、Zuba Flyover Bridge の壁高欄の損傷は、損傷状況からすでにコンクリート塊の落下していたことを容易に予想することが出来る。本橋梁は下に幹線道路が通じている高架橋であり、橋梁部材の落下は、橋梁下の道路を通行している自動車、運転手、同乗者に甚大な被害を与えることになるため、早急な緊急措置が必要である。

図 3-10 壁高欄コンクリートの損傷・鉄筋露出（Zuba Flyover Bridge）

- 今回の点検実習で確認された損傷の進行を止める（防ぐ）方法を教えてもらいたい。
  - まずは壁高欄の補修を早急に行う。放置すれば人命に関わる事故につながる。
  - 劣化因子である水の侵入を防ぐ。排水装置の設置や防水処理を施す。
- アバットのクラックについての原因と補修方法について教えてもらいたい。
  - 原因によって補修方法は変わる。アルカリ骨材反応が原因であった場合は水の侵入を防ぐ事が重要となるため、防水処理を施す。強度不足が原因である場合は、増厚等で耐力を向上させる必要がある。
- 支承の点検の方法について教えてもらいたい。
  - 目視点検もしくは触診を行う。
  - 支承の回りのコンクリートの強度を CTS で測定する。

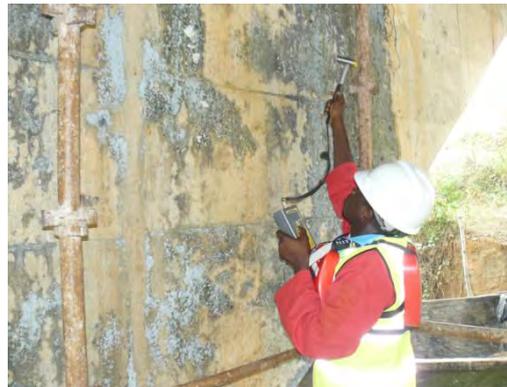
図 3-45 火災で損傷を受けた橋梁の検査状況

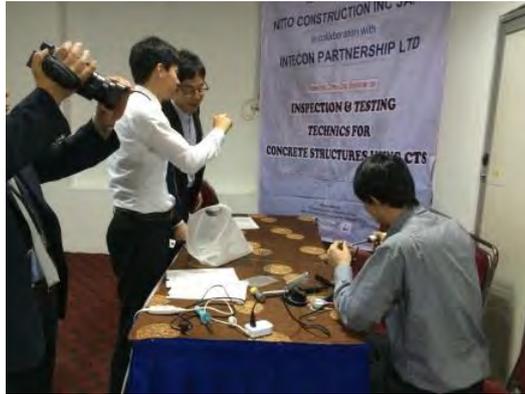
CTS は、簡易な測定器であるものの、運用するに当たり必ず不具合が発生する。また、精度確認のための校正試験も必要になる。現時点においては、当社の販売代理店として契約した Intecon Partnership 社が CTS の販売、修理、校正試験を担当することになる。CTS で想定される故障は様々あるが、修理対象となるのは、主に断線である。断線修理は、はんだ付けのみで修理可能であるが、手先の器用さを問う作業であり、経験によって仕上がり精度が異なる。実際に、Intecon Partnership 社の技術者が修理した断線部位は、仕上がり精度が悪く、またすぐに断線に至るというサイクルに陥っていた。本事業を通じ、機材の修理方法の講習も開催し修理スキルの向上に努めたが、依然として十分な修理スキルが身についた状況とは言い難い。

図 3-47 現地での機器修理状況

そのため、当社で詳細な修理マニュアルを作成し、マニュアルを通じ修理スキルの向上に努めてもらう予定である。装置そのものの改良として、断線しにくい機構に改良するということも想定されるが、いかなる措置を講じても故障のリスクは付きまとい、装置の機構を複雑にすれば、修理も容易に行うことが難しくなるため、現段階では装置の機構そのものを改良することは考えていない。

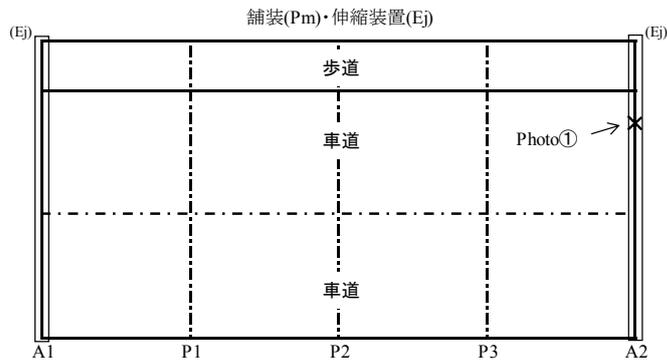
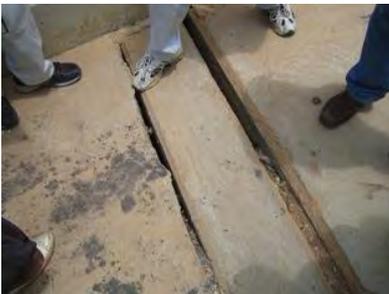
No.		4		橋梁ID	
対象部材		伸縮装置		橋梁名	Gwagwalada Lokaja Flyover Bridge (Right)
損傷の種類		隙間		点検実施日	2014/6/4
判定結果		-			
応急措置	実施	実施内容	-		
	未実施	できなかった理由	当面の緊急性は低い		
		実施予定時期	未定		
		実施予定内容	舗装施工前に補修工事が必要

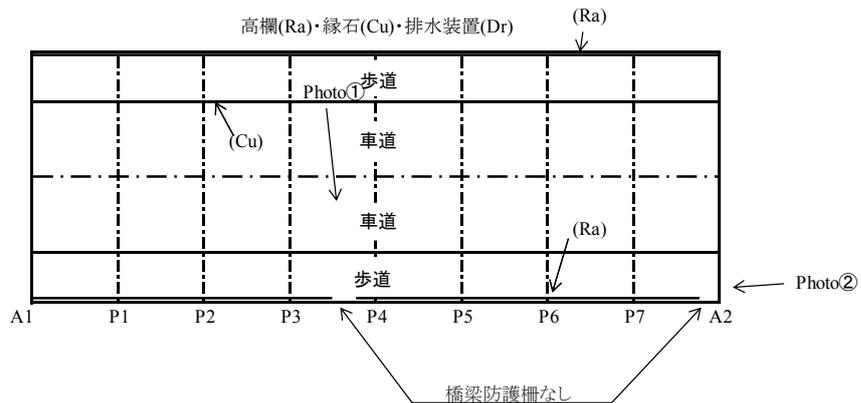
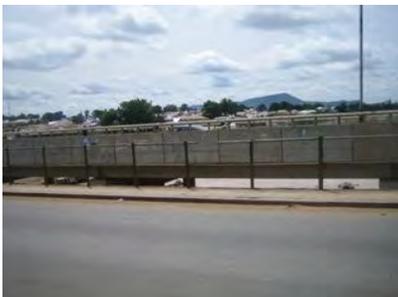
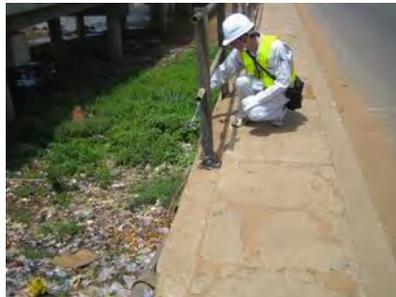
No.	5	点検実施日	2014/6/5
対象部材	高欄		
損傷の種類	設置不良		
判定結果	C		
応急措置	実施	実施内容	—
	未実施	できなかった理由	早急な防護柵の設置が必要
		実施予定時期	2014年度
		実施予定内容	橋梁防護柵設置工事

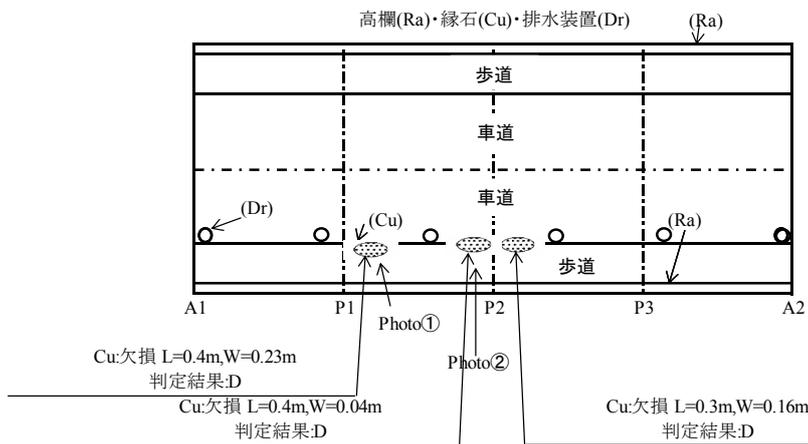
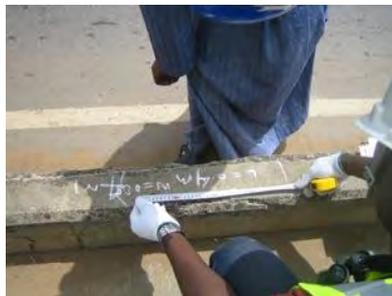
No.	5	点検実施日	2014/6/6
対象部材	縁石		
損傷の種類	欠損		
判定結果	D		
応急措置	実施	実施内容	—
	未実施	できなかった理由	当面の緊急性は低い
		実施予定時期	2016年度
		実施予定内容	設計図を確認し、対策の必要性を検討

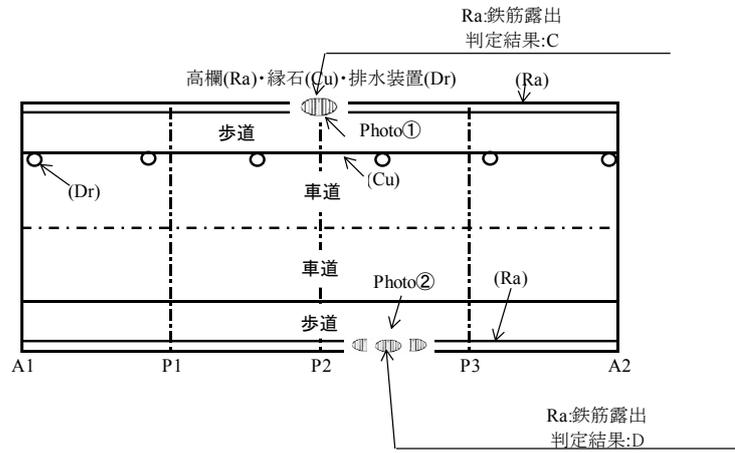
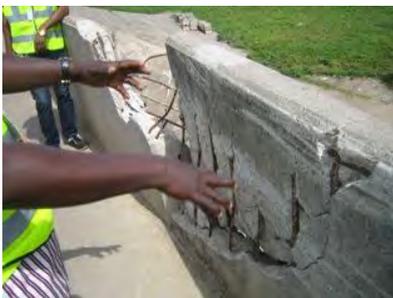
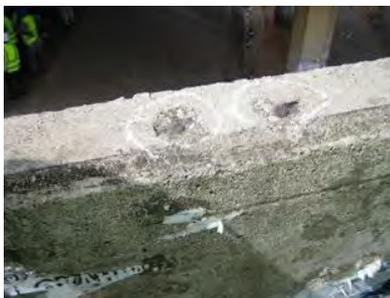
橋梁ID	
		橋梁名	Zuba Flyover Bridge (Right)
No.	5	点検実施日	2014/6/6
対象部材	高欄・緑石・排水装置		
損傷の種類	鉄筋露出		
判定結果	C		
応急措置	実施	実施内容	—
	未実施	できなかった理由	本格的な補修工事が必要
		実施予定時期	2014年度
		実施予定内容	詳細調査を実施し、補修工法を検討

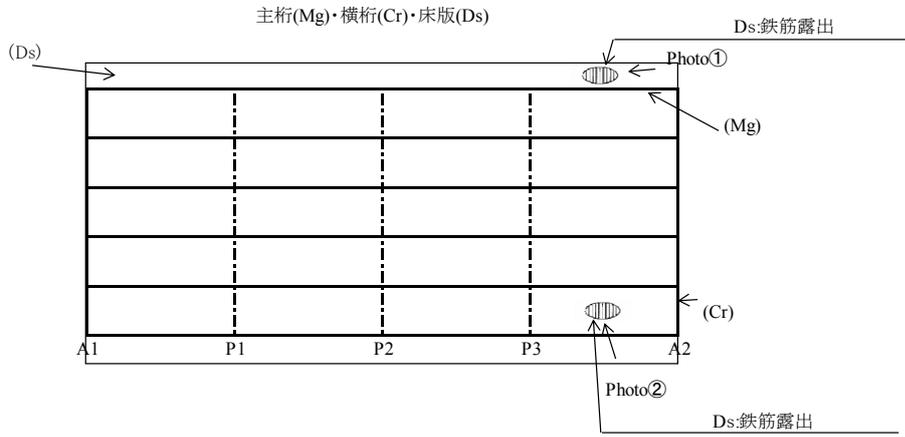
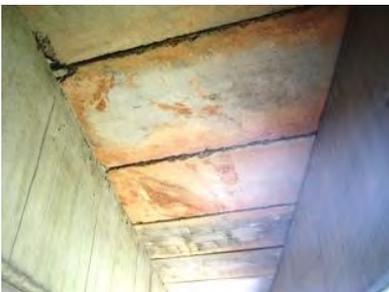
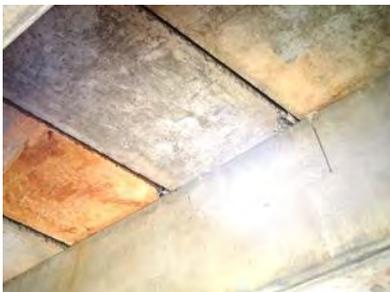
No.		1		橋梁ID	
対象部材		床版		橋梁名	Karu Flyover Bridge (Right)
損傷の種類		鉄筋露出		点検実施日	2014/6/6
判定結果		D			
応急措置	実施	実施内容	—		
	未実施	できなかった理由	当面の緊急性は低い		
		実施予定時期	2016年度		
		実施予定内容	設計図を確認し、対策の必要性を検討

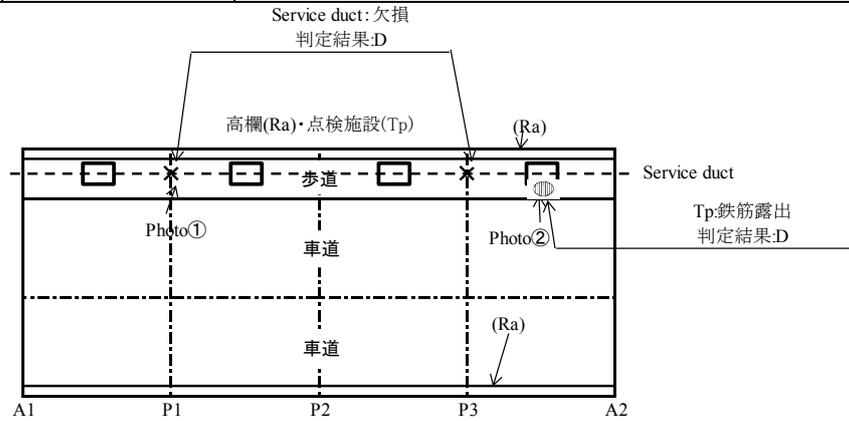
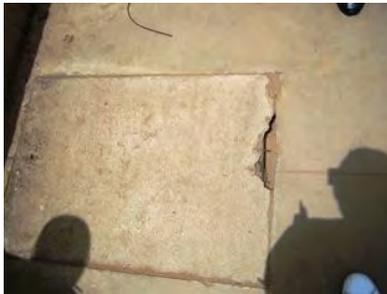
No.		5		橋梁ID	
対象部材		点検施設, Service duct		橋梁名	Karu Flyover Bridge (Right)
損傷の種類		鉄筋露出, 欠損		点検実施日	2014/6/6
判定結果		D			
応急措置	実施	実施内容	—		
	未実施	できなかった理由	当面の緊急性は低い		
		実施予定時期	2016年度		
		実施予定内容	設計図を確認し、対策の必要性を検討
