Minutes of Meeting on the Draft Final Report of Data Collection Survey on Disaster-resilient Feeder Ports and Logistics Network in the Republic of the Philippines

1-1-1 Major Condition of the Structure and Damages in Leyte Area

3. Results of Site Survey

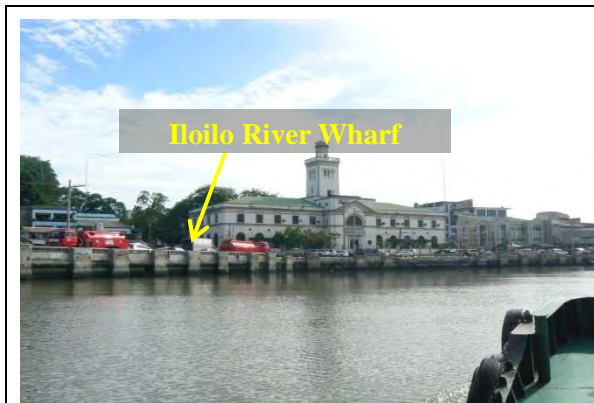
Figure No.2
Existing River Wharf.

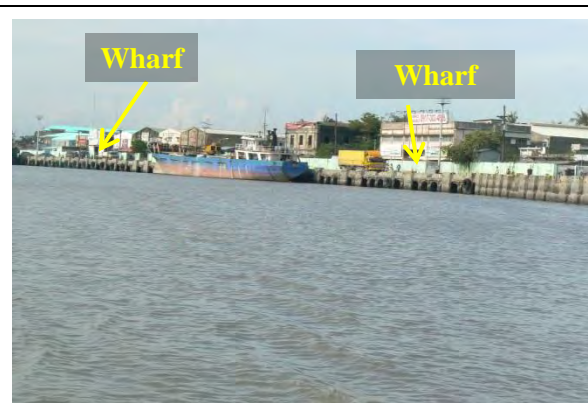
Figure No.3
Existing River Wharf

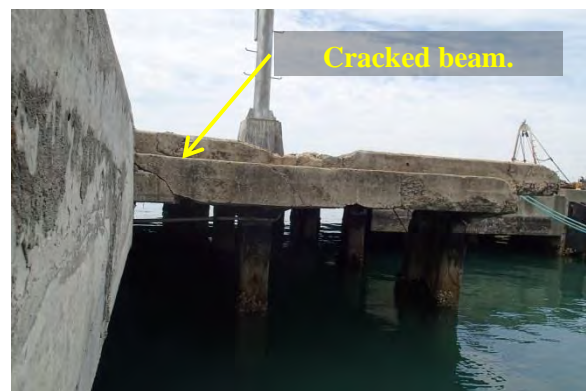
Figure No.7
Portion of the old RC Pier with structural damages visible.

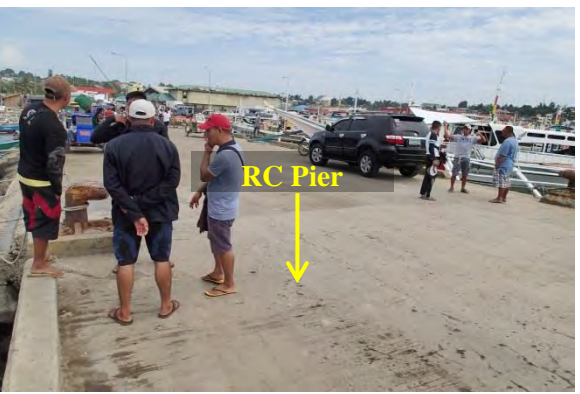
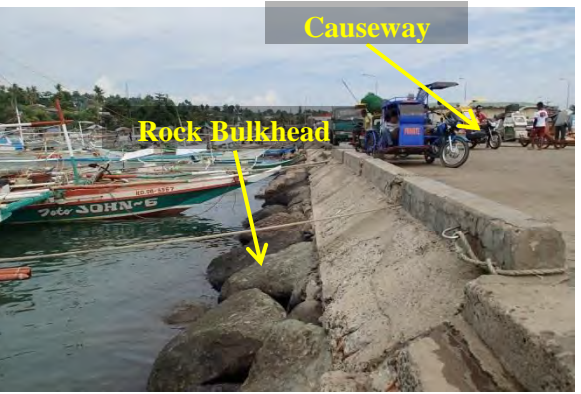
<p align="center">Figure No.1 Existing RC Pier</p>	<p align="center">Figure No.2 Left side of the Rock causeway facing on shore.</p>

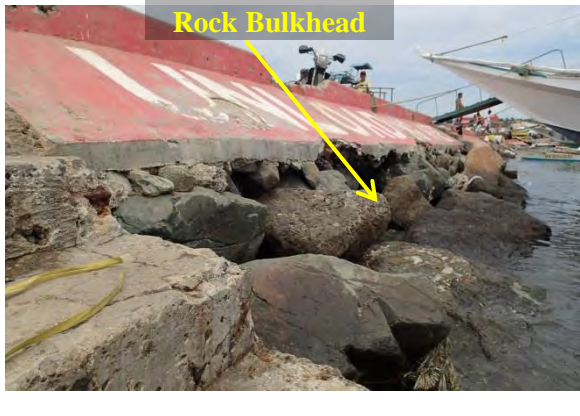
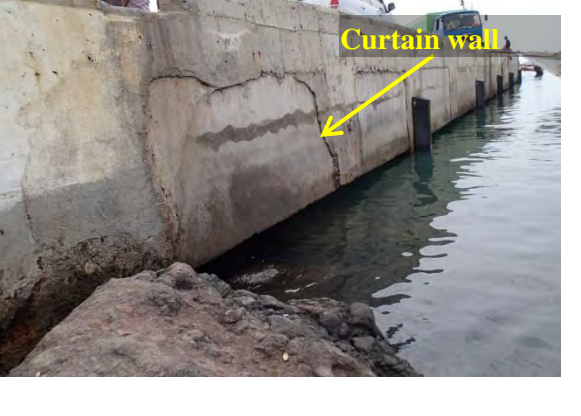
<p align="center">Figure No.3 Right side of the Rock causeway facing on shore.</p>	<p align="center">Figure No.4 Right side of the Pier facing offshore.</p>

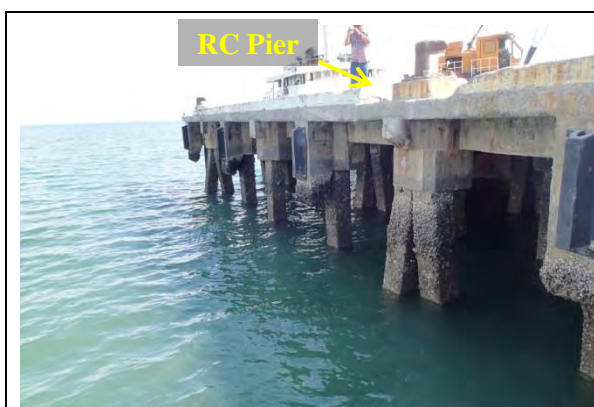
Figure No.2
Left Side of the RC pier.

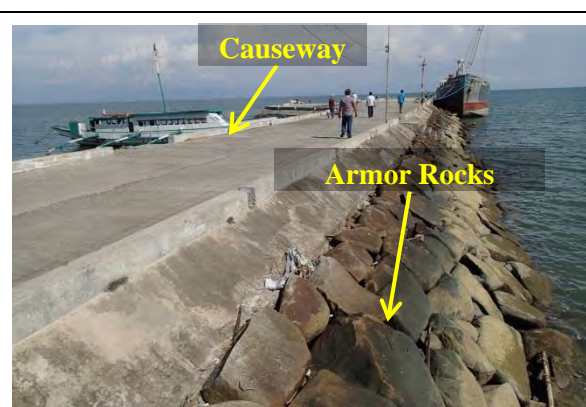
Figure No.3
Right side of the Rock Causeway.

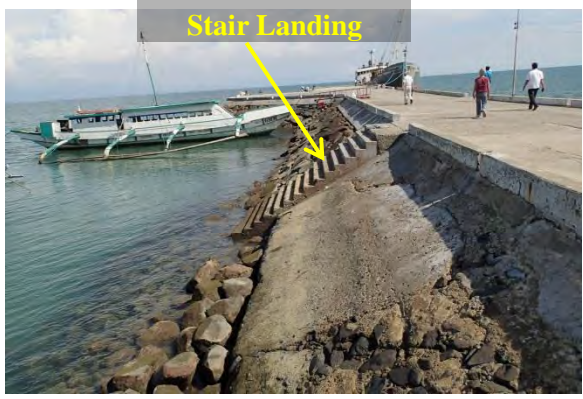
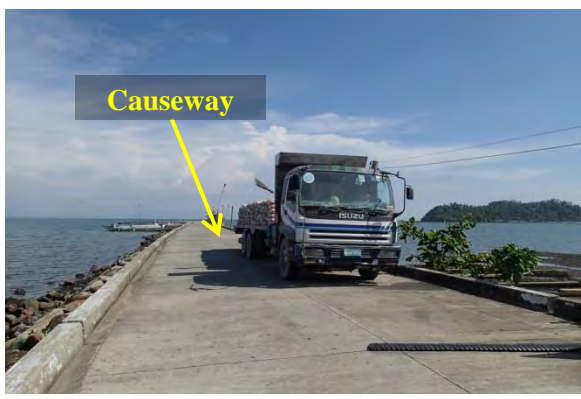
<p style="text-align: center;">Figure No.4 Left side of the Rock Causeway.</p>	<p style="text-align: center;">Figure No.5 Concrete pavement shows in good condition.</p>

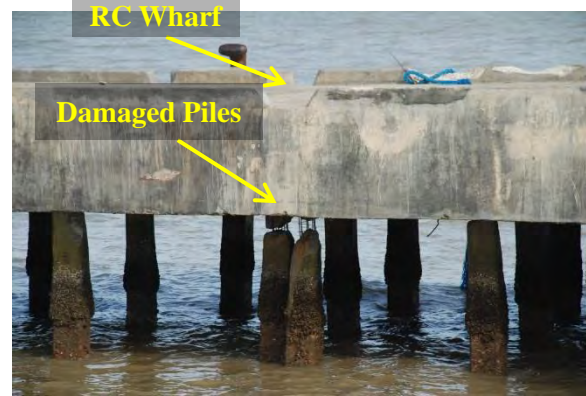
Figure No.3
Damaged RC Piles under RC Wharf.

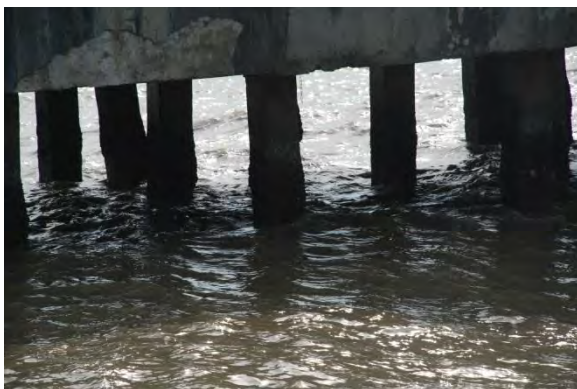
Figure No.6
Condition of RC Piles foundation of RC Trestle.
