3.2. Bohol Province

3.2.1. Tagbilaran

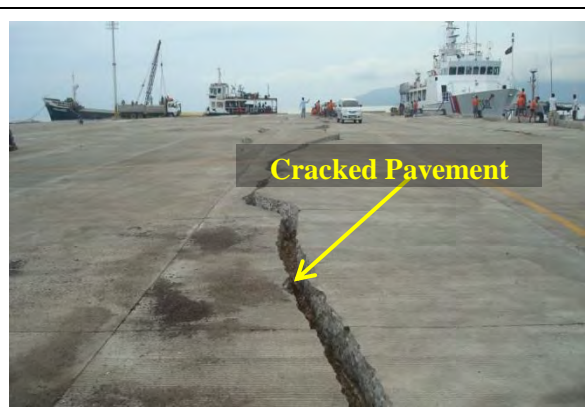
Figure No.2
Concrete Pavement at Open storage area settled after the OCT 2013, 7.2 magnitude EQ.

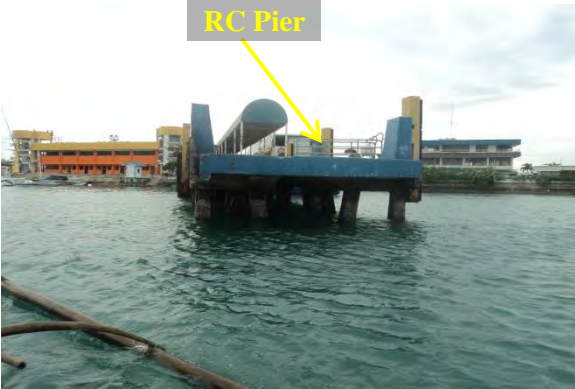
Figure No.3
Damaged after OCT 2013, 7.2 magnitude EQ.

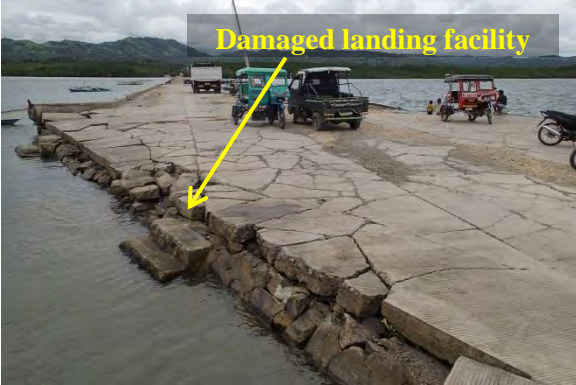
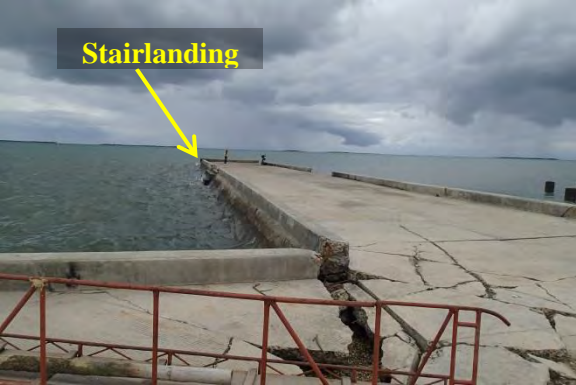
<p align="center">Figure No.6 The causeway concrete pavement shown in the above Figure is under water during high tide.</p>	<p align="center">Figure No.7 Damaged by October 2013 Earthquake.</p>

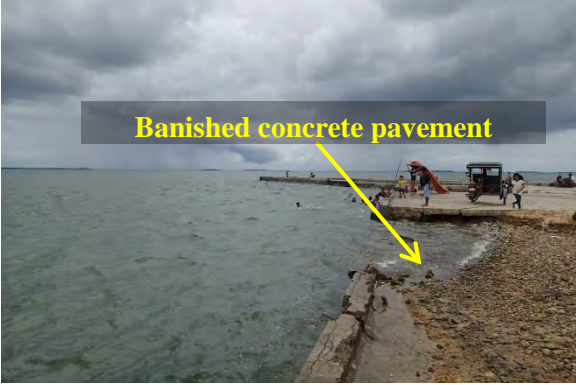
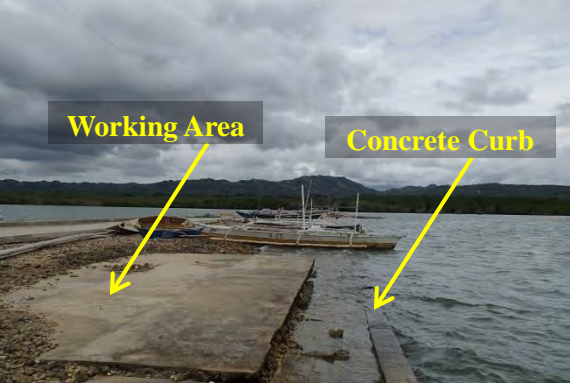
<p align="center">Figure No.8 Damaged concrete pavement at the landing facility.</p>	<p align="center">Figure No.9 Damaged by October 2013 Earthquake.</p>

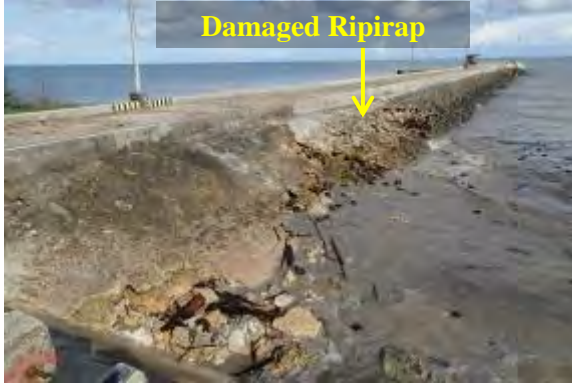
Figure No. 3
Existing Causeway with grouted riprap bulkhead.

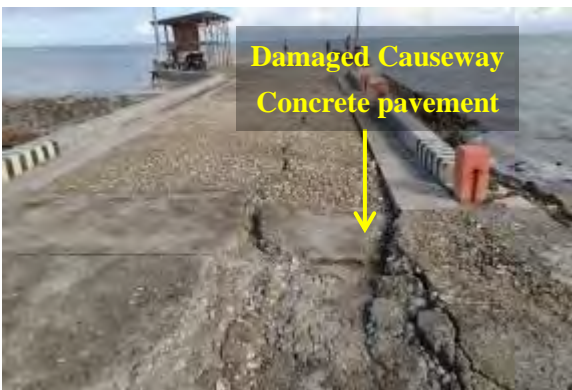
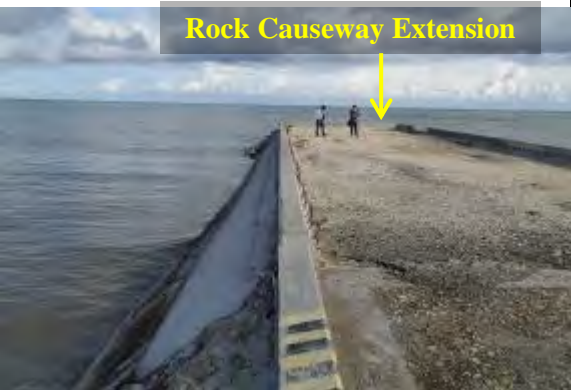
<p align="center">Figure No.4 Damaged grouted riprap at the Right side of the causeway.</p>	<p align="center">Figure No. 5 Gap between concrete pavement and curb, due to lateral movement of the structure.</p>

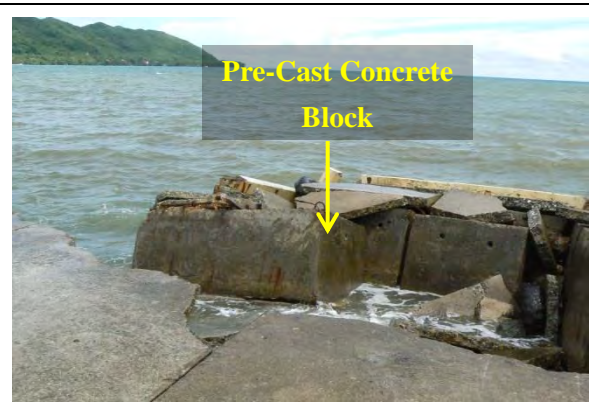
Figure No.4
Collapsed portion of the Causeway due wave action.

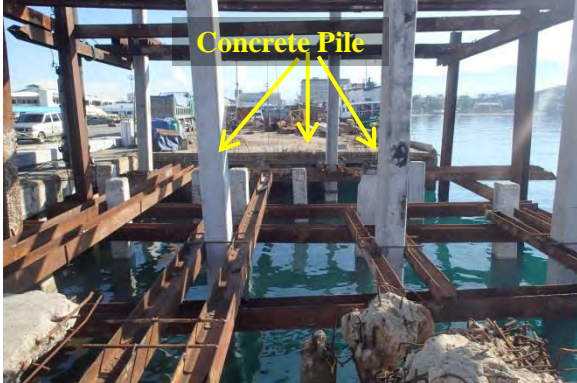
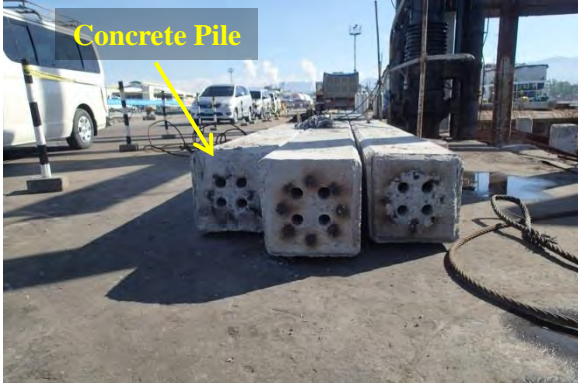
Figure No.8

Photo shows the existing RC Pier.
