**The Project  
for  
Rehabilitation of Yangon Port  
and  
Main Inland Water Transport  
in  
The Republic of The Union of Myanmar  
(Follow-Up)

Final Report**

February 2016

Nippon Koei Co., Ltd. (NK)

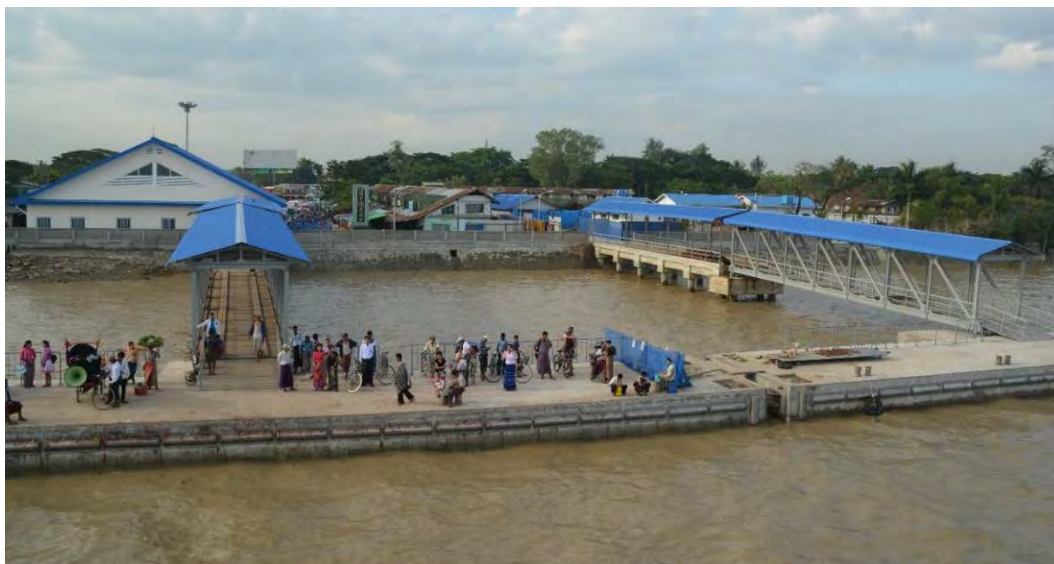
**Photo 2.2 Two Pontoons**

Some bolt connections of fenders and pontoons became loose. About 5 cm of water was found inside the pontoon because rain water had leaked through the manhole hatch covers.

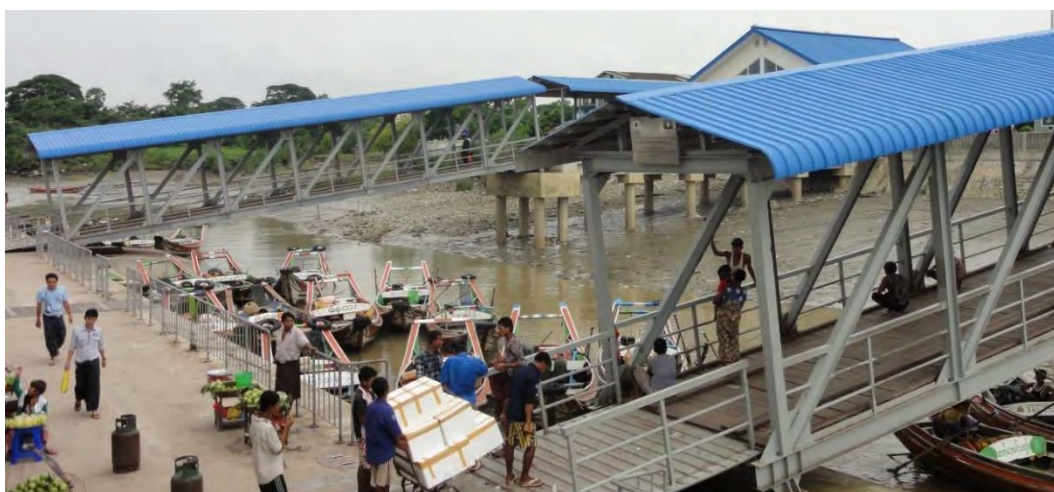
**Photo 2.3 Steel Bridges (East and West)**

The steel bridge structure, roof truss, and roofing of both bridges are in good condition. Some portions of the longitudinal beam floor had been rusty. Some timber planks of the timber floor had become loose.

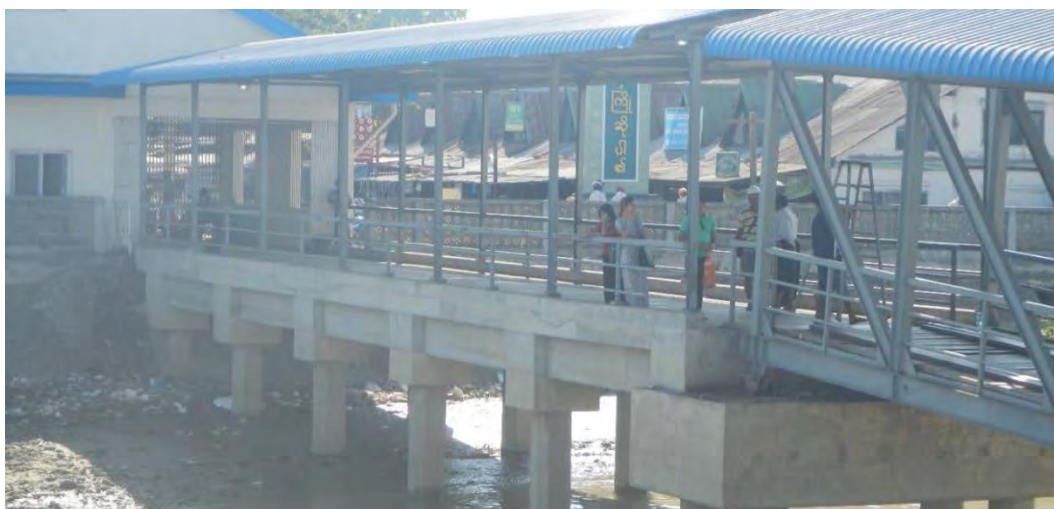
**Photo 2.4 East Porter Way**

The structure, roofing, and roof truss of both porter ways are in good condition. No serious defects or damages occurred after the completion of construction. Paint on the handrail had slightly faded because it was exposed to public use.

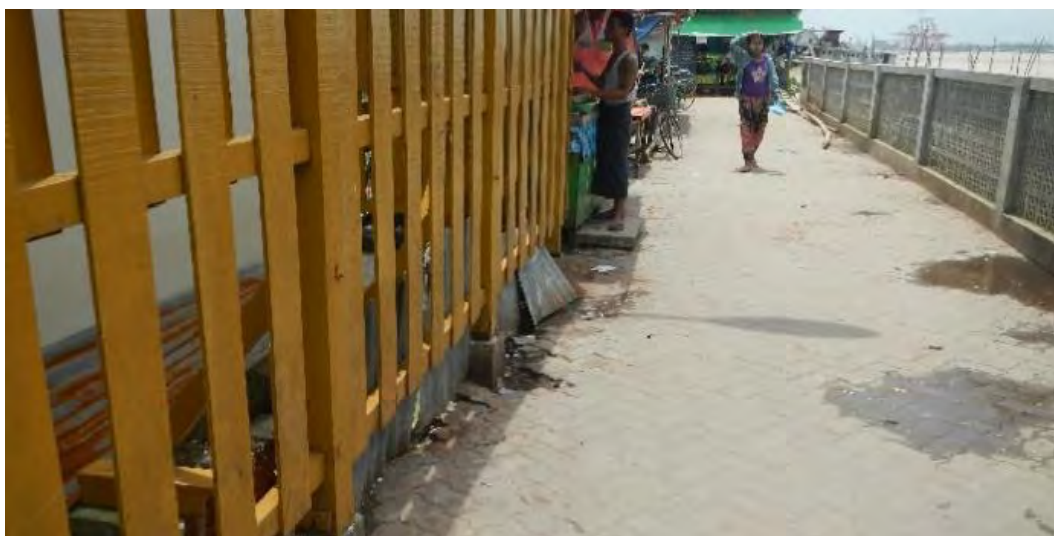
**Photo 2.5 Walkway**

The interlocking concrete block (ICB) walkway is in good condition. Concrete pavement beside the passenger terminal building is in good condition. Some ICB had sunk down at some places.

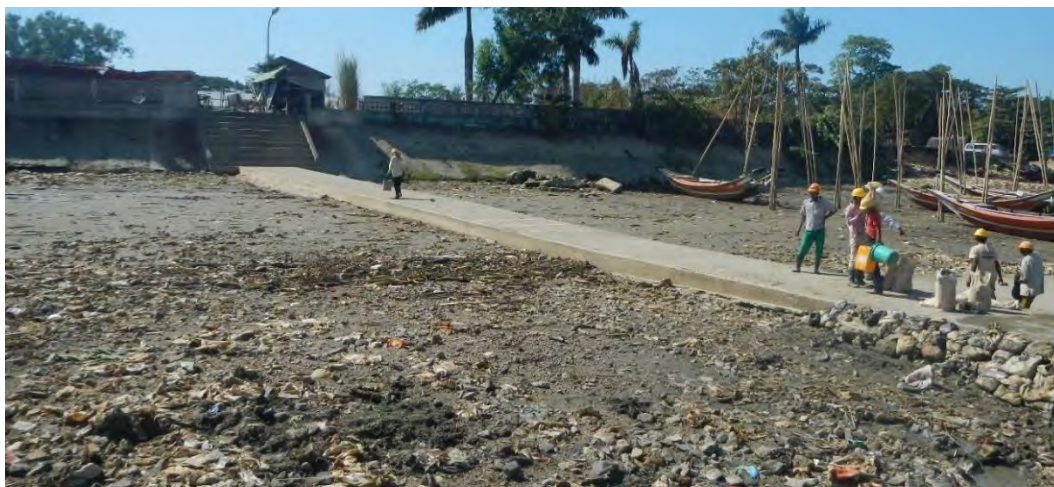
**Photo 2.6 Slipway**

The concrete structure of the slipway is in good condition. Small damages occurred along the edge of the slipway because of the berthing of small boats. Rubble stones for slope protection had been

washed away by tide and river flow at some places.

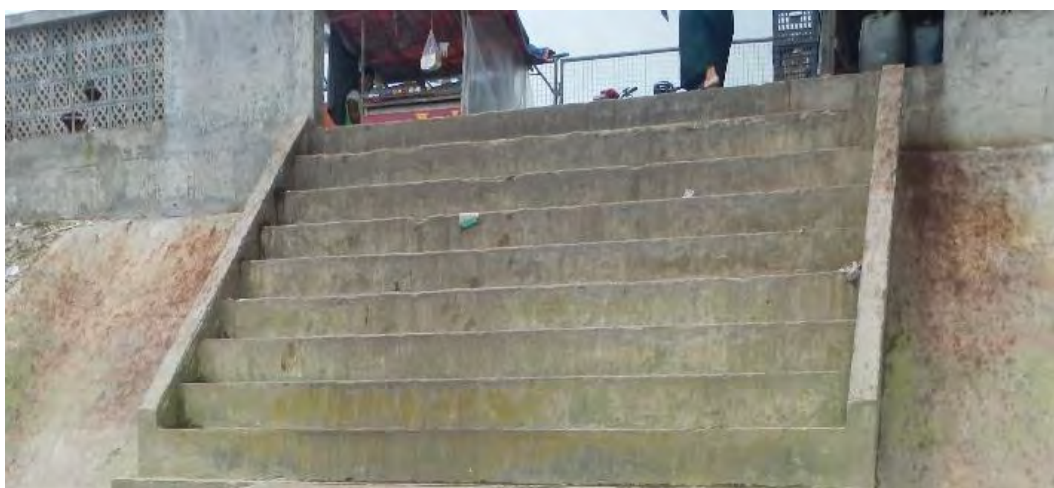
**Photo 2.7 Staircase at Slipway**

And the staircase at the slipway is in good condition. Passenger can pass through conveniently. Some nosing edge had been damaged because of the berthing of small boats during high tide. Also, some plaster damages had occurred at some thread surface and side wall.

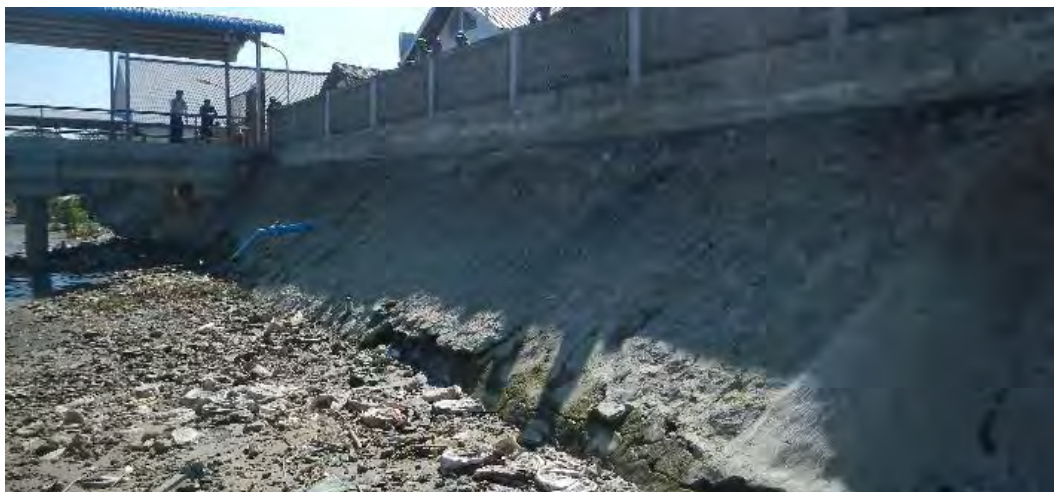
**Photo 2.8 Revetment**

The revetment has firmly protected the slope of the riverbank. Some rubble stones had been taken away at the toe in some places. Small cracks have occurred in some places.

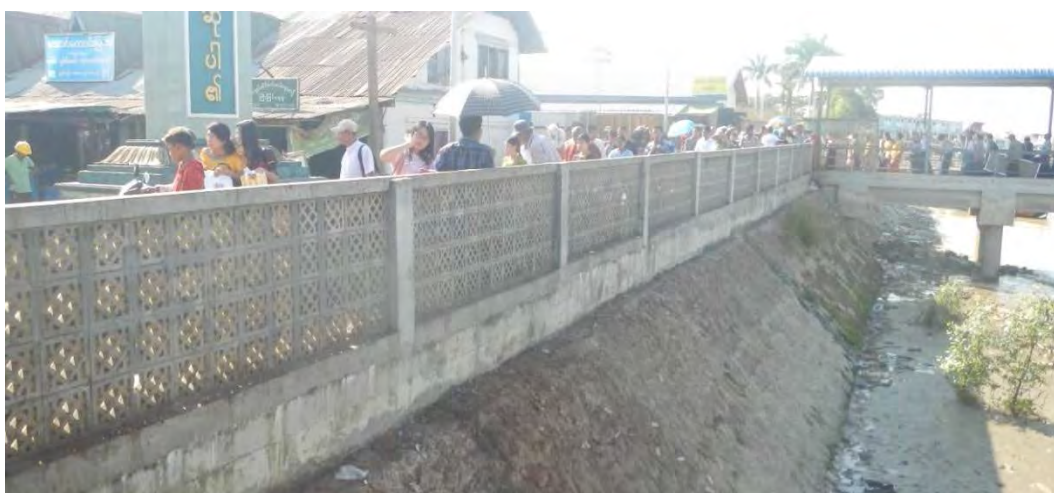
**Photo 2.9 Fence**

The fence structure is in good condition. Some concrete blocks had been damaged that were probably hit by motorbikes or trishaws. Cracks had occurred at connection joints between the concrete column and the brick capping on the top of the concrete blocks.

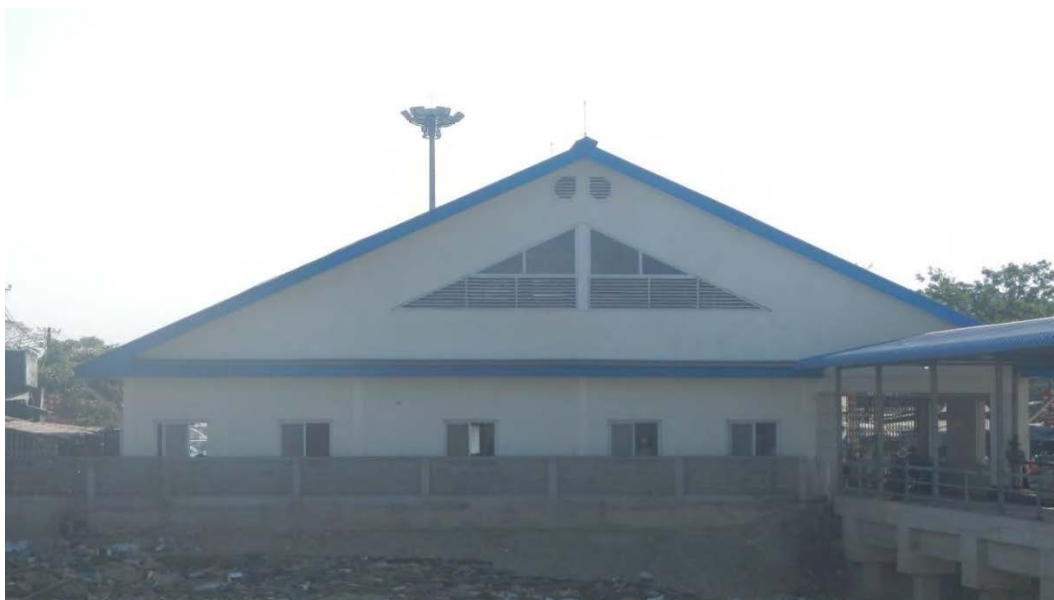
**Photo 2.10 Passenger Terminal Building**

The benches, diorama, revolving gate, and service counter are in good condition. Some handrail posts at the side of the portico (entrance porch) were broken due to the misuse by the passengers.

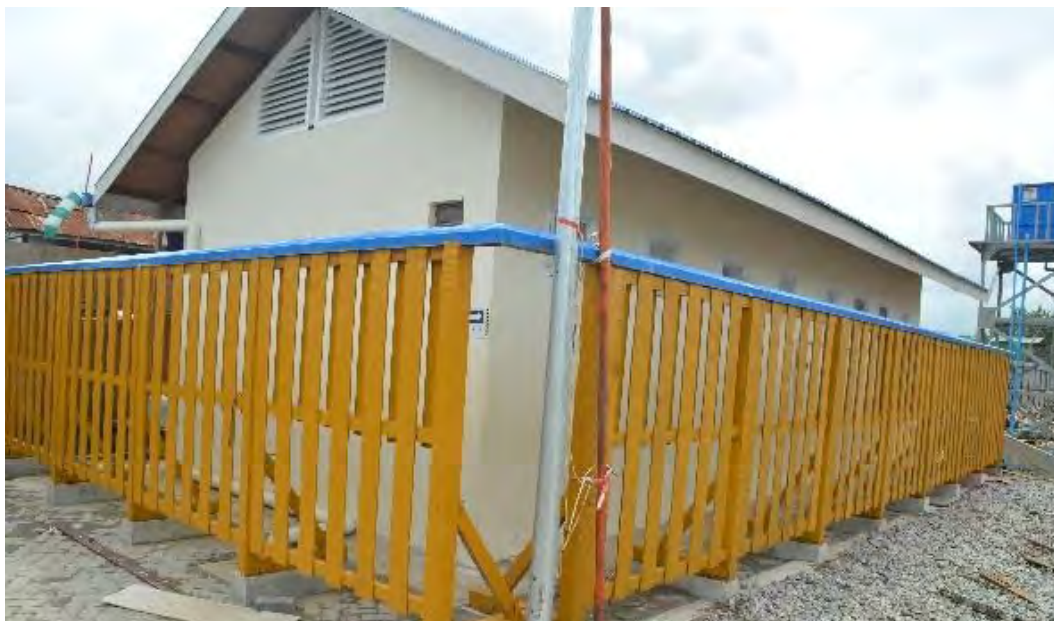
**Photo 2.11 Toilet (Male and Female)**

Toilet cubicles, urinal bowls, sinks, mirrors, and other toilet accessories are almost in good condition. One water tap in the male toilet and one tap in the female toilet have stopped operation.

The compressor pump for pumping water from the tube well to the ground tank is in a good working condition. Whereas, the pump for raising water from the ground tank to the elevated tank is not working.

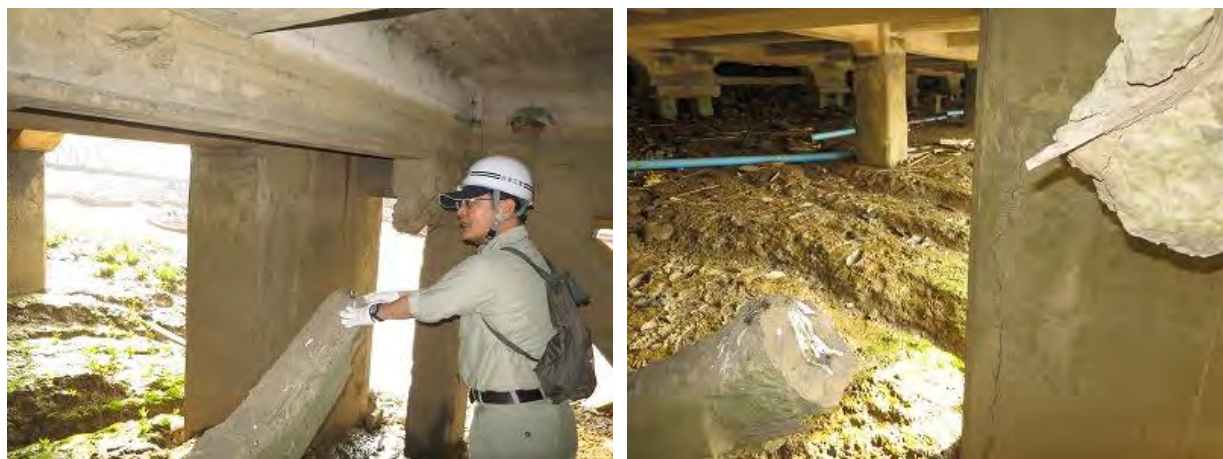
One of the slanted beams of Nan Thi Da 3 that was previously repaired was defective. The Expert suggested that this defect would be repaired as soon as possible.

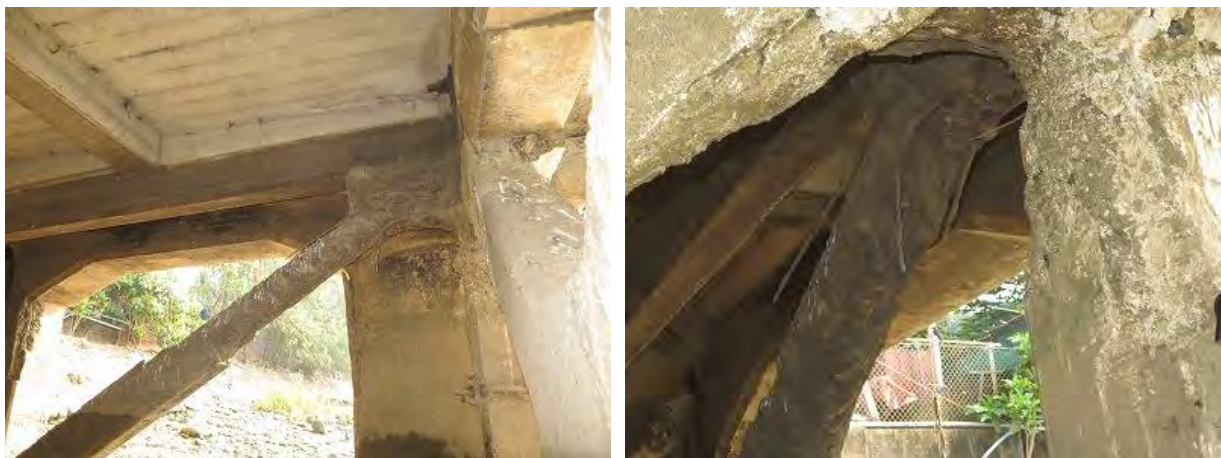
One part of Nan Thi Da 4 that was previously repaired has defective concrete cover and rebar. The Expert suggested that this defect would be repaired as soon as possible.

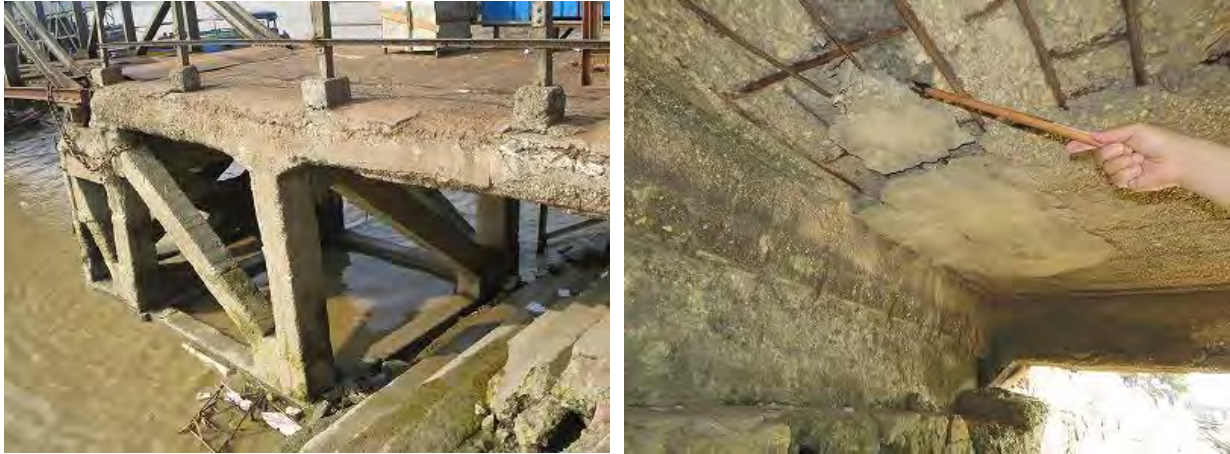
A part of Sin Oh Dang 1 and its condition during the survey are shown in Photo 3.5. The concrete cover of the underside of the repaired part was peeled off and the rebar was corroded.

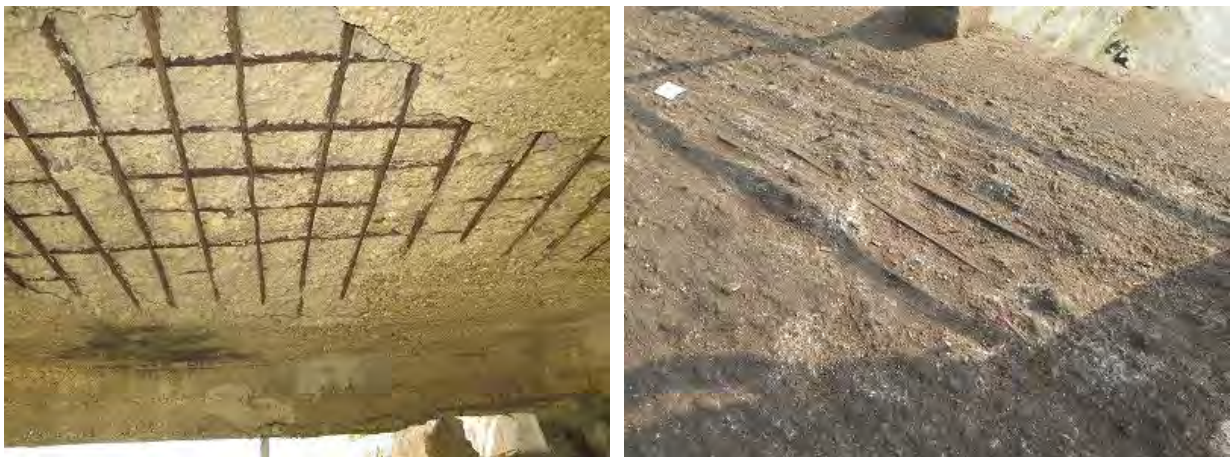
Other parts that were not repaired have peeled-off concrete cover and rebar corrosion. The underside has tensile stress so the Expert suggested that this part would be repaired as soon as possible. On the porter way, there are some exposed rebars. These rebars may not cause a structural problem but these are obstacles for carriage on the porter way. The Expert suggested that this part would be repaired soon.

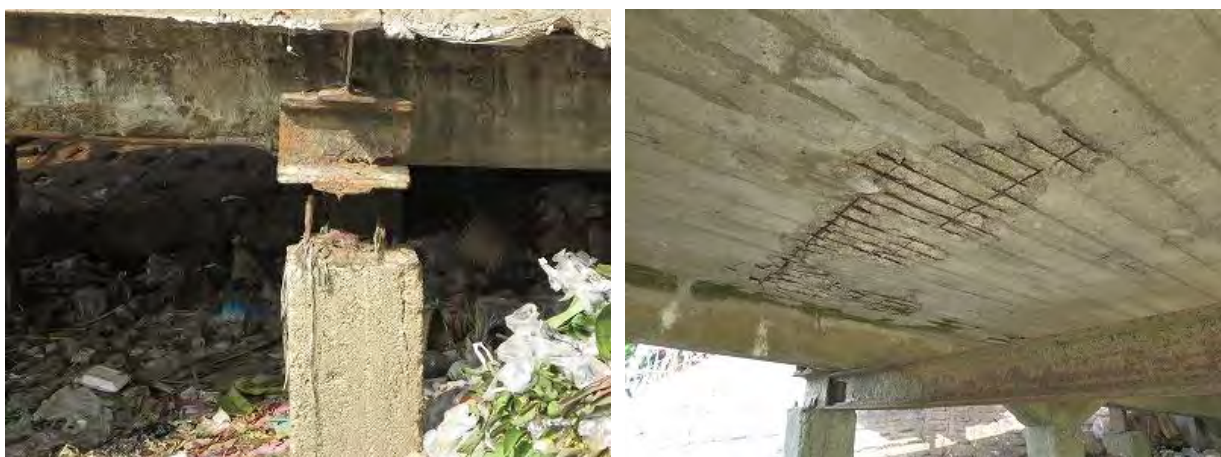
There was a defective part on the support of the porter way. There were peeled-off concrete cover and rebar exposure. The Expert suggested that these parts would be repaired as soon as possible.

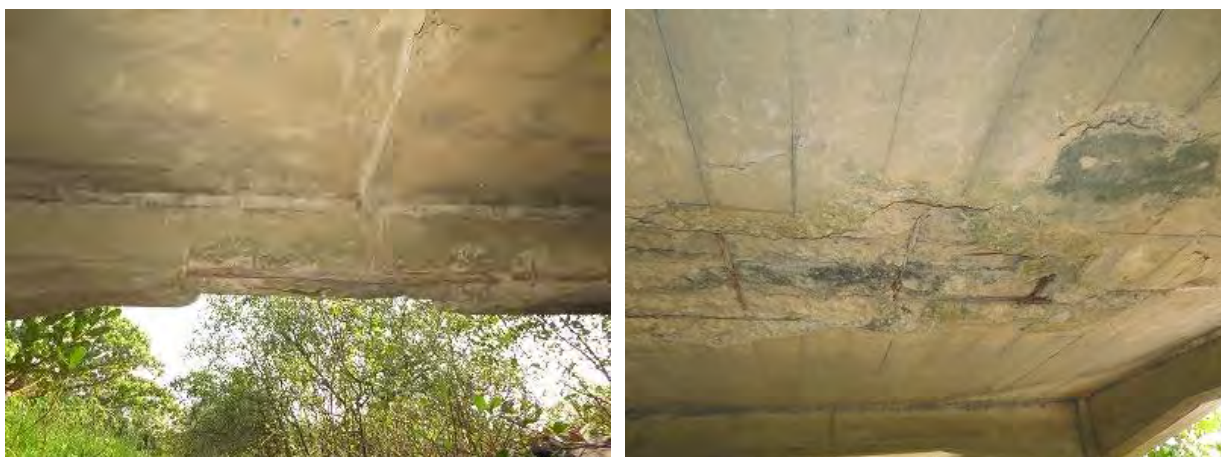
There was a defective part at the underside of Hledan 2. There were peeled-off concrete cover and rebar exposure. The Expert suggested that these parts would be repaired as soon as possible.

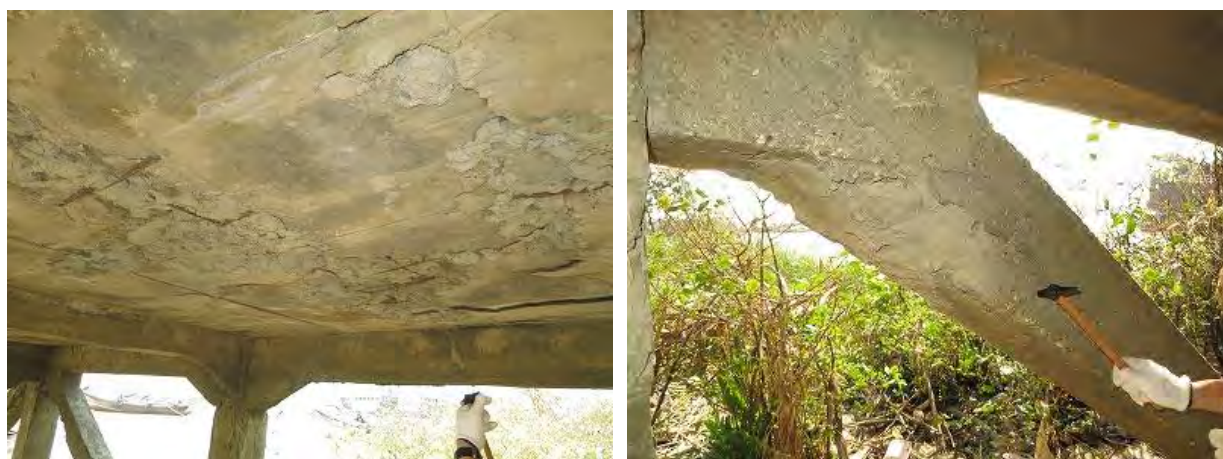
There were some repaired parts at the underside of Kaingdon Jetty 1. The refilled mortar in the repaired parts was damaged. These parts were just refilled with new mortar. There was no chipping off of deteriorated concrete and no anti-rust painting on the rebar.

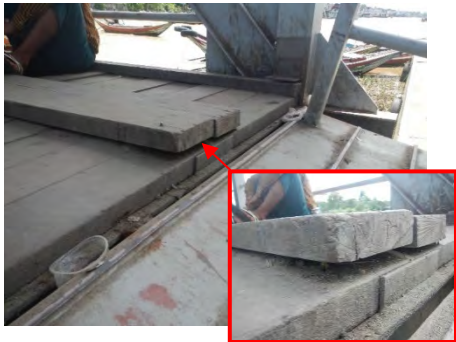
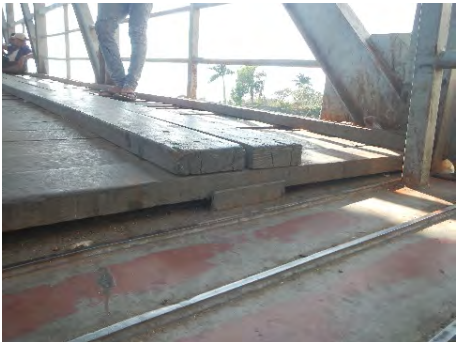
Timber floor connection is loosed and mounted.

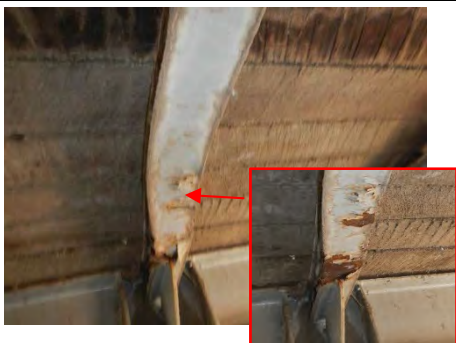
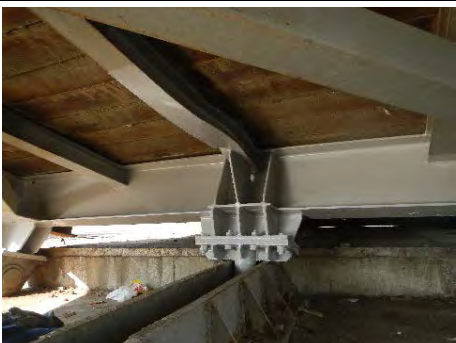
Rust and Paint is defected.

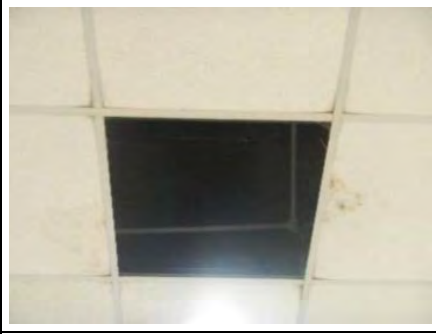
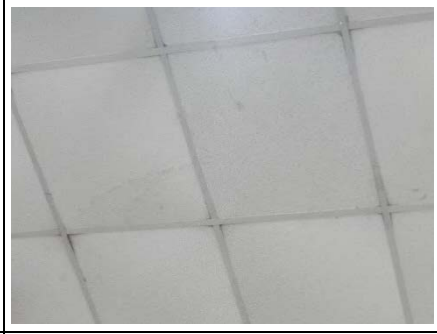
A photograph of the same ceiling area after repair, showing a new white ceiling tile in place.	4 numbers of ceiling are defected.

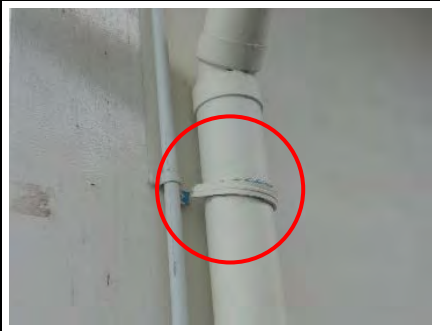
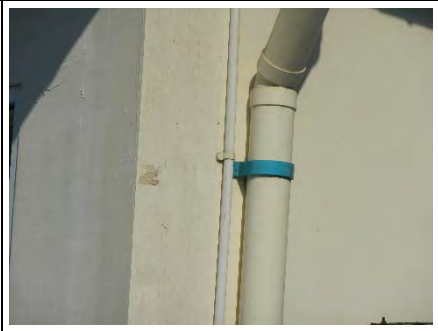
Downpipe brackets are damaged.

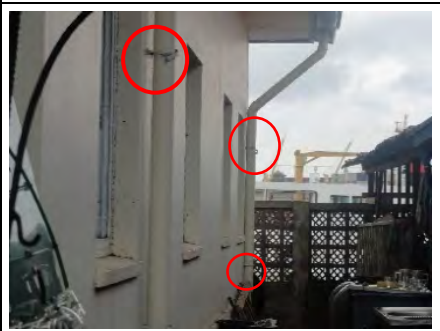
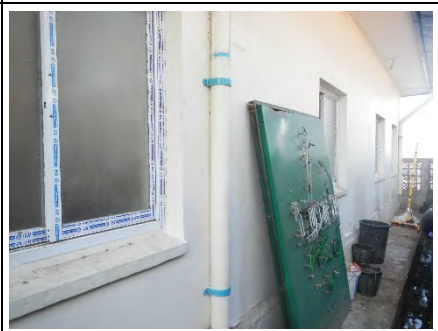
Downpipe brackets are damaged.

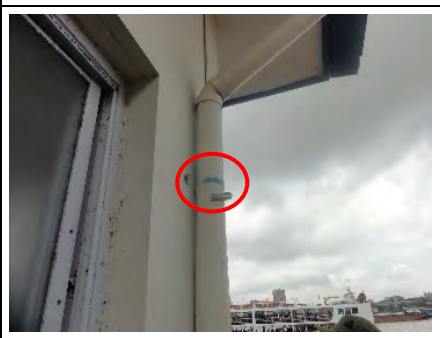
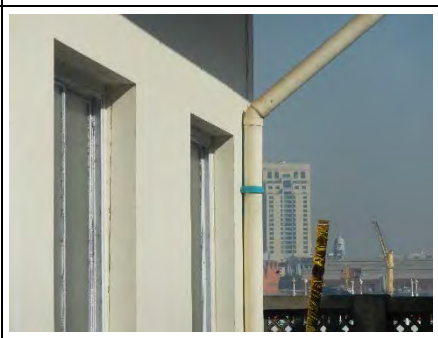
Downpipe brackets are damaged.
