**DATA COLLECTION SURVEY REPORT
FOR
IMPROVEMENT OF NAVIGATION
CHANNEL OF YANGON PORT
IN THE REPUBLIC OF THE UNION OF
MYANMAR**

FINAL REPORT

**CURRENT SITUATION OF
RIVERBANK EROSION OF YANGON RIVER**

MARCH 2016

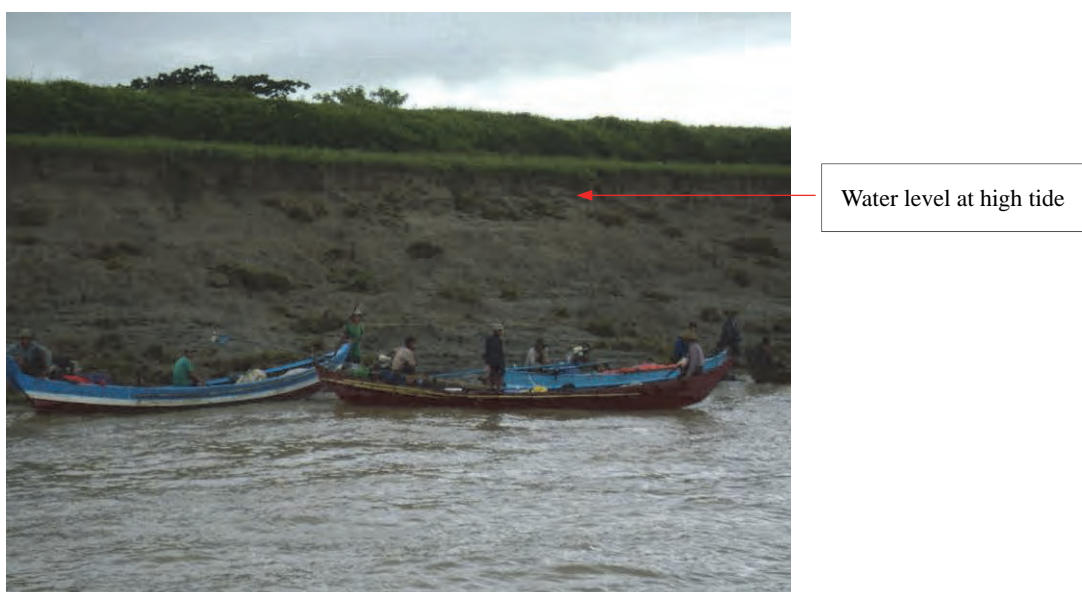
The long consecutive cliff continuing over 20 km can be seen on the right bank of the Yangon River from the Thilawa area to the river mouth. The following shows the general condition of it.

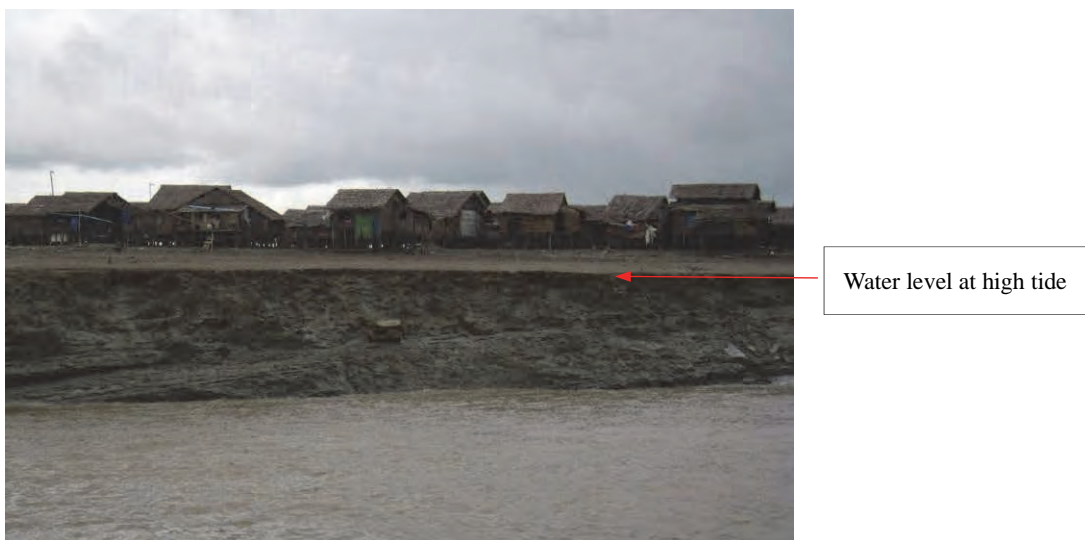
The next figure shows a part of the right bank near Thaung Gon village, located near Elephant Point. The figure of the cliff shows not a vertical but a gentle slope without steps. This picture was taken during lower tide and the water level at high tide would reach the level indicated by the red arrow, which is about 6 m higher than the water level shown in the following picture.

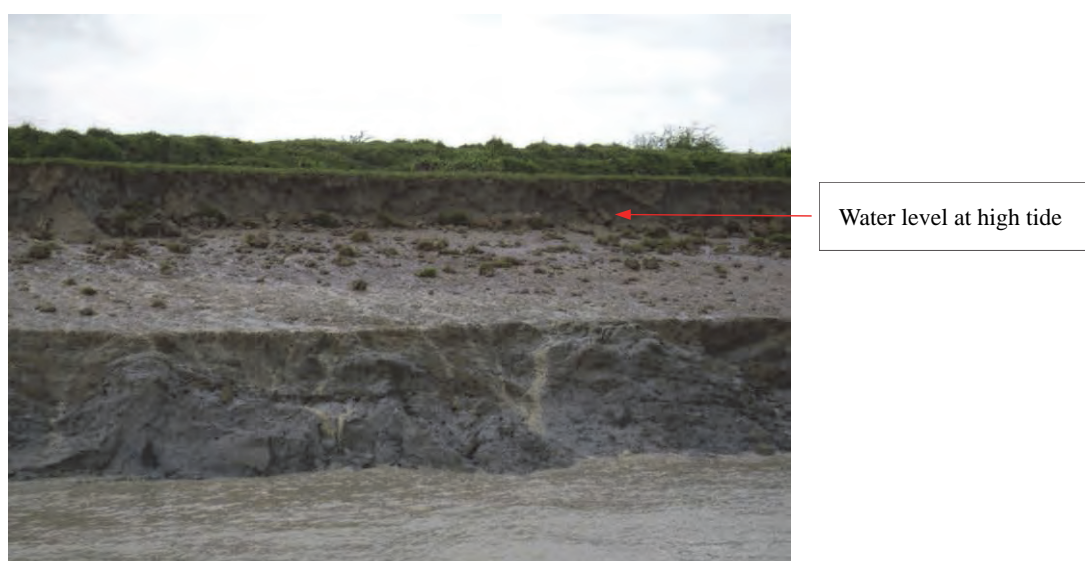
The next figure shows a cliff with one step, which can be seen near Elephant Point. A sea wall (About 1 m height x 1 m width, rubble stone mound) constructed by the municipal government can be seen on top of the cliff. Water level at high tide would be around the level indicated by the red arrow.

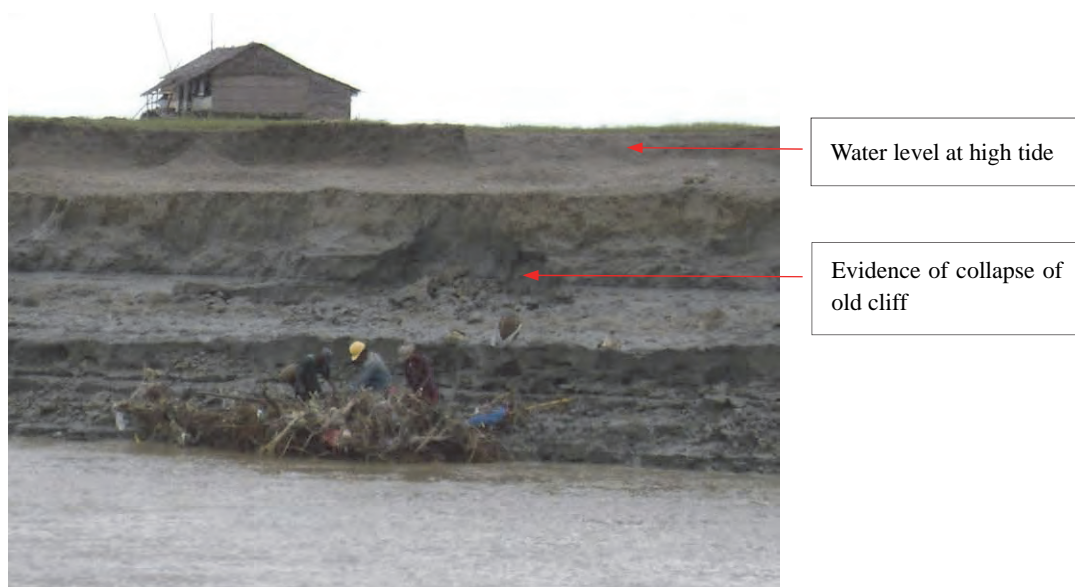
The next figure shows a cliff with 2 steps, which can be seen at a part of the right bank near Elephant Point. Evidence of the cliff collapse is shown in the centre of the picture. The water level at high tide would be at the level indicated by the red arrow.

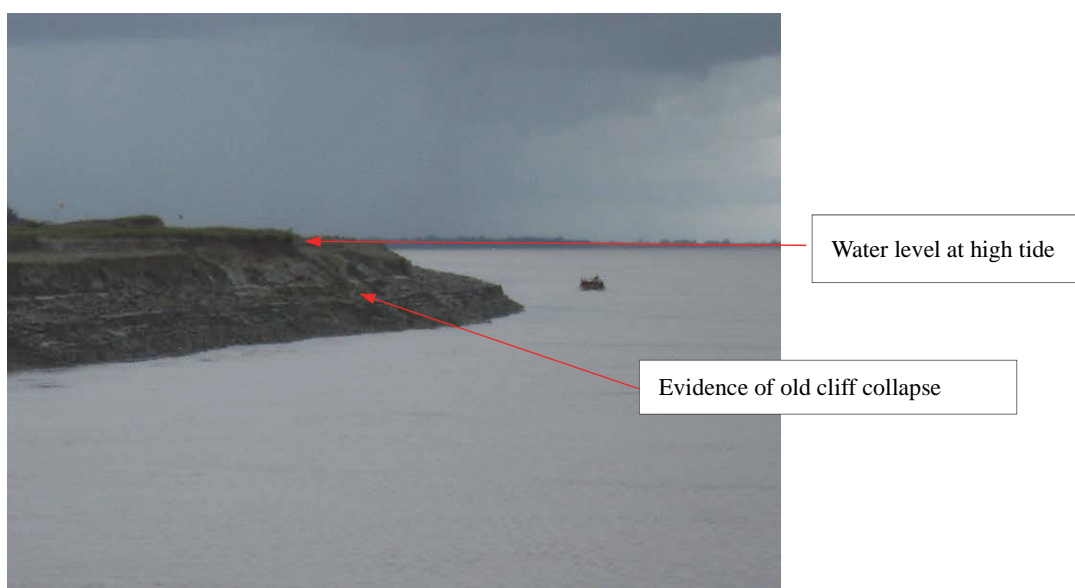
Figure 3-7: Western Side of the River Mouth (With 2 Steps)

The next figure shows a cliff with 2 steps, which can be seen at the river mouth along the right bank. The picture was taken with a distant view. Near the centre, evidence of a relatively large-scale cliff collapse can be found.

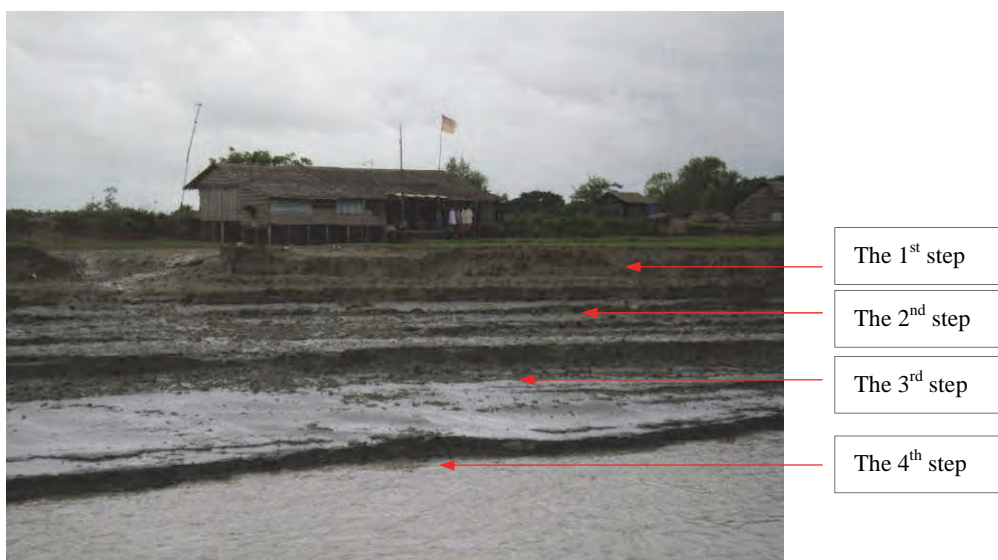
The above figure shows many steps in a cliff, which can be seen downstream of Elephant Point. There are more small steps between the 2nd and the 3rd steps.

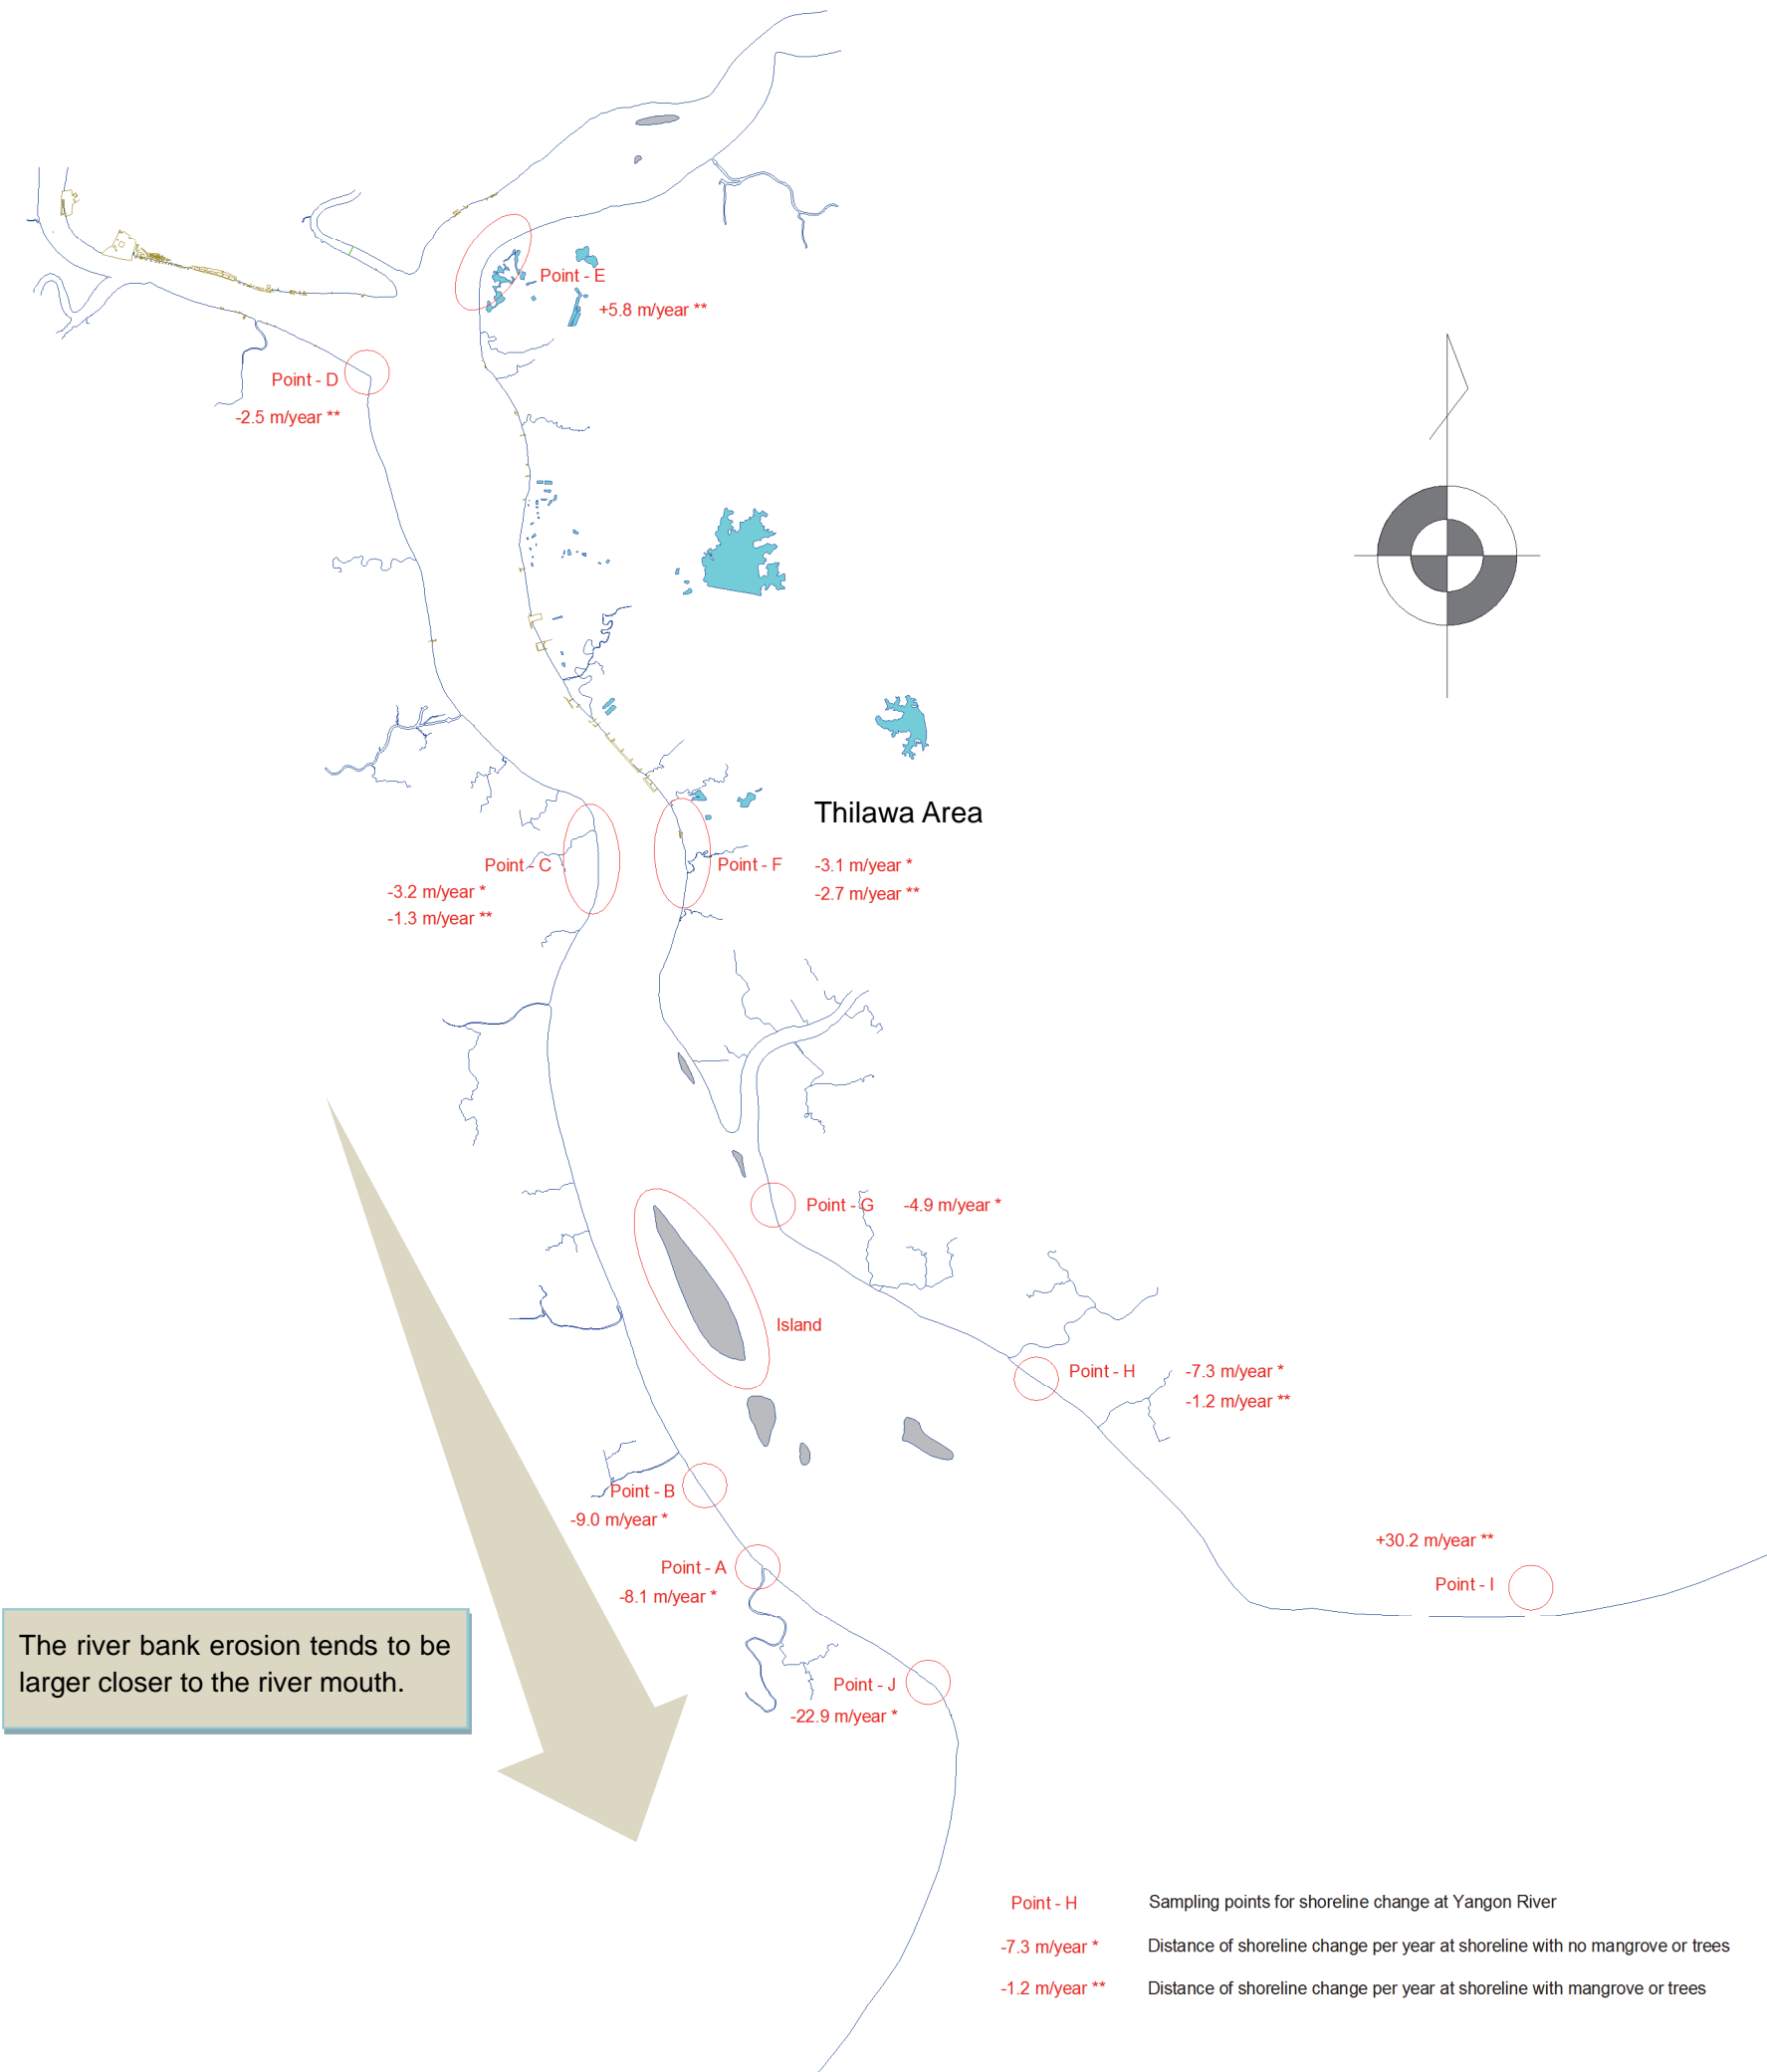
The following drawing shows the result of the image analysis on the secular change of the Yangon Riverbank.

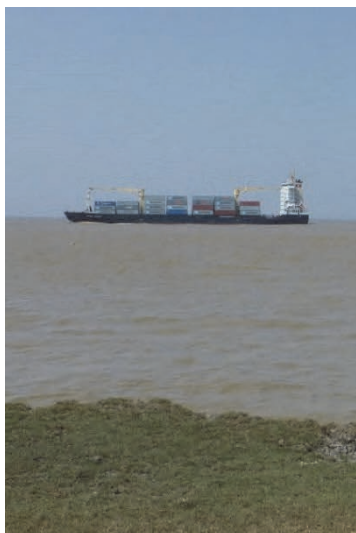
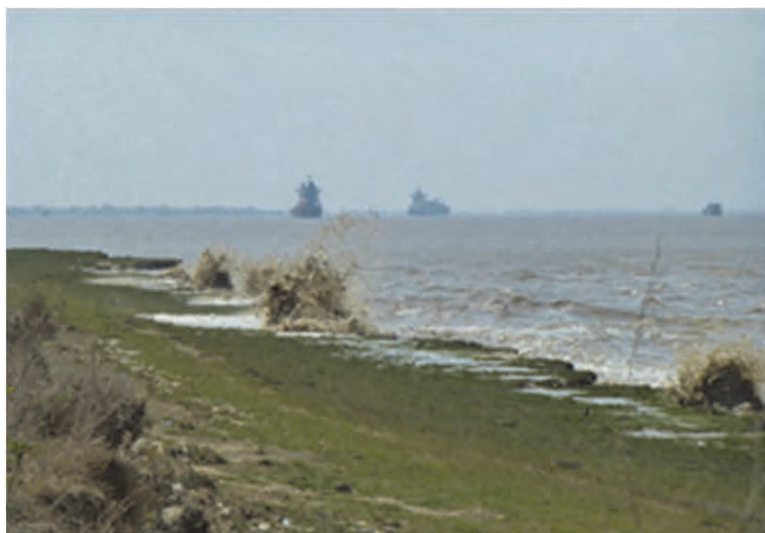
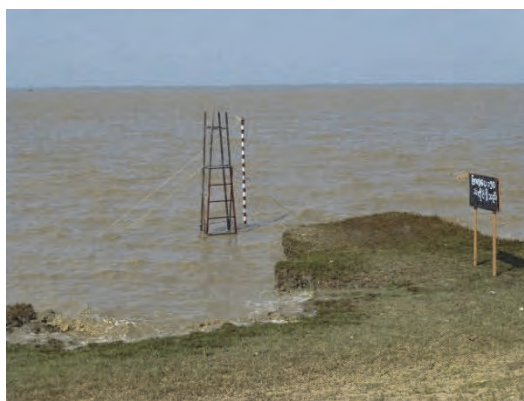
Figure 5-8: Influence of Ship Waves Observed on the Right Bank near the River Mouth

① Objective Cargo Ship

② Ship Waves reached the riverbank (splash height: about 1.5 m)

③ Normal condition without ship waves (1 hour after the ship passed)

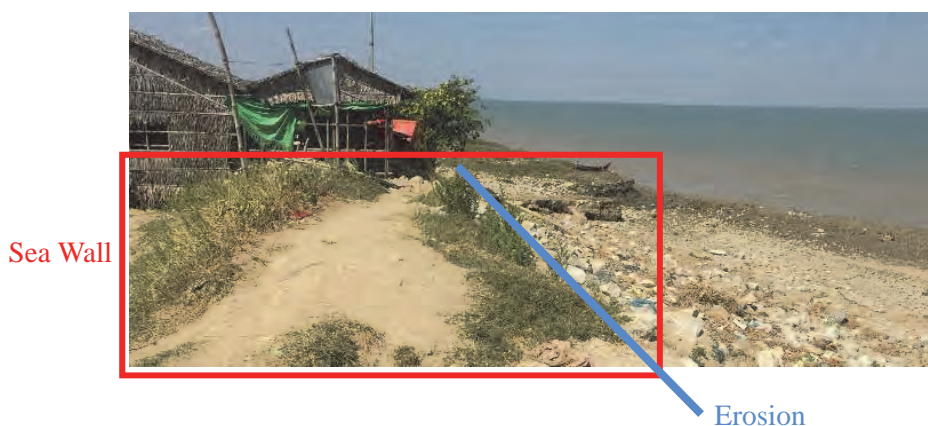
The Municipal government constructs rubble-stoned sea wall along the riverbank. The dimension is 1 m height x 1 m width, and the main purpose of the wall is a countermeasure to storm surges caused by cyclones. The sea wall has to be remade every 6 months or 1 year due to the backdown of riverbank caused by erosion, according to the local people.

Note: Riverbank erosion comes just by the sea wall
Source: JICA Study Team

Normally, armor-stoned or concrete-blocked protection is a preferable countermeasure to stop further riverbank erosion. Also, the protection could contribute to the protection of hinterlands and villages. The Yangon River has very hard natural condition as mentioned, and the area requiring urgent protection is quite long, about 20 km on the right bank only. Considering the difficult conditions and the long work range, the policymaking of the countermeasure work should be carefully examined. If a cheap structure was procured, it would be need frequent updating with a short lifecycle. On the other hand, if a more expensive structure was procured, the initial construction cost would be quite huge and at the same time, it would bring a certain volume of environmental impact.

In the case that concrete blocks or armor stones were placed at the riverbank, spiral flow would make a force of riverbed scour. The Yangon River is a big river and the force would be quite strong so a strong foundation should be placed under the cooping structure In the case that a

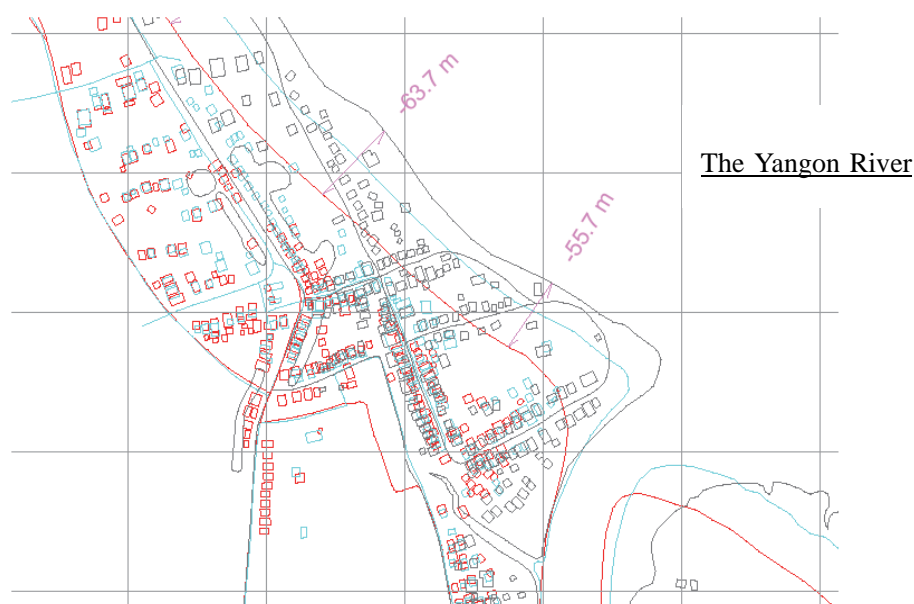
Attachment Figure 2-1: Secular Change at Point A (Section 2~3)

Point A indicates a part of the village located a little upstream of Elephant Point. Three satellite images—from March 23, 2006, February 10, 2010, and February 3, 2014—were selected from Google Earth. The centre road alignment did not change during the period but it was confirmed that many houses shifted farther to the land side due to the recession of the riverbank line.

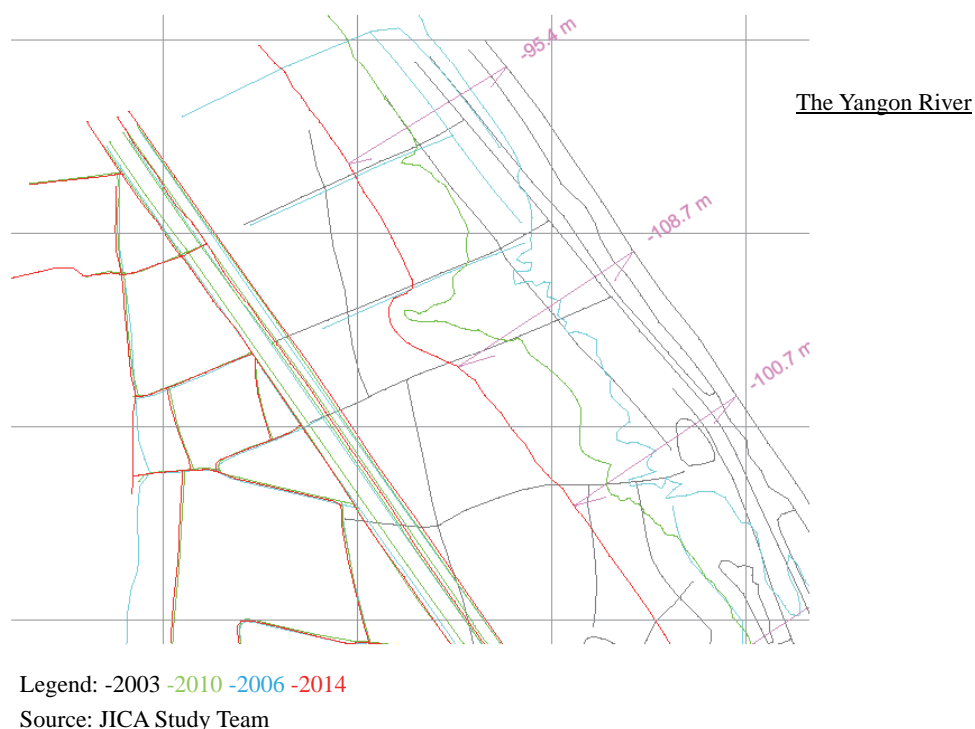
Attachment Figure 2-2: Secular Change at Point B (Section 1~3)

Point B is a little on the upper side of Point A and 4 satellite images—on November 25, 2003, as of March 23, 2006, February 10, 2010 and December 31, 2014—were selected from Google Earth. The line of the cliff top edge, roads, and boundaries of the agricultural area and so on were traced from these images.

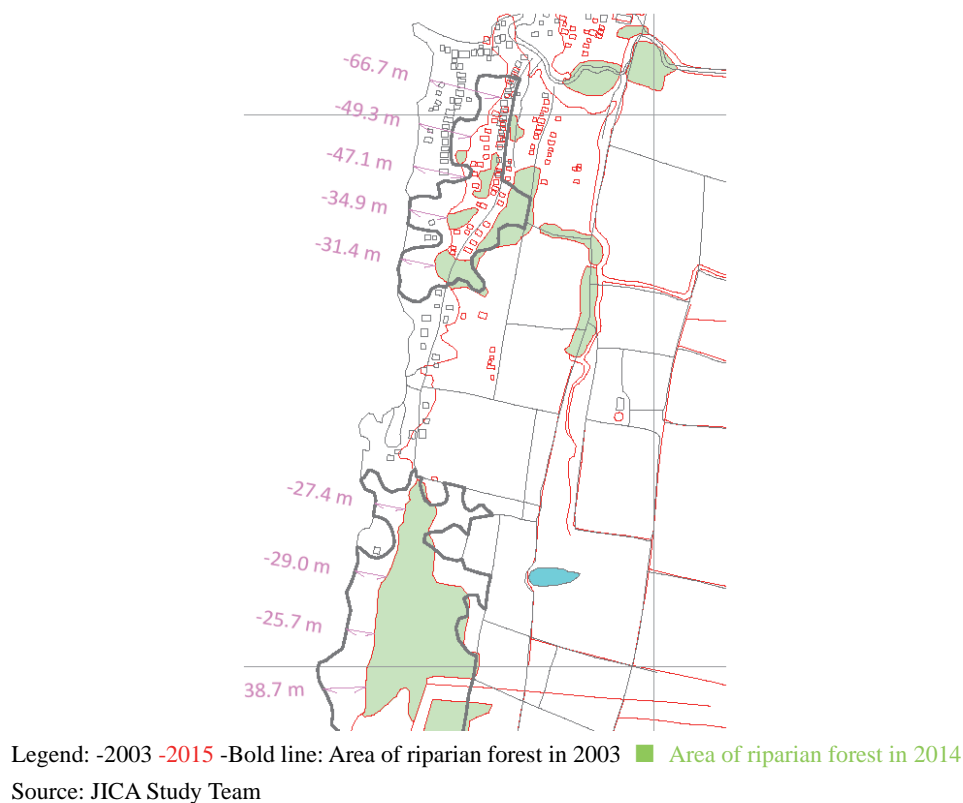
Attachment Figure 2-6: Secular Change at Point F (Section 1~9)

Point F is located a little to the lower side of the Thilawa Area. Two images, from November 25, 2003 and March 9, 2015, were selected from Google Earth. The line of the cliff top edge, roads, houses, a pond, riparian forest area and boundaries of agricultural areas were traced.

As per the results of the above calculations, all types are in erosional trend. In the case that both have forest, the amount is 2.7 m/year on average. In the case that both have no forest, the amount is 3.1 m/year on average. In the case that the forest was lost, the amount is 2.9 m/year on average and no big difference could be found among the 3 types.

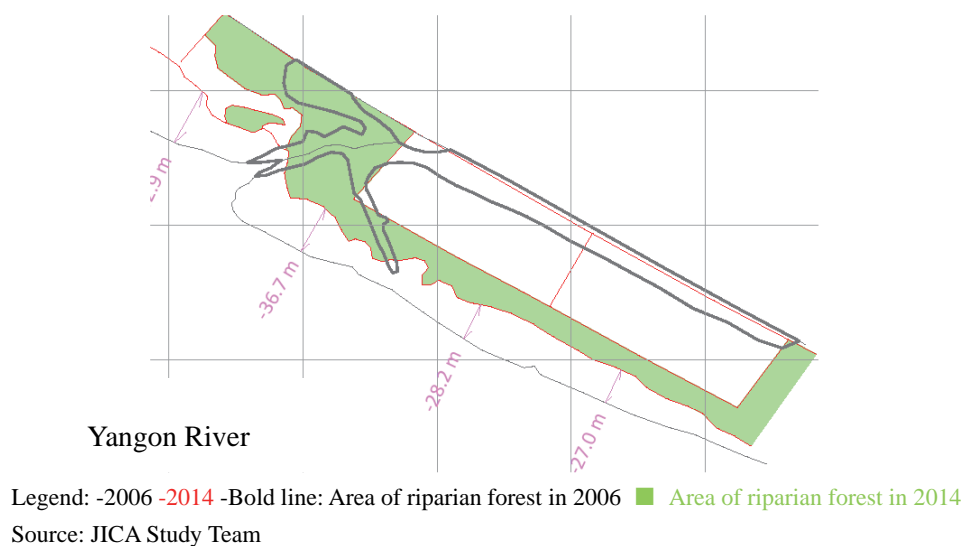
Attachment Figure 2-7: Secular Change at Point G (Section 12~15)

Some parts of this area had riparian forest from 2006 to 2014 but a part was found in 2014 to have been recently forested, although it had no forest in 2006. So the following calculations were conducted in each trend of the forest, respectively, same as for Point F.

As per the results of the above calculations, basically all areas are in an erosional trend. In the case that both images have riparian forest, the amount is 4.1 m/year on average. In the case that the forest was newly found in 2014, the amount is 4.9 m/year on average.
