THE PREPARATORY SURVEY
ON
THE PROJECT FOR RECONSTRUCTION ON
NIPPON CAUSEWAY ON TARAWA
TO ADAPT CLIMATE CHANGE
IN
REPUBLIC OF KIRIBATI

FINAL REPORT

JAPAN INTERNATIONAL COOPERATION AGENCY

CTI ENGINEERING INTERNATIONAL CO., LTD.
IDES INC.

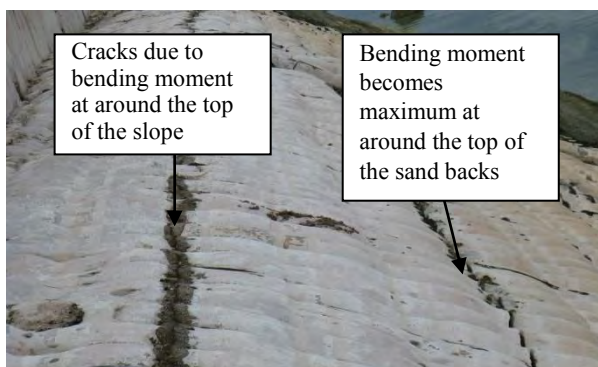
Photo 2.2.1-1 Typical Crack due to Bending Moment

The first cracks including bending and shear cracks occurred due to the softness and/or small voids of the sand embankment. This phenomenon is commonly observed along the entire causeway not related to locations. This means that differences of damage scales actually observed along the revetment are to be largely dependent on those of the external forces acting on the revetment.

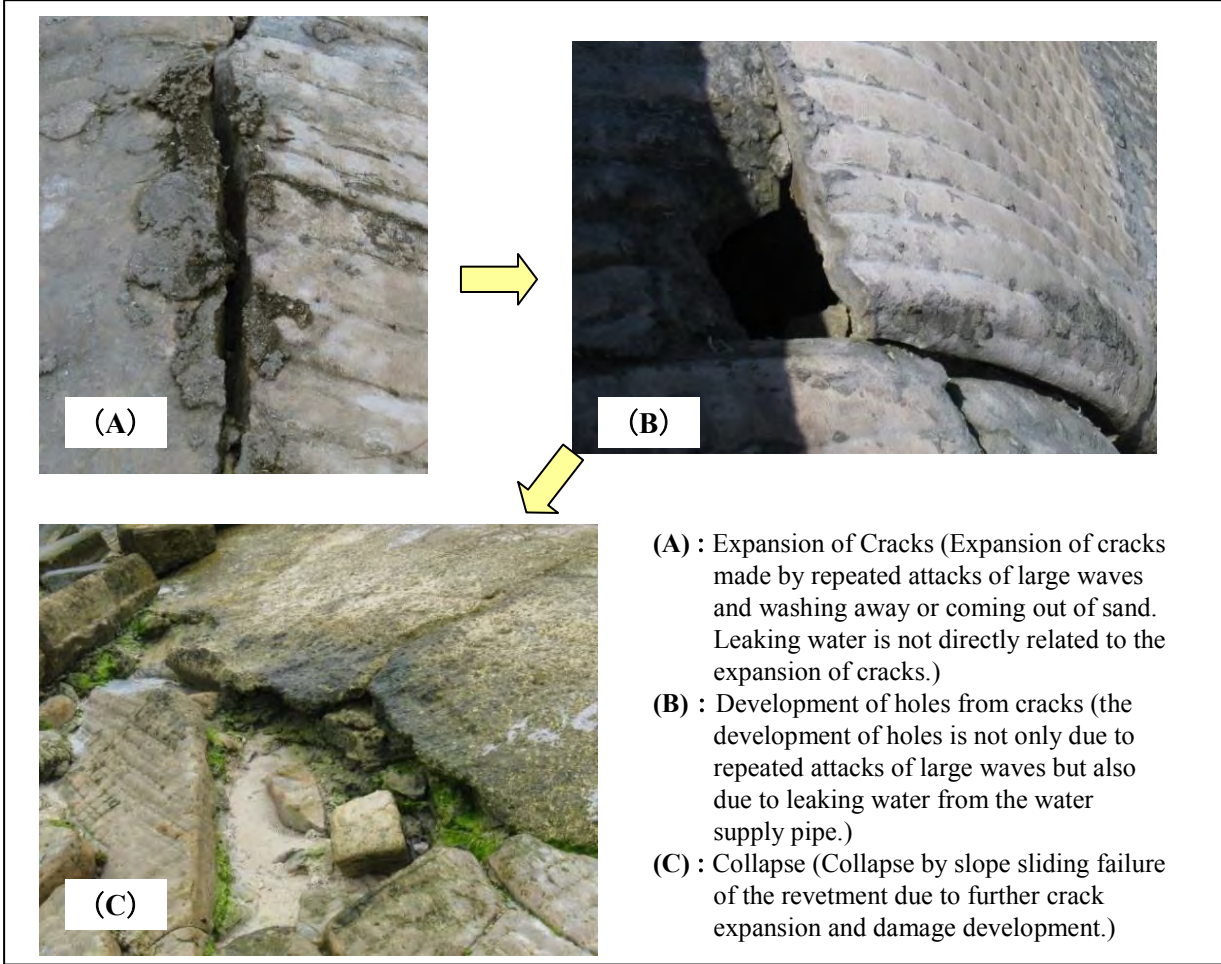
Photo 2.2.1-3 Collapse from Crack Expansion

It is commonly observed that damages with a hole shown in Photo 2.2.1-3 (B) developed and expanded quickly due to repeated attacks of large waves. Coming out of sands constructing the revetment is to be the cause of damage after development of cracks.

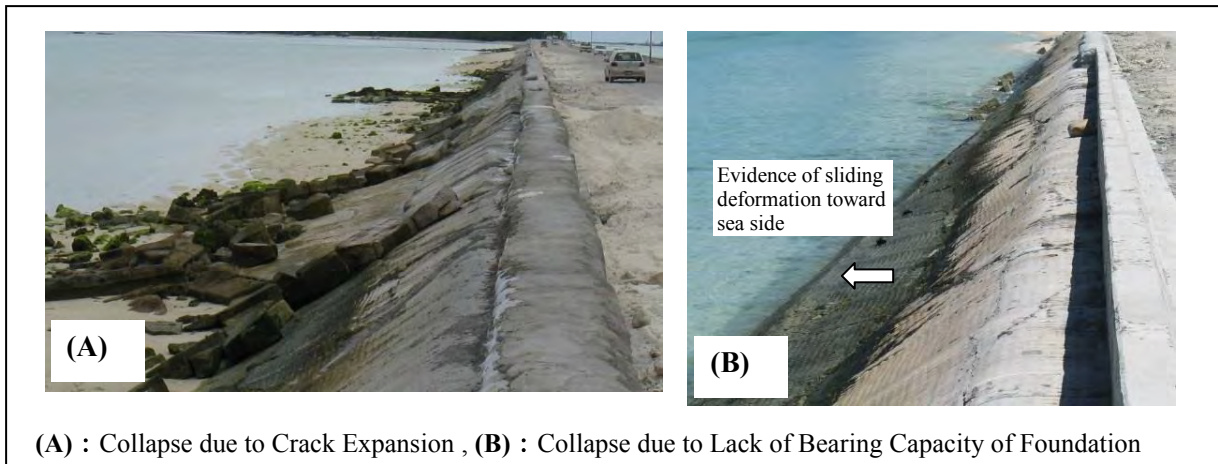
Photo 2.2.1-4 Collapse Types of Revetment

Collapse types of the revetment are to be classified into two types, which are collapse due to crack expansion and collapse due to lack of bearing capacity of foundation, as shown in Photo 2.2.1-4. Collapse due to crack expansion is caused by coming out and washed away of sand inside of the bank, on the other hand collapse due to lack of bearing capacity of foundation is caused by the revetment foundation not firmly being placed in the proper ground.

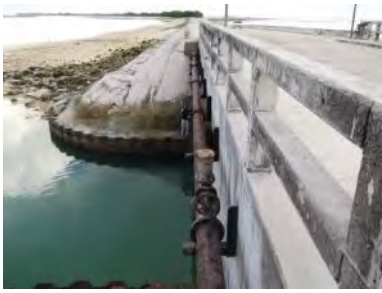
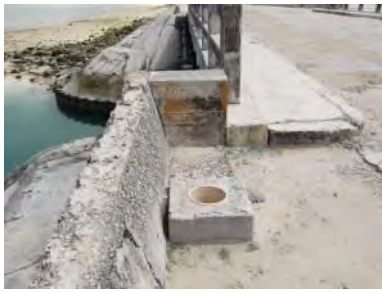
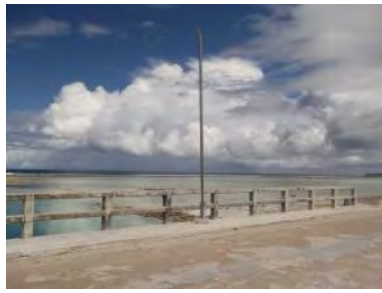
[Photo-10] Attached water pipe at ocean side of bridge (There is no water leaking and the condition is sounded)	[Photo-11] The water bulb at Bairiki side.	[Photo-12] The lighting pole not operated.

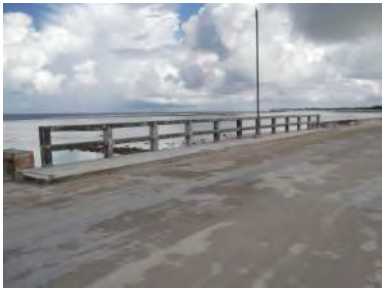
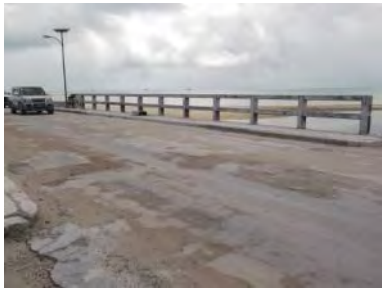
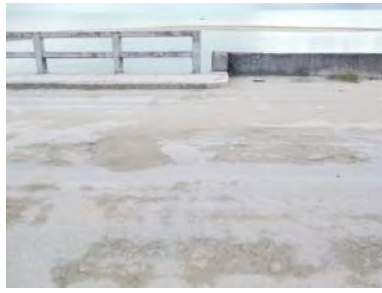
[Photo-13] Handrail at ocean side (There is no damage)	[Photo-14] Handrail at lagoon side (There is no damage)	[Photo-15] The boundary of box culvert and road (There is no expansion joint)

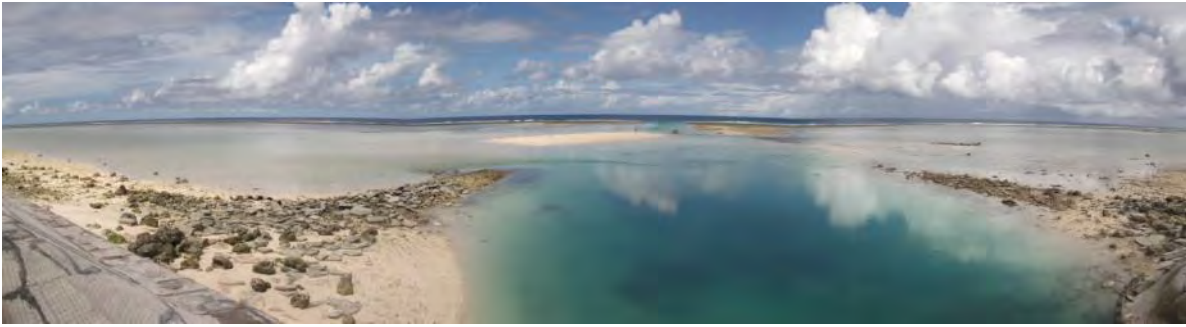
[Photo-16] Waterway at ocean side (The opening is protected by concrete blocks. The navigational operation is difficult during low tide)

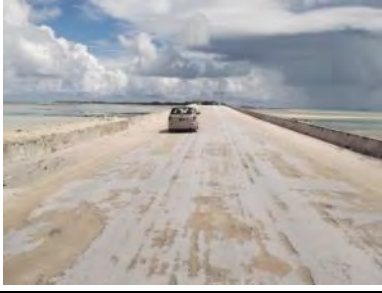
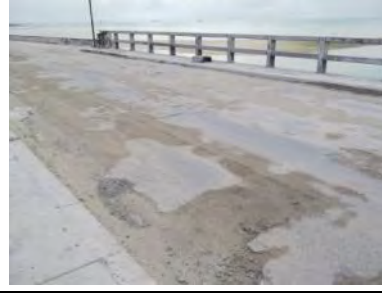
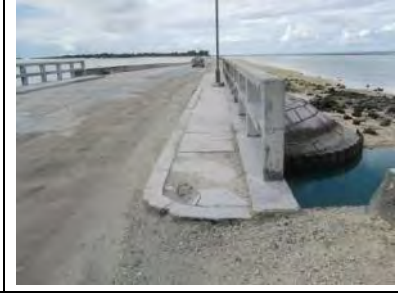
[Photo-18] Road surface condition (The pavement had washed out)	[Photo-19] Bridge surface condition (The pavement had washed out)	[Photo-20] Bridge newel post at Betio-Ocean side is corrupted.

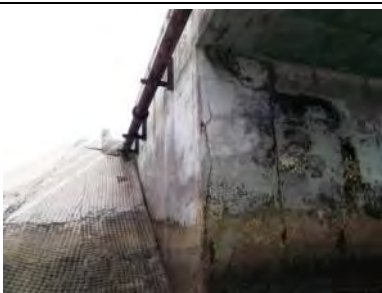
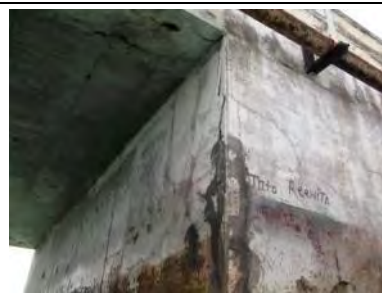
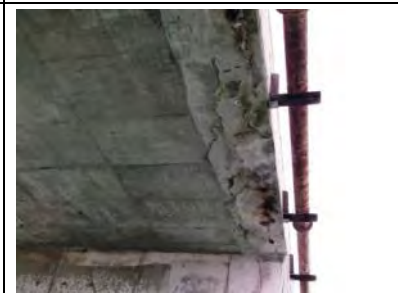
[Photo-21] Damage of concrete wall with rust fluid and spalling (Betio-ocean side)	[Photo-22] Damage of concrete wall with rust fluid and spalling (Bairiki-ocean side)	[Photo-23] Damage of concrete slab with rust fluid and spalling (Ocean side)

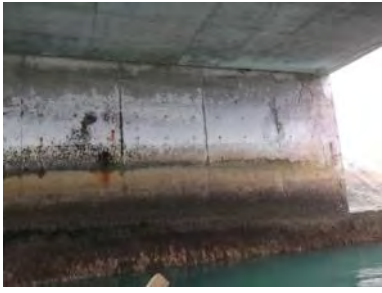
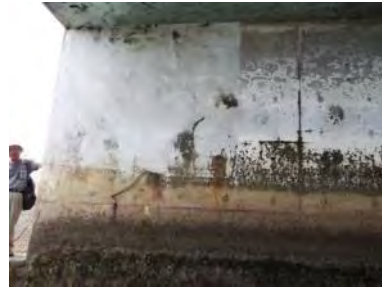
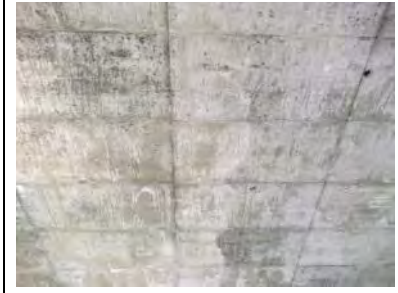
[Photo-24] Damage of concrete wall with rust fluid and spalling (Betio-lagoon side)	[Photo-25] Damage of concrete wall with rust fluid and spalling (Bairiki-lagoon side)	[Photo-26] Damage and deterioration on the bridge slab

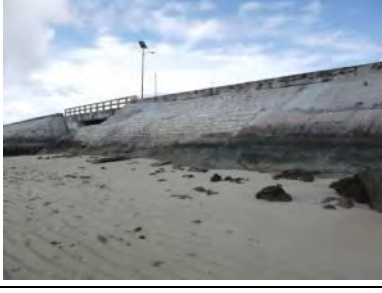
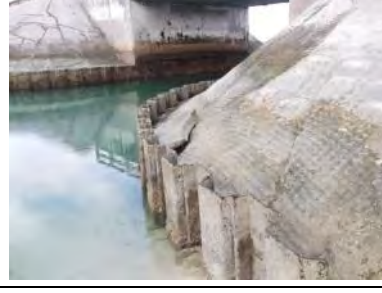
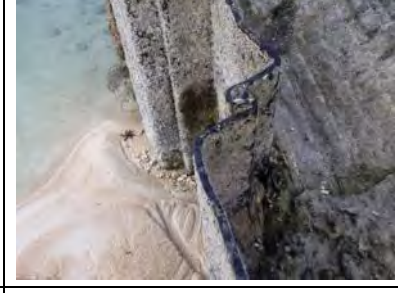
[Photo-27] Damage of road retaining wall (Fabric mattress) and repair work (Betio-lagoon side)	[Photo-28] Damage of Steel Straight Sheet Piles (The concrete cover has washed off)	[Photo-29] Steel Sheet Pile (There is no damage and deterioration)

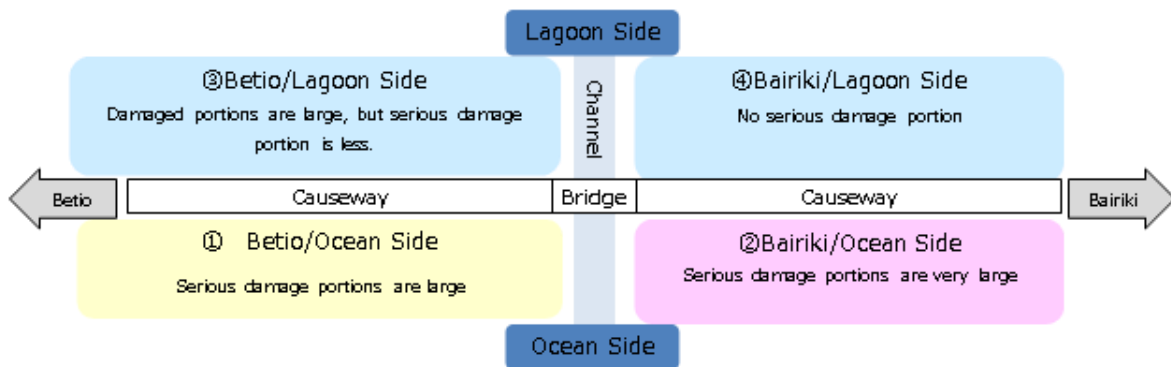
Figure 2.2.1-2 Features of the Causeway Damage

Schematic drawing of the causeway which is divided into four sections is shown in Figure 2.2.1-2. Existing revetments of lagoon side and ocean side are same structure. But disaster situation by the waves in the past differs in each section. In the results of inventory survey of the revetments, the revetment damage of ocean side is very serious, and revetment damage of lagoon side is small. In particular, the damage of the revetments of ocean side and Bairiki side are very serious.

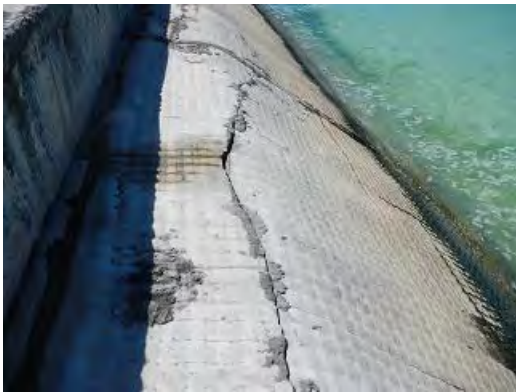
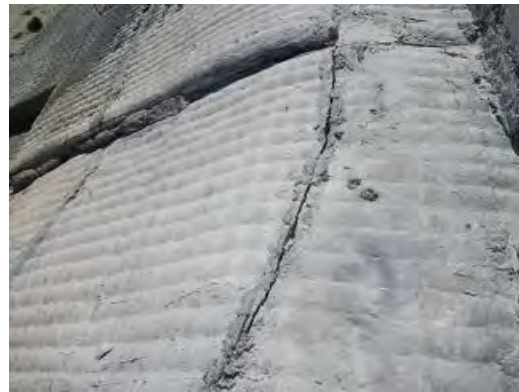
Peeling after application of mortar due to poor workmanship

(2) Slope crack repair by using mortar

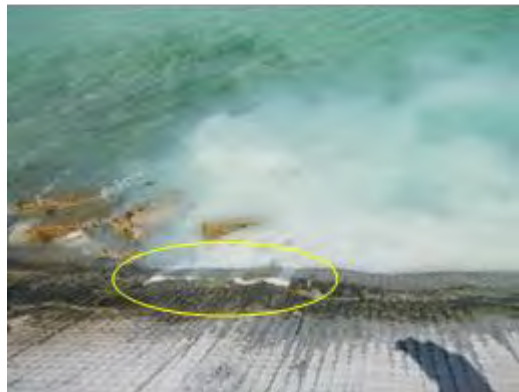
Outflow of filling materials from cracks

(3) Cavity filling behind slopes

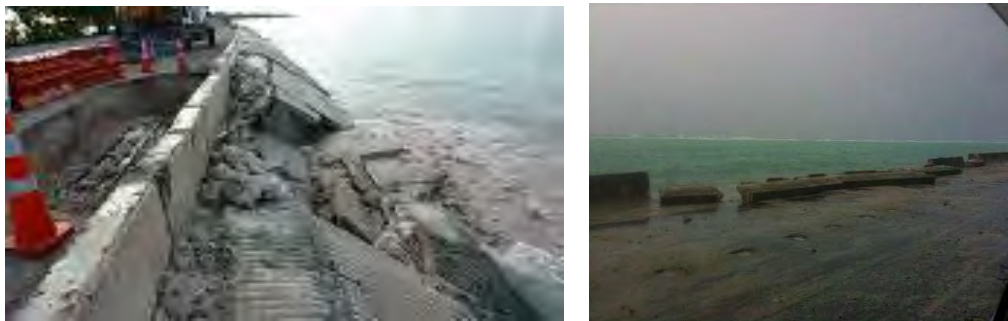
The damage of causeway was brought about by the overtopping seawater which overflows on the shoulder and penetrates the soil from the loose place and flows along with backfilled sand. Then the slope collapsed and the seawall is also destroyed by the repeating wave force.

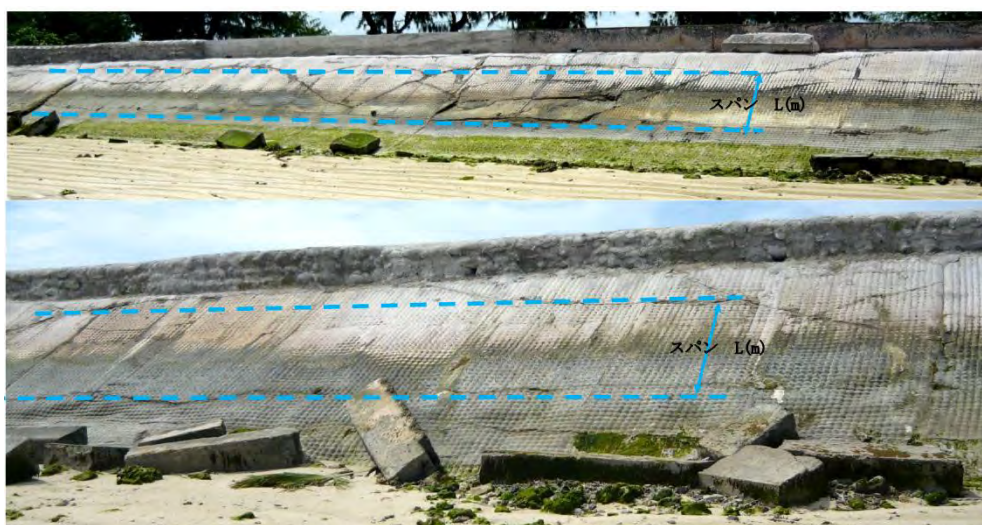
Photo 2.2.2-1 Site Condition of Cracks on Revetment Slope (Bairiki Ocean Side)

The water proof characteristics of the fabrimat mat should cause a repeated alternate forces acting to the mat surface due to the difference in ground water level, wave height and tidal level on the both faces. Since the upper and lower slope of the fabrimat mat are fixed, cracks around at the fixed parts are likely to be generated due to the bending moment caused by external forces when the fabrimat mat fluctuates. In fact the cracks develop at the upper and lower parts on the many slope surfaces as shown in Photo 2.2.2-1.
