**Ministry of Works, Transport and Communications
Reli Assets Holding Company
United Republic of Tanzania**

**Preparatory Survey on
Flood Protection Measures for
Central Railway Line
in the United Republic of Tanzania**

**Final Report
Volume 1: Main Text**

July 2016

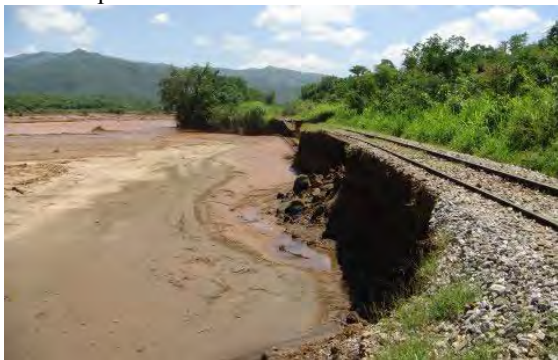
Pattern 1: Flood damages from the main stream (Kinyasungwe River)	
<p>Pattern 1-1: Washaway and/or scouring of bridges foundations. An example at Km 293</p>  	<p>Pattern 1-2: Erosion of the track embankment. An example at Km 299.5</p>

<p>An example at Km 337.4, 6 March 2015</p>

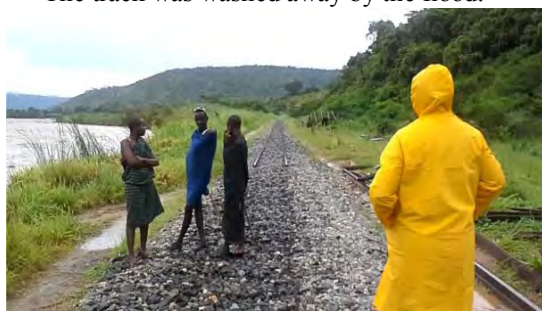
<p>Pattern 1-3: Washaway of the track and/or water/mud flowing over the track An example at Km 302 (toward Kilosa) The track was washed away by the flood.</p>

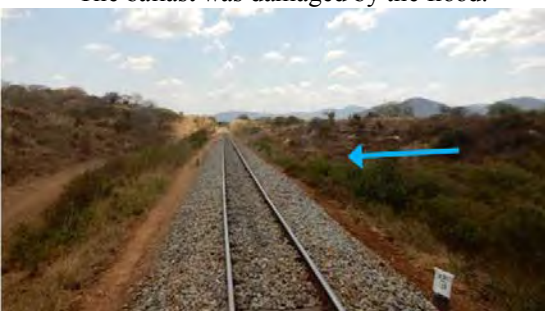
<p>An example at Km 331 (toward Gulwe) The ballast was damaged by the flood.</p>

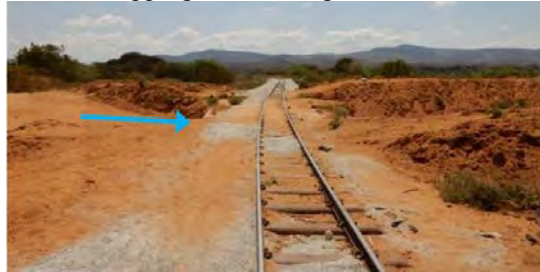
An example at Km 337.1 (toward Gulwe)
Overtopping flood damaged the track.

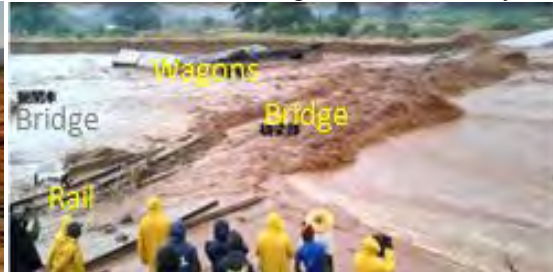
An example at Km 365 (Mzase River)
The track on the bridge was washed away.

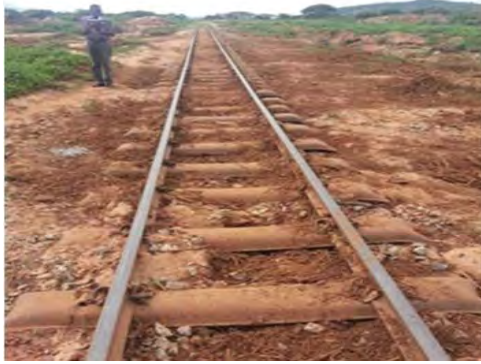
Km 349 (4B - 7C) Maswala Section
Overtopping flood damaged the track.

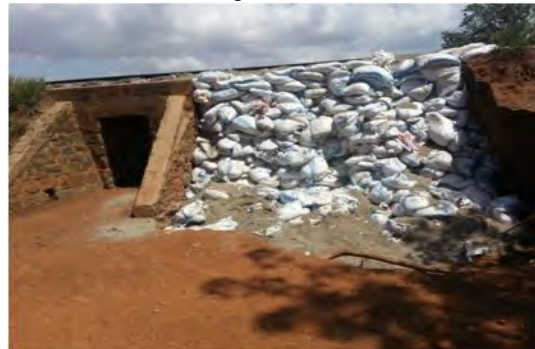
Pattern 2-2: Damage of the track embankment
An example at Km 378.5

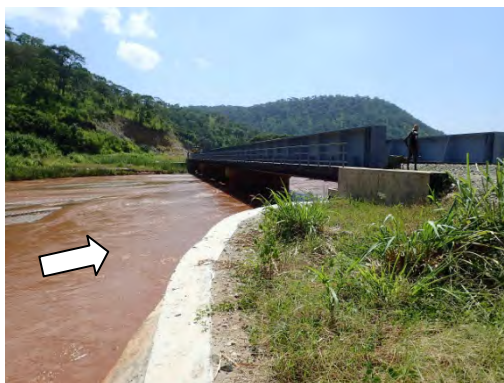
**Figure 5.9: Completed New Bridge
at km 293**

No significant change at the section of new bridge crossing was observed upon inspection on 11 February 2015 with TRL Dodoma staff.

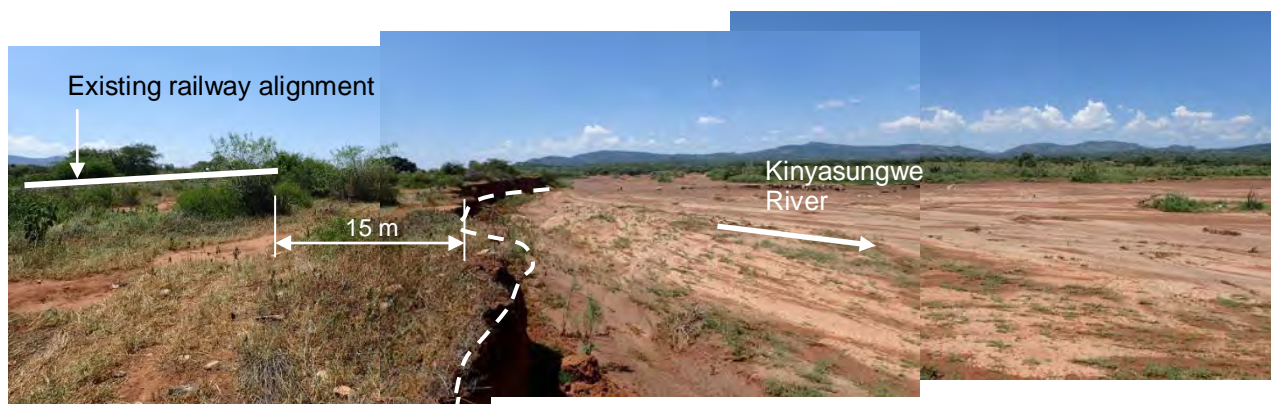
Figure 5.15: Panoramic View toward Upstream at Km 337.4 (11 Feb. 2015)

In December 2014, among the stretches excluding the section where restoration works were undertaken by TRL, this site was considered to be the most crucial portion susceptible to bank erosion caused by directly hitting of floodwaters. The riverbank at Km 337.4 remained at a distance of about 15 m in February 2015, as shown below:

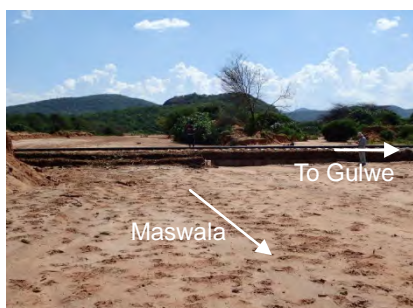
Figure 5.16:
Near CL349.5B
(buried)

It is noteworthy that the existing railway alignment is running on the under-developing alluvial fan near the confluence of the Maswala and the Kinyasungwe Rivers between Km 349.4B and Km 349.9B. Since the sediment yield of the upstream of the Maswala River is huge, this section is suffering from frequent overtopping sediment discharge, which causes washaways of ballast material and collapsing of railway embankments, etc. In fact, on 1 February 2015, a small-scale flash flood occurred in the Maswala River and hit the railway section and all culverts (five in total: CL349.4, CL349.5, CL349.6, CL349.8 and CL349.9) underneath the railway have been buried completely. TRL deployed their work gangs from neighboring sections and immediately restored the damaged section as an urgent measure. The following photos were taken on 11 February 2015.

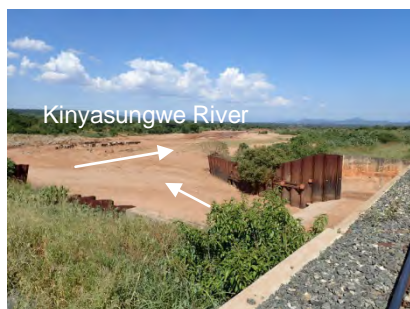
Figure 5.19:
Confluence
with Kinyasungwe

The Kidibo River meets with the Kinyasungwe River at Km 355.0. The existing railway crosses the Kidibo River just upstream of the confluence. The river channel downstream of the Kidibo is protected by steel sheet piles to protect from bank erosion at both sides. Although sediment deposition in the Kidibo River seems progressive, no serious damage to the structures can be confirmed. The span of the Kidibo Bridge is rather short compared with the river channel width of the upstream stretches. Therefore, the bridge section makes an unfavorable bottleneck and forces the water level to rise in the upstream stretch during floods. Further, since the Kidibo flows into the Kinyasungwe at almost a right-angle, channel improvements to make more smooth flow will be necessary.

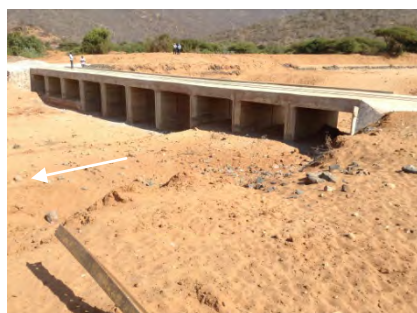
22 Jul. 2014 (1)

A serious accident happened on 28 March 2014 due to a flash flood of the Mzase River. Although the catchment area of the Mzase is rather small, huge sediment discharge brought about serious problems at this section. The following photos show the conditions of box culvert crossing the Mzase River on three different dates:
