**Ministry of Works, Transport and Communications
Reli Assets Holding Company
United Republic of Tanzania**

**Preparatory Survey on
Flood Protection Measures for
Central Railway Line
in the United Republic of Tanzania**

**Final Report
Volume 2: Appendices**

July 2016

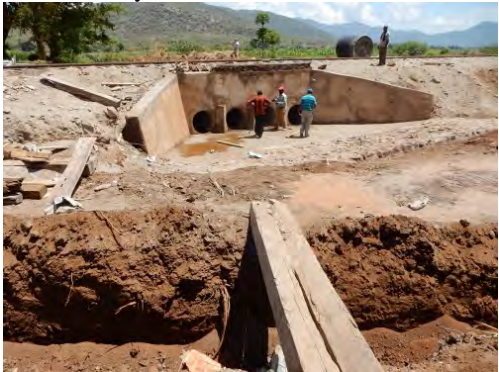
Location	Activities	Photos, Maps, etc.
		<p>Dec. 2014 (Toward downstream) A new Cross drainage due to the relocation of the railway</p>

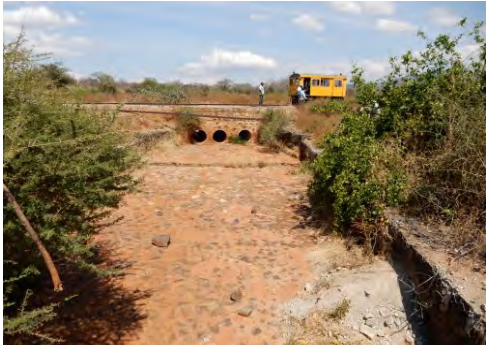
Location	Activities	Photos, Maps, etc.
	4) Km 345.6 and Km 346: Inadequate Cross Drainage Capacity	4) Km 346.1: Dec.2014 (Toward mountain side)

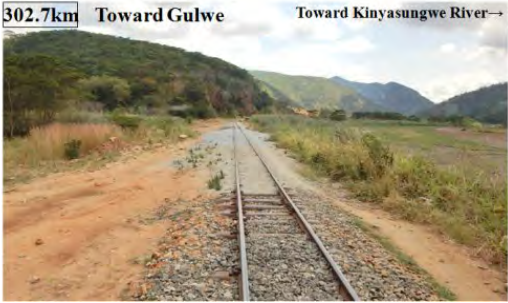
Location	Pattern of Damage	Temporary Remedial Works in the past	Distance between track and river * ¹	Difference of elevation between track and river * ²	Photos of the section	Possible Flood Protection Measures	Priority for Flood Protection
Km 302.6– Km 302.8	• Pattern 1-2, 1-3	• Restoration of the washed-away track	4 m–10 m	2.0 m

<p>302.7km Toward Gulwe Toward Kinyasungwe River→</p>	<ul style="list-style-type: none"> • Re-routing toward the mountain side • Track raising by embankment • Protection from the erosion of the riverbank, etc. • River training works 	High
Km 302.8– Km 303.4	• Pattern 1-3	• Restoration of the washed-away track	30 m–150 m	2.0 m – 2.5 m

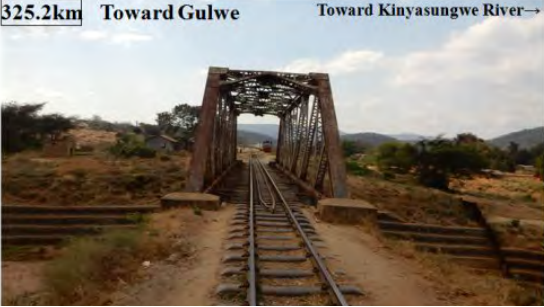
• Improvement of cross-drainage	Low
Km 325.2 Lumuma Bridge	• Pattern 2-2	• Repair works was conducted in 1998, as the bridge downstream was scored, gabions were washed away by the flood wave after the failure of Kidete Dam.	900 m	8.0 m	<p>325.2km Toward Gulwe Toward Kinyasungwe River→</p>

• Repair of the gabion works	Low
Km 325.2– Km 325.5 Kidete Station	• Pattern 2-1		480 m	7.0 m	<p>325.3km Toward Gulwe Toward Kinyasungwe River→</p>

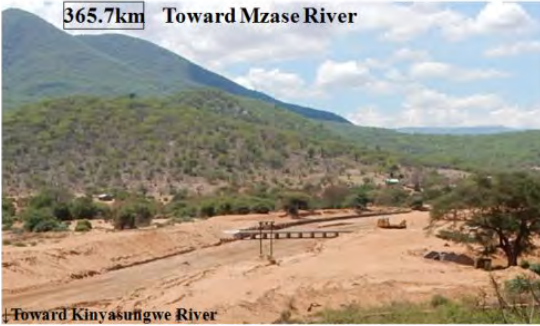
Location	Pattern of Damage	Temporary Remedial Works in the past	Distance between track and river * ¹	Difference of elevation between track and river * ²	Photos of the section	Possible Flood Protection Measures	Priority for Flood Protection
Km 365.7 Mzase River Mzase Bridge	• Pattern 2-1	<ul style="list-style-type: none"> The ballast was solidified with cement, as the track on the Mzase Bridge was washed away on Mar. 30, 2014. Gabion works Re-routing the Mzase River 	300 m	2.0 m

<ul style="list-style-type: none"> Re-routing the track toward the mountain side Tack raising 	High
Km 366.0 Gulwe Station	• Pattern 2-1	<p>(Sometimes, if the space under the bridge is full of mud, Gulwe Station floods.)</p> <ul style="list-style-type: none"> Restoration of the washed-away track 	100 m	2.0 m
